Conservation of Jiaohe ancient earthen site in China

Key words: earthen site; conservation technology; Jiaohe Ancient City; arid areas

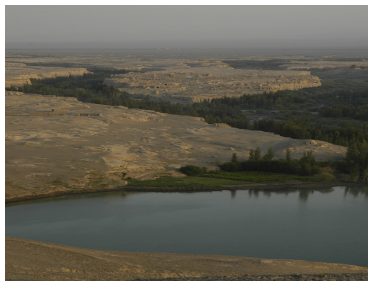
Fig.1 Panorama of Jiaohe Ancient City.

The Jiaohe ancient earthen site is located on land terrace II, a tableland of a willow leaf shape between two rivers. The tableland is about 30 m high, trending in WN-ES direction. The direction of striking is 320° (Fig.1). The altitude of northwestern region is 80.64 m above the sea level. The southeast side is 42.95 m above the sea level. The longest length from north to south is 1 787 m, and the widest width from west to east is around 310 m. The cliff face with almost 90° steep slope borders the tableland.

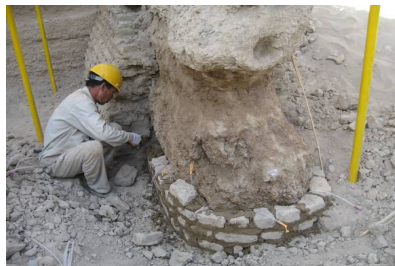
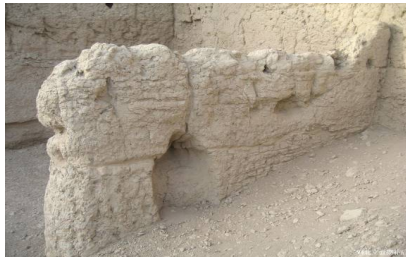
Fig.2 Great Buddha Temple of EW4 during and after reinforcement.

(a) During reinforcement.

(b) After reinforcement.

The mud bricks were fabricated by using soil with less than 0.5% soluble salt content that was similar to the soil used at the site. Local clay with soluble salt content lower than 0.5% was crushed, sifted (diameter less than 0.6 mm), and then mixed with molar ratio (SiO_2 to K_2O) of 3.7–3.8 and 3% concentration of PS to develop the stabilization mixture with water to ash ratio of 0.4. During reinforcement, small bamboo nails 5–10 mm wide and 100–200 mm long were used. The longitudinal and transversal spacings were both no less than 200 mm, and the depth of the hole was 40 mm. In order to improve the adhesive forces between main body and mud bricks for bricklaying and reparation, the areas with large openings were filled with certain types of structural materials, such as steel and wooden frames. Through detailed investigations on colors, shapes, structures and other surface appearances of the reinforced body, the final reparation measures were

implemented (Fig.2) to be in harmony with the original appearances of the reinforced body.

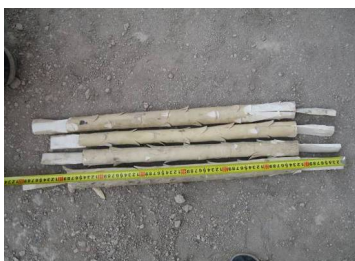
Fig.3 Wooden anchor employed for reinforcement of earthen site.

Generally, anchor bamboos or wooden rods with diameter ϕ 35–50 mm, wall thickness of 0.5–1.0 cm (Fig.3) and water content not greater than 3.0% were used at this site. The tensile strength of a single bamboo or wooden rod was not less than 10.0 kN. Holes of 50 mm in diameter were drilled with a helical auger and the inclination angle was no more than 5° (Fig.4). The mortar was prepared by mixing molar ratio of 3.7 and 10% concentration of PS, and fine particle soil. The water to ash ratio was 0.5–0.6. Upon the completion of drilling, 5% concentration of PS solution with molar ratio 3.8 was injected into the holes for consolidation. During construction, the mortar was poured into the holes firstly, and then the anchor rod was inserted to a proper position. After insertion of the rod, the holes were sealed with a mixture of PS (molar ratio 3.7, 10% concentration) and silty soil. The water to ash ratio of the mixture was 0.3–0.4.

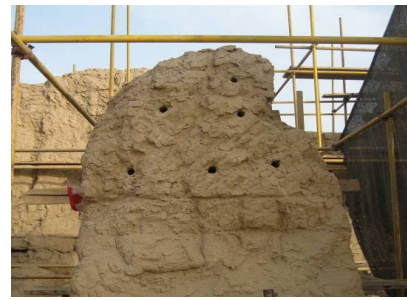
Fig.4 Pre-drilling anchor holes before sealing.

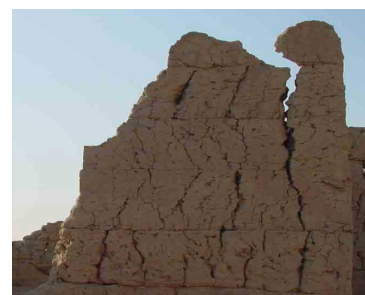
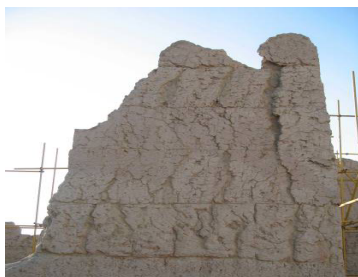
Fig.5 The south facade of northeastern temple S5 before and after consolidation.

(a) Before consolidation.

(b) After consolidation.

According to the characteristics of cracks at Jiaohe Ancient City, three types of consolidation procedures were implemented. They were microcrack and small cavity consolidation, small crack consolidation, and penetrated crack consolidation measures. The grouting materials for crack consolidation was prepared with silty soil and PS (molar ratio 3.7 and 3% concentration) solution, and at the same time, kept the soluble salt content less than 0.5%. According to the scale of the cracks, grouts with different water to ash ratios were developed, generally 0.3–0.6. During the consolidation process, cracks were sprayed with a PS solution (molar ratio 3.8 and 5% concentration) once or twice to reinforce its strength at both sides. The microcrack was filled with the prepared grout using a 5–10 mm size of restoration scalpel. As for small and penetrated cracks, firstly the injective catheter was inserted and the crack was sealed on surface, then the PS-C grout was injected through the injective catheter from bottom to top. If the crack was fairly narrow and small, the water to ash ratio was appropriately increased to reduce the viscosity of the grout, thus to ease the injection process. According to the actual condition, the quantity of the injected grouting material shall be properly controlled. Usually, the grout injection was selected at different spacings to prevent over-filling. Upon completion of injection, the injective catheter was pulled out. Then, a prepared mortar of PS solution (molar ratio 3.8 and 3% concentration) and silty soil with water to ash ratio of 0.3–0.4 was used to seal the injection holes. Figure 5 exhibits the south facade of northeastern temple S5 before and after consolidation.

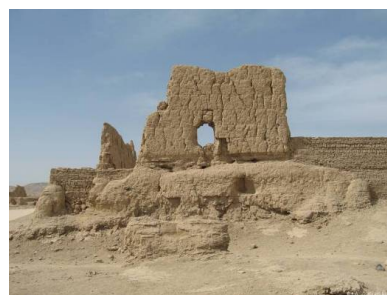
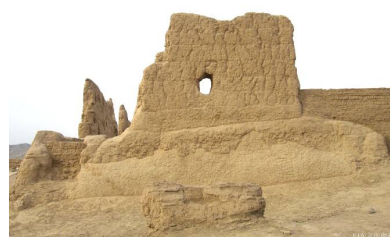
Fig.6 The east facade at Great Buddha Temple E4 before and after reinforcement.

(a) Before consolidation.

(b) After consolidation.

If the weathered surface layer of an earthen body was loose and thick, a large size of syringe needle was directly inserted into the loose strata to increase the height of PS solution. The drip penetration could be conducted via the pressure caused by different water levels. If the surface layer of an earthen body was compact but the inner layer was loose, small holes must be drilled on the surface of the earthen body with a small electrical drill. Then, a large size of syringe needle or a small size of catheter could be inserted into the earthen body for conducting drip penetration. Some surfaces have a great loose thickness and broken blocks due to weathering, and then it would be difficult to drill a complete hole for conducting drip injection. Sometimes the drilling process might cause damage to the surface layer. In these cases, the surface layer of the earthen body should be sprayed with PS solution once firstly to enhance the integrity of the loose surface. Then, holes were drilled and the drip penetration was carried out by using a 5% PS solution. When the integrity of the surface layer cannot be guaranteed, the surface of the earthen body was firstly sprayed with 5% PS, and then it was bored before drip penetration. After drip penetration, 5% PS solution can be sprayed one more time to improve the consolidation of local areas. Figure 6 shows the east facade at Great Buddha Temple E4 before and after consolidation.

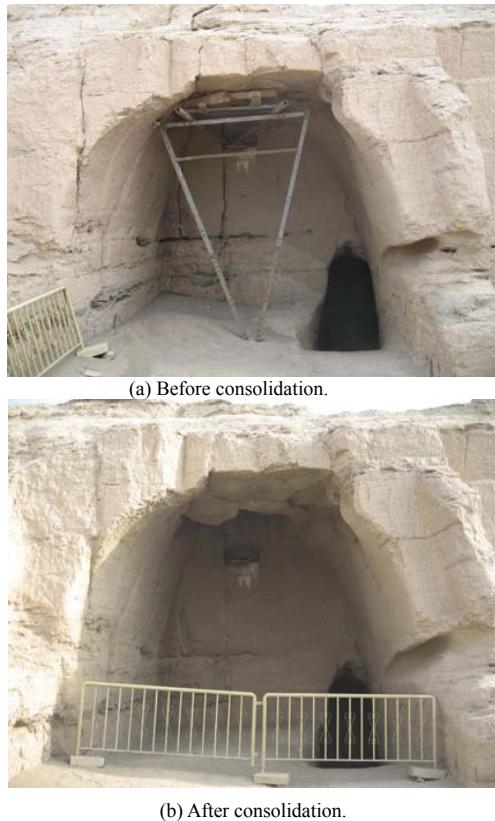
Fig.7 West cave opening of the official building before and after consolidation.

Cracks have been developed drastically in caves at Jiaohe Ancient City. Very often, cave top was split into several separated blocks by cracks. Gravity pull and/or other external forces caused caves to collapse (Fig.7). Aiming at the above mentioned situation, if a traditional method would be applied to support or jack and repair, it would cause a great negative impact on the original appearance of the cultural heritage sites.

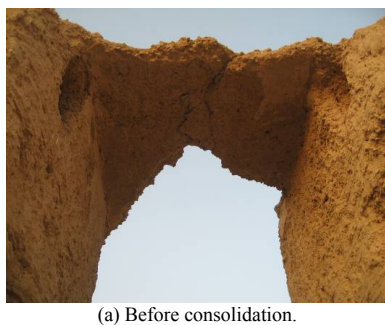
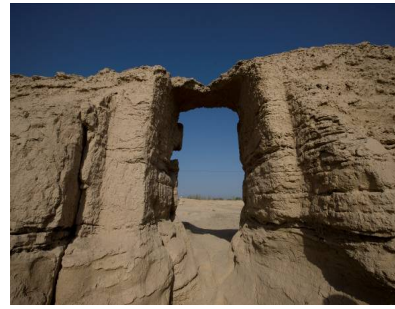
Fig.8 Doorway of the official building before and after consolidation.

Utilizing the suspended steel beam ceiling method could effectively preserve the original appearance of the caves, in which the inner force would be transferred to the stable parts of the cave through steel beams. Therefore, anchor rods or other measures could be taken to improve the integrity and ensure the stability of the site (Fig.8).

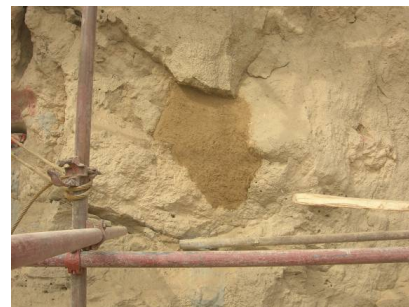
Fig.11 Anchor hole with completion of old treatment.

Finally, the borehole was sealed with 3% PS solution mortar containing 10% hemp fiber, then the soil block was embedded in the mortar, and it was coated again with a layer of hemp fiber mortar for the second time to achieve the “appearing-old” purpose (Fig.11).

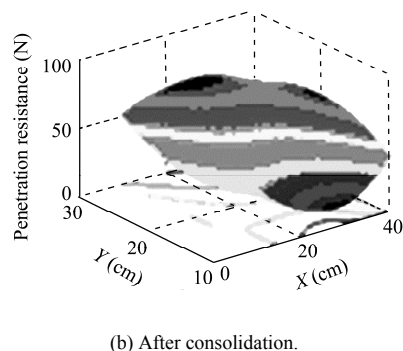
Fig.13 Test results of micro penetration meter.

In addition, a micro penetration meter was used to check the effectiveness of consolidation of PS material (Fig.13). From Fig.13, it was observed that the penetration value of wall body was increased after consolidation, which illustrated that the consolidation was effective.

(a) Before consolidation.

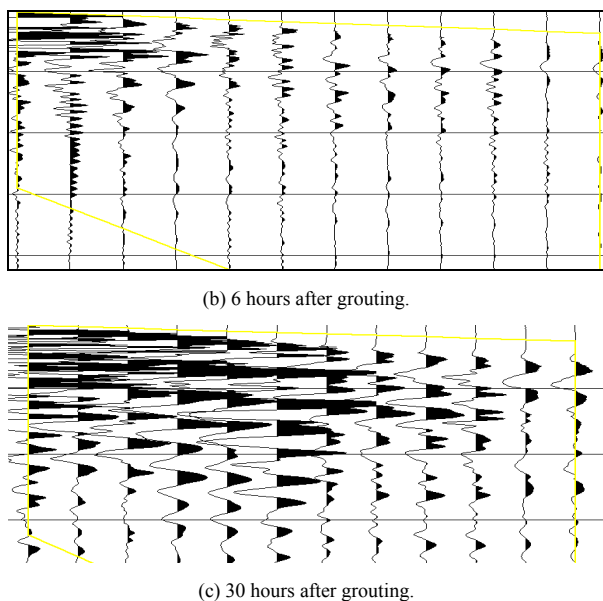
Fig.14 Wave forms of grouting inspection of cliff top at various times.

Figure 14 shows that before grouting, surface wave energies were attenuated during passage through the cracks. Only very low wave intensity was recorded.

(a) Before grouting.

Six hours after the completion of grouting, the wave form exhibited little variation. This insignificant change might result from that the mortar grouting was not totally cured yet. However, 30 days after the completion of grouting, intense continuous waves were recorded during inspection. This meant that the grouting material had successfully sealed the cracks.

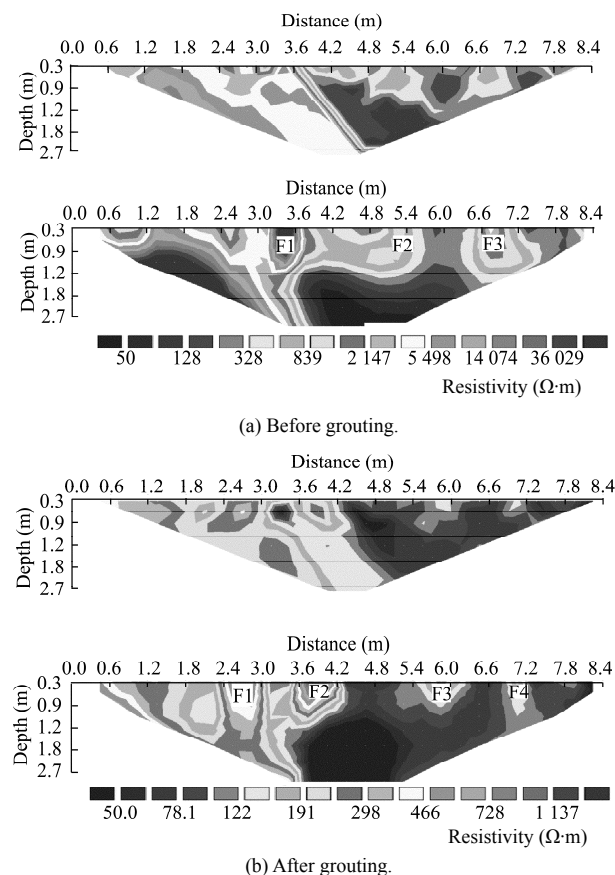
High-density resistivity method was used to measure the changes in stratum resistivity (Fig.15). From Fig.15, it was observed that the resistivity forms of cracks and sand layer before and after grouting were exceptional. Before grouting, the crack F1 was wide, and its vertical depth was great. The value of resistivity was as high as $(3-6) \times 10^4 \Omega\cdot m$. The resistivity of other small cracks was also very high. After grouting, the resistivity of separated blocks at the edge of the cliff and the shallow stratum was lowered to some extent, and the resistivity along the cracks had also been changed. The resistivity of crack F1 was lowered to several hundred $\Omega\cdot m$ and that of F2 was lowered to approximately 1 000 $\Omega\cdot m$, while those of cracks F3 and F4 were only 200 $\Omega\cdot m$. Since the size of the crack was smaller than electrode distance, the resistivity of the cracked area was in fact the composite resistivity of crack and the surrounding stratum. The actual crack resistivity was less than the resistivity of consolidated mortar. According to test results, it can be seen that the grouting was effective.

Fig.15 Distribution and comparison of apparent resistivity (upper) and inversion resistivity (low) before and after grouting.
