XXIII R-S-P seminar, Theoretical Foundation of Civil Engineering (23RSP) (TFoCE 2014)

The Washout Mechanism of the Niedów Dam and its Impact on the Parameters of the Flood Wave

Stanisław Kostecki^{a*}, Wojciech Rędownicz^a

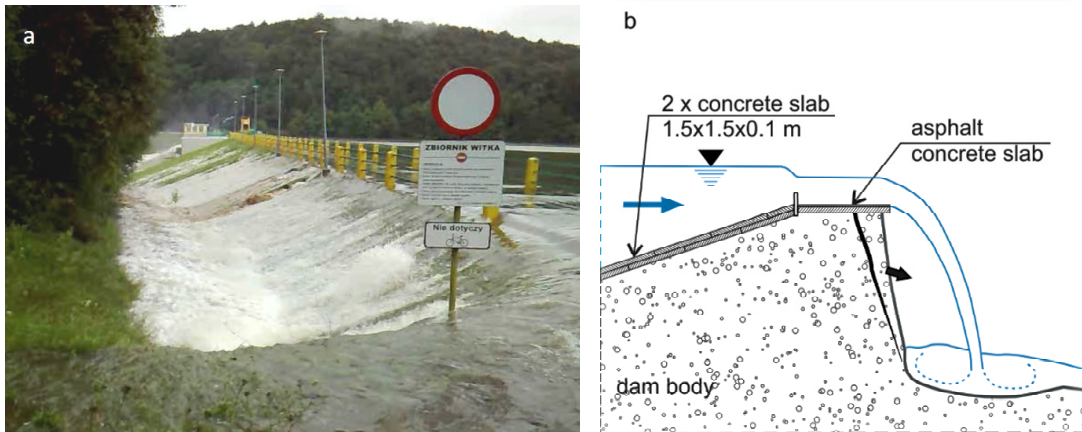
Fig. 2. (a) Phase 1: time 5:10 PM, water level $H = 211.60$ m a.s.l.; (b) Mechanism of phase 2 of the slope washout.

The washout progressed through 3 phases featuring different breach development conditions. In the 1st phase, water flew over the crest and the downstream slope with high velocity. Within minutes water tore off the compact layer of sod, starting from the weakest spots around the light posts, and the washout of the dam body followed (Fig. 2a).

Phase 2 devastated the dam body from the downstream side. Water falling from the crest with high velocity hollowed the body, forming the characteristic breach shown in Figs. 2b) and 3a). The growth of the breach destabilized body, which collapsed into the gap and were washed out and down the river. Within approx. 25 minutes the concrete crest lost its base, with different rates at various cross-section points, and then broke down, collapsed and was washed out, which triggered the next washout phase (Fig. 3b).

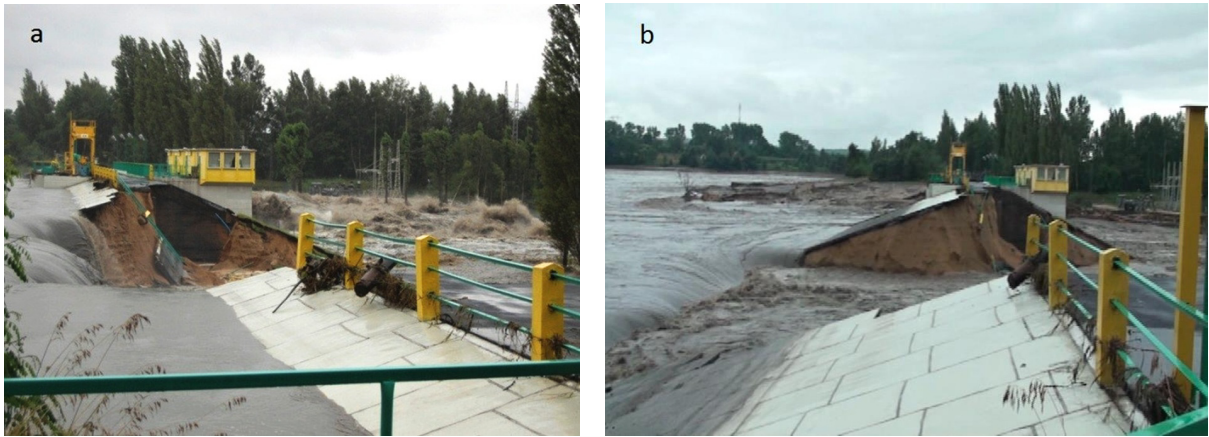
Fig.4. Phase 3 of the right side: (a) 6:22 PM, water level $H = 210.70$ m a.s.l.; (b) 7:45 PM, right side, empty reservoir.

Phase 3 took from approx. 5:35 PM to the complete drainage of the reservoir as the concrete slabs of the upstream slope resisted longer. The upstream slope had a two layers of slabs, the top ones offset by 0.5 of their widths and heights relative to the bottom slabs, bound together with bituminous sealant. This made the concrete

cover of slope more rigid and resistant to overturning by the force of water. Once the next slice of the body was washed out, the slabs broke one horizontal row after another and were washed down by water (Fig. 4a). Given the progressing decline of the dam height and high water velocity on the overfall, the range of the stream grew, which significantly extended the duration of the slab bottom washout process (Fig. 4b).
