Brief Clinical Reports

Early structural valve deterioration of 18-mm Sorin Soprano aortic pericardial bioprosthesis

Luis Fernando López Almodóvar, MD, Pedro Lima, MD, Alfonso Cañas, MD, José Buendía, MD, and Emilio Monguió, MD, Toledo, Spain

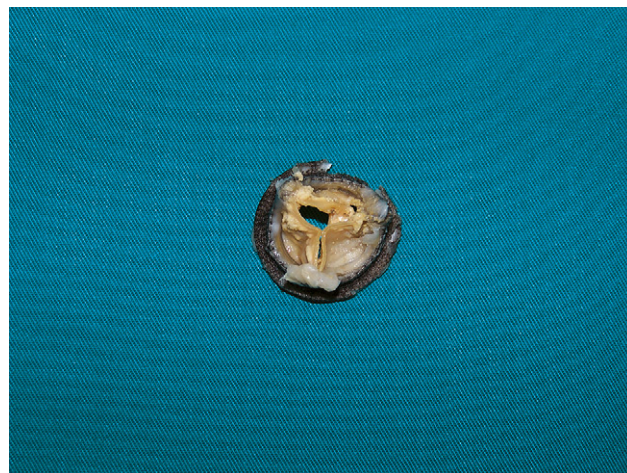
A reoperation was performed, and examination of the prosthesis before explantation showed the valve to be well seated in the supra-annular position. The prosthesis was stenotic because of intrinsic and vegetating calcifications in all leaflets, and a calcified tear in the noncoronary leaflet resulted in a lack of leaflet coaptation, causing aortic regurgitation (Figure 1). The valve was replaced with a 19-mm mechanical valve. The patient recovered completely and was discharged uneventfully.

FIGURE 1. Explanted prosthesis shows intrinsic and vegetating calcifications in all leaflets with calcified tear in noncoronary leaflet.

Sorin Biomedica Cardio was contacted, and the prosthesis was sent to the manufacturer for analysis. Sorin has confirmed that the cause of this valve structural deterioration was related to large intrinsic and vegetating calcifications affecting all the leaflets and causing stenosis (mean calcification score 3.33 out of 4). This prosthesis was initially stenotic because of intrinsic and vegetating calcifications in all leaflets and subsequently became insufficient because of tears. In this case,

a calcified tear in the noncoronary leaflet with perforation was observed. It is difficult to determine whether the tear was primary or calcium related.⁴ Probably, the presence of these calcium depositions encouraged tearing. We speculate that the postoperative finding of elevated peak transvalvular gradient was associated with a dynamic obstruction in the left ventricular outlet, and this situation led to mechanical stress during the systolic phase. The right coronary leaflet had intrinsic and vegetating calcifications with stiffness but without tearing. In addition, the commissural areas were severely calcified. These areas are designed to absorb and distribute the mechanical stress during the cardiac cycle. Thus when the leaflets are opened, they are completely free of stresses. Although a stent distortion is extremely rare and unusual, we can not reject this possibility completely.

The Sorin Biomedica Cardio technical report concludes that in presence of severe aortic stenosis and massive calcification before the implant, calcifications may have been triggered by the presence of such risk factors as hyperlipidemia and hypercholesterolemia.
