Procedia Engineering 117 (2015) 891 – 899

**Procedia  
Engineering**[www.elsevier.com/locate/procedia](http://www.elsevier.com/locate/procedia)International Scientific Conference Urban Civil Engineering and Municipal Facilities,  
SPbUCEMF-2015

# Saving the Architectural Appearance of the Historical Buildings due to Heat Insulation of their External Walls

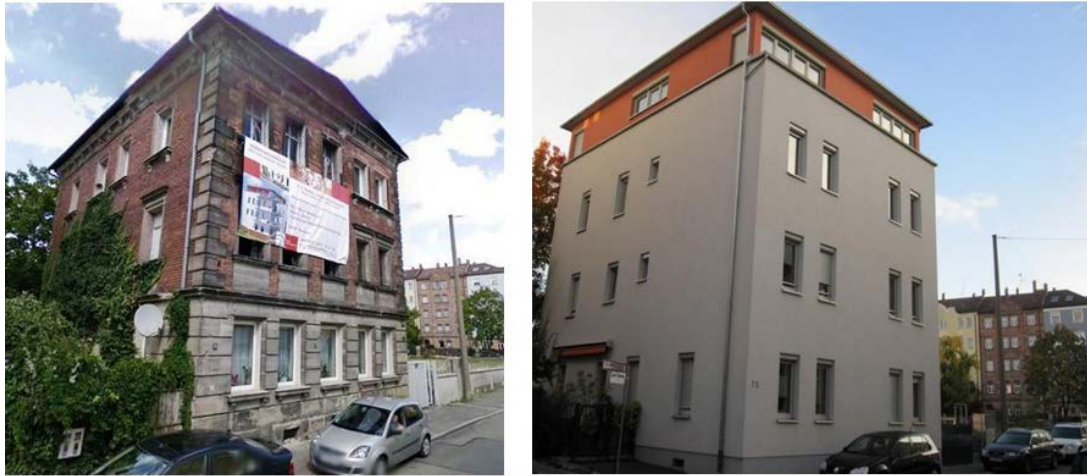
Fig. 1. Thermal insulation historical building, Ludwig Feuerbach-Strasse 75, 90489 Nuremberg Germany [3]

There are some examples of bad practice reconstruction of historical buildings abroad showing complete loss of a historical building image caused by thermal insulation. (Figure 1-3)

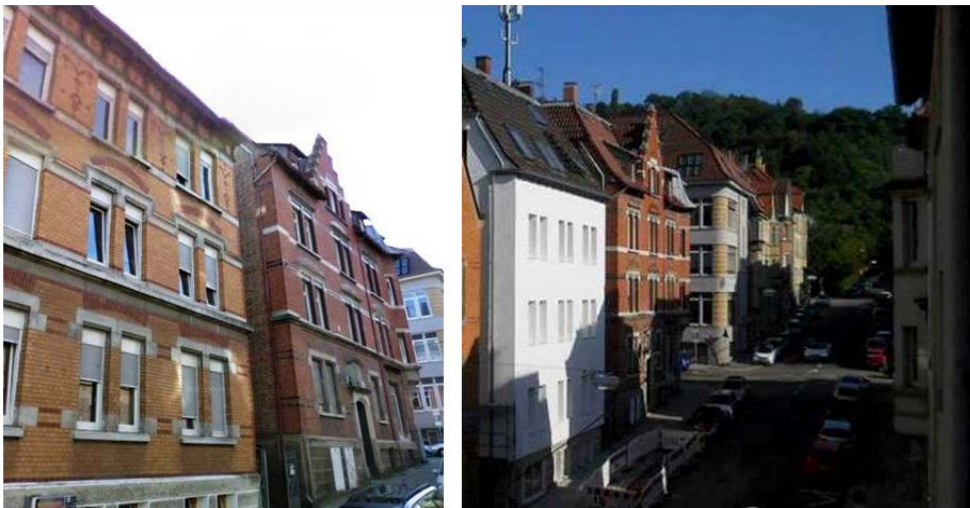
Fig. 2. Thermal insulation house in Stuttgart (Schreiberstraße 23), Germany [3]

An external placement of an insulation layer (Figure 2, 3) is more preferable to insulate facades of buildings while repair and reconstruction works. However, an internal placement of an insulation layer should be applied for front facades of historical buildings under protection which are normally rich in decorative elements.

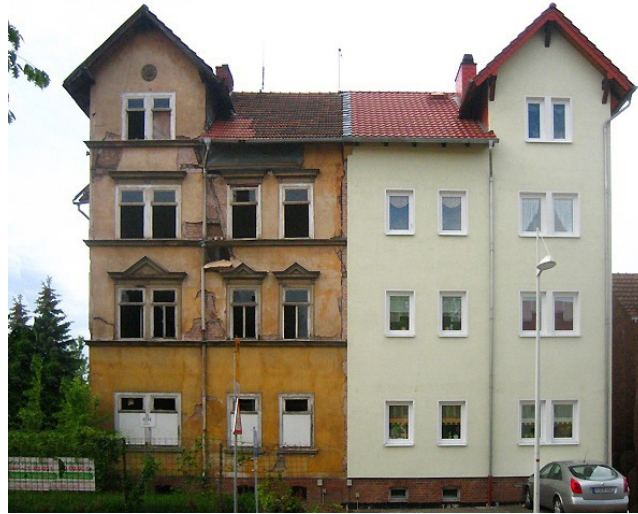
Fig. 3. Thermal insulation historical building in Eisenach, Germany [3]
