## CASE STUDY

# The protection project of Hanyuan Hall and Linde Hall of the Daming Palace

Weidong Hou\*, Wei Wang, Yan Xu

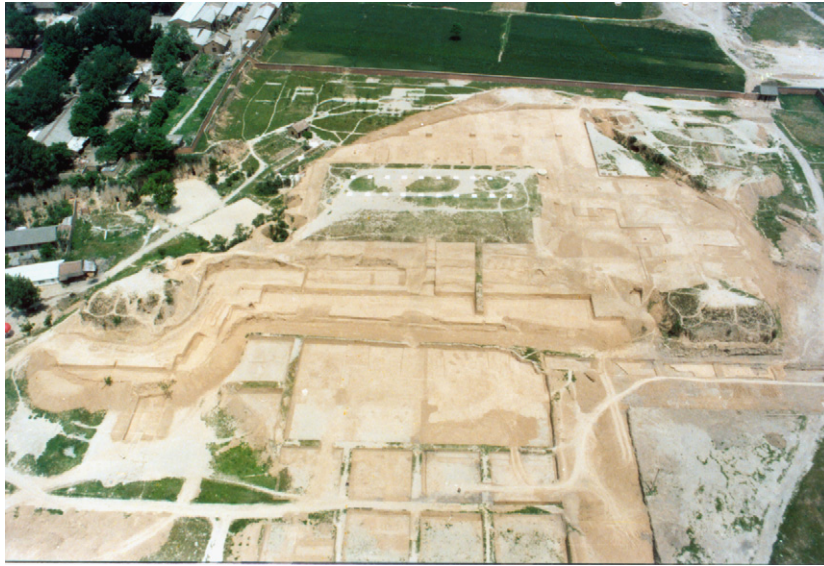
Fig. 1 The site of Hanyuan Hall unveiled by archeology.

- 4) *Limited partial exhibition*: There are remnants that can be exhibited to visitors in some parts of this site, including intact layers of rammed earth, brick apron pavement, and stone foundations under pillars. They were exhibited by setting up observation windows or observation wells in the protective layer, so that visitors could have a realistic feeling (Figs. 1 and 2).

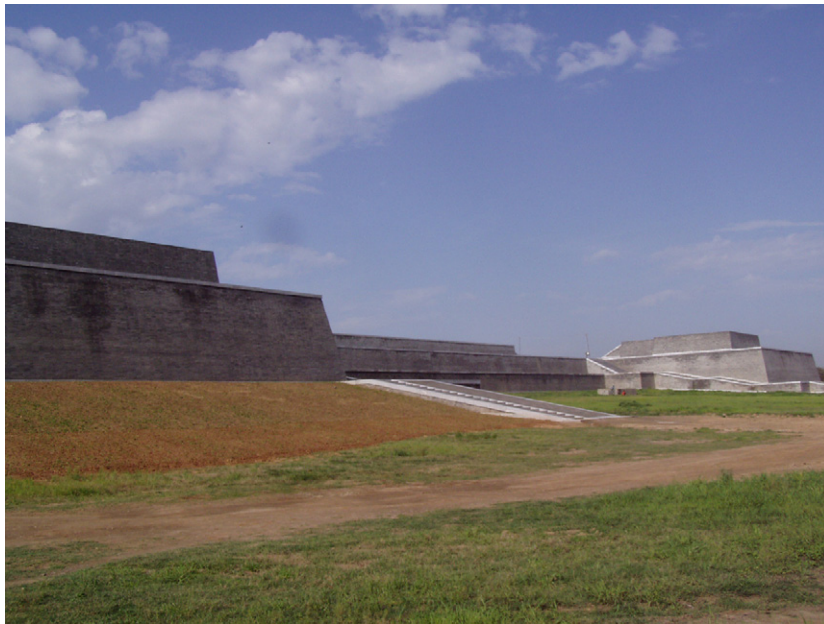
Fig. 2 The site of Hanyuan Hall after the protection project.

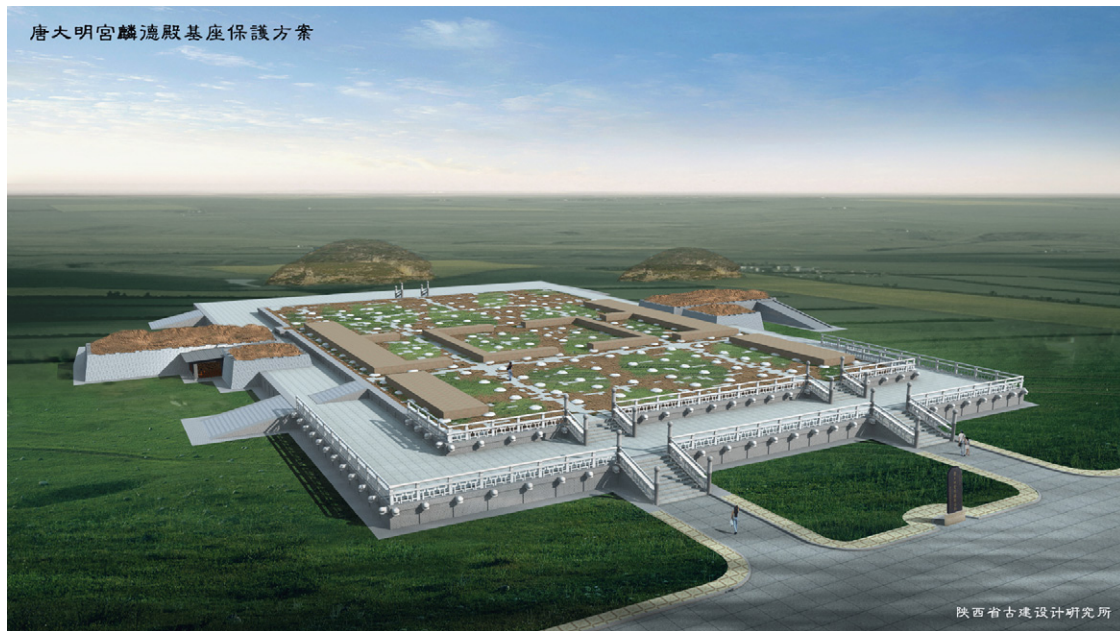
Fig. 3 Rendering of the Protection of Linde Hall Site.

- 2) Shed-cover protection and display window: shed-covers were built in the form of an apron for protective exhibition of the partially intact brick walls. For pillar-foundation stones and gate-pier stones on the surface of the hall, special protective windows and observation wells were built so that viewers can have a better perceptive understanding of the building materials and practices of the Tang Dynasty (Figs. 3 and 4).

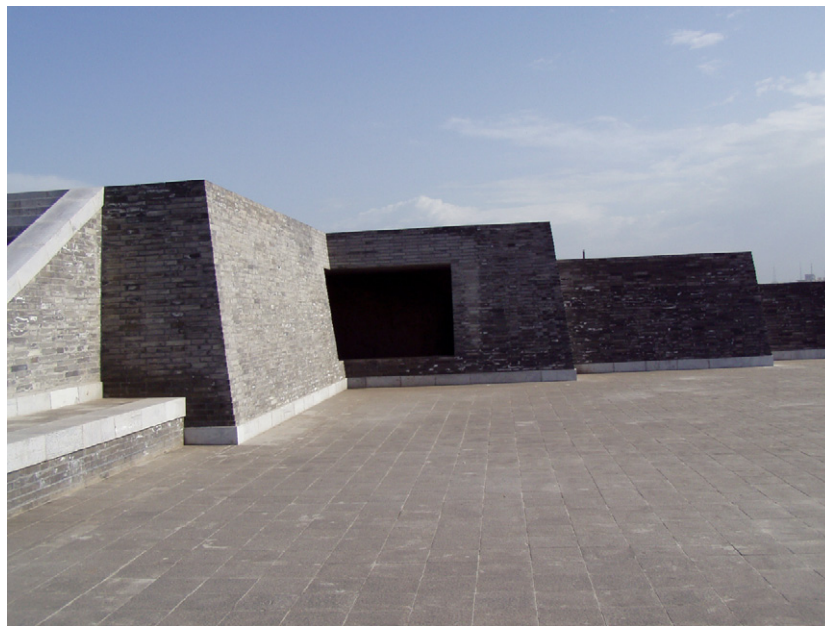
Fig. 4 Recent picture of display window at the Qifeng Palace Site after the protection project.
