# Case Studies in Engineering Failure Analysis

# A failure study of a locking compression plate implant

In this case study a failed locking compression plate was investigated. Such plating systems are used to provide the stability to fractured bone and fixation. The locking compression plate had been separated in two pieces. One of the fracture surfaces from the failed component was investigated for surface topographical features. The visual, optical and scanning electron microscopy results indicated the presence of beach marks, intermetallic inclusions, corrosion pits and striations indicating fatigue crack propagation and overload failure. Some corrosion damage also was documented on the fractography. This case study shows that corrosion may have initiated fatigue crack which grew by the activities of daily living causing the failure.

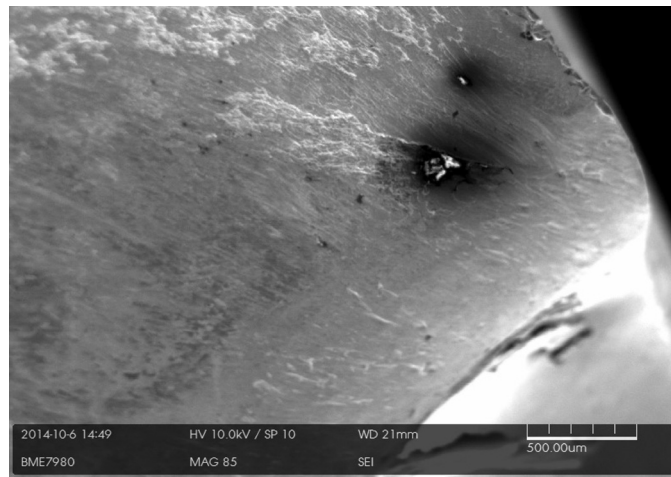
Fig. 4. Image observed under SEM.

Intermetallic inclusions were observed near the area of crack initiation site as shown in Fig. 4. These particles may have formed during material production, manufacturing and/or other treatment methods used. Machining and cleaning details were not available for this study. Due to the presence of the intermetallic inclusion at the surface, this particular area concentrated stress and may have corroded resulting in pit formation. Corrosion damage is also evident in the fracture surface, Figs. 5 and 6.

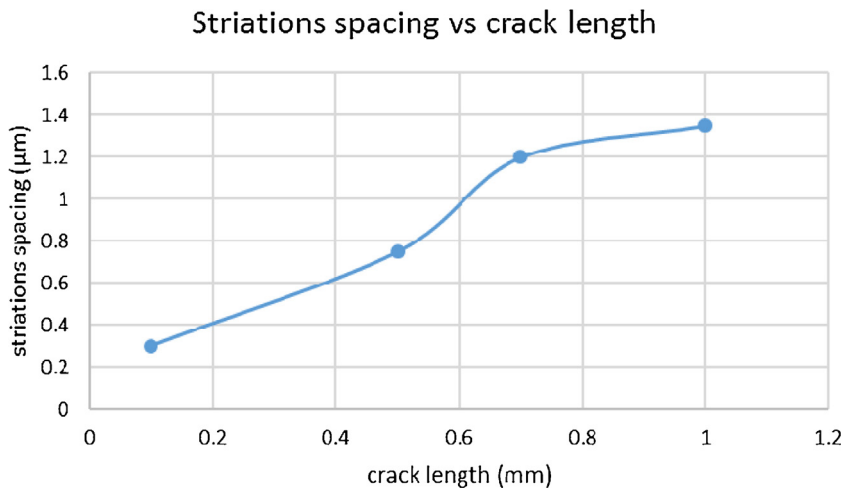
Fig. 7. Striation spacing versus crack length.

thickness of the LCP was 3.5 mm. So from the striation spacing and the thickness of LCP the number of cycles for propagation of fatigue crack was estimated to be approximately 2035 cycles, given that the limited amounts of activities are allowed after surgery. The number of striations was obtained and plotted in Fig. 7. The striation spacing increased as the crack length increased. Since the life of the plate includes both the phases; (1) to crack initiation and (2) propagating the crack to failure, the first phase cannot be quantitatively described. It is well known that the interactive mechanisms between corrosion, which starts a pit, and then transitions to crack, and fatigue which propagates a crack, there may still be interactions between corrosion and fatigue, corrosion fatigue. Therefore, it is not possible to isolate these two phases.

Post-surgery, upon load bearing, the construct was subjected to not only the static loads but also the cyclic loading. When the LCP was subjected to the cyclic loading, the crack propagated. Striations were counted where the convex fracture appearance was found, Fig. 3. The striation spacing at the crack initiation site was small, amounting to 0.3 μm and the spacing increases as the crack increases. In the middle of the fracture surface, the striation spacing was 1.72 μm and the
