Ecological engineering: from concepts to applications

## Management practices for the amelioration of urban stormwater

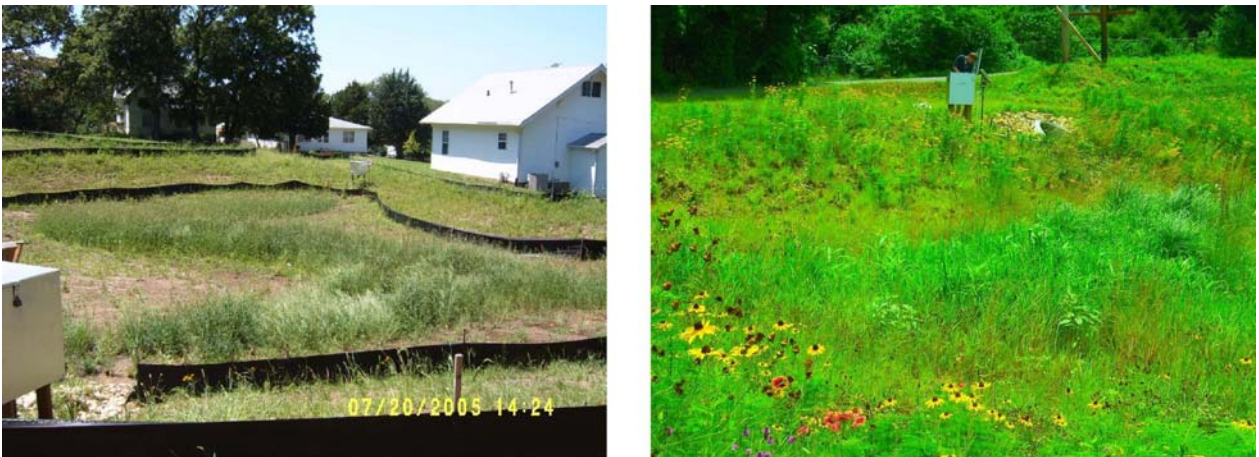
Fig. 2. Quinton Heights site after planting in July 2005 and at the beginning of the third growing season in May 2007. Note the grassed waterway through the bottom of the cell was planted with prairie cord grass plugs while the rest of the site was drilled with seed

Construction on the stormwater project began in 2004 with planting of the site completed in the spring of 2005. The 1,550-m<sup>2</sup> basin was designed to receive runoff from a 6,000-m<sup>2</sup> area, the majority of which flows down a street and into the basin through a grated opening placed in the middle of the street [7]. After excavation, the basin was replanted with grasses and forbs native to the tallgrass prairie, including big bluestem (*Andropogon gerardii*), Indiangrass (*Sorghastrum nutans*), switchgrass (*Panicum virgatum*), prairie cord grass (*Spartina pectinata*), and sideoats grama (*Bouteloua curtipendula*).

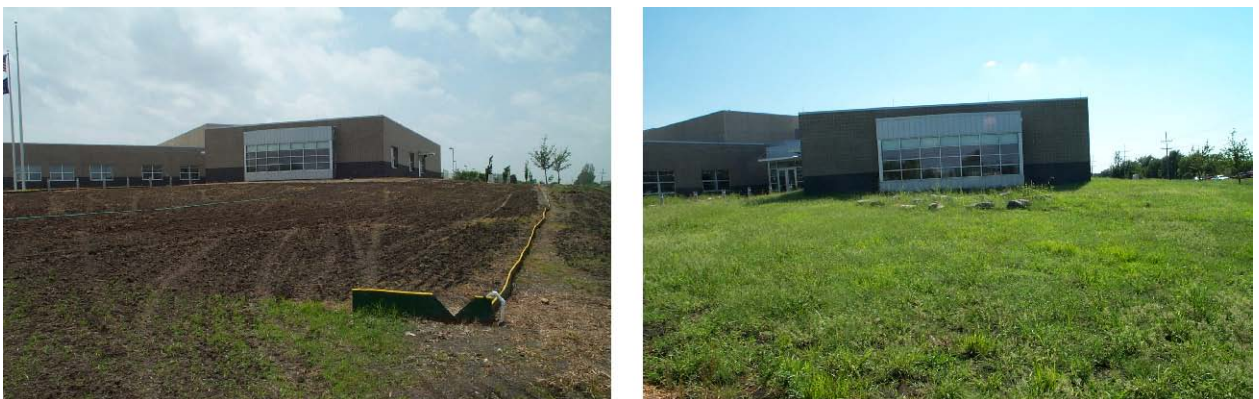
Fig. 4. Johnson County Transit Center prairie restoration site immediately after seeding in June 2007 and after the growing season in September 2007

A prairie restoration project was established at the Johnson County Transit Center located in Olathe, Kansas, United States to assess the impact of native vegetation on stormwater quantity, ability of plants to enhance infiltration and reduce runoff, and ability of vegetation to remove pollutants from water through filtration and pollutant transformation/ degradation. The project was established in June 2007 (Fig. 4) when the traditional fescue turfgrass lawn was converted to a mix of native prairie grasses and forbs (Table 1).

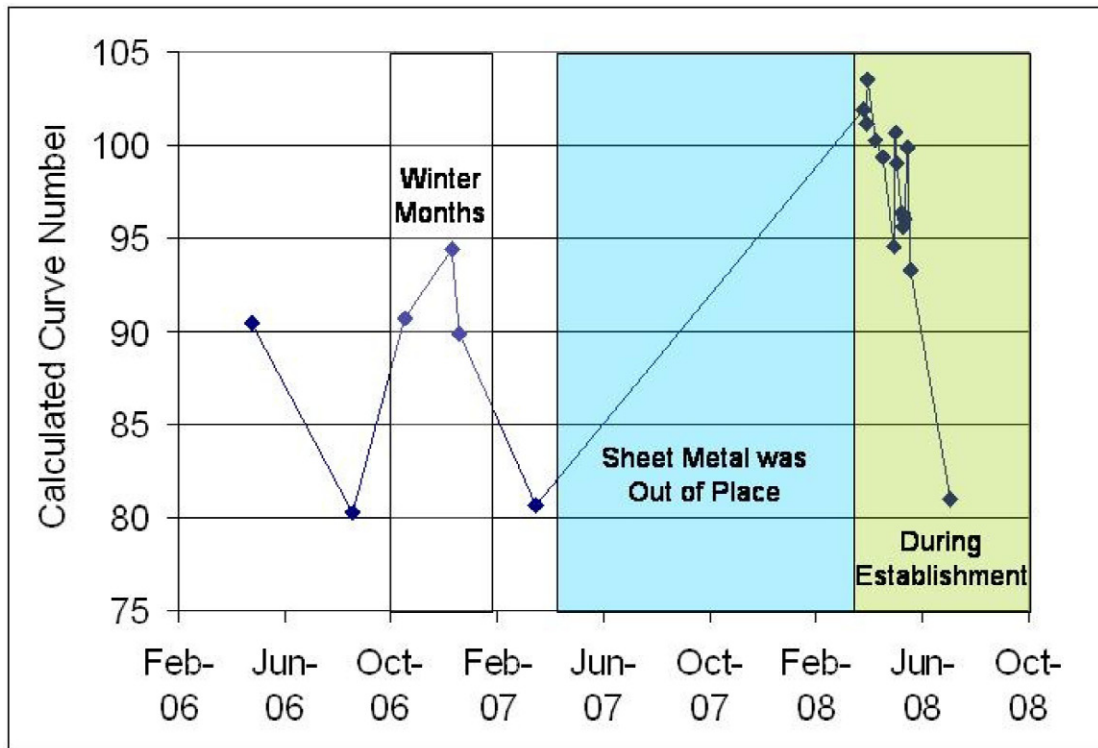
Fig. 5. NRCS curve number for the Johnson County Transit Center prairie restoration site from pre-planting (fescue turf) in 2006 through the 2009 growing season. No runoff producing events occurred in 2009 so the last data points occurred in 2008. Additional roof runoff was rerouted to the site in fall 2007, resulting in curve numbers greater than 100

Preliminary results indicate that the prairie grasses are improving the infiltration of stormwater runoff. Changes in the NRSC Curve Number [8] show a reduction in infiltration after planting with continued improvement during site establishment (Fig. 5). Curve numbers greater than 100 were attributed to rerouting of roof runoff onto the project site in the fall of 2007. There were no runoff producing storm events during the 2009 monitoring season.
