CASE REPORT

Explosion of Fixion[®] humeral nail during cremation: Novel “complication” with a novel implant

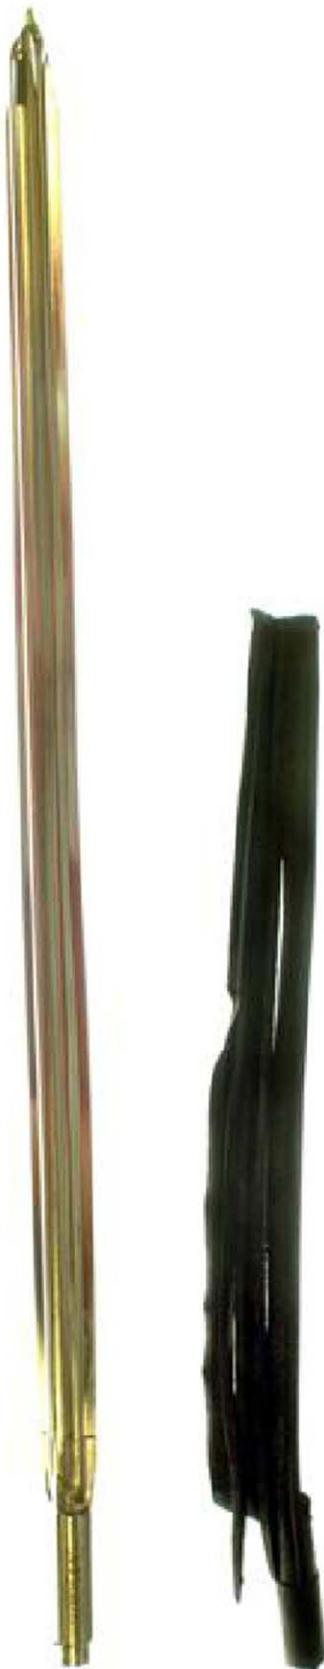
The patient was certified arrangements were made for him to be cremated. The nail was noted but not removed, as it was not normal practice. At the crematorium, one of the staff was overseeing the firing of the oven through a transparent observation port when the coffin exploded. This was felt and heard by other staff elsewhere in the building. Extensive damage was caused to the oven, and considerable distress to the staff. It transpired that the cause of the explosion was the humeral nail.

Figure 1 On the left is an intact Fixion[®] nail inflated and on the right the exploded nail (proximal half) recovered from furnace.

thin membranes and is inflated via a unidirectional valve using saline.^{2–4} It is introduced into the bone in the deflated state and inflated to a pressure of 70 bar.³ Once inflated the resultant press fit with the endosteum ensures no further rotation or displacement of the fracture can occur.³ Pressure can be distributed evenly throughout the entire length of the nail, thus preventing localised forces that would be generated by conventional screws used in interlocking nails.² This method of locking is particularly beneficial for bones that have sustained a pathological fracture. It is recommended by the manufacturers that after inflation the pressure is released.

Modern cremators operate at a temperature of between 800 and 1000 °C and once the coffin is committed the temperature rises quickly to this level.⁵ In the UK crematorium regulations insist that coffin fittings should be made of a combustible material with handles and nameplates being made of hard plastic. The Fixion nail, when in situ, represents a metal container filled with saline. The sudden increase in temperature of the cremator caused this nail to explode with repercussions being felt throughout the building and damage occurring to its interior.

Eleven Fixion nails have been used for palliation in pathological humeral lesions at our hospital over the last year. We are aware of a second nail that has exploded during cremation. We now remove the nail in our mortuary prior to release to the crematorium. Patients and their relatives, as well as medical staff, need to be aware of this problem.
