Procedia Engineering 62 (2013) 663 – 670

**Procedia
Engineering**www.elsevier.com/locate/procediaThe 9th Asia-Oceania Symposium on Fire Science and Technology

Review on the fire safety of exterior wall claddings in high-rise buildings in China

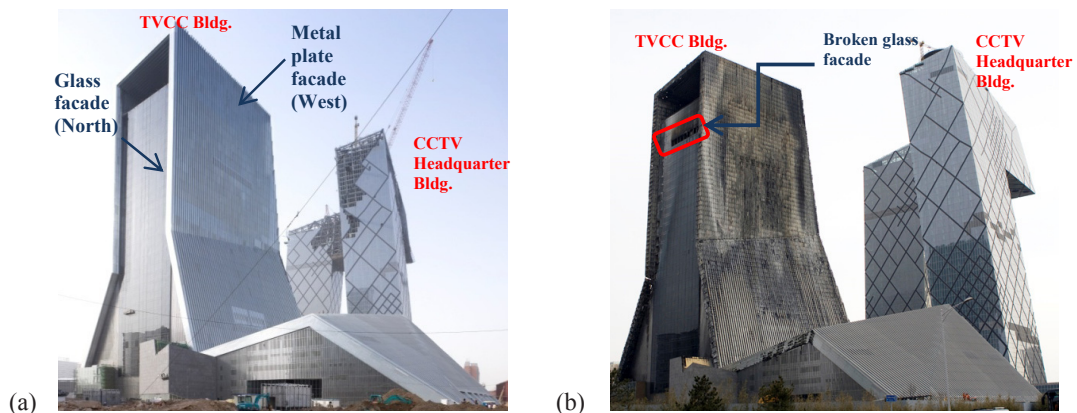
Fig. 1. (a) The TVCC building before fire; (b) the TVCC building after fire.

The Television Cultural Center (TVCC) fire burned at night on February 9, 2009, which was the last night of the Chinese New Year’s celebration. One firefighter dead and seven people were injured. The TVCC building is owned by China Central Television (CCTV) and built adjacent to the CCTV headquarters, shown in Fig 1. The building was not yet completed at the time and not occupied.

The TVCC tower is 159 meters high (32 storeys) and comprises three structures: a main tower in the center and two angular wings that branch off the tower on the east and west side, shown in Fig. 1(a). The main tower, with an atrium in the center located from 5th floor to 26th floor, was to house a restaurant and a hotel. The tower's northern and southern facades were installed with glass curtain walls, while the east and west claddings featured metal panels and strips made with titanium-zinc alloy.

The fire was initiated on the roof by fireworks. The high temperature particles from fireworks landed on the west part of the roof, penetrated the metal panels, and ignited the insulation materials and water proof sheets underneath the panels. The titanium-zinc alloy was reported to be able to melt at about 400 °C. The water proof materials were EPDM rubber sheet and the insulation was Extruded Polystyrene (XPS) foam. Cavities exist between the metal panels and the insulations.

The fire started to spread on the roof to the east and west sides. It was reported that, when the fire reached the roof edges, the melting and burning drops of XPS flew down through the facades. The fire then propagated to the lower floors. Fed by high winds, the fire spread quickly and the tower was completely engulfed in flames within less than 20 min.

The fire also spread into rooms because some of rooms had been partially furnished and decorated. The fire and smoke entered the atrium in the main structure. The 20-storey high atrium enhanced the smoke movement, and the smoke with high temperatures and pressures caused breakage of the glass facade on the upper floors to allow the smoke to vent out, shown in Fig. 1(b). Fortunately, most of the glass facade was intact because the rooms were not fully furnished throughout, and therefore the interior fire did not have enough fuel to produce any severe propagation and damage in the structures.

Building fires normally spread from lower floors to upper, or from internal to external. The TVCC fire exhibited totally different spread patterns. The fire developed initially on the roof and spread from upper floors to lower and from external to internal. The extensive use of combustible insulation and large cavities without stops are believed to contribute to the fast spread. The melting and dropping feature of the XPS insulation (thermoplastic) helped to accelerate the downward fire spread. The striped panels also contribute to intense burning of the facade.

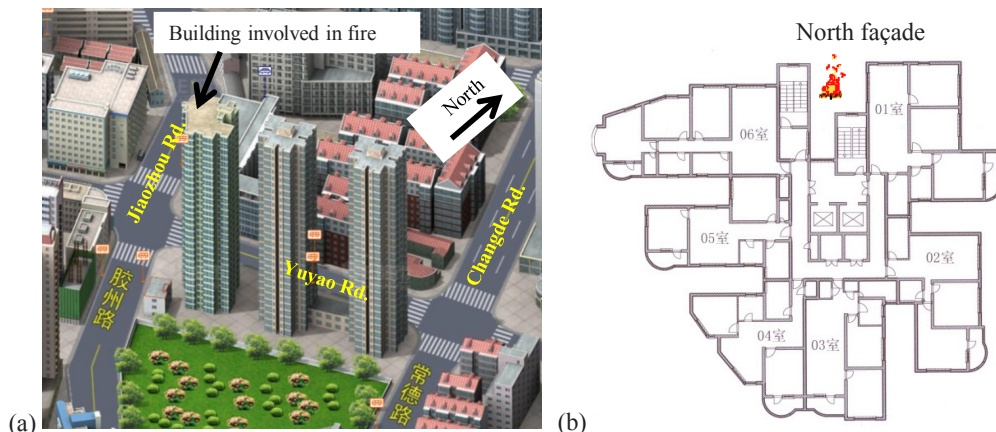
Fig. 2. (a) The residential high-rise building; (b) the plan view of the fire building.

On November 15, 2010, a fire occurred in a high-rise residential building in Shanghai, killed 58 residences and injured 71. The building, constructed in 1997, is a steel-reinforced concrete structure with 28-storey high. Fig. 2(a) shows the fire building and the adjacent buildings. When the fire occurred, the three high-rising residential buildings were undergoing renovation for installing exterior wall insulations, and the buildings were covered by steel scaffolding around the structures. The scaffolding was decked with wood and bamboo plates to allow workers to walk on and operate. Moreover, the scaffolding was wrapped with nylon netting to prevent falling of construction materials.

The fire started in an L-shape channel on the north facade between the 9th and 10th floor, shown in Fig. 2(b). Welding sparks ignited insulation (polyurethane foam) chips or pieces falling on the wood and bamboo decking at about 9th floor. The burning polyurethane (PU) foam soon ignited the decking wood and bamboo, nylon nettings as well as the insulation on the exterior wall. The external fire spread rapidly because the external envelope materials were highly flammable and with very good access to air supply. The stack effect in the L-shape channel was also considered to contribute to the rapid

vertical propagation. It was observed that within about 3 min, the flame reached the 20th and 21st floor, and it only took about 4 min for the fire to spread up to the roof. About 14 min after the ignition, the external fire almost burned out on the north facade but the fire had spread into the apartment rooms on the floors from 6th to 27th. The fire also spread onto the west and east facades along the envelope of the building.

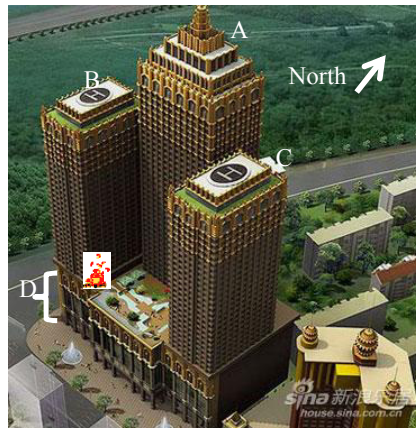
Fig. 3. The Wanxin Complex buildings.

Newly constructed and put in use in 2009, the Wanxin Complex comprises four individual parts, three towers and a skirt building interconnecting the three towers at the base, shown in Fig. 3. The skirt building is labeled as D, which is 10-storey or 46.8 m high over the ground and 3-storey underground. Above Skirt D, sitting three towers, labeled as A, B and C. Tower A is 45-storey or 180 m high and the rooms are used as a hotel. Tower B and C are both 37-storey or 140 m high. Tower B was occupied as an apartment building while Tower C was used as an office building. The horizontal distances between tower A and B, and A and C are both 6.5 m, while the distance between B and C are 63 m.

The facade of the towers was cladded with aluminum panels and aluminum composite panels. For Tower A, Expanded Polystyrene (EPS) foam was used as insulation and the cavity between the claddings and insulation varied from 170 to 600 mm. While for Tower B, XPS was used as insulation and the cavity ranged from 190 mm to 600 mm. Investigation showed that the XPS used for Tower B was tested to have combustibility of Class B2 and the combustibility of the EPS used for Tower A was tested to be Class B1. For Tower A, the openings on the south facade directly opposite to Tower B and C were protected with fire-resistant windows and the rest of the windows were equipped with 3-layer of toughened glazing.

The fire broke out at midnight. Particles from fireworks landed on the roof of Skirt D and ignited plastic grass for decoration on the 11th floor, close to Tower B. A few minutes later, the fire spread to the exterior wall of Tower B and penetrated the surface of aluminum composite panels and ignited the XPS insulation behind. After the insulation was ignited, high temperatures caused more aluminum composite paneling to fail, enabling more insulation exposed to heat and oxygen. The fire propagated vertically very fast, and after about 15-20 min, the flame reached the top of Tower B on the south side and started to spread upon the east and west sides of Tower B. The fire also entered the internal rooms through broken windows, but suppressed by sprinklers on those lower floors in Tower B. However, the sprinkler system was unable to control a large interior burning area, because more and more rooms were ignited floor by floor. It was found that fire in the internal rooms on higher floors caused significant damage in Tower B.

At about 1 hour after the fire started, Tower A was ignited. The distance between A and B is only 6.5 m. It was believed that fire debris and high radiation heat flux from Tower B contributed to the ignition of the Tower A. The fire started to spread upon south facade of Tower A, but was successfully controlled by the fire department. The fire only spread to partial part on the east and west facades of Tower A and no burning was observed on the north facade. Tower C was not affect by the fire at all.
