Energy Procedia 48 (2014) 1442 – 1448

SHC 2013, International Conference on Solar Heating and Cooling for Buildings and Industry
September 23-25, 2013, Freiburg, Germany

Ambitious renovation of a historical school building in cold climate

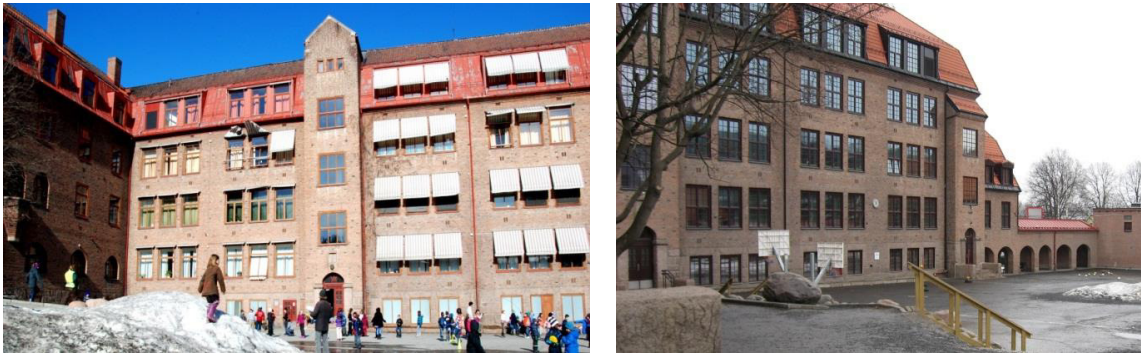
Fig. 2. (a) South façade before retrofitting; (b) South façade with new windows and roof cladding.

«Passive house windows» from the Norwegian manufacturer NorDan are now installed [2]. As these windows substantially decrease heat losses, they contribute to both better indoor thermal comfort and reduced energy bill. Thanks to the glazing's low solar energy transmittance (g-value = 27 % on south and west façades), the exterior sunscreens could be removed from the façades, in order to restore the façade aesthetics as close as possible to the original look.

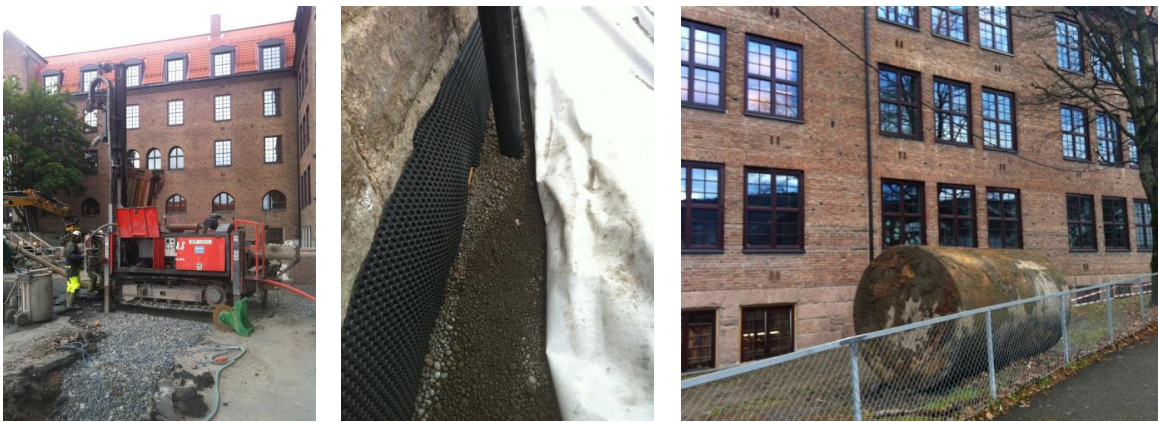
Fig. 4. (a) Digging for the ground source heat. (b) Combined digging for collector pipes, exterior insulation and drainage. (c) The oil tank on the way to destruction. Photos: G. Andersen, September 2012.

New drainage along the south and east basement walls was necessary to avoid moisture in the basement. The drainage ditches serve several tasks; revealing the basement walls under the ground for external insulation, filled with extruded concrete gravels the ditches provide additional insulation of the basement, and last but not least, the ditches hold collector pipes for the new heat pump. New drainage was necessary to maintain the building, and insulation will allow for a better use of the basement areas. The drainage ditches' primary function is to keep the basement dry. However; the ditches contribute to energy savings.

The old 80/60°C oil based heating is replaced with a heat pump system with heating capacity of approximately 200 kW. The heat pump utilizes ground heat from 18 energy wells drilled in the schoolyard. An existing oil burner is modified for bio oil for peak load. This burner plus an existing electrical boiler serve as backup. The heat pump has 4 compressors and is dimensioned to 85 % of the energy demand. Under normal conditions this is enough, and the bio burner will be used only a few days when it is very cold.

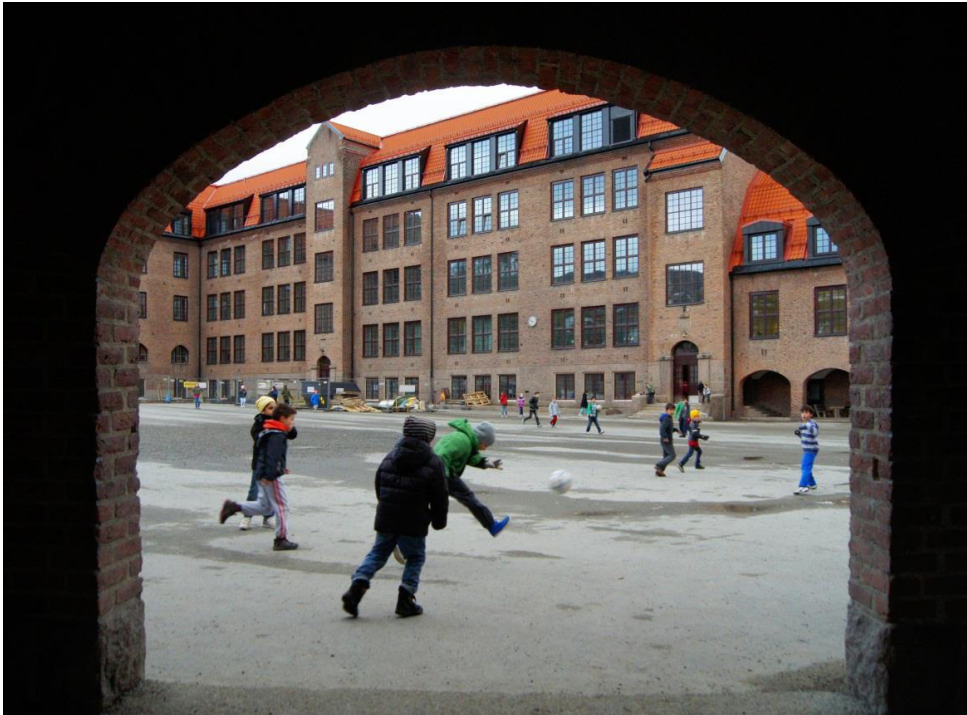
Fig. 5. South façade after replacement of windows and roof cladding. Photo: S. Røgeberg, Mai 2012. Architect for the retrofitting: a-form architects / Nils Herland.
