Union of Compact Accelerator-Driven Neutron Sources I & II

Target Performance at the Low Energy Neutron Source

Abstract

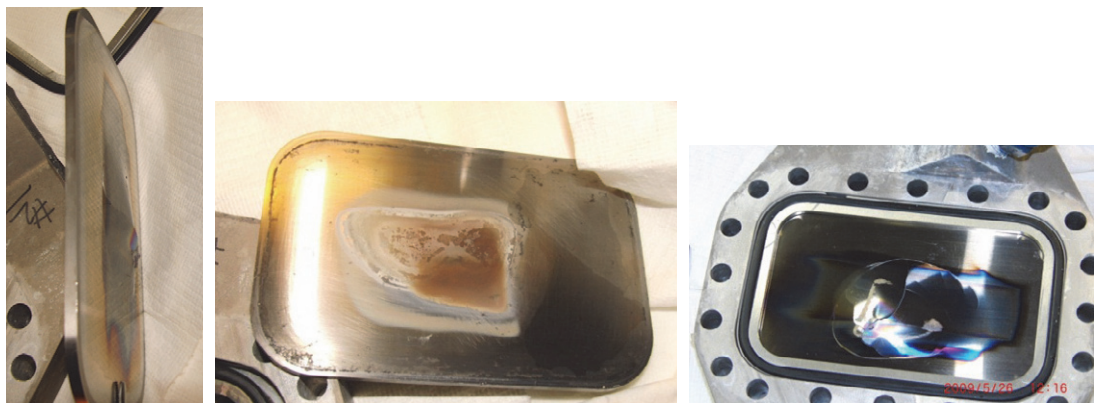
The third failure mode associated with this initially-deployed target design was hydrogen impregnation of the target itself. At 13 MeV proton energy, 4 kW of beam power and a week of continuous operation (roughly 670 kW-hr of beam) a vacuum excursion was observed which shutdown the accelerator (closing a fast-acting valve installed to protect the accelerator in the event of a coolant breach of the target). Upon examining the target system (See Figure 6), we found that the target was not breached, i.e. there was no water in the vacuum. Instead the target had blistered into the vacuum. After much discussion, the cause of this blister was determined to be the protons stopping in the beryllium and not migrating out until the concentration reached the point where internal pressure exceeded the strength of the material (as reduced by supersaturated hydrogen). When enough protons were put into the target blank, it blistered and the hydrogen being released caused the vacuum excursion.

Fig. 6. Hydrogen impregnation failure at 13 MeV

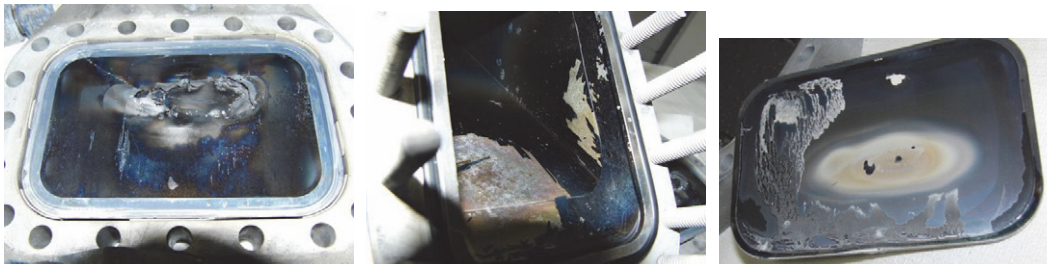
Figure 8 shows a target failure from hydrogen impregnation at 7 MeV proton energy. At 7 MeV the protons range out in 0.5 mm of beryllium as opposed to 1.2 mm at 13 MeV. This failure occurred when the accelerator was with only 2 cavities because of klystron problems. Here the vacuum excursion occurred after a few days of operation. Because the vacuum excursion was small, beam operation was continued after several excursions. Eventually the target broke. Upon opening of the target system, it was discovered that each new blister had been burnt through with the proton beam. This blister of beryllium had been deposited on the vacuum walls of the target chamber. Cleanup after these events took significantly longer.

Fig. 8 Multiple Target Failures at 7 MeV

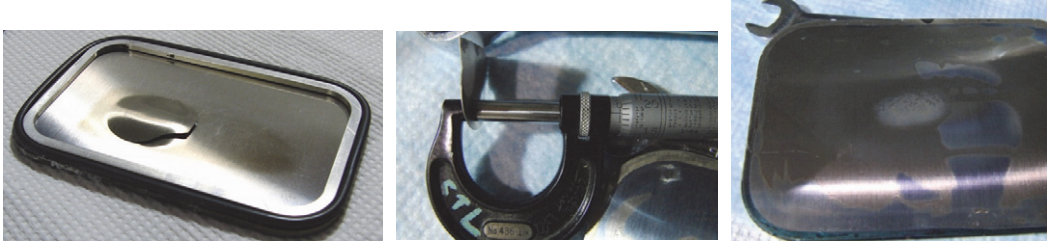
Figure 9 shows a target failure at 7 MeV after only one vacuum excursion. The blister measures 0.5 mm.

Fig. 9. Target failure at 7 MeV

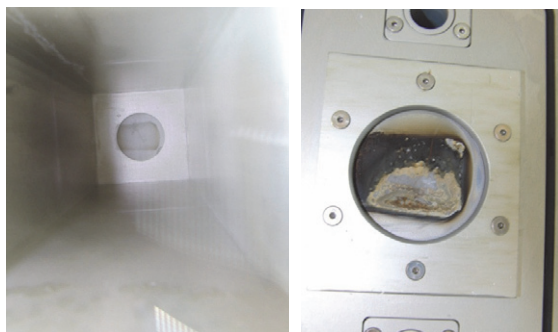
The first operating experience with the new Target ended with a vacuum break after about 200 beam hours. This failure seen in Figure 14, was caused by junk buildup on the back of the target and little buildup elsewhere. This failure forced another upgrade to the target water system, since the proton beam hitting the water is roughly 2 orders of magnitude more intense than the neutron beam leaving the target, and therefore the problem with water radiolysis is much more pronounced with this new design.

Fig. 14. New Target failure; beam side on left and water side on right.

The target water system which consisted of a charcoal filter, a 20 micron filter followed by a 5 micron filter was augmented with a de-Ionizing filter (Pentek model BBF1-20MB). This additional unit raised the resistivity a factor of 10 to > 1 Mohm-cm and dropped the total dissolved solids (TDS) to < 0.5 milligrams/liter. The water system flows 5 gallons per minute behind the target with a target pressure of 5 PSI. Current practice has this de-ionizing filter being changed every 4 months as the resistivity starts to go below 1 Mohm-cm.
