# Corrosion Fatigue Studies on a Bulk Glassy Zr-Based Alloy under Three-Point Bending

Grell D, Wilkin Y, Gostin PF, Gebert A  
and Kerscher E (2017) Corrosion  
Fatigue Studies on a Bulk Glassy  
Zr-Based Alloy under Three-Point  
Bending.  
Front. Mater. 3:60.  
doi: 10.3389/fmats.2016.00060

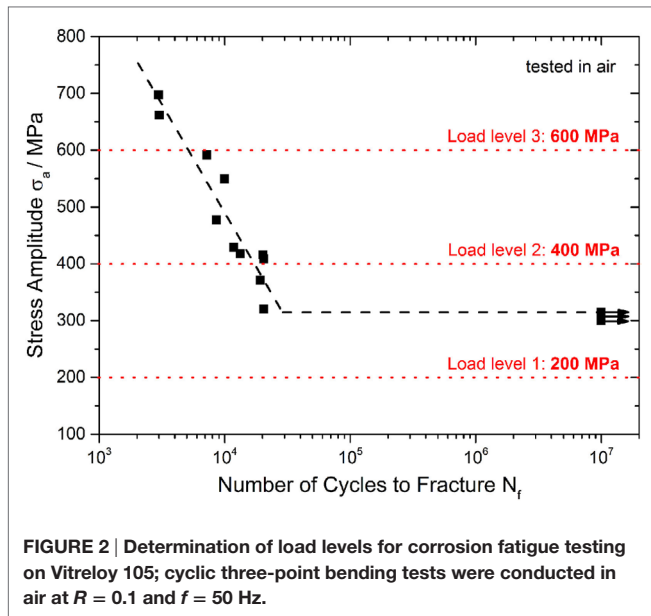
In order to select three load levels for CF tests, the S–N curve of the bulk glassy Zr<sub>52.5</sub>Cu<sub>17.9</sub>Al<sub>10</sub>Ni<sub>14.6</sub>Ti<sub>5</sub> alloy was determined in air (**Figure 2**). The black trend line characterizes the fatigue life of the tested Vitreloy 105 samples, and horizontal arrows denote runouts that endured more than  $10^7$  load cycles. It should be noted that the real fatigue strength of Vitreloy 105 was determined at  $\sigma_a = 315$  MPa. When assuming an ultimate tensile strength

of  $\sigma_{UTS} = 1,700$  MPa [only determined for Vitreloy 105 under four-point bending conditions (Morrison et al., 2007b)], there is a normalized fatigue limit of  $\sigma_a/\sigma_{UTS} = 0.19$ . The load levels for later CF tests were chosen in order to cover an interval of number of cycles to fracture as wide as possible.

of Vitreloy 105 and should be discussed in correlation with the fatigue behavior in air (see S–N curve in **Figure 2**). Although all three selected potentials are located in the anodic regime enabling pitting corrosion [all three potentials are higher than the repassivation potential, i.e., mean value  $-99$  mV vs. SCE, SD 28 mV (Gostin et al., 2015a)], there seems to be a lifetime extending effect of the most negative potential, i.e.,  $-50$  mV vs. SCE, and an obviously degrading effect of  $0$  mV vs. SCE and  $+50$  mV vs. SCE, which are closer to the critical pitting potential  $E_p$  (Gostin et al., 2015a) compared to the results of the samples tested in air. The fine grading of the chosen potentials offers a much more explicit view on the electrochemical influence of fatigue life than the research of Morrison et al. (2007a) who distinguished only between anodic polarization at  $100$  mV vs. SCE and cathodic polarization at  $-900$  mV vs. SCE in aqueous  $0.6$  M NaCl solution. Their research also detected an environmental degradation mechanism only at anodic potentials and concluded that anodic dissolution is responsible for the negative effect. That assumption is in good accordance with the results of our recent CF reference tests in halide-free  $0.01$  M  $\text{Na}_2\text{SO}_4$  solution, where no negative effect on fatigue life could be detected. So, we consider the increased pitting propensity in presence of chloride ions to be the driving force during crack propagation.

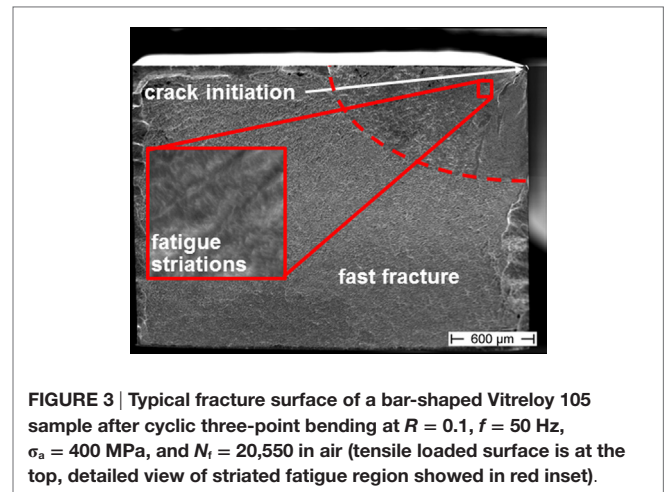
Fractographic analysis of samples fractured in air revealed characteristic features of Zr-based BMG fracture surfaces as also detected in Hess et al. (2006) and Morrison et al. (2007b). **Figure 3** shows a representative fracture surface of the three-point bending fatigue samples. Cracks were found to initiate at the tensile stressed surface, especially at sample edges starting from small surface defects or sometimes at near-surface micropores that act as supplementary stress concentrators (not shown here). Stable crack growth occurred in the quarter-elliptical fatigue region that is characterized by fine striations (see red inset in **Figure 3**) that result from stepwise crack propagation along small shear bands arising in the plastic zone in front of the crack tip. However, crack propagation could not be correlated directly to striation spacing, which suggests that there is an accumulation of damage over several loading cycles as also reported by Liu et al. (2015). The area of fatigue crack growth covered between 6 and 35% of the whole fracture surface in the present study. After passing a sharp transition region, the crack propagates much faster until final fracture occurs. The resulting fast fracture region has a characteristic vein-like morphology, which is commonly observed in BMGs.

explained by a varying sample quality. Fracture can be influenced by micropores with sizes up to  $50 \mu\text{m}$  as well as by other material imperfections (e.g., unmolten particles). The formation of such defects during the suction casting process could not be avoided completely. Both features led to a shifting of the crack initiation site from the tensile-stressed surface to inner regions in some cases, and this could also be detected on the fracture surface.

Besides the bending fatigue samples tested in air, which showed the characteristic features on their fracture surfaces (see **Figure 3**), the polarized samples have also been investigated by SEM. The observed fractographic characteristics are presented exemplarily in **Figure 7** on a CF sample tested at  $\sigma_a = 388$  MPa and an anodic potential of  $0$  mV vs. SCE.

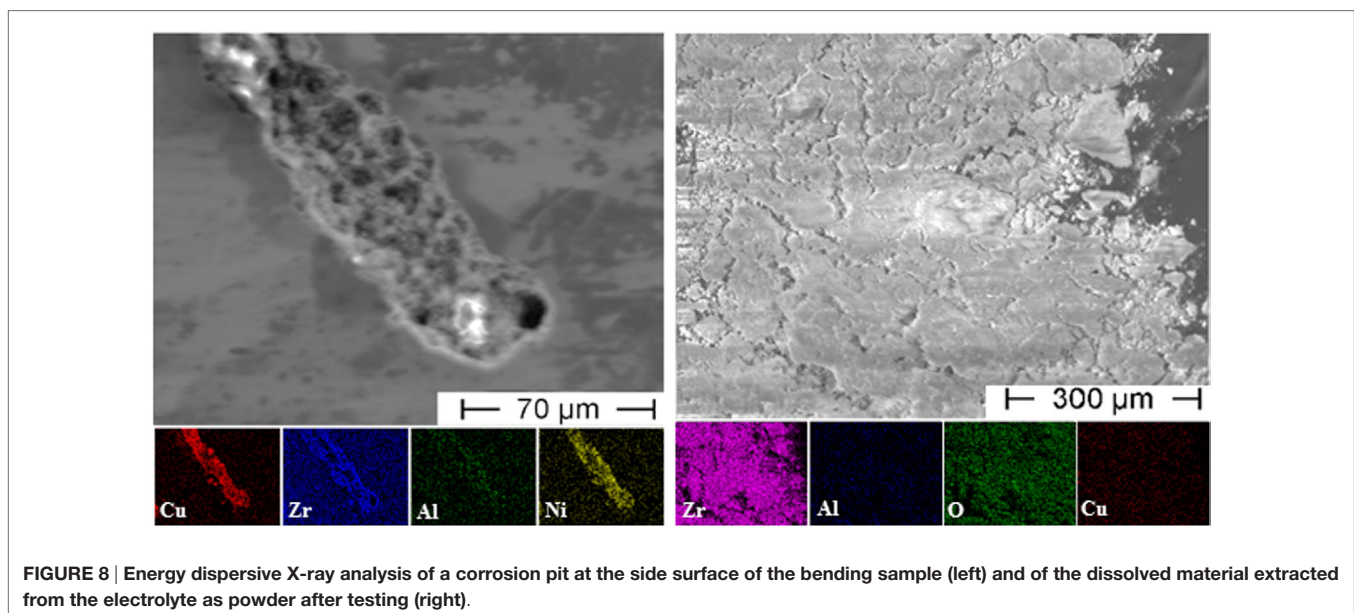
**FIGURE 8 |** Energy dispersive X-ray analysis of a corrosion pit at the side surface of the bending sample (left) and of the dissolved material extracted from the electrolyte as powder after testing (right).

The onset of anodic dissolution could be determined easily during CF testing under potentiostatic control. Characteristic corrosion products developed at the crack tip and spread out quickly. After the experiment, it was possible to gather the dissolved material in form of fine powder at the bottom of the electrochemical cell and to extract it from the residual electrolyte. This powder was investigated by EDX as well, and the results are shown in **Figure 8** (right). As expected, it consists basically of Zr and O while only traces of Cu could be detected. However, the fraction of Al seems to be smaller than expected due to the results from the corrosion pit, but this element could be detected poorly overall.
