NASA/TM-2017-219611

Autonomous Inspection of Electrical Transmission
Structures with Airborne UV Sensors
NASA Report on Dominion Virginia Power Flights
of November 2016

Andrew J. Moore
Langley Research Center, Hampton, Virginia

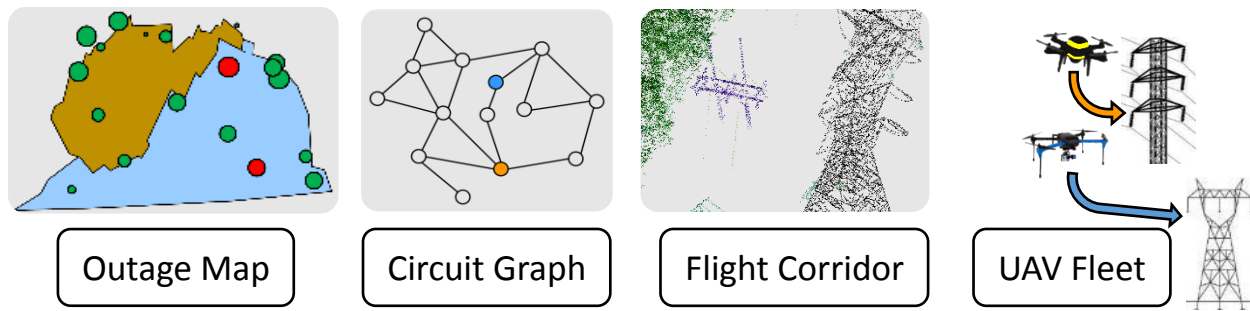
Figure 1. Components of a self-diagnosing power grid. UAVs cached at locations across the grid, such as electrical substations, can be deployed on demand to locate and characterize the faults based on geographic outage maps and topological circuit maps.

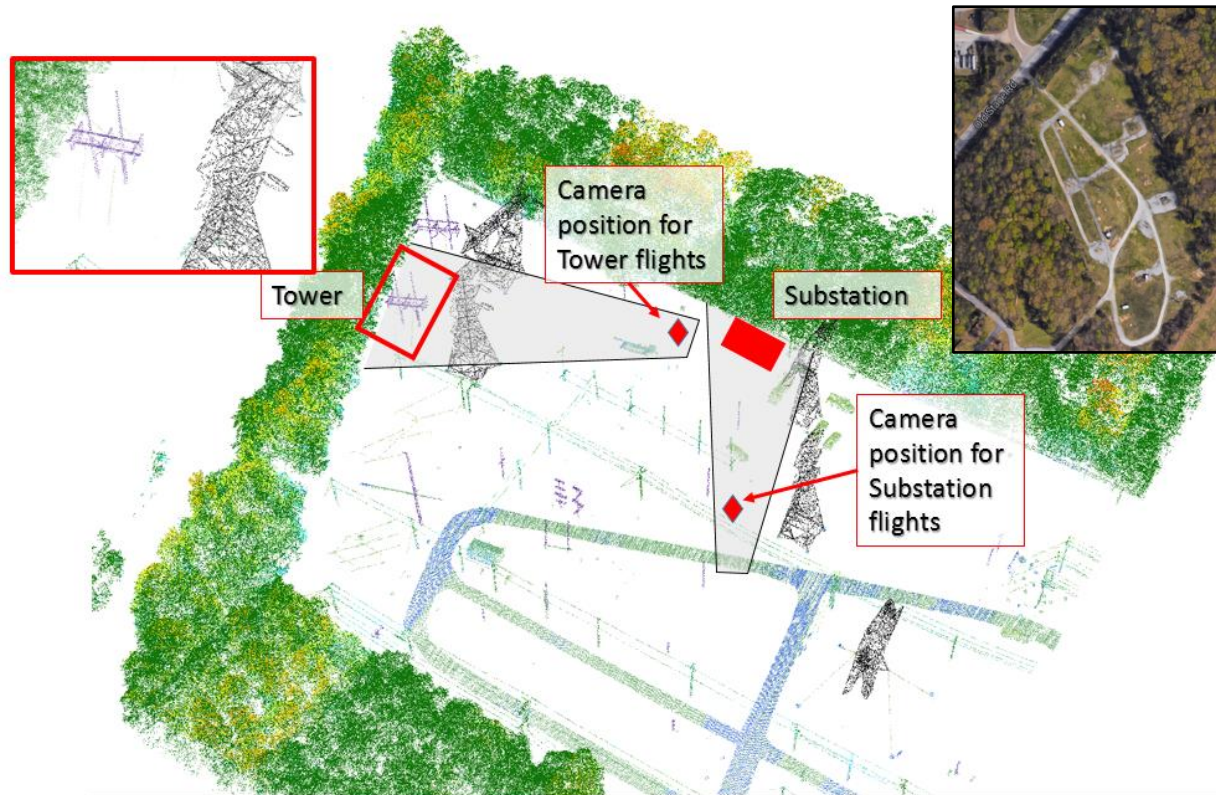
Figure 2. Chester Virginia flight range. Flight and camera positions superimposed on Dominion-provided lidar. The flight locations and camera recording positions for the substation and tower flights were in the northeast corner of the range. A close-up of the switching tower is shown in the top left inset, and a satellite image of the facility (for which up is north) is shown in the top right inset. ©Lidar data: Dominion Virginia Power; Map data: Google, DigitalGlobe & NASA

Flight locations within the Chester training facility are shown in Figure 2. The substation is a recently added structure at the east side of the facility, and the switching tower is at the far north side, close to Old Stage Road in Chester, Virginia. The video and corona cameras were placed 200 to 300 feet from the flight locations to accommodate the small depth of field of the corona camera.

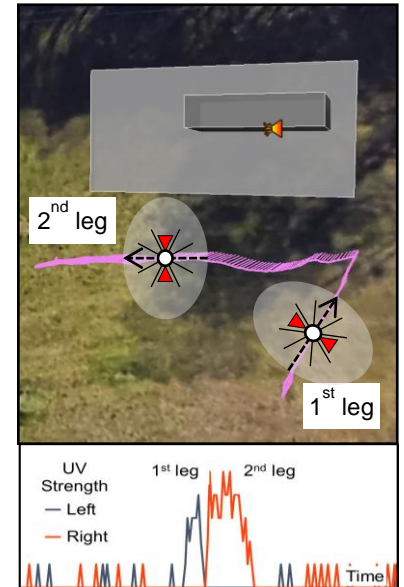
Figure 3. Spatial validation of the signals from port (left) and starboard (right) compact UV sensors ©Map data: Google, DigitalGlobe & NASA

Low-altitude flight maneuvers and sensor checks were accomplished in the substation (S) test flights (top of Table 1). After a free-ranging manual flight S1_1 that approached as close as 12 feet to the target location, the corona source was energized and the UV sensors were tested in autonomous flights S1_2 and S1_3, which approached as close as 20 feet to the target location. Figure 3 illustrates the physical interpretation of the UV plots in this report, using as an example L-shaped UAV flight path of test flight S1_3. Since the corona sensors were on the sides of the UAV, the left (port) sensor detected corona during the first leg, and the right (starboard) sensor detected corona during the second leg, which was ~8 feet from the concrete pad of the structure, and ~20 feet from the substation hardware. With the waypoints used in S1_2, the flight ended before the UAV made a full sweep in front of the source, and so the final waypoint was moved north for a full sensor sweep (column 'UV Plot' of Figure 4).

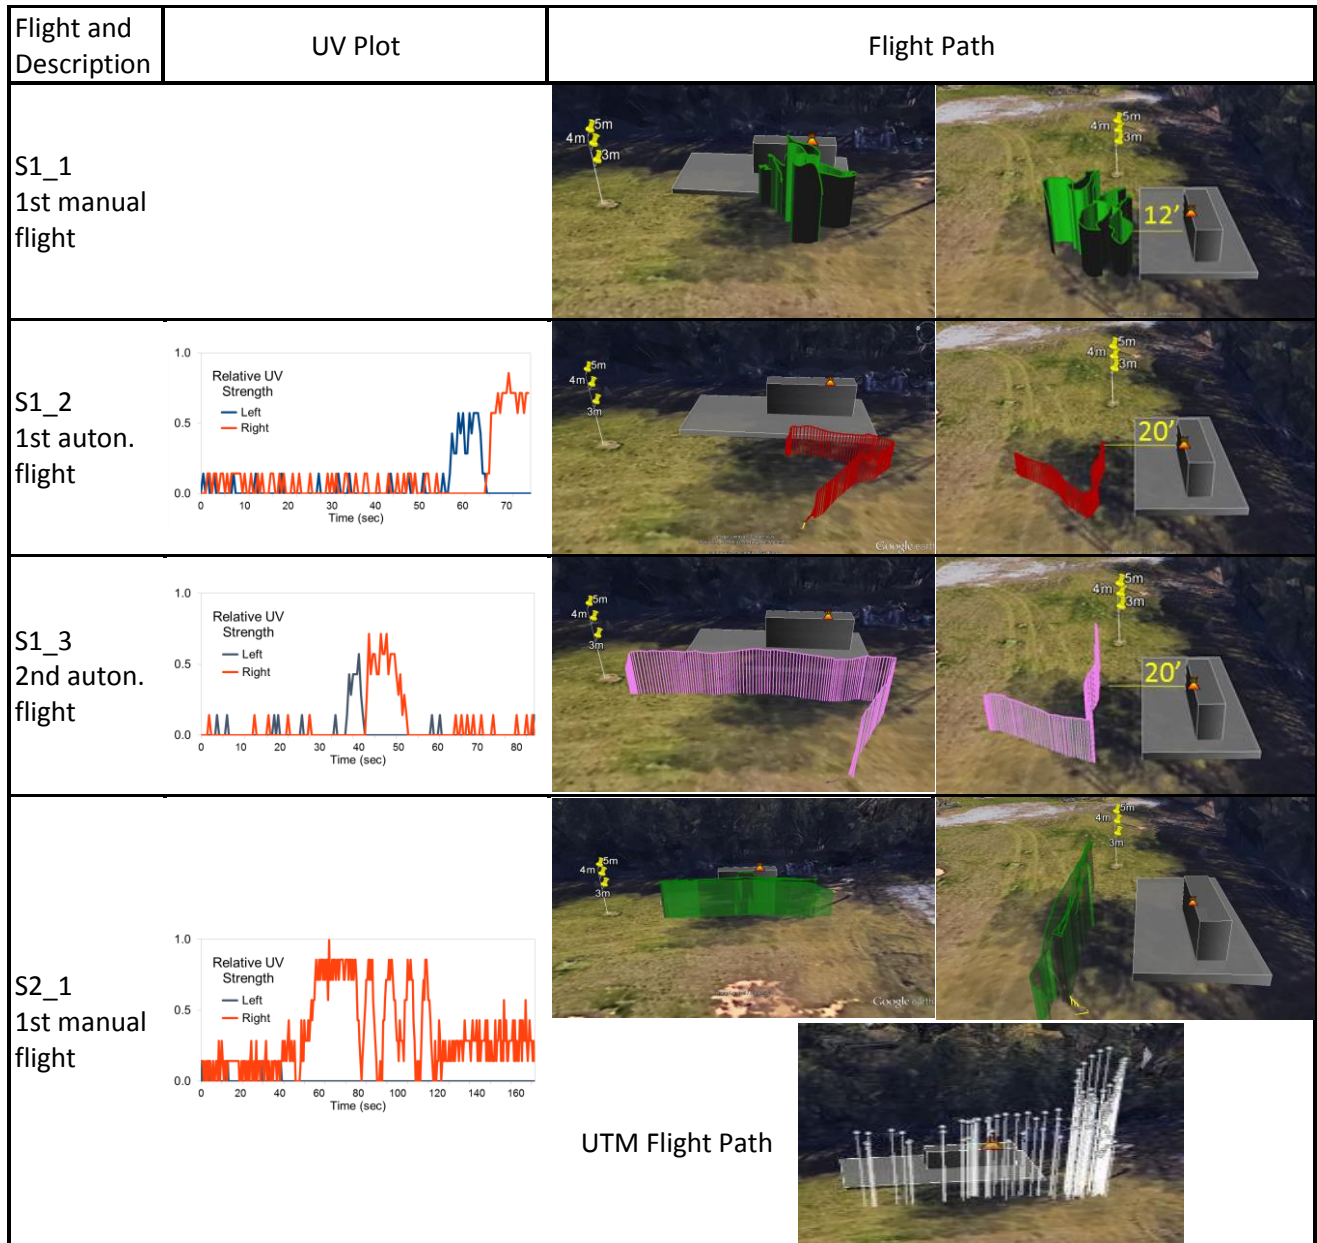
Figure 4. UV signal and flight path plots for the four substation test flights. The approximate distance to the corona generator (12' or 20') is indicated for the first three flights, which verified the compact UV sensor response. For the final test flight, the flight path was transmitted to the NASA UAS Traffic Management (UTM) server, and is shown at the bottom right for flight S2_1. ©Map data: Google, DigitalGlobe & NASA

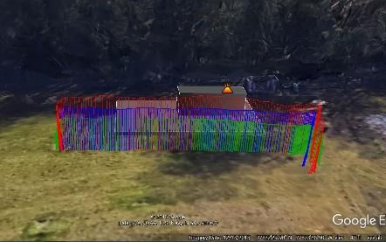
Figure 5. Altitude, UV signal and flight path plots for the three substation measurement flights. Both autopilot and UTM flight paths are shown; autopilot flight paths for all three flights are overlaid in the center column, showing flight paths with three altitudes (3, 5, and 4 meters colored green, red, and blue) in frontal and lateral views. The UTM flight paths (right column) are shown individually for each flight in frontal view. Note the altitude errors in the UTM plots; please see the section *Altitude reporting in autopilot and UTM records* below for a discussion of the origin of these errors and alternative altitude measures. ©Map data: Google, DigitalGlobe & NASA

Finally, corona camera recording and UTM flight path transmission was conducted in the trio of measurement flights S2_3, S2_4, and S2_5 (Figure 5 and bottom of Table 1)². The UAV altitude was varied in these three flights so as to frame it in the limited field of view of the corona camera. Altitudes of 9.8 feet (3 meters; flight S2_3) and 16.4 feet (5 meters; flight S2_4) were too low and too high, respectively, to capture the UAV within the corona camera frame, but an altitude of 13.1 feet (4 meters; flight S2_5) produced corona camera video imagery that independently validated the corona signal detected by the onboard sensor (Figure 6).

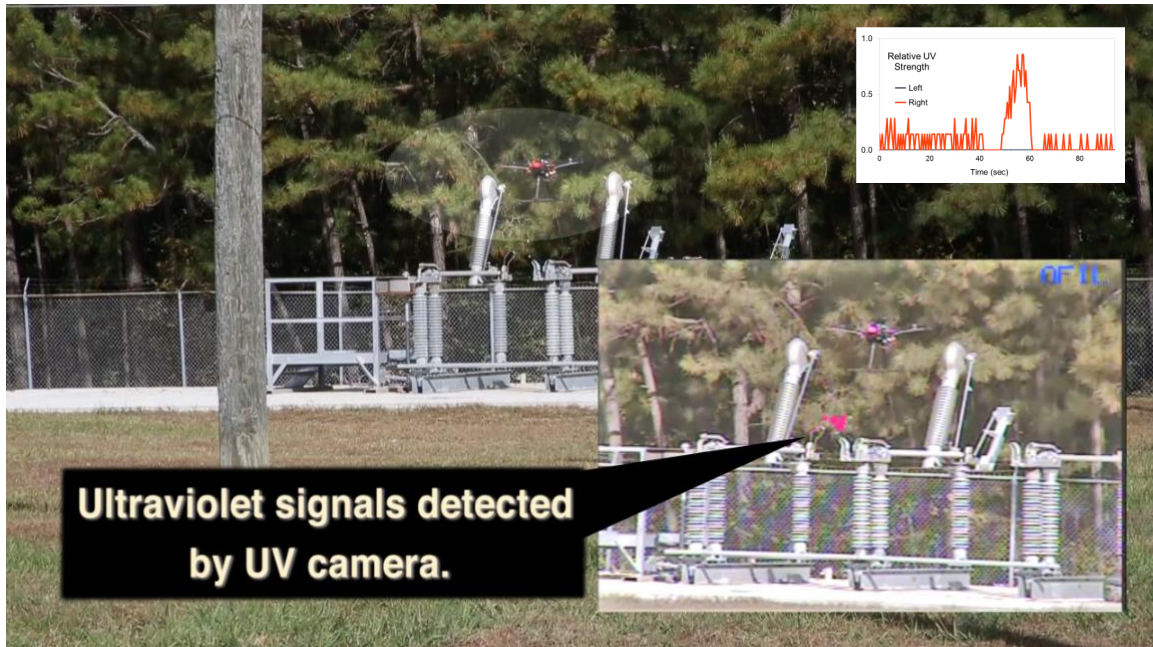
Figure 6. Validation of the compact UV sensor signal with corona camera in a substation measurement flight. The visible camera image shows the UAV above the substation structure (background; UAV is in lightened ellipse). The inset at top right shows the compact UV sensor recording, which reaches a maximum as the UAV passes the corona generator. The inset at bottom right shows the corona camera record; the bright red blobs at the center of the image are locations of UV emission.

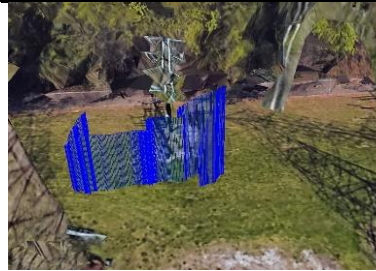
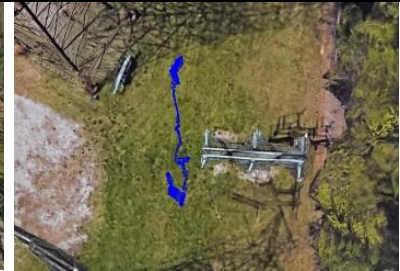
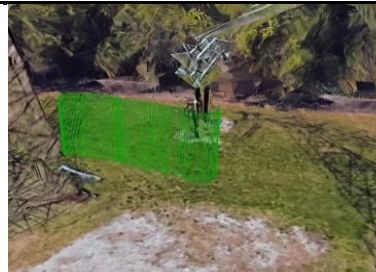
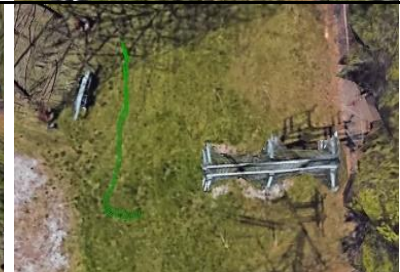
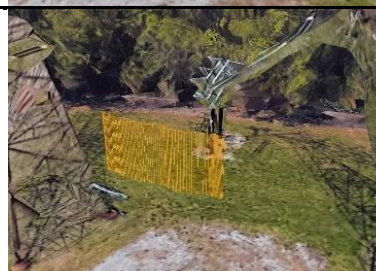
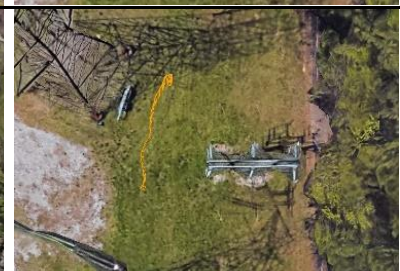
Figure 7. UV signal plot and autopilot flight path for the tower test flights. As with the substation flights, the standoff distance is 12' for manual flights and 20' for autonomous flights. The outputs from the compact UV sensor, recorded in the autonomous flights, show no signal, due to a corona generator malfunction. ©Map data: Google, DigitalGlobe & NASA

Medium-altitude flight maneuvers and sensor checks were accomplished in the tower (T) test flights (top of Table 2; Figure 7)³. A back-and-forth manual flight with increasing altitude (T1_1) was executed to frame the UAV in the corona camera's field of view and to set waypoints for an autonomous flight. In two subsequent autonomous flights on day 1 (T1_3 and T1_4), the UAV failed to detect an ultraviolet signal and drifted off of the planned flight path halfway between the waypoints. The detection failure was due to a poor contact between the corona generator's body and its emitting tip.

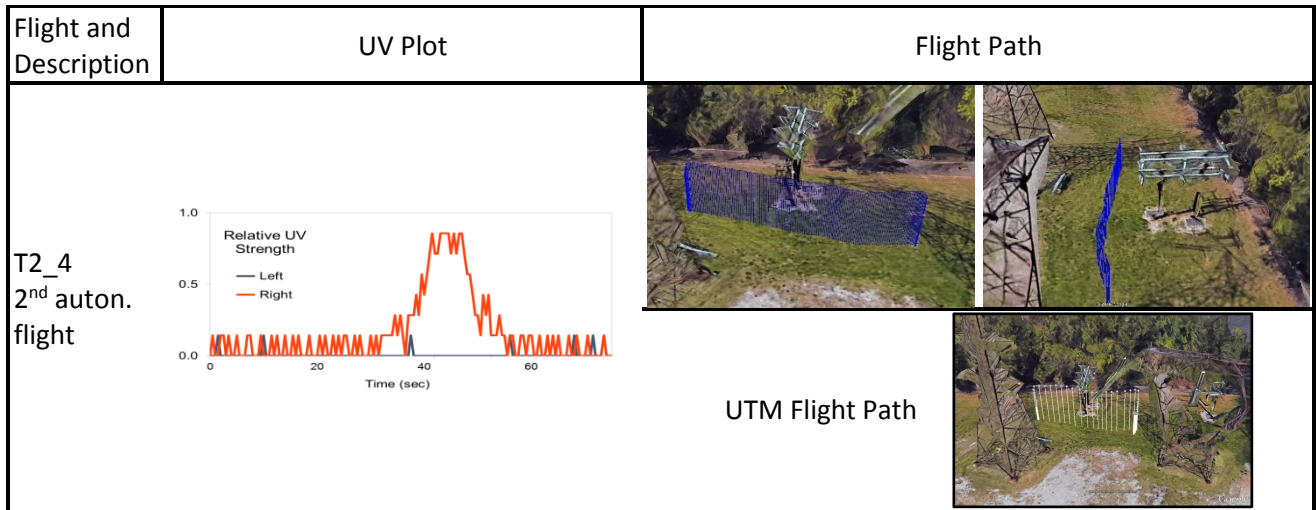
Figure 8. UV signal plot and autopilot flight path for the tower measurement flight T2_4. The compact UV sensor records a signal as the UAV passes the corona generator. Both autopilot (top right) and UTM (bottom right) flight paths are shown. ©Map data: Google, DigitalGlobe & NASA

All experimental datatypes were captured in measurement flight T2_4 (Figure 8): onboard UV sensors recorded the generated corona as verified with the ground-based corona camera (Figure 8), and the UAV flight path was transmitted to a remote NASA UTM server (bottom right of Figure 8; Figure 10). Success at the altitude of the switching tower confirmed the practicality of the UAV-based method for corona inspection of transmission line infrastructure.

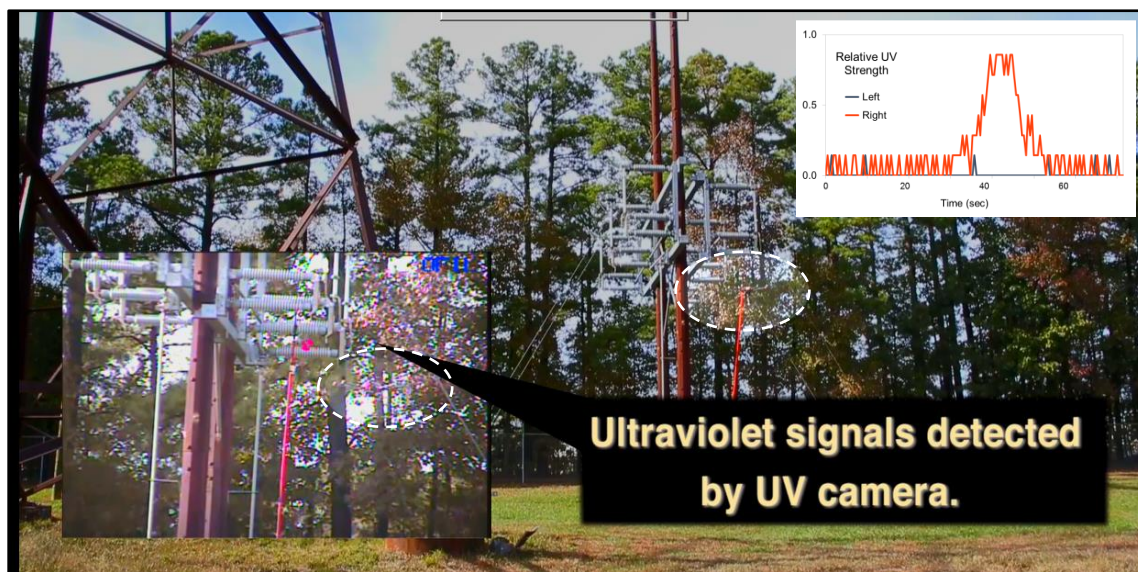
Figure 9. Validation of the compact UV sensor signal with corona camera in tower measurement flight T2_4. The corona camera imagery (inset at left) verifies the UV sensor result (inset at top right). The UAV is framed in a low-contrast oval (white dashed outline) in this imagery. The bright red blobs at the center of the corona camera image are locations of UV emission.

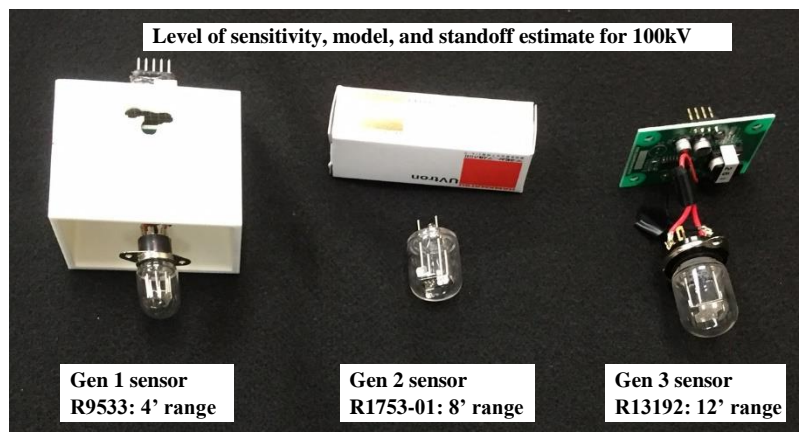
Figure 11. Left: The Hamamatsu line of compact UV sensors from the first generation, which can sense a 100kV corona at four feet of standoff, to the third generation (R13192), which can sense a 100 kV corona at a distance of approximately twelve feet.

Figure 11 shows the improvement in sensitivity of a commercial line of UV sensors [18] that use the photoelectric effect to sense narrow-band UV photons in a Geiger-Mueller tube and circuit configuration. The leftmost model was calibrated experimentally at the Electric Power Research Institute in July of 2015 to determine detectability of a 100 kV corona [15]. The device (R9533, left device in Figure 11) has to be within four feet of the discharge to reliably report a signal corresponding to a 100 kV corona (four foot maximum detection distance). Its successor (R1753-01, middle device in Figure 11) is twice as sensitive in our laboratory tests (eight foot maximum detection distance from a 100 kV corona). In 2016, a new design (R13192, right device in Figure 11) yielded an additional 50% higher sensitivity (twelve foot maximum detection distance from a 100 kV corona).

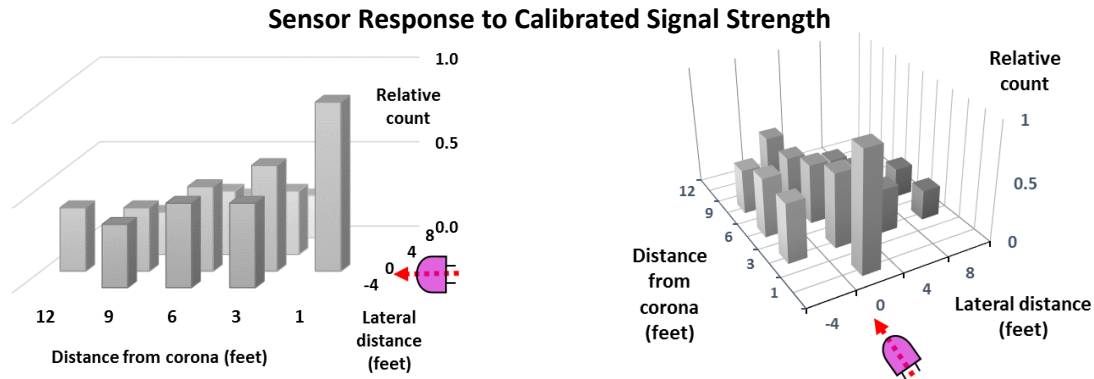
Figure 12. Sensitivity profile of the R13192 photoelectric UV sensor, with the corona generator set to approximate a 100 kV corona. At left is a top oblique view of the profile, and at right is a moderately elevated side view. The sensor location is indicated by the arrow and bulb icon.

In our laboratory tests of the third generation device (Figure 12), a commercial corona generator (Electro-Technic Products BD-20A High Frequency Generator) was energized to approximate a 100 kV corona, and a signal was detected at a distance of sixteen feet. This exceeds the expected maximum detection distance of twelve feet. This discrepancy was likely due to a laboratory corona generator setting that produces more UV flux than a 100 kV corona; the depth axis in Figure 12 is scaled by 0.75 to correct this calibration error.

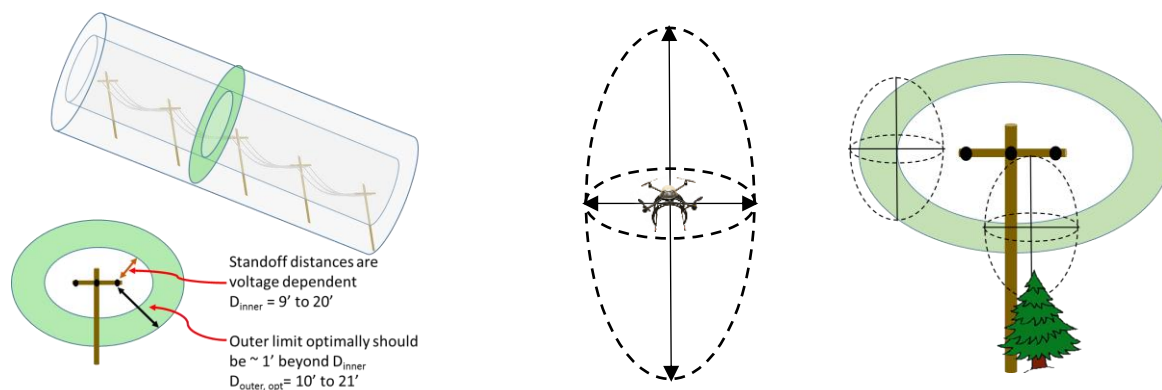
Figure 13. Flight volume (left), positional uncertainty (middle), and sensing pose (right). With single-ended GPS, the positional uncertainty is a large fraction of the desired standoff distance.

Twelve feet is only slightly greater than the accuracy of standard, consumer-grade sGPS. GPS accuracy is a statistical quantity, meaningful only for a percentage of measurements. Using 95% as the statistical allowance, sGPS accuracy is about six feet in latitude and longitude and approximately 2 times poorer in altitude accuracy [17]. UAV autopilots commonly use a barometer for altitude correction of sGPS. Figure 13 illustrates this challenge: inexpensive sGPS introduces an envelope of positional uncertainty around the UAV that is a large fraction of the corridor volume needed for accurate measurement.

Using only sGPS positional accuracy as a guide, we can conclude (right image of Figure 13) that flying beneath power lines is not safe, and that flying to the side (as done in this study) is safe but not adequate. Flying over lines using sGPS for navigation is safe, but adequacy is even more problematic because sGPS vertical positional uncertainty is 2X greater than sGPS horizontal positional uncertainty. If the vertical positional uncertainty can be reduced, then flying over lines or above and to the side of them is possible (Figure 15). We did not thoroughly quantify the accuracy of the autopilot's fusion of sGPS and barometer, but the results from flights S2_3, S2_4, and S2_5 indicate that the required vertical accuracy is already available. Currently available low-cost laser altimeters are rated at ± 0.3 ft (10 cm) at 16.4 ft (5 m) and higher altitudes. An example flight geometry with these assumptions is provided in Appendix 3.

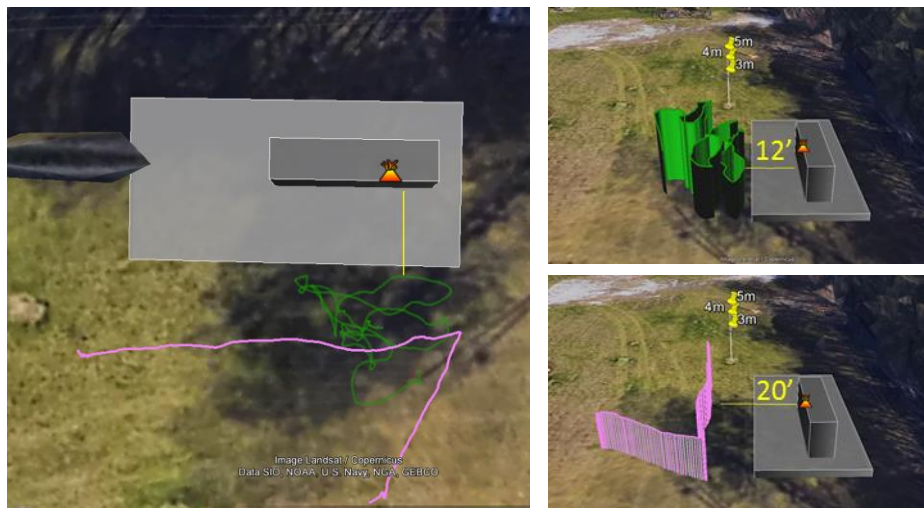
Figure 14. Distance from corona source in manual and autonomous flights. Top and side views for flights S1_1 (green) and S1_3 (pink) are shown. Due to GPS uncertainty, while manual flights approached the 12 foot calibration distance, autonomous flights approached no closer than 20 feet (horizontal yellow line). To compensate, the corona generator output was increased above calibration levels. ©Map data: Google, DigitalGlobe & NASA

To compensate for this, we increased standoff distance for autonomous flights from 12 to 20 feet (Figure 14). At a twenty foot standoff distance, even a shift of six feet (from the center to the outer limit of the positional accuracy envelope) would not result in a collision of the UAV into the inspected structure. The corona generator output had to be increased above the 100 kV

In manual flights, standoff distances adequate for UV sensing is attainable if a pilot has a good view of the UAV standoff from the inspection structure. In all flights described in this report, the pilot position was chosen to ensure a good view. We designed autonomous flight paths (i.e., waypoints) sufficient for successful inspection without manual pilot intervention. Due to the horizontal positional uncertainty (95% confidence level) of single-ended GPS (Figure 13), we were forced to adopt a conservative and inadequate horizontal standoff distance for autonomous flights (Figure 14).

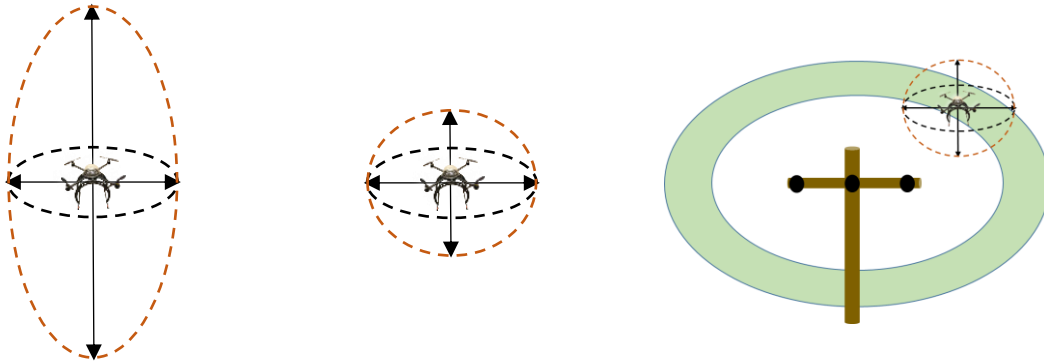
Figure 15. Reducing vertical position uncertainty. Left: sGPS uncertainty. Middle: Barometric or laser altimeter correction of vertical position estimate, fused with sGPS horizontal position estimate. Right: An example safe position that results from improved vertical accuracy.

Flights above (rather than to the side of) inspection structures can take advantage of the smaller vertical uncertainty afforded by non-GPS altimetry (Figure 15). Specific examples are shown in Figure 17. The placement of static wires, which are sometimes poorly resolved in lidar imagery, is an important constraint to consider in developing this approach.

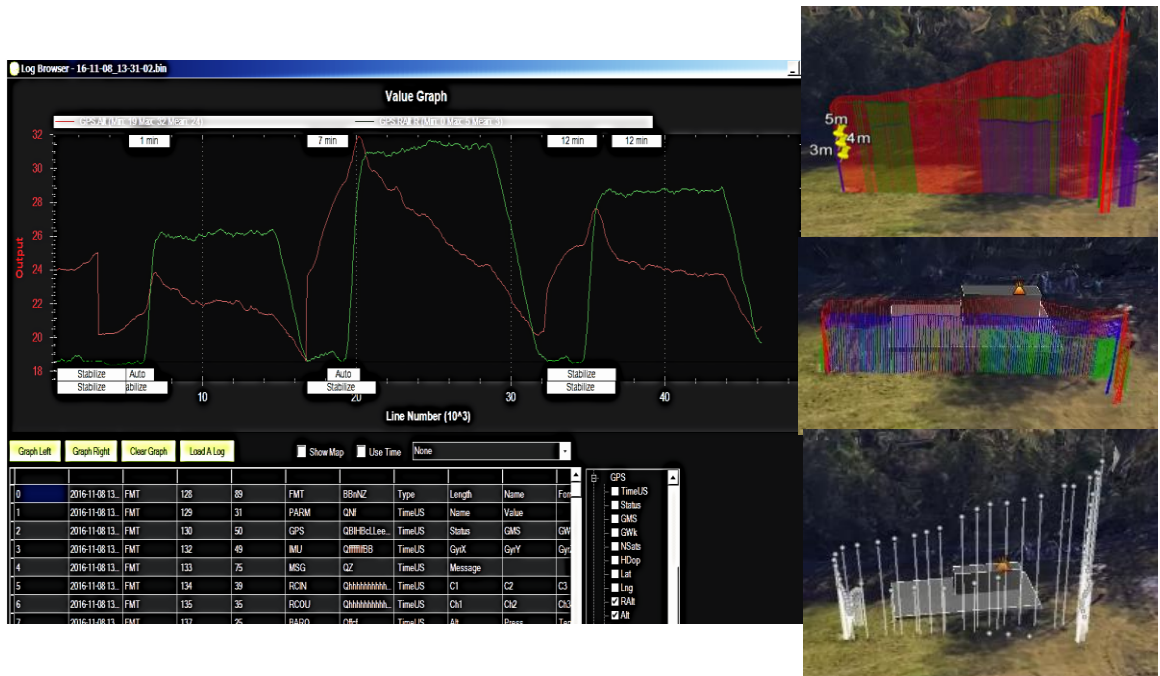
Figure 16. Altitude reporting among data types. Data is shown for flights S2_3, S2_4, and S2_5, with known altitudes of 9.8 ft, 13.1 ft, and 16.4 ft, (3m, 5m, and 4m), respectively. In this autonomous flight series, the UAV flew from south to north, which is from right to left in the views shown. The default UAV altitude is subject to profound drift (red trace at left), but a stable form is available in the logs (green trace). At right are the flight paths using the two forms: top, the default autopilot log; middle, corrected autopilot log; bottom, UTM record. The UTM stream would benefit from substitution of the corrected altitude.

Merging and reconciling the multiple data types gathered in these experiments was demanding due to the data volume, but not difficult, with one exception. The UAV autopilot forms altitude estimates from barometric, inertial, and sGPS/dGPS sensors, and from combinations of these. The estimates are computed relative to ground, relative to takeoff altitude and relative to a fixed datum, e.g., sea level. Reconciling the observed and recorded altitudes required a survey of all of these computed altitudes, trying each on our mapping tool (Google Earth). To render sensible flight paths, custom processing was needed to substitute a stable altitude record prior to mapping, because the default record is subject to profound drift as shown in Figure 16. A beneficial advance that emerged from this study is the discovery that the UTM record, which uses the error-prone default, can be improved with the same simple substitution.

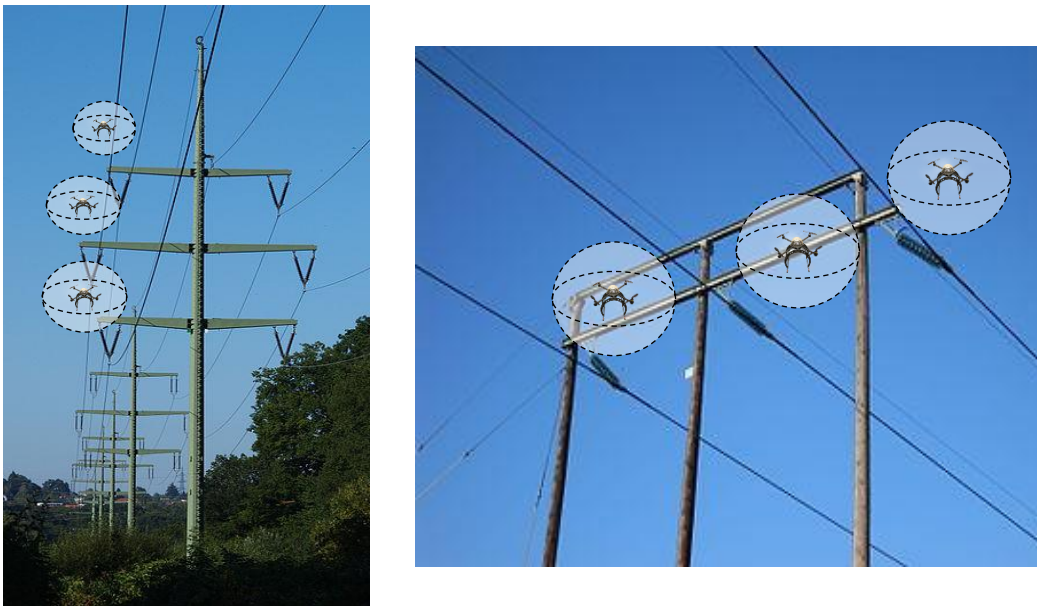
Figure 17. Examples of inspection positions that take advantage of reduced vertical uncertainty

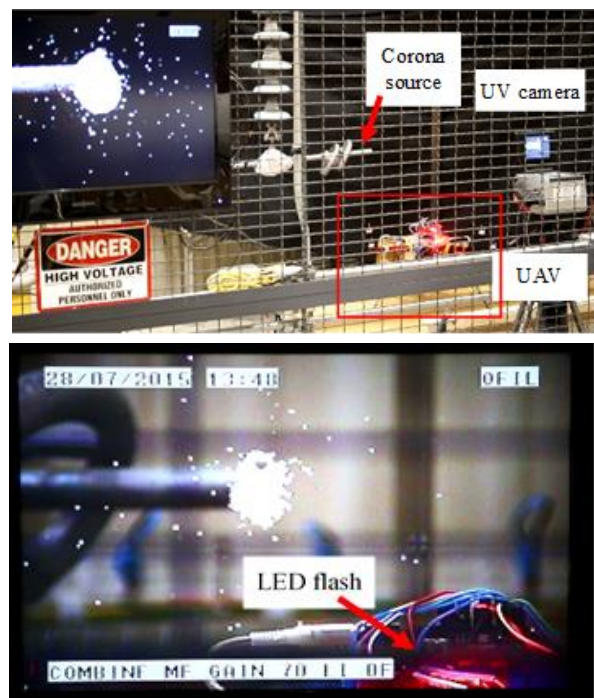
Figure 18. Multi-sensor payload design, used to calibrate the first generation sensor. Left: concept and prototype. Right: calibration to 100 kV corona at the Electric Power Research Institute, July, 2015 [23]. The top right image shows the calibration setup, and the bottom right image shows view through a commercial corona camera. The corona is indicated by white spots overlaid on a visible-band image. The red LED flash indicates UV detection. *UV imagery source: Electric Power Research Institute, Charlotte, NC*

Our early designs for airborne compact UV sensors used three sensors on each side of the UAV, so that a corona source was tracked during approach, at closest separation, and after the UAV flew past (Figure 18). This horizontal, fore-mid-aft design offered signal validation and directional information at a low cost - each sensor added only modestly to the cost of a UAV. We used a downward facing vertical array design in a feasibility study to measure from two conductors simultaneously with a UAV flying over them (Appendix 3). Given the arbitrary pose angles that may arise in some of the vertical standoff UAV positions sketched in Figure 17, we expect that an array of multiple onboard sensors is the most agile and productive approach at this stage of research.

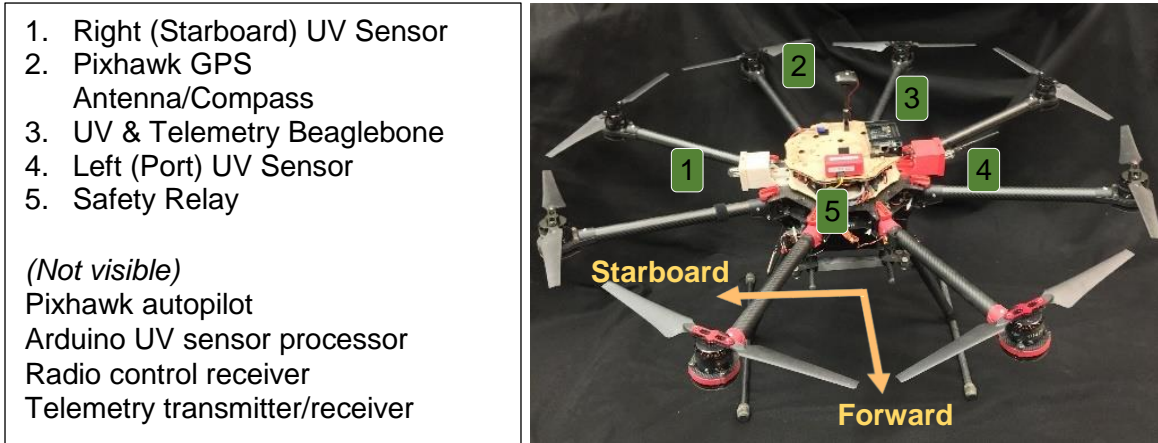
Figure 19. The aircraft FA3WEANXWH was used in all flights. It is comprised of a DJI S1000 frame, a Pixhawk autopilot, three onboard single-board computers, and custom sensing and telemetry electronics.

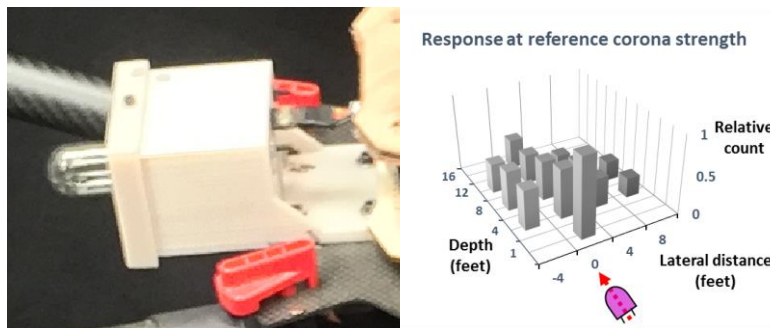
Figure 20. Left: The Hamamatsu R13192, which can sense a 100 kV corona at a distance of ~12 feet. Center: Sensitivity plot of R13192.

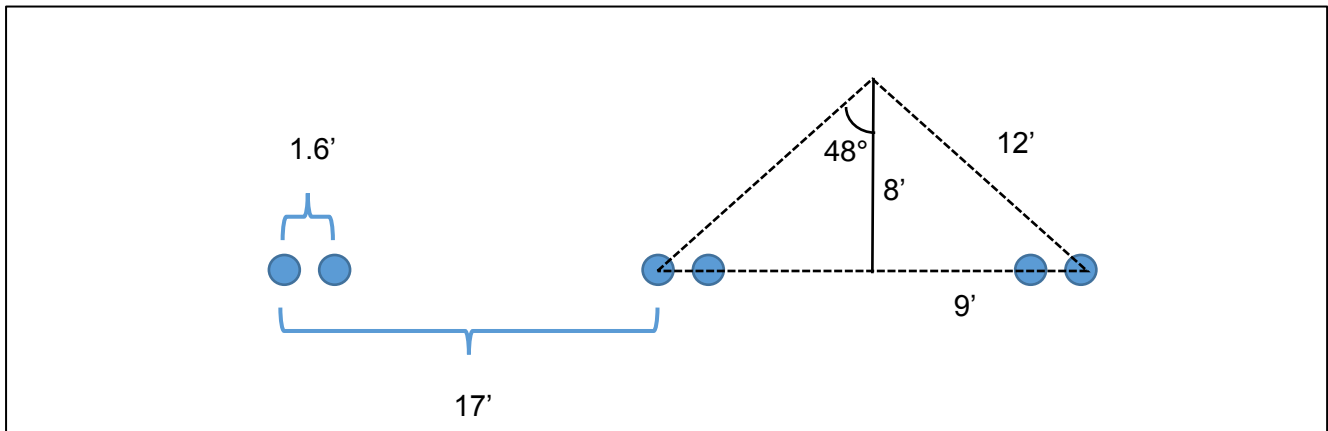
Figure 22. Example flight geometry for transmission line with conductors separated by 17 feet (view along the conductors). Due to the maximum sensing distance of twelve feet, two passes of the UAV carrying two sensors are needed. At an eight foot height above the midline between 2 phases is, the sensors should be mounted 48° from vertical.

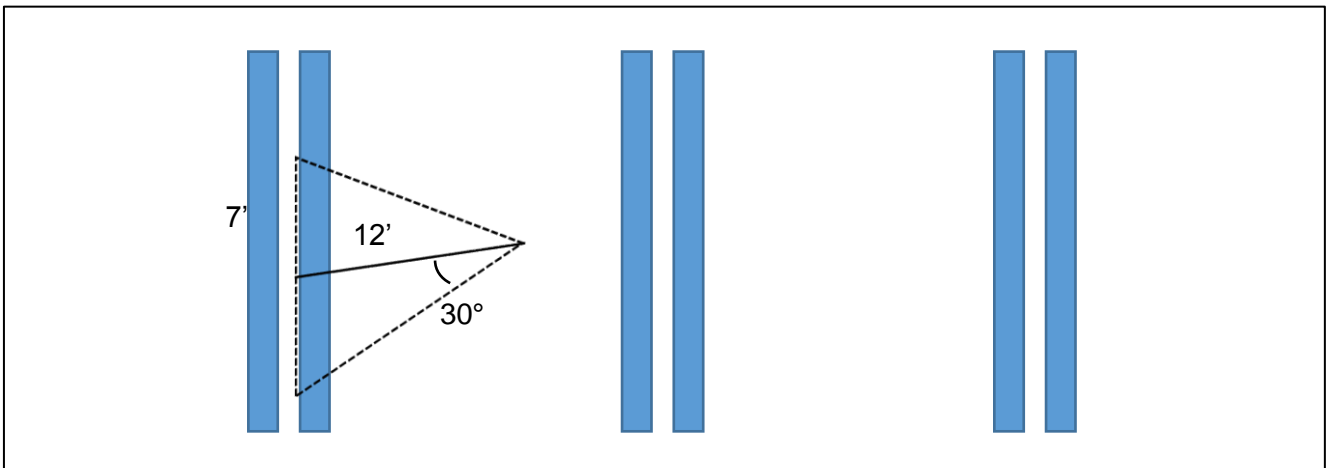
Figure 23. Example flight geometry for transmission line with conductors separated by 17 feet (view from above, looking down at the conductors). According to the sensitivity plots from the sensor manufacturer (not shown), each sensor will be at 95% sensitivity 30° in front of and behind the current location. For a standoff distance of twelve feet, this corresponds to a fourteen foot field of view.
