WEAR TESTING OF THE HERMeS THRUSTER

AIAA-2016-5025

52nd Joint Propulsion Conference

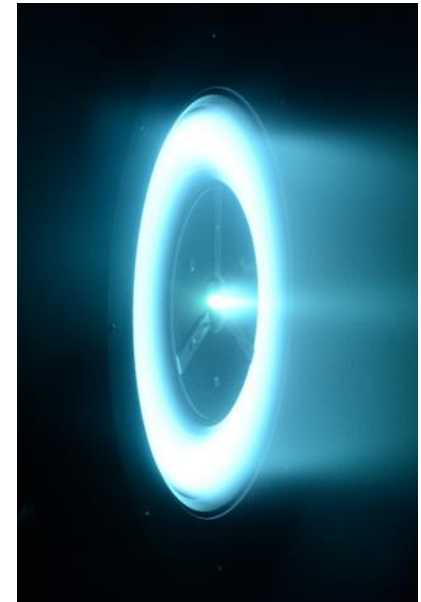
12.5 kW HERMeS operation in VF-5 at GRC

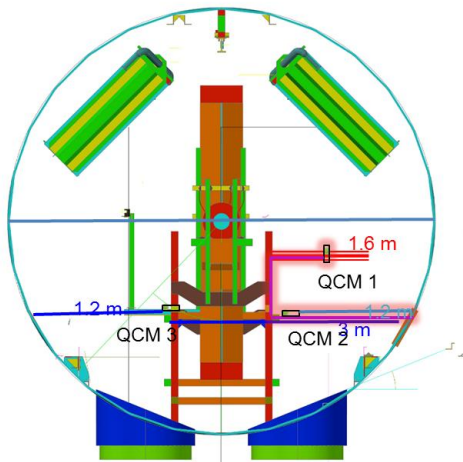
- Three QCMs near thruster plane
- Monitor horizontal, vertical symmetry of deposition
- Modeling predicts uniform flux at thruster position
- Long term diagnosis
 - Ta foil coupons on sides of panel
 - graphite nuts facing beam dump
 - Multiple (24) locations
 - Provide spatial (z, θ) resolution of total carbon deposition throughout tank

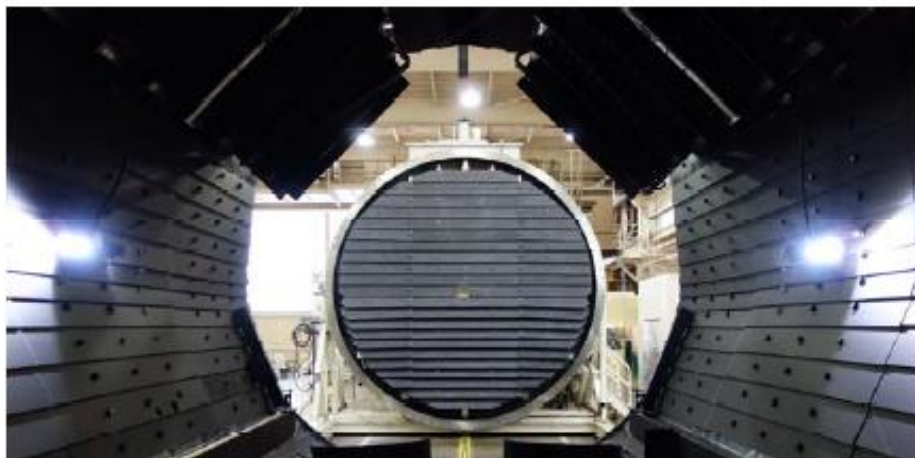
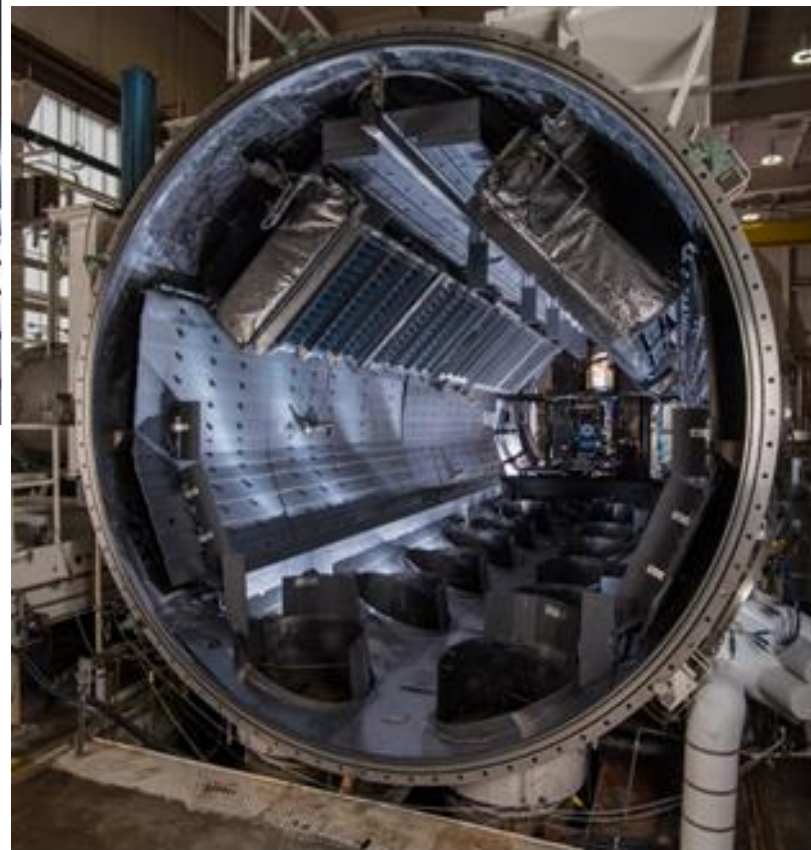
- All TDU-1 operation is in GRC's Vacuum Facility Five (VF-5)
 - Configuration identical to that of 2015 TDU performance testing base pressure $\sim 1 \cdot 10^{-7}$ Torr. Pressure near TDU $\sim 4.4 \cdot 10^{-6}$ Torr (Xe)
- Operation on laboratory power supplies/power console
- Operation on laboratory Xe feed system

- Graphite paneling protects all surfaces downstream of thruster
- 10 degree and 30 degree angling of beam dump plates
- Aperture introduced for IR camera
- Beam dump can be biased as part of test-like-you-fly analysis/assessment

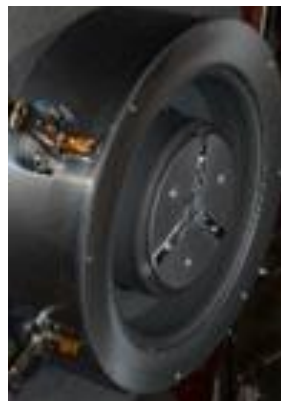
Magnetic shielding has yielded net deposition on BN channel—**no evidence of BN erosion**

- Deposition estimated to be $\sim 1 \mu\text{m}$ after 728 h (measured $< 1 \mu\text{m}$ for 360 h)
- Surface resistance measured at 35Ω
- No change in thruster performance noted over first 50 h during coating

TDU-1 showing BN channel before testing and after 122 h

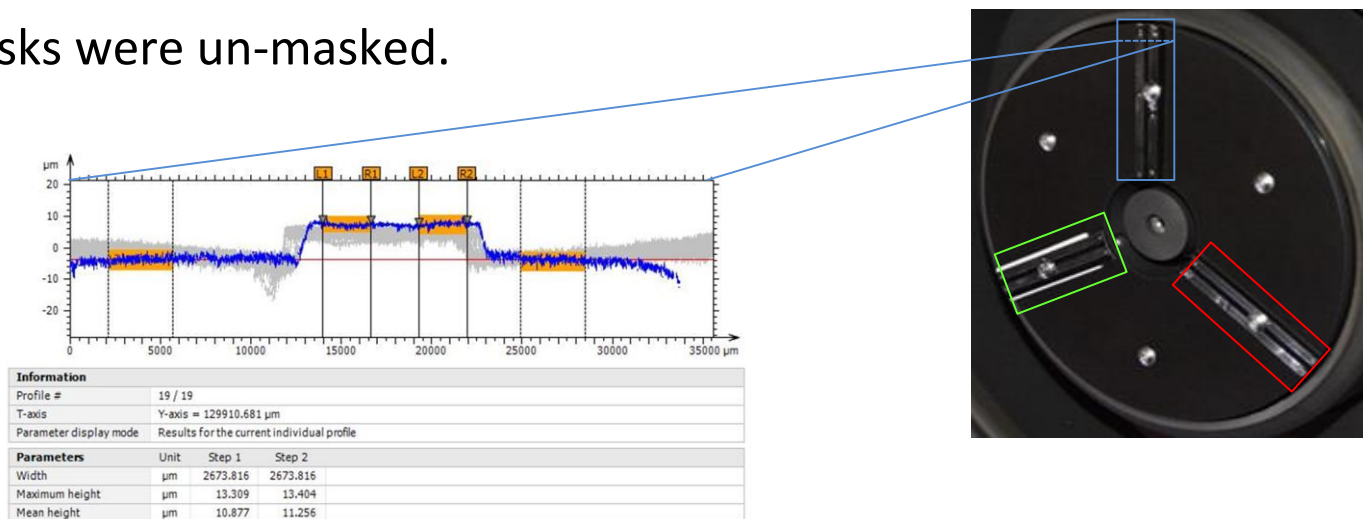
Sputter-erosion of graphite inner pole cover

- Graphite:
 - Erosion rate of 45 $\mu\text{m}/\text{kh}$
 - Maximize near edges
 - Nominal pole covers sufficient
- Molybdenum:
 - Maximum rate of 600 $\mu\text{m}/\text{kh}$
 - Appears to follow same trends...but doesn't!
- OES data suggest erosion increased between 20 and 75 h. Change in B-field at 20 h

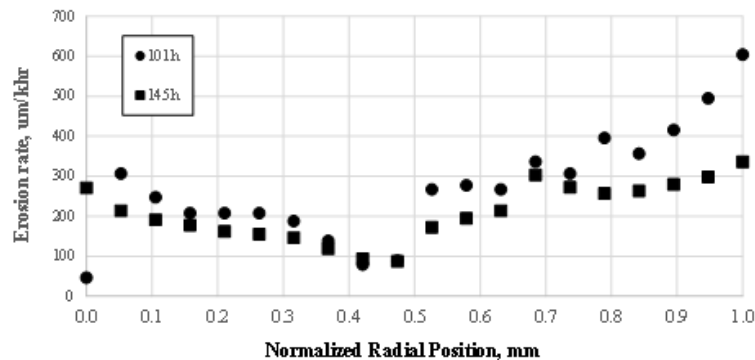
Measured erosion of Mo plates on inner pole cover 15

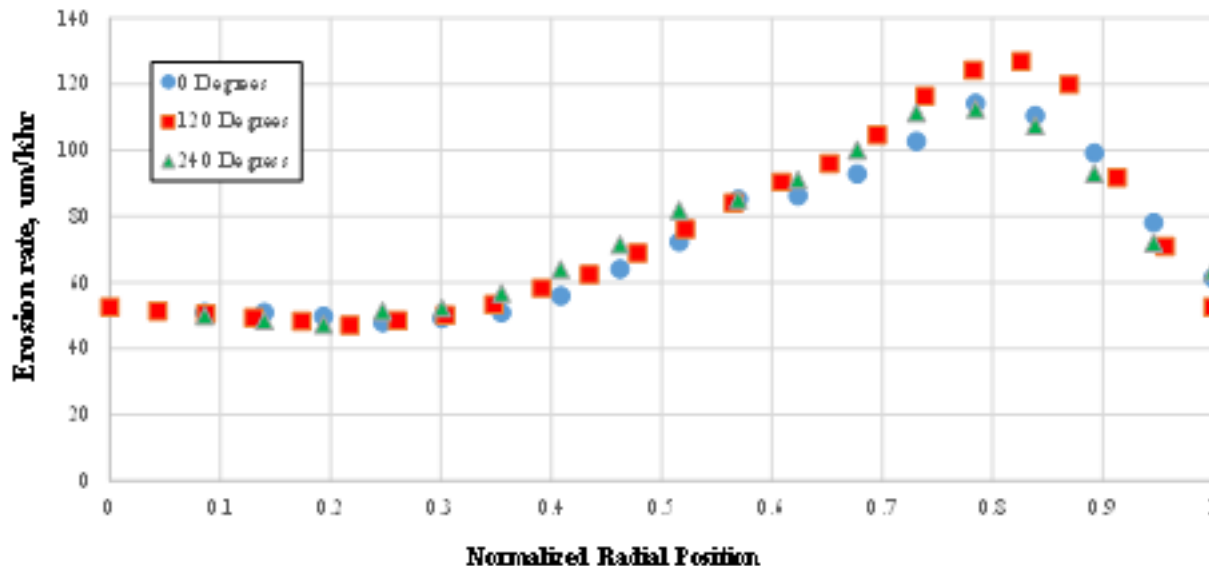
- Maximum Al_2O_3 rate of 135 $\mu\text{m}/\text{hr}$
 - Thick covers required to meet ARRM mission
- Fundamentally different erosion pattern
- OES data again suggest erosion was roughly constant (within uncertainty of measurement)

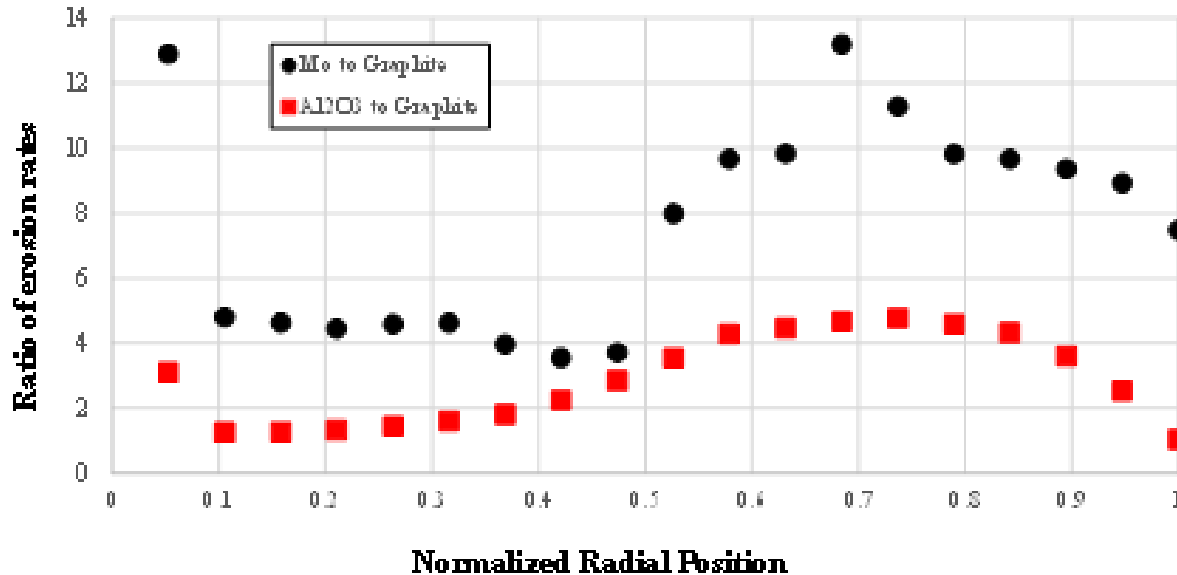
- Ratio of Mo and Al₂O₃ to graphite erosion rates
 - Intended to shed light on energy of sputtering ions
 - Reveals Mo and Al₂O₃ are eroding in similar regards wrt graphite (Mo rates being roughly 3x Al₂O₃ rates across the radius)
- Suggests erosion patterns are dominated by ions' angles of incidence rather than energy levels. (Cf. Oyarzabal, AIAA-2005-3525)
 - Ions between 75 eV and 125 eV
 - 15 degree variation in angle of incidence
