# Seismic vulnerability and damage of Italian historical centres: a case study in the Campania region

## THE HISTORICAL CENTRE OF SAN POTITO SANNITICO

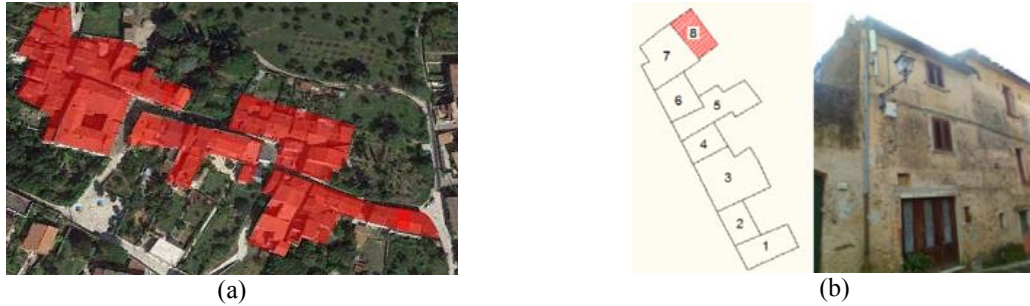
FIGURE 1. Bird-eye-view of the historical centre of *San Potito Sannitico* (a) and structural unit 8 of the aggregate H (b).

In the historical centre of *San Potito Sannitico* ten building aggregates composed of 43 Structural Units (S.U.) have been herein examined (Fig. 1a). Each aggregate is referred to by a letter [A, B, C, D, E, F, G, H, I, L], while the structural units are referred to by a number [1÷8]. In order to assess the vulnerability of these aggregates, some surveys have been performed with the purpose to acquire photographs and maps for them. For the sake of example both the plan view and the main façade of the S.U. 8 of the aggregate H are shown in Figure 1b.

The masonry aggregates under study generally range from 2 to 3 stories. The inter-storey height is about 3.00-4.00 m for the first level and 3.00-3.50 m for other floors. Horizontal structures are made of either steel-hollow tile floors or timber ones. Instead, roofing structures are often composed of double pitch timber beams with clay tile covering. Vertical structures are made of tuff or brick masonry squared stones (51%), masonry roughly squared stones and bricks in bad conditions (35%) and masonry irregular stones (14%). Masonry walls usually have constant thickness along the building height, with values between 50 and 70 cm.

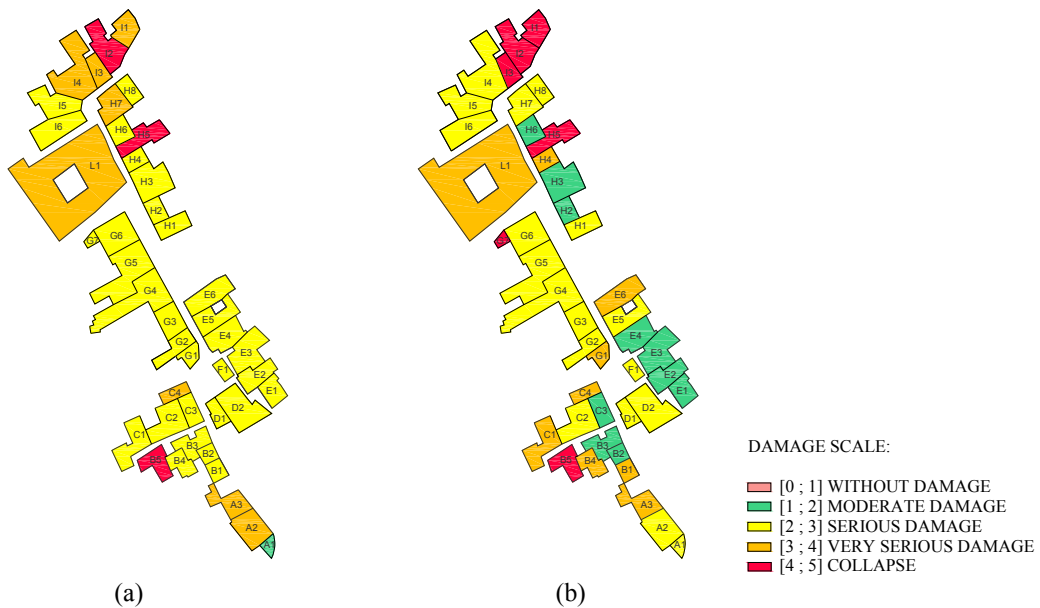
FIGURE 4. Damage maps of isolated (a) and aggregated (b) S.U. ( $I_s = 12$ )

In the last figure it is apparent that, when placed into aggregates, some S.U. having intermediate and corner positions show a damage reduction, whereas others in the corners have increased damage levels.
