# Comparing overflow and wave-overtopping induced breach initiation mechanisms in an embankment breach experiment

**Abstract.** As part of the SAFElevee project Delft University of Technology collaborated with Flanders Hydraulics Research, and Infram B.V. in the preparation and execution of a full scale embankment breach experiment in November 2015. This breach experiment was performed on an 3.5m high embankment with a sand core and clay outer layer situated along the tidal river Scheldt in Belgium near Schellebelle. During the experiment a wave overtopping simulator and overflow simulator were used to initiate a breach. Both simulators were placed near the top of the waterside slope. The use of the simulators facilitated comparison between the effects of continuous overflow and the effects of intermittent wave overtopping. This paper presents the data collected during the experiment, describe the development of hypotheses on the failure processes using the latest insights, and comment on the failure initiation process of a grass covered flood embankment with a clay outer layer and a sandy core.

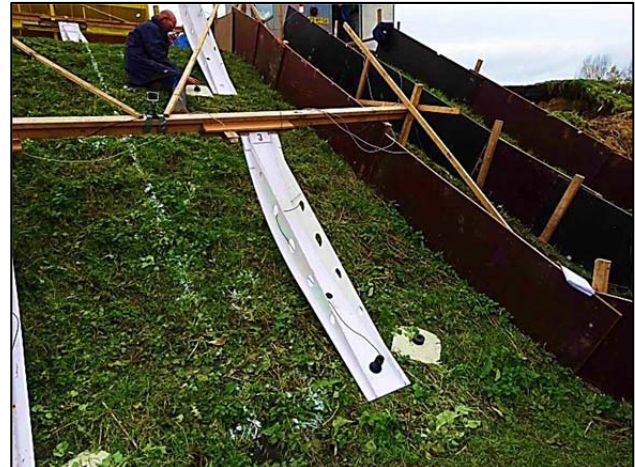
**Figure 2.** Setup for performing hydraulic measurements during wave overtopping tests.

To assess the roughness parameters on the embankment, hydraulic measurements were performed with waves of respectively 500, 1000, 1500, 2000, 2500, 3000, and 3500 l/m. During the hydraulic measurements the flow velocities were continuously measured at the bed and surface of the waves using paddle-wheels. To measure the change in depth profile of a wave over time, a surf-board like construction was used (see Figure 2). The

water depth was derived from measuring the change in angle of the surfboards when a wave passed under it. The paddle-wheels were placed near the downstream tip of the surfboard, both in the embankment surface and on the tip of the surfboard. This way both the flow velocity at the bed and at the surface could be measured. The front velocity of the wave was derived by measuring the time lapse in signal from the surfboards and the known distance between two surfboards.

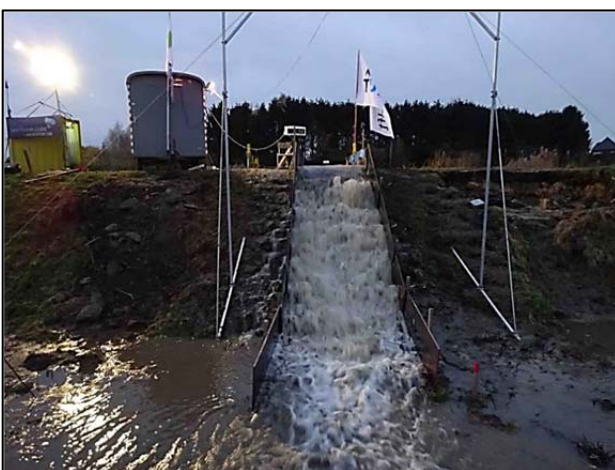
Figure 6. Observed aerated flow during the overflow experiment

Due to limitations in the minimum allowable frequency at which the pump could be operated, tests with the overflow simulator started at 10 l/m/s, followed up by 25, 50 l/m/s and 85 l/m/s. Contrary to expectations, the damage that occurred to the grass cover at overflow discharges of 50 l/m/s and 85 l/m/s was negligible. Instead of the theoretical nice smooth flow of constant density, during all overflow tests the flow became highly aerated down the landside slope (see Figure 6). This could be of influence to the spatial velocity distribution down the slope. Between changes in the discharge the flow was stopped during which became apparent that contrary to the behaviour of grass during wave overtopping the grass cover remained in a flattened position and did not bounce back upwards. Another noticeable, and potentially important observable difference with the wave overtopping tests, was that during overflow the reattachment point of the flow was closer to the crest than during wave overtopping. The normal impact at the reattachment point is therefore also expected to be smaller during overflow than during wave overtopping. These differences with wave overtopping could potentially help in better explaining the difference in timing in failure initiation of the grass cover.
