JPL PUBLICATION 79-55

Hydrogen-Fueled Postal Vehicle Performance Evaluation

June 15, 1979

by
Jet Propulsion Laboratory
California Institute of Technology
Pasadena, California

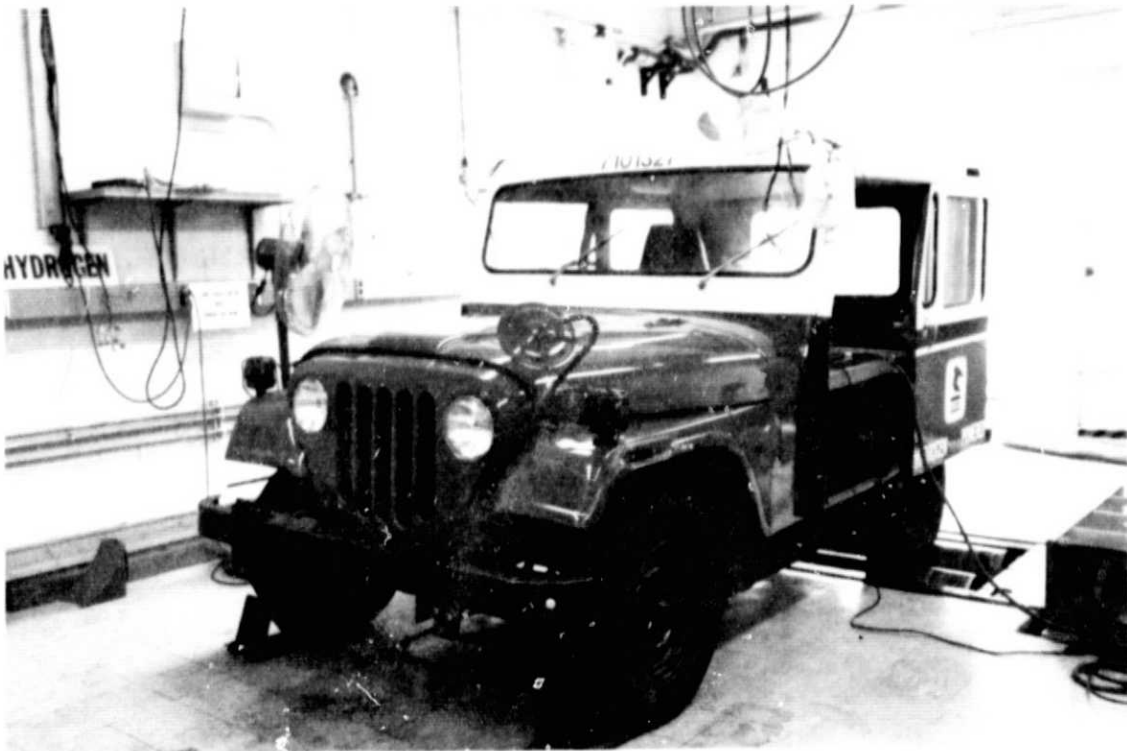
Figure 1. USPS Hydrogen-Fueled Jeep Delivery Vehicle on JPL Chassis Dynamometer

The vehicle (Figure 1) is basically a 1977 Jeep model DJ-5F Dispatcher 100 with an AMC 232 CID six cylinder engine and automatic three-speed transmission. The rear axle and suspension system have been modified: (1) The rear axle is equipped with a Trac-lok differential and 4.89 gears. The 4.89:1 axle ratio was installed in place of the original 3.07:1 ratio to allow the engine to operate in an adequate power-producing region at normal vehicle speeds. The transmission shift program appears to have been altered to allow the vehicle to shift at normal speeds, compensating for the 4.89 gears installed in the differential. (2) The suspension system has been modified to support the added fuel tank weight. The original shock absorbers have been replaced with air shocks, and additional leaves added to the rear springs to provide a 900-pound increase in the vehicle load capacity.

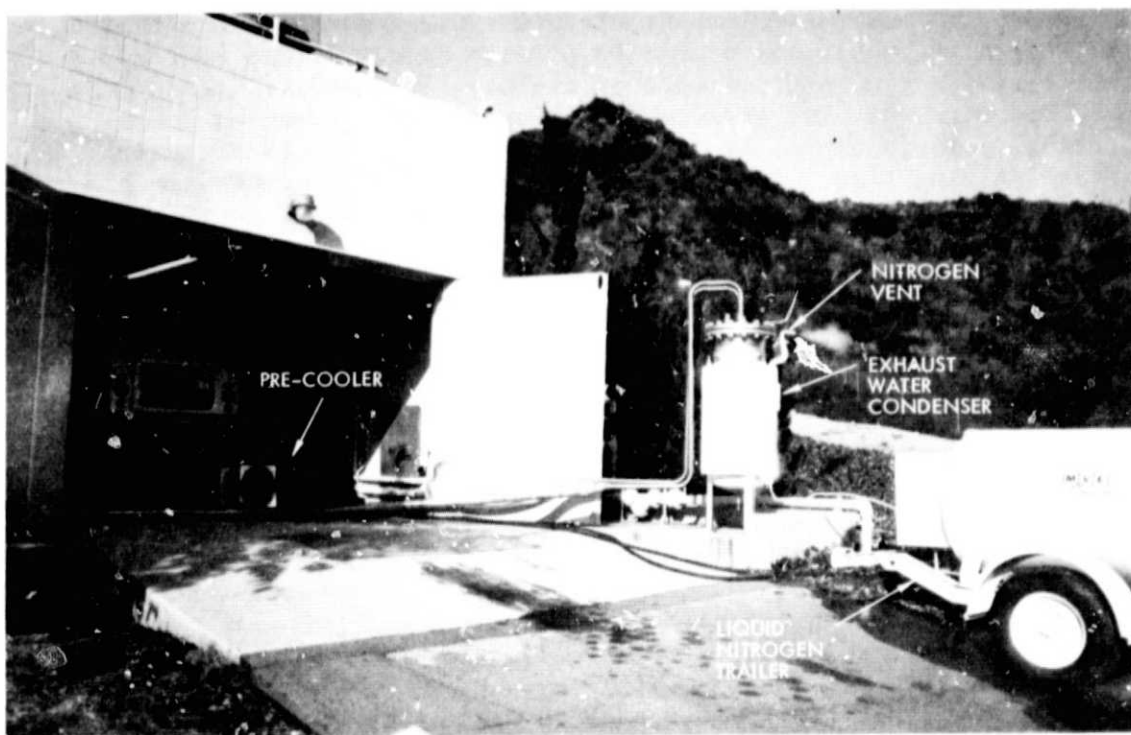
Figure 2. Exhaust Cooling System for Hydrogen USPS Jeep Tests

Since the principal product of combustion from hydrogen and air is water, there is a considerable amount of water in the vehicle exhaust. For complete combustion, it can be shown that up to 9 pounds of water can be produced from the combustion of 1 pound of hydrogen. It was determined that for a complete Urban Driving Cycle, the total amount of water in the exhaust would be excessive for the capabilities of the Constant Volume Sampler (CVS) and other exhaust instruments. Therefore, the vehicle exhaust was cooled and sufficient water condensed such that the remaining exhaust stream, when at room temperature, was above its dew point. The postal vehicle, installed on the chassis dynamometer with its exhaust connected to two coolers, is shown in Figure 2. The first heat exchanger is a liquid-to-gas heat exchanger. Tap water was used for the liquid, and the gas (vehicle exhaust) temperature was reduced to approximately 225-250°F. Minimal condensation occurred in the first heat exchanger and in the plumbing between it and the second heat exchanger. The second heat exchanger shown in Figure 2 consists of a pressure vessel surrounded by a closed outer cylinder. Liquid nitrogen was used to fill the outer cylinder, and the majority of the vehicle exhaust water was allowed to condense in the inner vessel. The vehicle exhaust leaving the second heat exchanger ranged from 80-125°F. The side effects of this technique are discussed in Section IV.

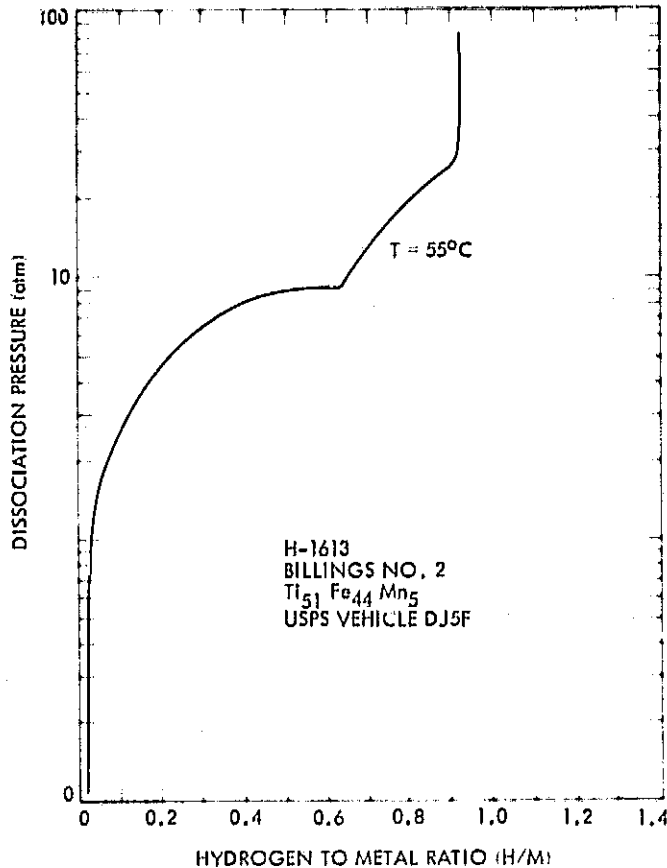
Figure 3. Hydride Dissociation Pressure Equilibrium Curve (reproduced from Hydrogen Fueled Vehicle-Hydride Storage System, Project 6120, final report to the U. S. Postal Service, by V. Anderson, Billings Energy Corp., July 31, 1978)

The ratio of hydrogen mass to hydride mass is nearly constant when the vehicle tank pressure is near 500 psig (a constant temperature is also assumed). This is illustrated in Figure 3 (by one isotherm) by the nearly vertical hydrogen/hydride ratio at 34 atm (500 psig). Small variations in the final vehicle tank pressure following refueling do not appreciably change the mass of hydrogen contained in the vehicle.

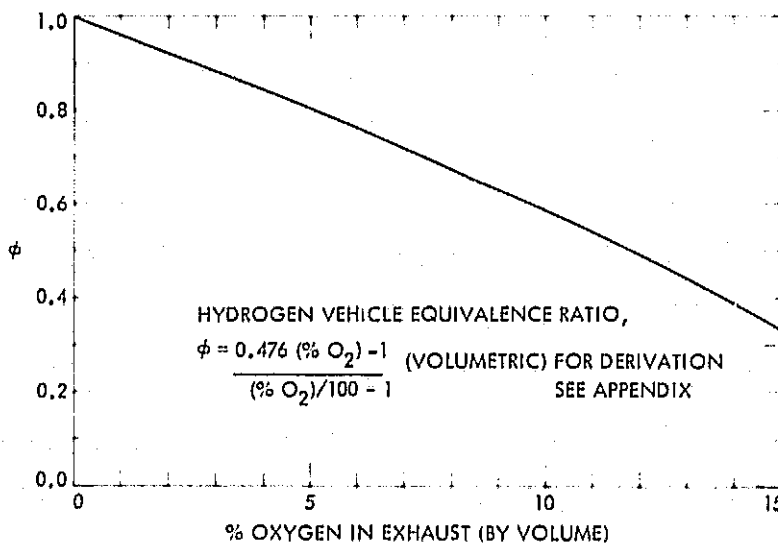
Figure 4. Equivalence Ratio vs. Exhaust Oxygen Volume for Hydrogen and Air Combustion

Since the test vehicle experienced a considerable number of flashbacks, and the Urban Driving Cycle NO_x emissions were high, it was suspected that the vehicle was operating at an equivalence ratio* which would aggravate these conditions. An investigation of the approximate equivalence ratio at typical steady-state level-road load (LRL) conditions was performed. The approximate equivalence ratio was determined from measurements of the vehicle exhaust oxygen content. The relationship of theoretical exhaust oxygen content to combustion equivalence ratio is illustrated in Figure 4. The measured

oxygen by volume in the exhaust was 3.6% at 15 mph LRL, 3.8% at 30 mph LRL, and 4.9% at 40 mph LRL. These correspond to equivalence ratios of 0.85, 0.86, and 0.81, respectively. Indeed, the vehicle was operating in the equivalence ratio region near maximum NO_x production, and flashback susceptibility. Further investigation of the trade-offs between emissions, flashback susceptibility, efficiency, and performance is recommended. Previous JPL experience with hydrogen-fueled vehicles has demonstrated more satisfactory results where the engine operates in the equivalence ratio region of 0.60 to 0.70.

The equivalence ratio at which the test vehicle operates was determined by measuring the oxygen content of its exhaust. The steady-state equivalence ratio was determined to be approximately 0.81 to 0.86. This is the region of maximum oxides of nitrogen production, and possibly in the region of maximum susceptibility of flashbacks. It is recommended that operation of the vehicle be investigated at lower equivalence ratios. Lower oxides of nitrogen and less susceptibility to flashbacks should be experienced if the equivalence ratio is changed to be in the region of 0.6 to 0.7.

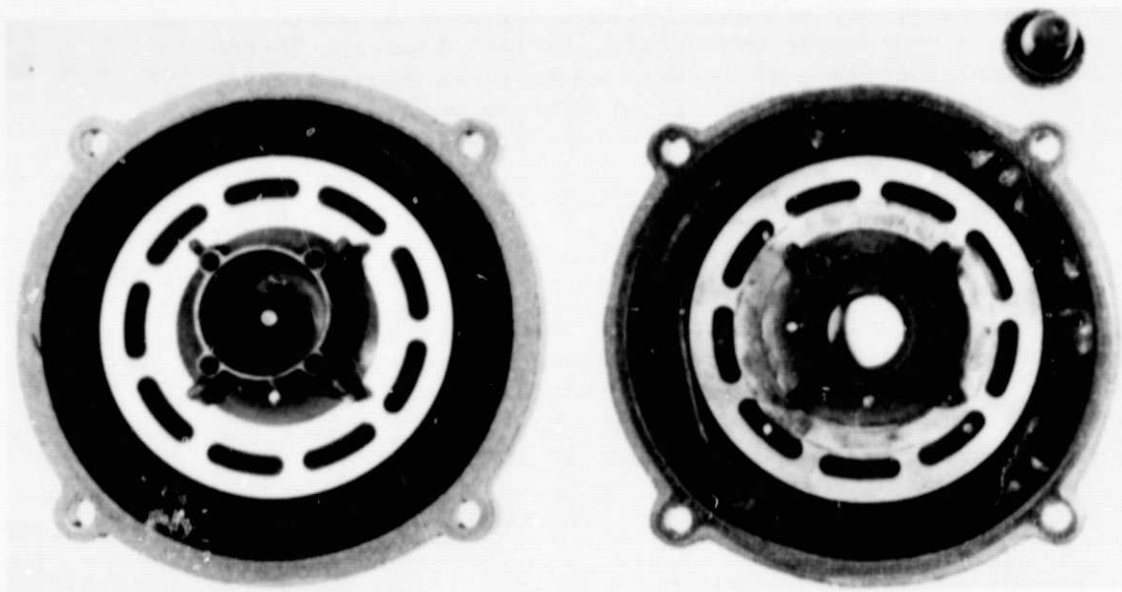
Figure 5. USPS Hydrogen Jeep - Carburetor Diaphragms

While being prepared for the Urban Driving Cycle tests, the vehicle was exposed to some 45 to 57 mph conditions during practice runs. Severe flashbacks were experienced followed by an audible leaking of hydrogen to the atmosphere from one or both of the hydrogen pressure regulators. A leak test revealed that the leak was in the area where the regulator diaphragm is secured by the two halves of the body. Regulator repair kits were provided by Billings (Impco Kits) and were installed by JPL personnel. The carburetor diaphragm was also replaced at this time because of prior experience, but the removed diaphragm did not have a broken casting, as did all the other replaced carburetor diaphragms.

ORIGINAL CONDITION

FAILURE OBSERVED AFTER SEVERE FLASHBACKS

Aside from the above-mentioned carburetor/diaphragm repair work, little maintenance was performed during the evaluation. During the checkout and preparation phase of the evaluation and prior to any of the PSDC or Urban Driving Cycles, a Billings representative twice verified proper vehicle performance. The first time that the JPL operation was inspected by the Billings representative, the problem with the carburetor diaphragm was discussed and JPL personnel were shown how to change the diaphragm. The first broken carburetor diaphragm was replaced at this time.

The second time the Billings representative visited JPL, four carburetor diaphragms had been broken and the Billings representative installed new spark plugs, adjusted the water injection system, arranged the spark plug wires (to avoid potential cross-firing), checked the ignition spark timing, and checked the vehicle coolant and crankcase levels. The Billings representative monitored a practice PSDC test, during which the fifth carburetor diaphragm was changed. Following this practice test, the vehicle was declared by Billings to be operating as designed and ready for evaluation. The tune-up parameters were not adjusted again during the evaluation.

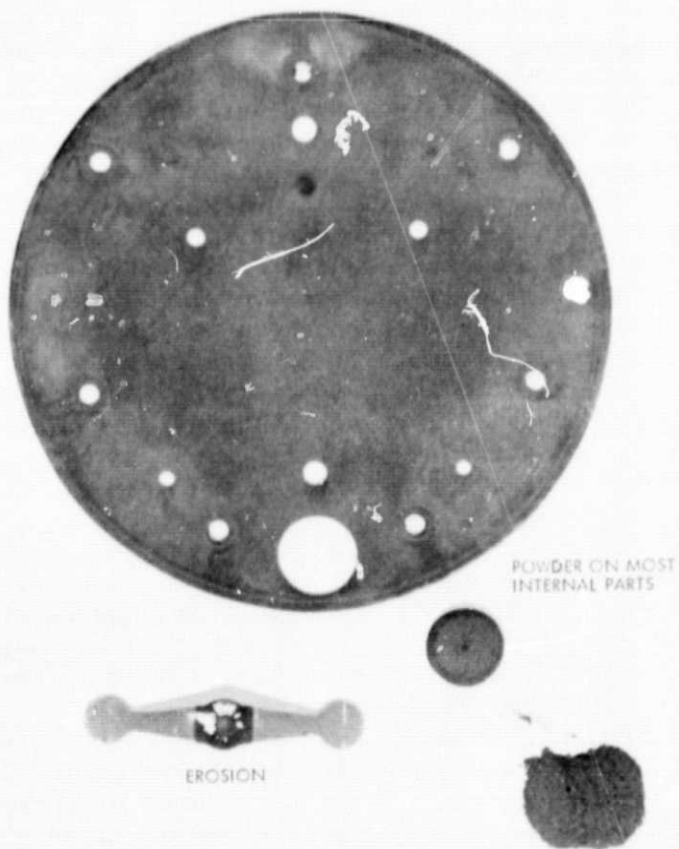
POWDER ON MOST INTERNAL PARTS

EROSION

During the repair of the regulators, it was noted that the inside regulator surfaces were covered with a fine, dark-gray powder. A flow valve in one of the regulators was severely eroded such that it could no longer seal. These conditions are illustrated in Figure 6. A portion of the powder recovered from the regulators was sent to Billings and they concluded that the powder was iron-titanium hydride. The hydride is evidently not being held in the tanks. This should be noted as a potentially serious problem. Premature engine wear may result from relatively small amounts of the iron-titanium.

Iron-titanium hydride was found in the fuel system. The source of this should be found and corrected. Wear in the engine should be measured to determine if the iron-titanium hydride has caused any engine damage.
