NASA CR-72979
Bell Model 8606

EVALUATION OF METALLIC POSITIVE EXPULSION BELLOWS
OPERATING PARAMETERS WITH CRYOGENIC PROPELLANTS

Bell Aerospace Company
A Division of Textron

FINAL REPORT

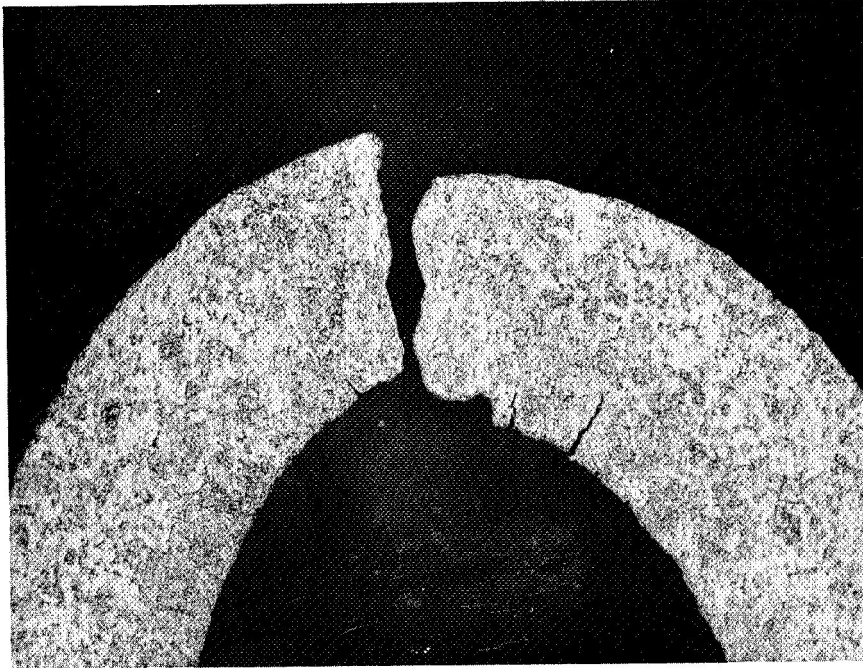
FIGURE 15
FATIGUE CRACK TYPICAL OF FAILURE
PRODUCED BY LIFE CYCLING TESTS

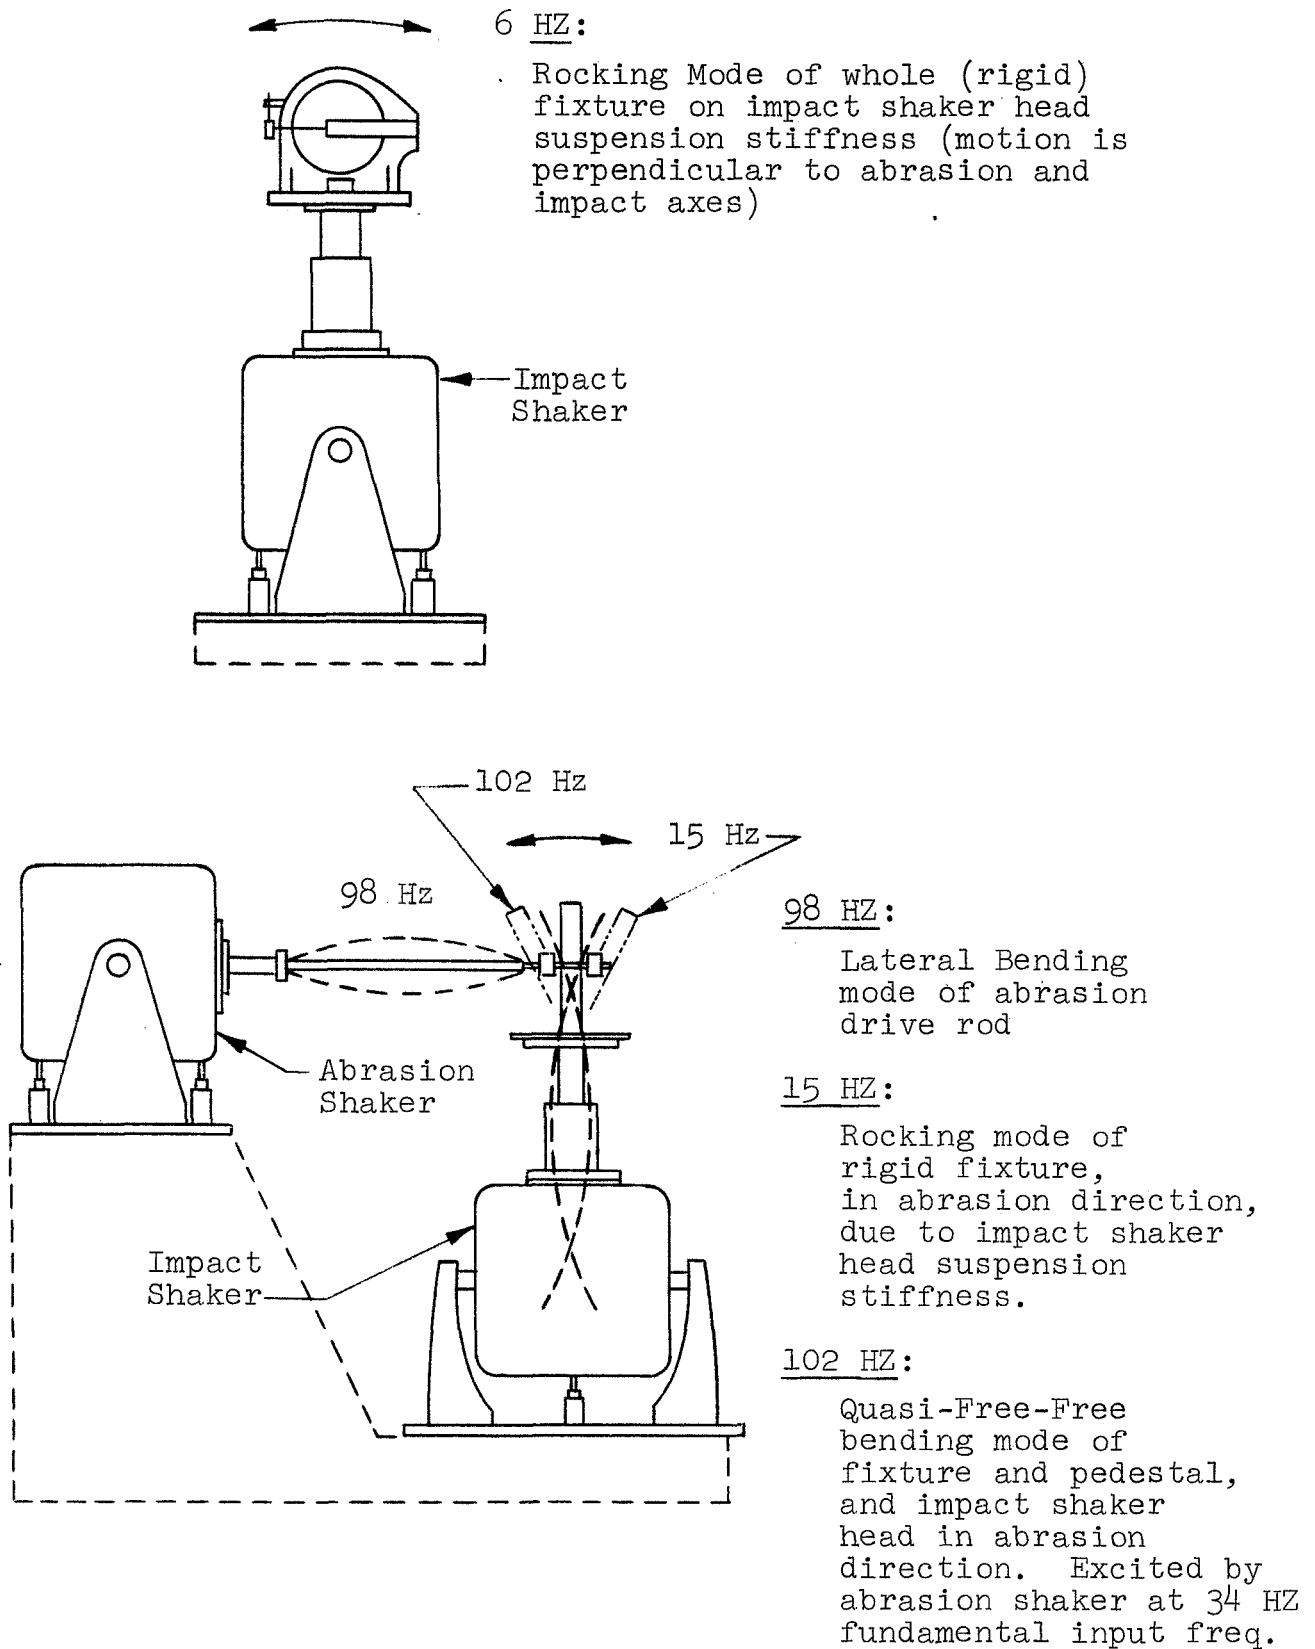
FIGURE 22. (Continued)

SUMMARY OF RESONANT VIBRATION MODES OF CRYO-IMPACT
AND ABRASION WEAR FIXTURE

45 Hz: Bellows pivoting mode about a vertical axis thru arm support shaft. Abrasion drive rod also deflecting laterally

60-65 Hz: Pumping mode of bellows (gas filled)
