FINAL REPORT
EXPERIMENTAL EVALUATION OF
LOW CYCLE THERMAL FATIGUE IN A TURBINE VANE
FABRICATED FROM LAMINATED POROUS MATERIAL

DETROIT DIESEL ALLISON DIVISION OF GENERAL MOTORS
Post Office Box 894
Indianapolis, Indiana 46206

NATIONAL AERONAUTICS AND SPACE ADMINISTRATION

15 March 1971

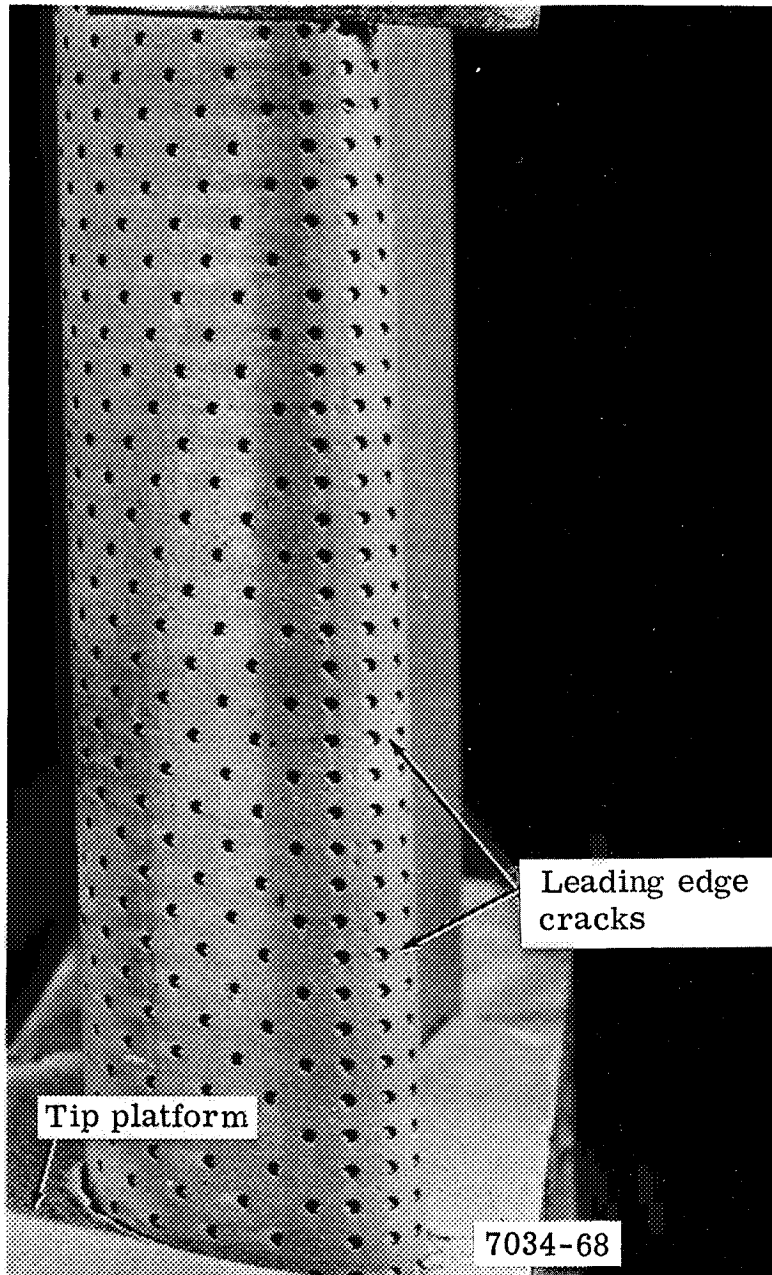
Figure 51. Leading edge and suction side view of test vane No. 4 after 110 cycles.

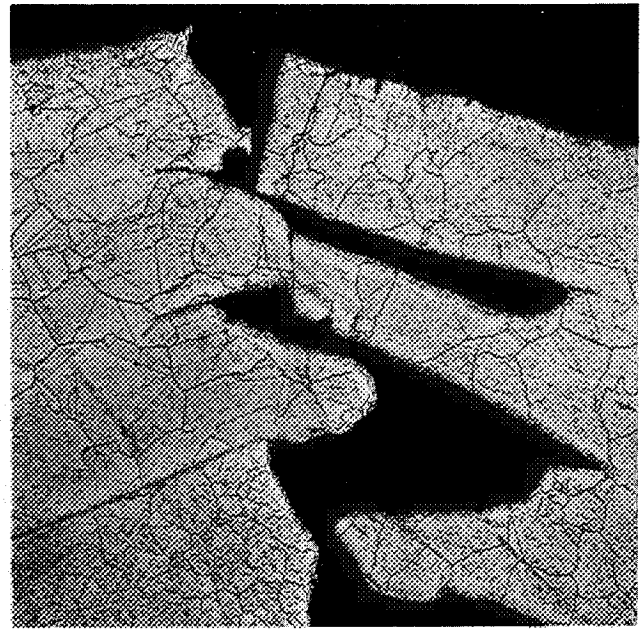
Figure 71. Photomicrographs of longitudinal failure sections in test vane No. 2 (magn: 100X).
