ADVANCED TURBINE ENGINE MAINSHAFT LUBRICATION SYSTEM INVESTIGATION

Part 2 - Detailed Face Seals Performance, Mass Spectroscopic Study  
of a Test Fluid, and Supplementary Test Data

NASA Lewis Research Center  
Contract NAS3-6267  
William R. Loomis, Project Manager

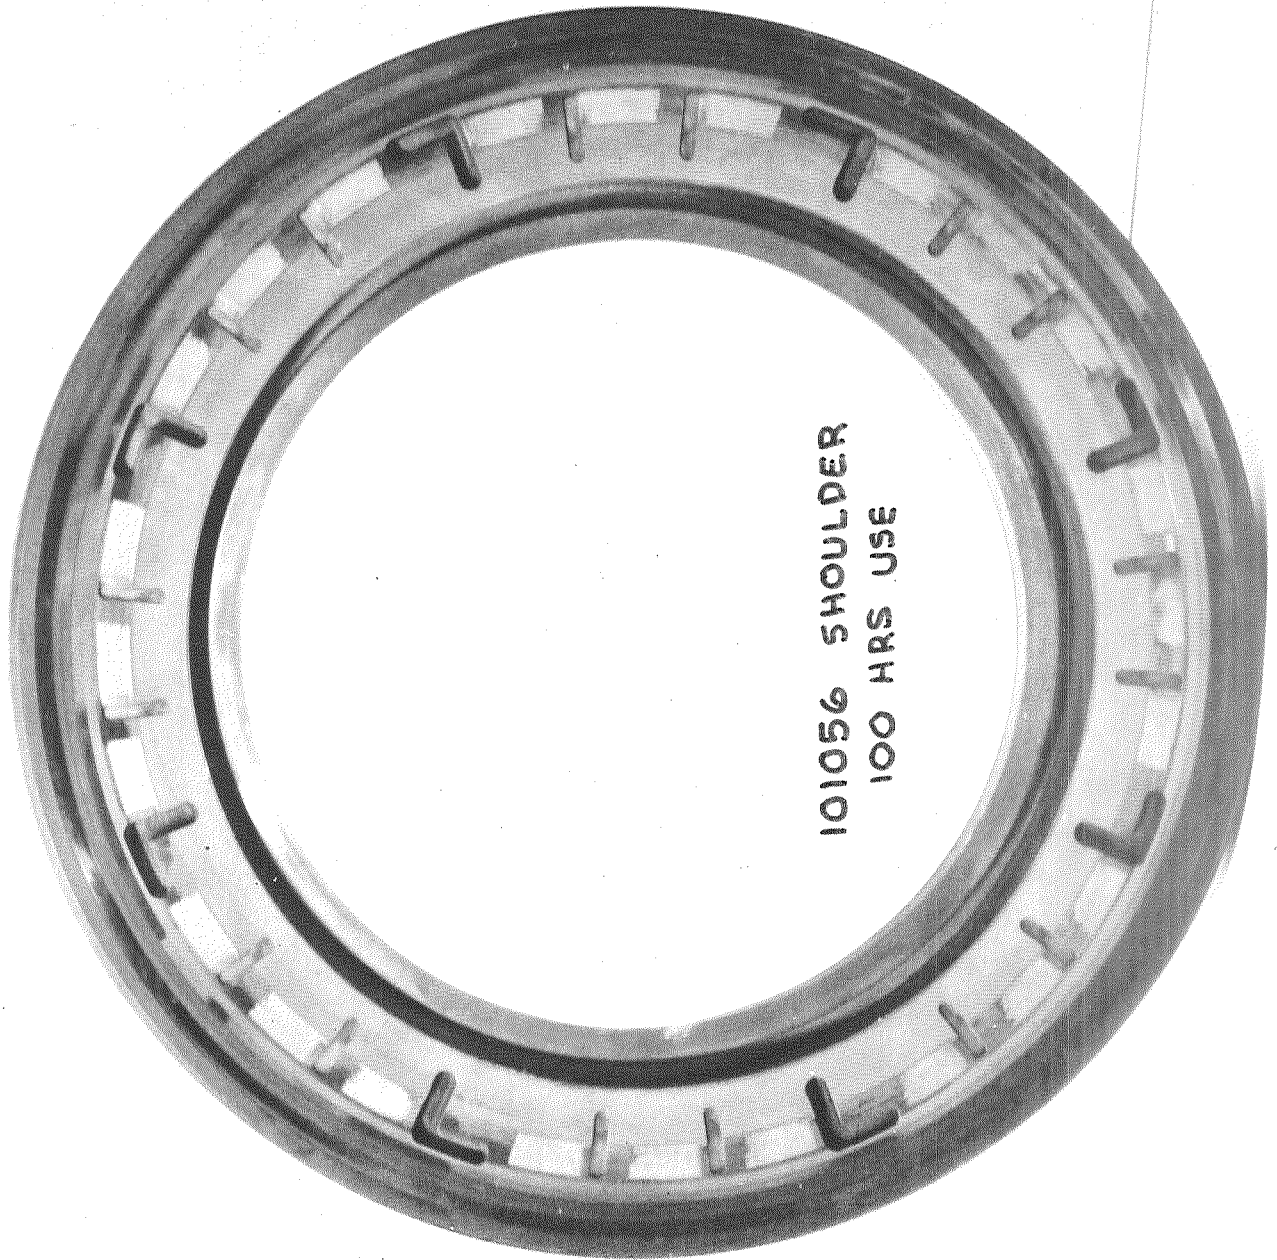
HYDRODYNAMIC LIFT DESIGN SHOULDER
