NASA CR-72852

ADVANCED SUPERALLOY PROTECTION SYSTEMS EVALUATION

GENERAL ELECTRIC COMPANY

Contract NAS 3-12414

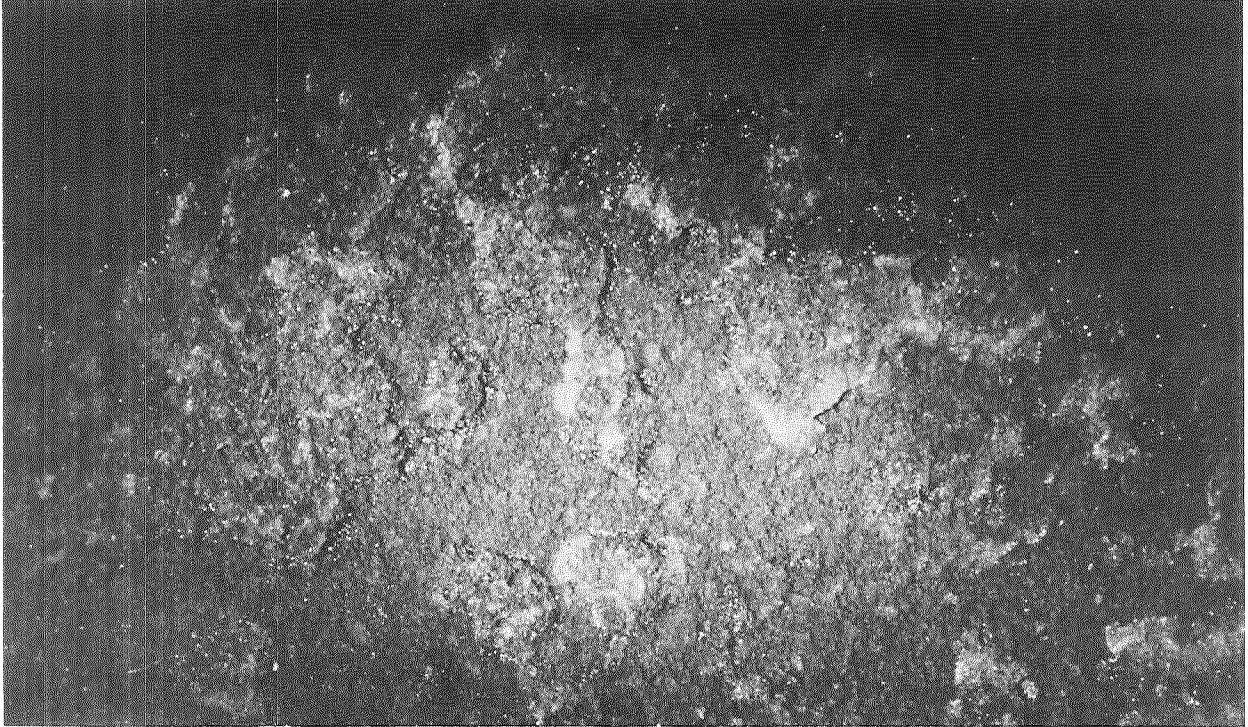
Figure 12. Appearance of Manganide/Chromide System After 158 Hours Static Oxidation at 2000°F (1367°K) (C70052709, 10X).

Figure 12 illustrates the surface appearance of the specimen with spalling clearly visible. Figure 13 shows a metallographic section of the impact areas of the 1900°F (1310°K) specimen. Loss of coating is evident not only as a spalled patch on the impact side, but also loss of coating is complete on the opposite surface. Furthermore, intergranular oxidation is evident.

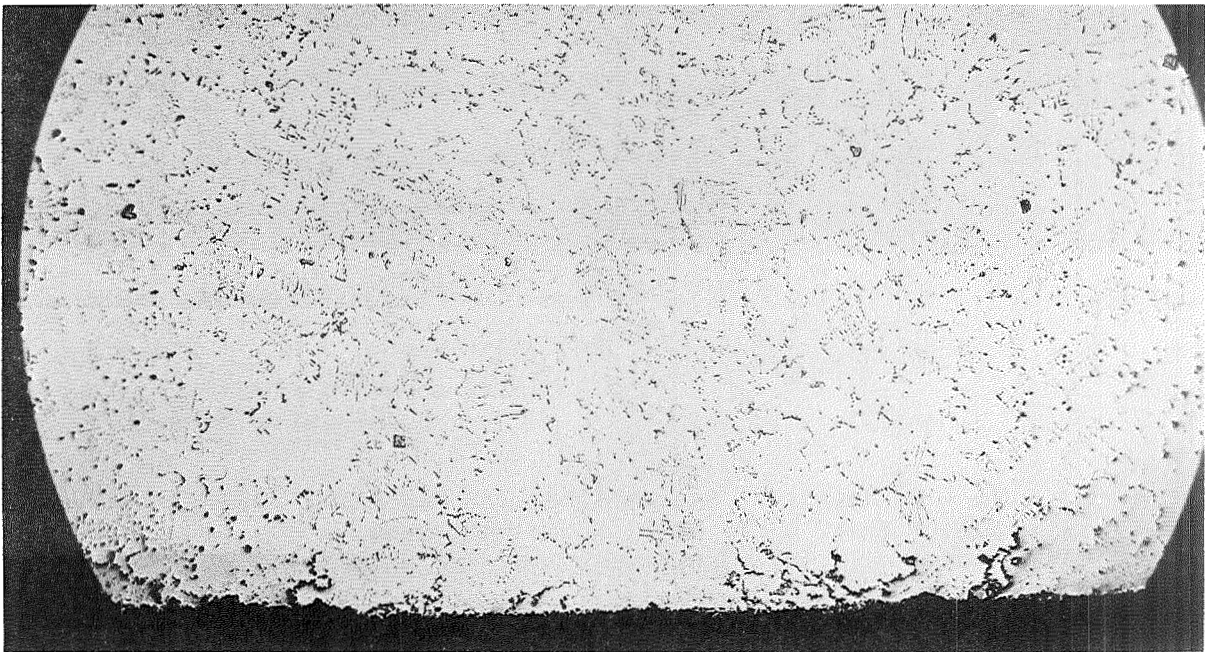
Figure 13. 1900°F (1310°K) Ballistic Impact Site on Mn + Cr Metallide System After 200 Hours Static Oxidation at 2000°F (1367°K). Intergranular Oxidation May be Seen on the Surface Opposite Impact (F 6007, F 6008, 50X).

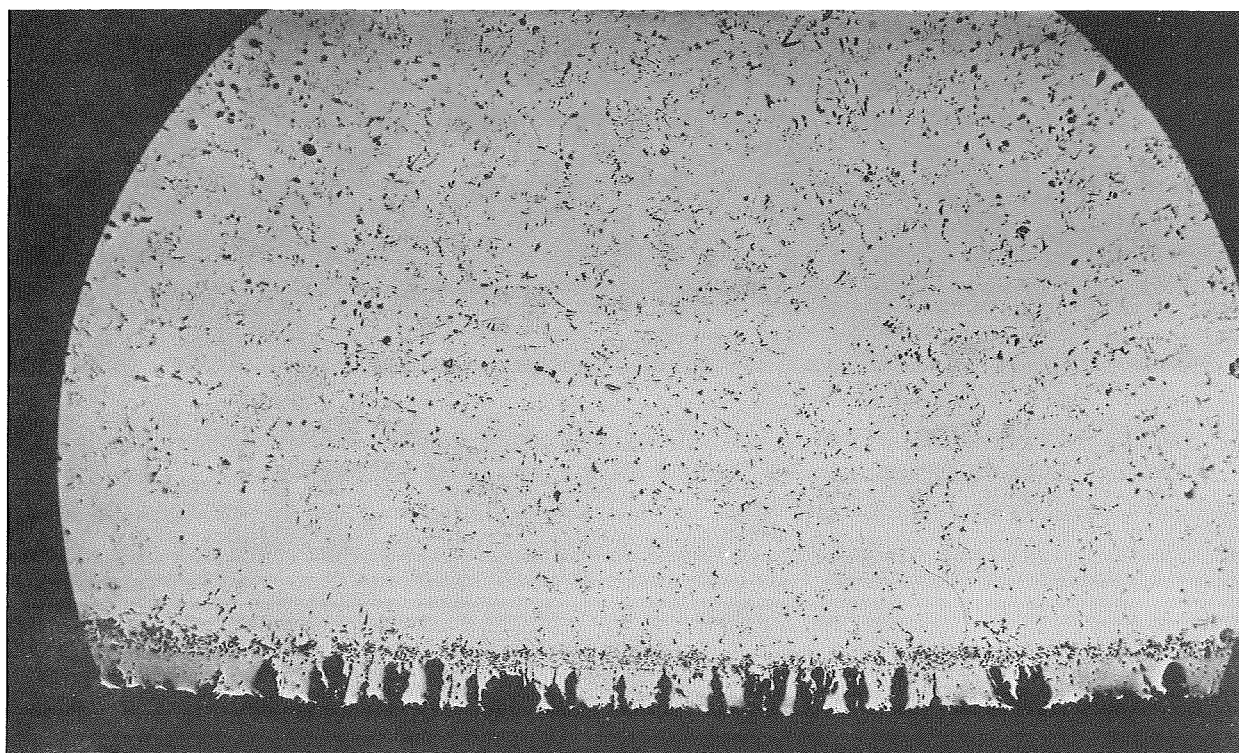
Figure 18. Ballistic Impact Sites 1900°F (1310°K) Impact on Al + Y Metallide System After 200 Hours Static Oxidation at 2000°F (1367°K) (F 6009, F 6010, 50X).

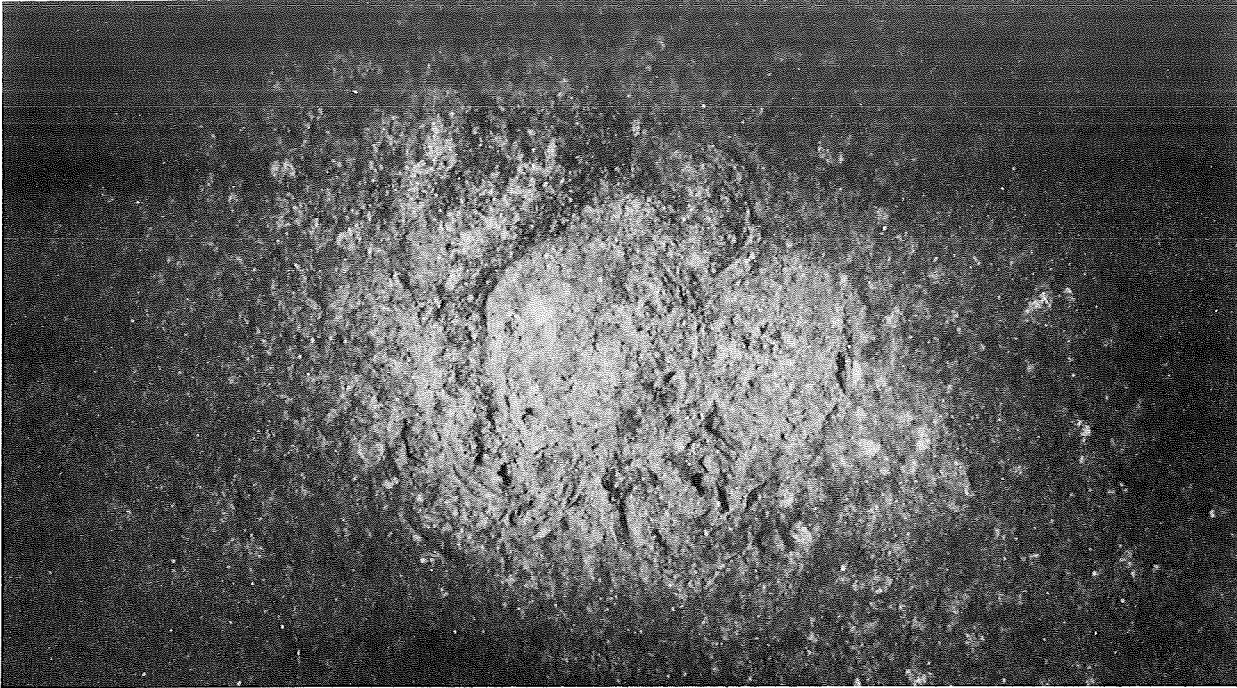
Figure 23. Macroscopic Appearance of Ballistic Impact Sites on Ta + Al Metallized System After 200 Hours at 2000°F (1367°K) (C70052719, C70052720, 10X).

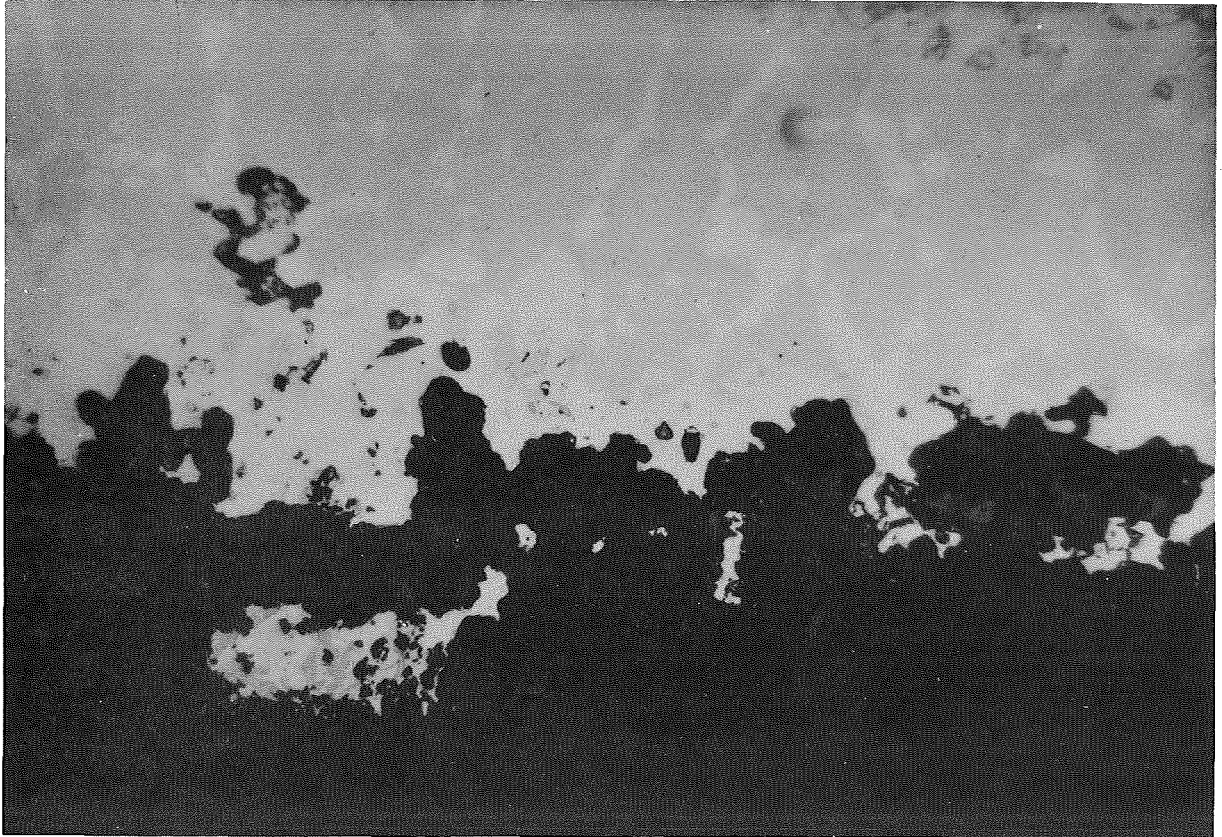
Figure 24. Microstructure of Ta + Al Metallide System on NASA/TRW VI-A After 200 Hours Static Oxidation at 2000°F (1367°K) (F 6004, 500X, Unetched).

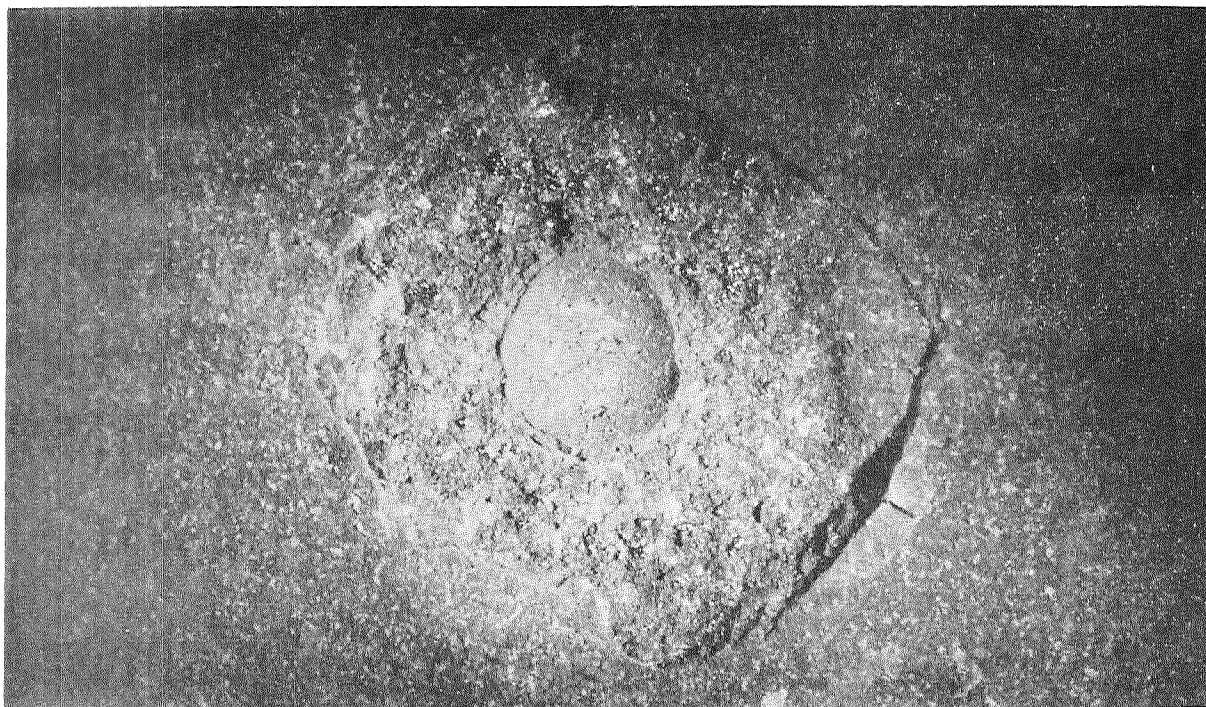
Figure 29. Room Temperature Ballistically-Impacted Aluminum Metallized System After 200 Hours Static Oxidation at 2000°F (1367°K) (C70052715 Lower, C70052716 Upper, 10X).

Figure 29 illustrates a ballistically-impacted specimen after oxidation. This specimen had been impacted at room temperature and as previously reported, was badly spalled and then oxidized at the impact site. The elevated-temperature impacted specimen was not badly spalled but suffered damage and subsequent oxidation on the impact surface.

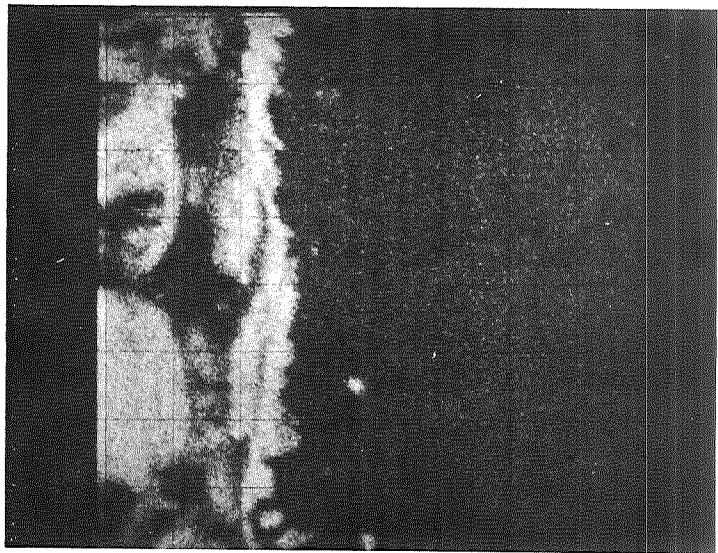
Figure 40. Microprobe Scans of CODEP C-2 on IN-100 Showing Principal Additives and Ni Base After 600 Hours Dynamic Oxidation at 2000°F (1367°K) (E 4931, 360X).

Furthermore, Ti appears as particles in the Al_2O_3 layer, as the result of TiO_2 particles in the original coating. X-ray diffraction confirmed the presence of $\alpha\text{-Al}_2\text{O}_3$ and rutile TiO_2 . Ni and Co are present through the structure except for the oxide layer and the Mo-Ti phase areas.
