**ADVANCED REFRACTORY ALLOY CORROSION LOOP PROGRAM**

**QUARTERLY PROGRESS REPORT NO. 22**

**For Quarter Ending October 15, 1970**

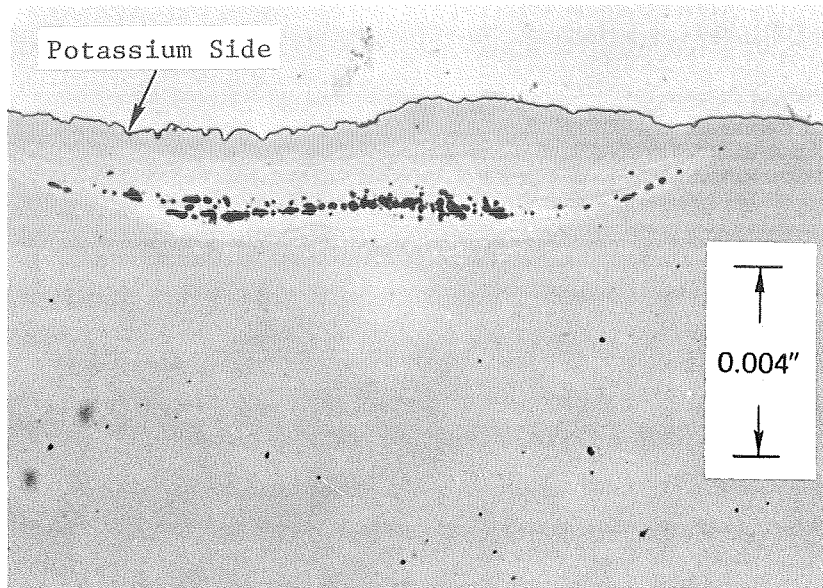
Figure 4. Base Metal-Weld Interface at Bottom of the 3/8-inch OD T-111 Potassium Containment Tube in the Plug Section of the Boiler Before and After Etching.

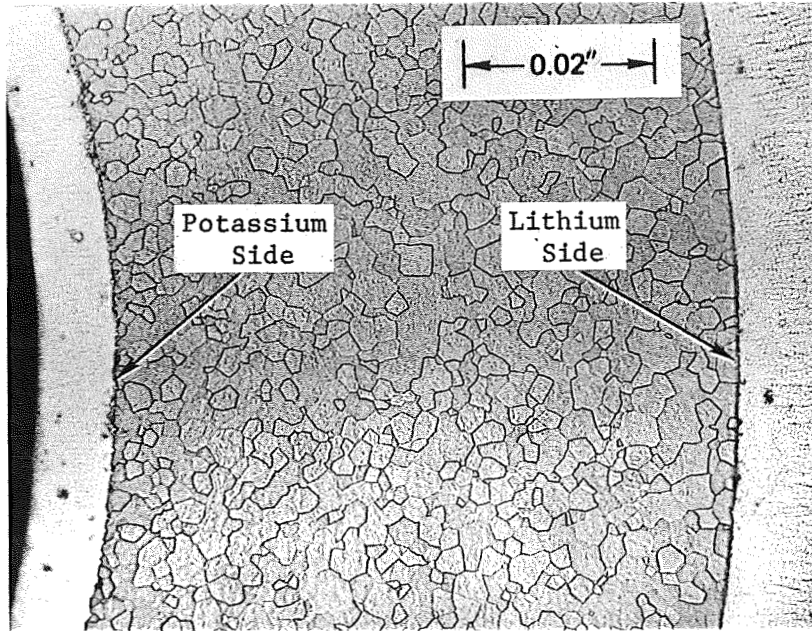
Figure 7. T-111 Potassium Containment Tube in the Plug Section of the Boiler Adjacent to the Top of the Swirler Wire Insert.

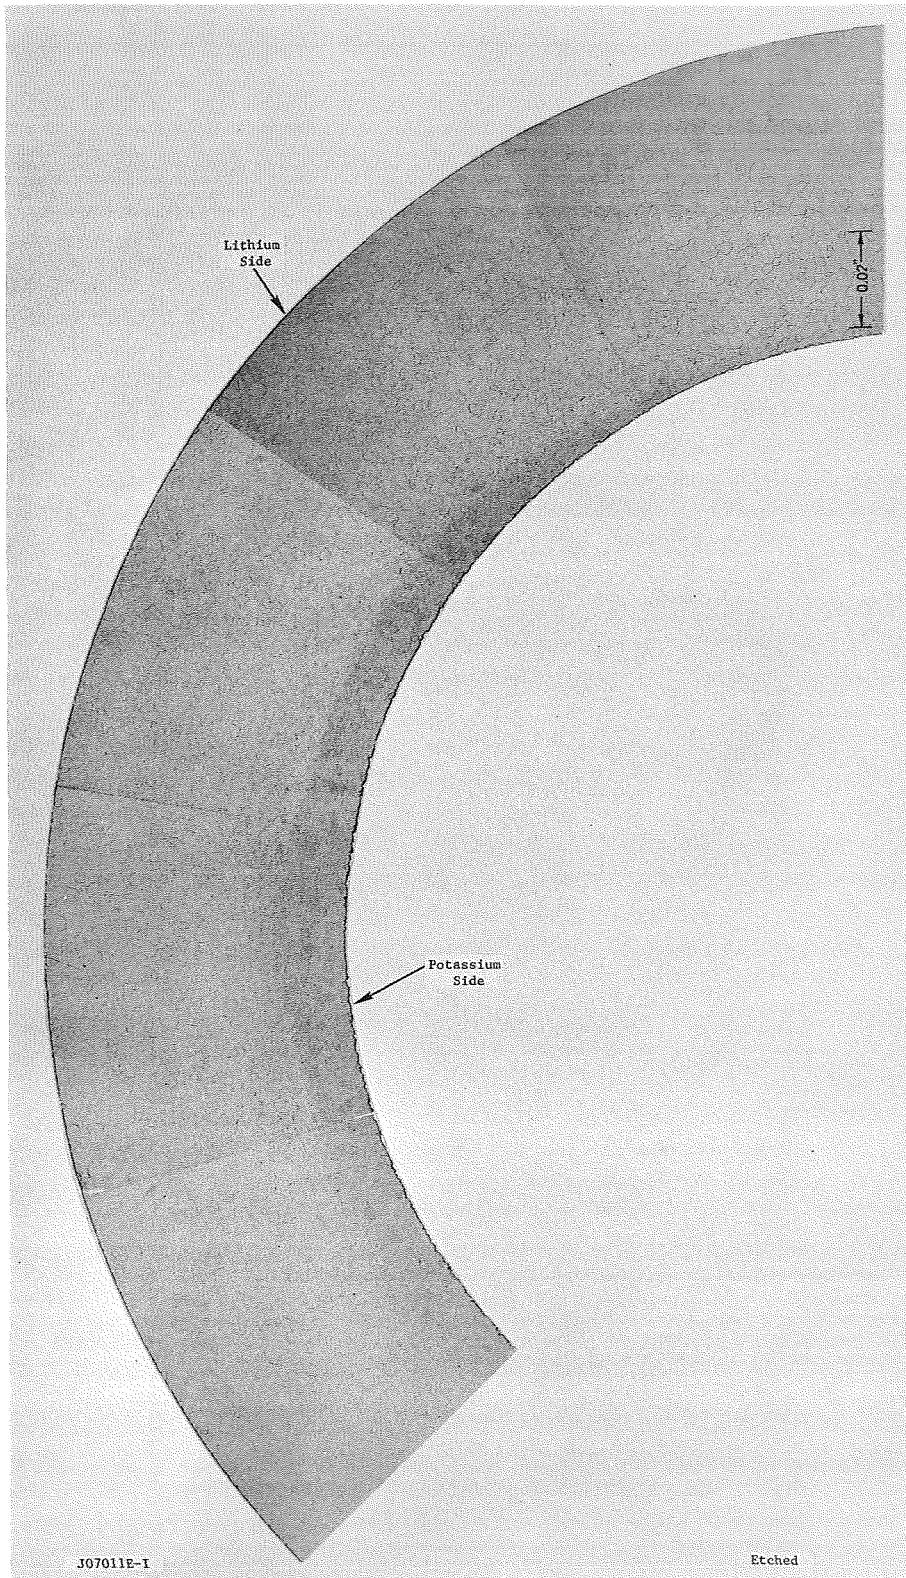
Figure 8. 3/8-Inch OD Potassium Containment Tube Approximately One-Half Inch Above Top of Swirler Wire Insert.

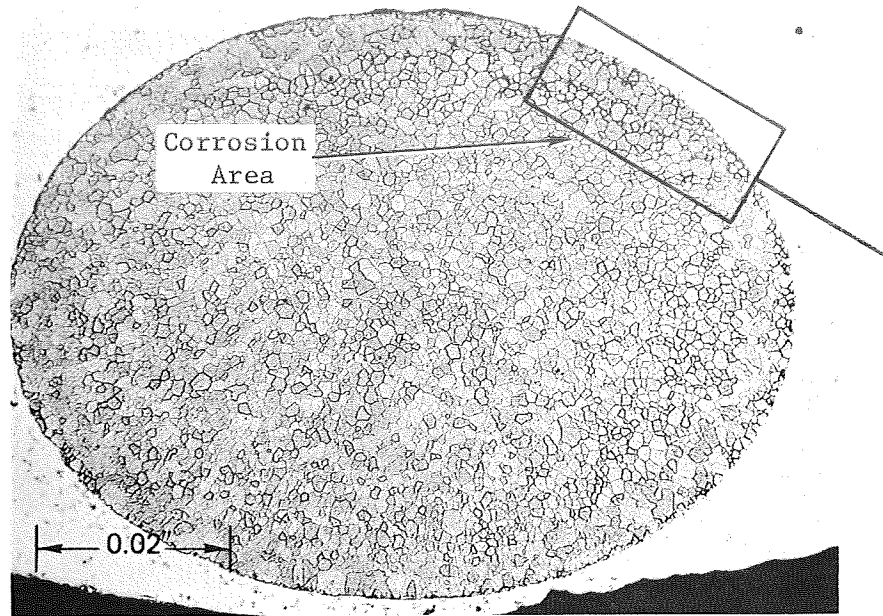
a. Overall

b. Corrosion area

Figure 11. T-111 Swirler Wire From Plug Section of the Boiler Approximately 6 Inches From the Lithium Exit.

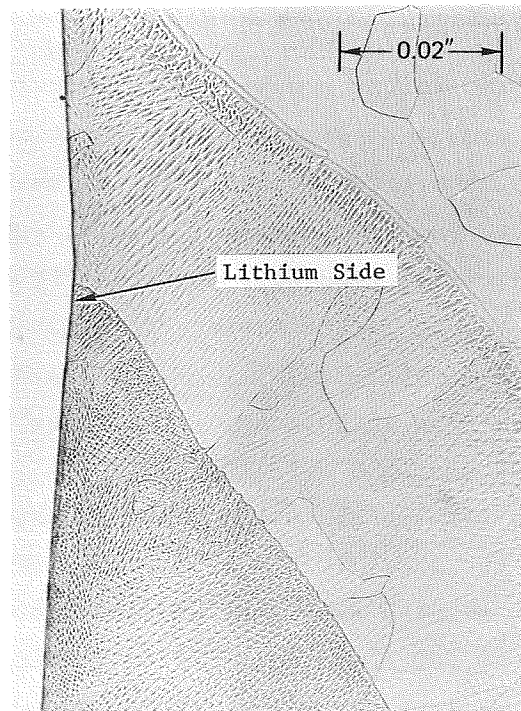
a. 3/8-inch OD potassium containment tube

b. 1-inch OD lithium containment tube

Figure 13. Repair Welds in Top Coil of the 3/8- and 1-inch T-111 Tubing from the Boiler.

boiler which were representative of the hottest (2240°F) part of the boiler. The repair welds on both the 3/8 and 1-inch tubing appeared to be in excellent condition as shown in Figure 13. The areas shown represent the weld metal-base metal interface, which past experience has shown to be the most critical from the standpoint of alkali metal compatibility, and, as clearly seen, no evidence of corrosion is evident.

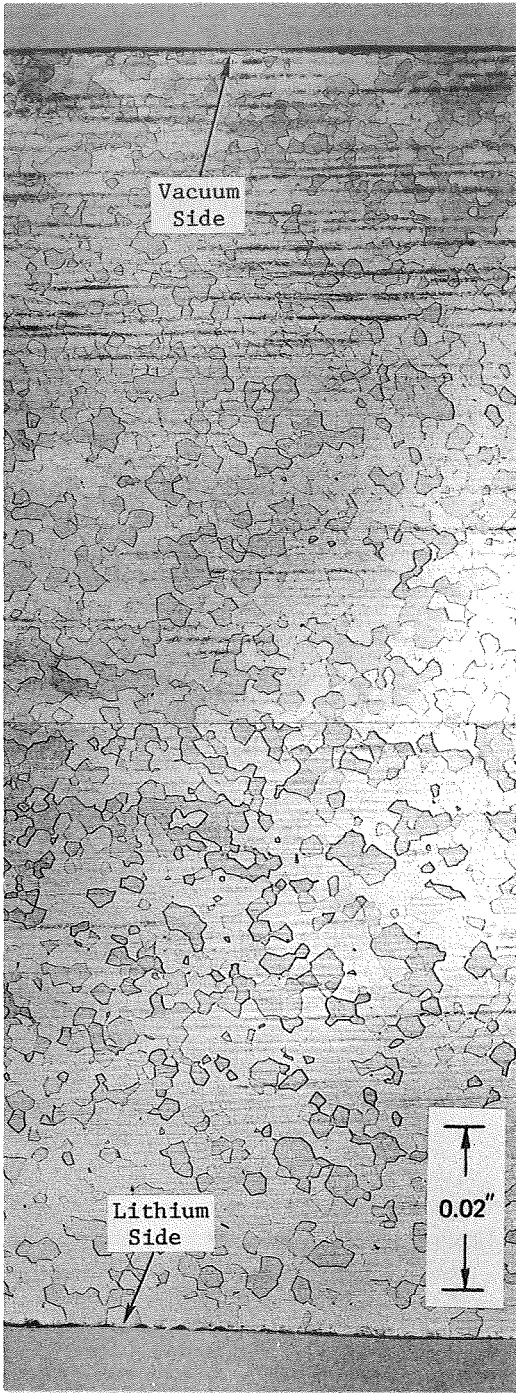
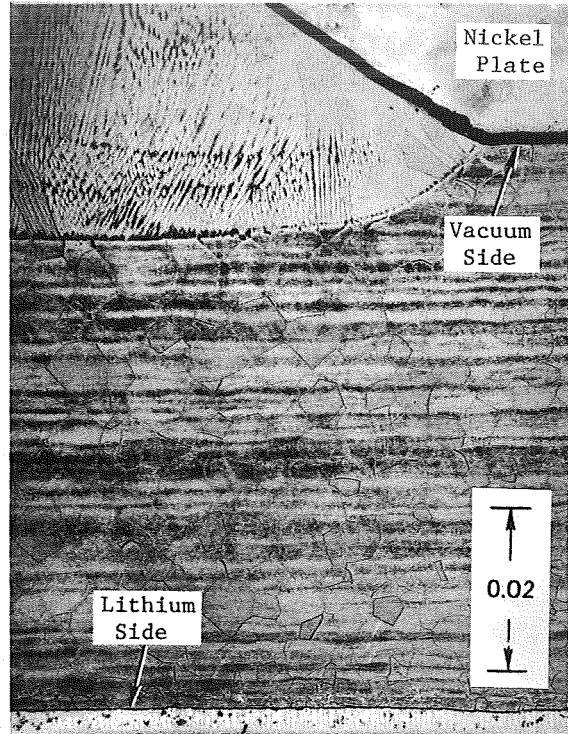
Figure 17. Repair Socket Weld in 3/8-inch Lithium Exit Line from Boiler.

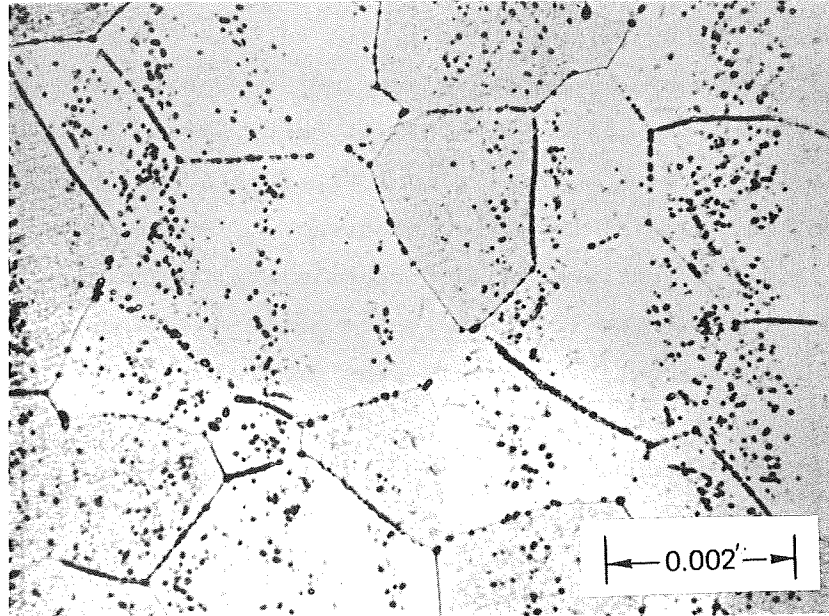
Figure 18. 3/8-inch Tube at Repair Socket Weld in Lithium Exit Line from Boiler. Same Area as Figure 17.

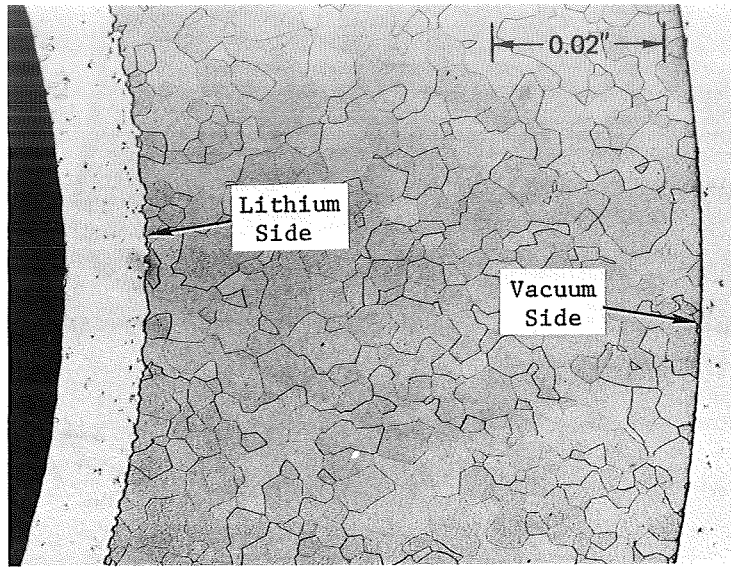
a. Total Wall

b. Inner Wall

c. Outer Wall

Figure 20. Lithium Line Connecting Heater Exit to the Boiler Inlet.

cleanest microstructure of any the tubing examined as shown in Figure 20. Also as seen in Figure 20 the grain size is approximately three times that of the pretest material shown in Figure 2a. Also, note that this is still considerably less grain growth than the strain induced growth at the top of the boiler (Figures 14 and 15).

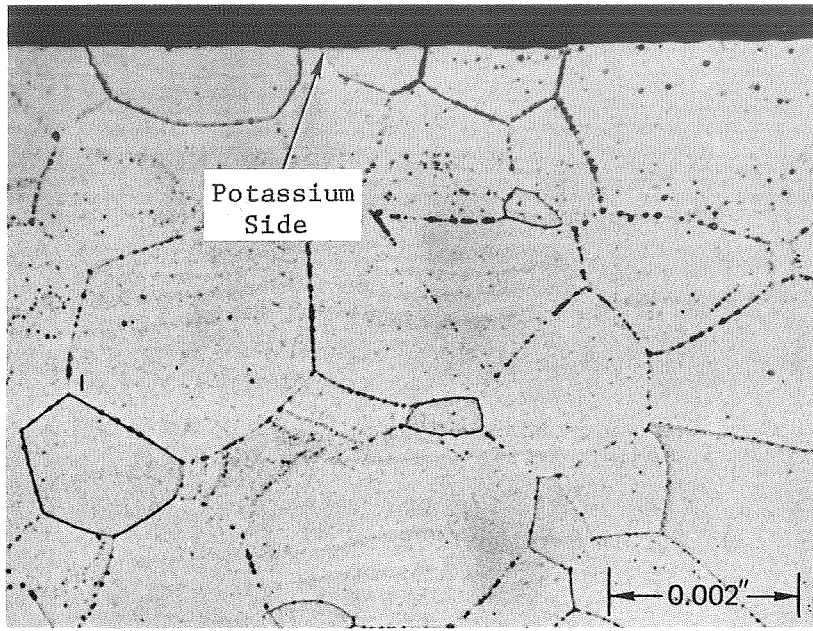
a. Inner Wall

b. Outer Wall

Figure 22. 1-Inch OD Potassium Vapor Crossover Line Following 10,000 Hours of Continuous Operation at Approximately 1880°F.

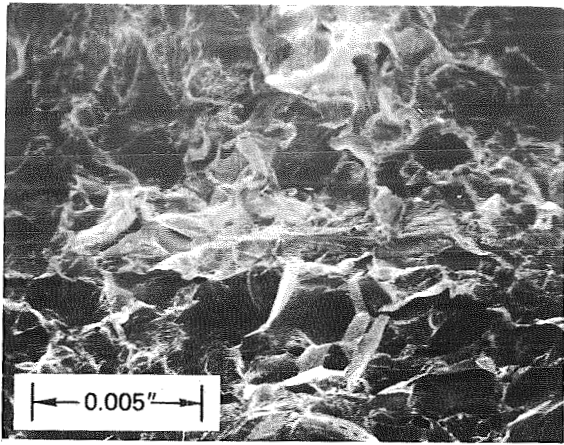
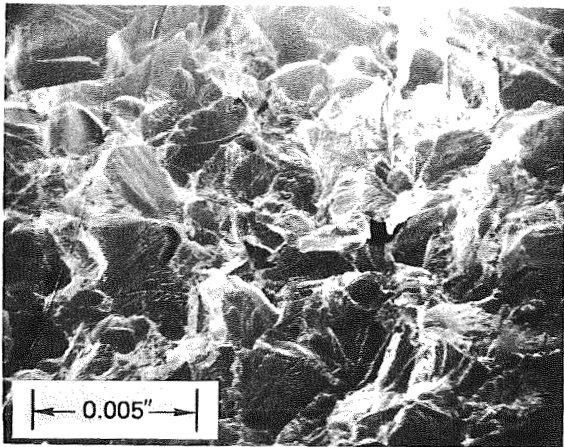
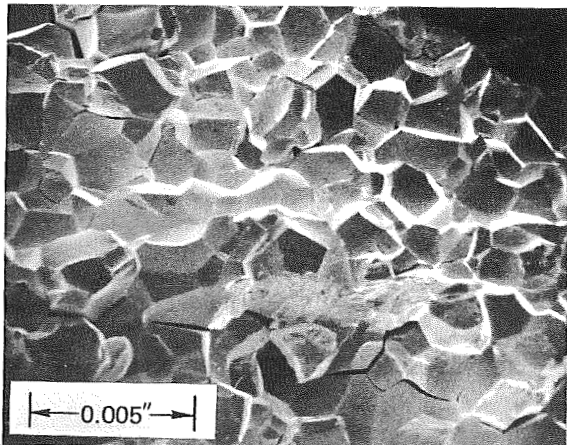
a. Pretest

b. Boiler - 2240°F

c. Vapor Crossover Line - 1880°F

Figure 23. Scanning Electron Micrographs of Various Components of T-111 Rankine System Corrosion Test Loop. All are Fractures from Compression Tests on Rings from 1-inch OD Tubing. (P71-2-3H)

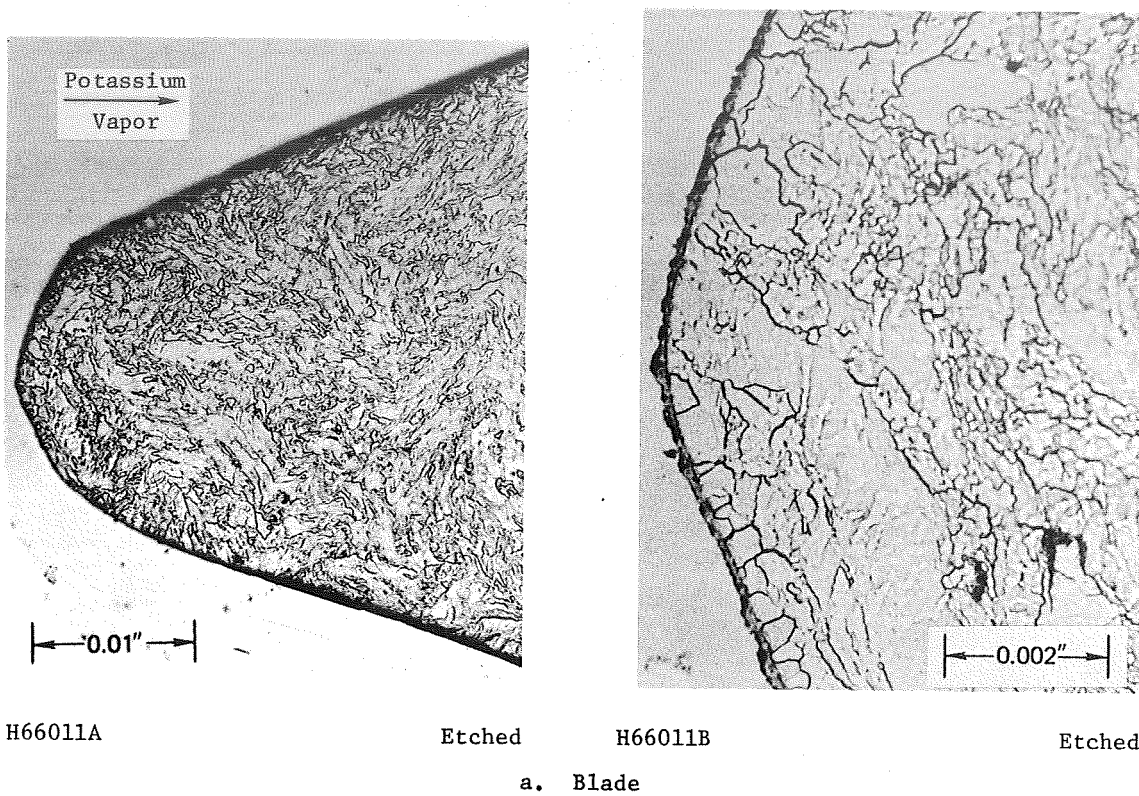
Figure 24. Mo-TZC Alloy First Stage Nozzle and Blade Turbine Simulator Following 10,000 Hours of Continuous Exposure to Flowing Potassium Vapor in the T-111 Rankine System Corrosion Test Loop.

Sections from the Mo-TZC first, second and tenth stages and the Cb-132M sixth stage nozzle and blades were examined in the vapor impingement area. No change in general microstructure was observed in any of the specimens examined as shown in Figures 24-27. The only anomalous feature is a thin coating on the leading edge of the first and second stage blades and on the second stage nozzle as shown in Figures 24 and 25. Microprobe evaluation will be performed to determine the composition of the film. Typical pretest photomicrographs of each material are shown in Figure 28.

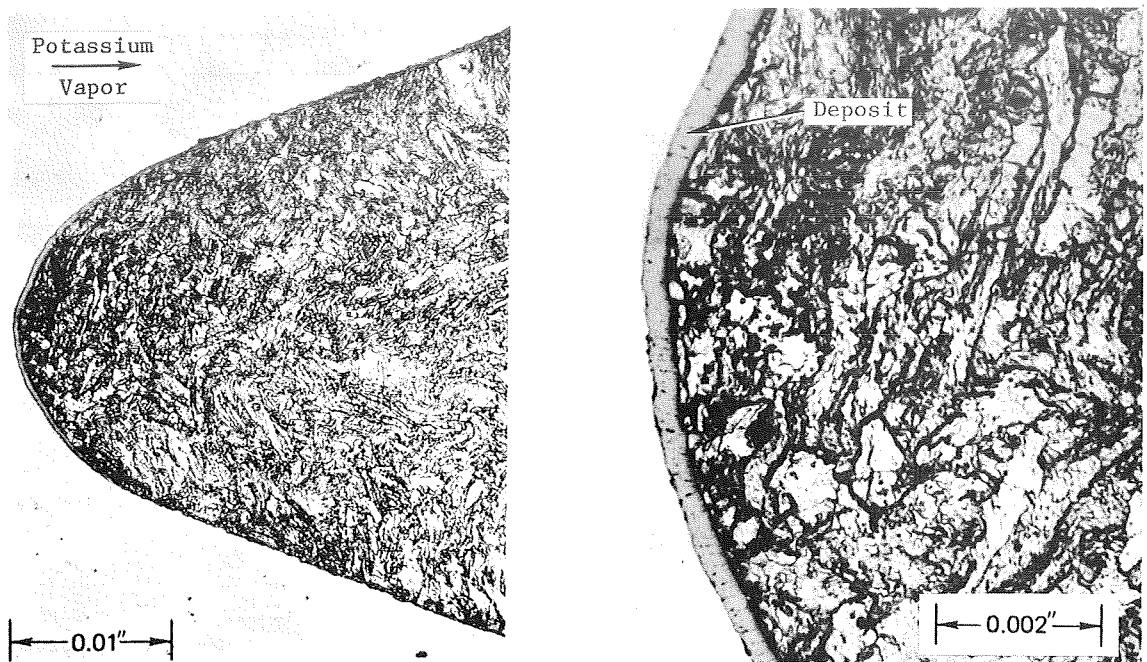
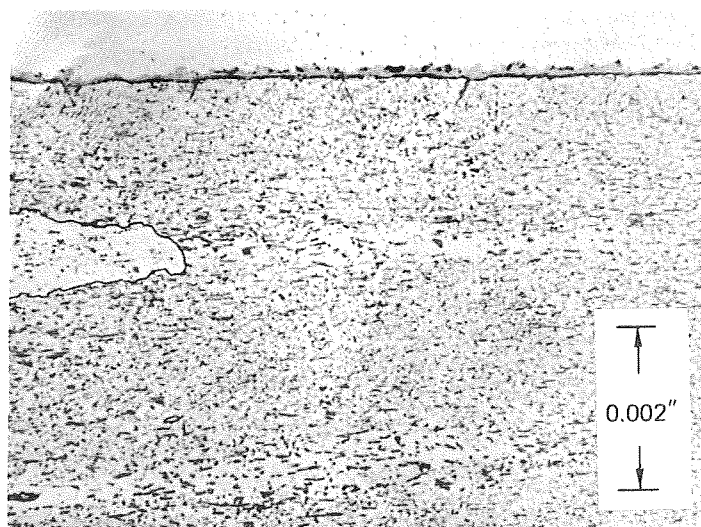
a. Blade

b. Nozzle

Figure 25. Mo-TZC Alloy Second Stage Nozzle and Blade Turbine Simulator Following 10,000 Hours of Continuous Exposure to Flowing Potassium Vapor in the T-111 Rankine System Corrosion Test Loop.

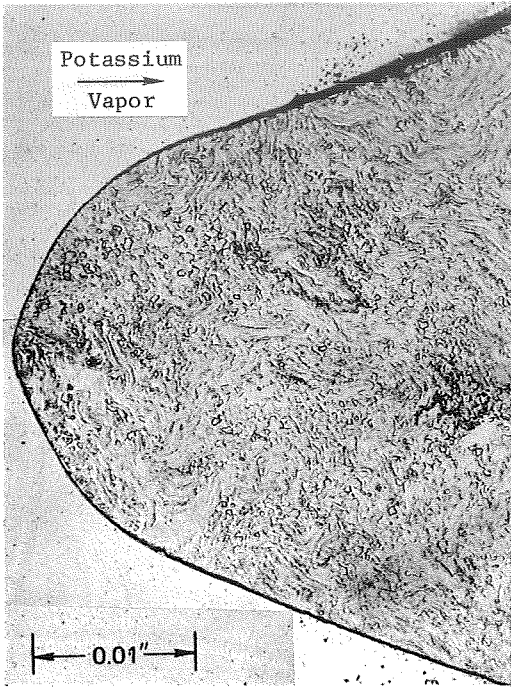
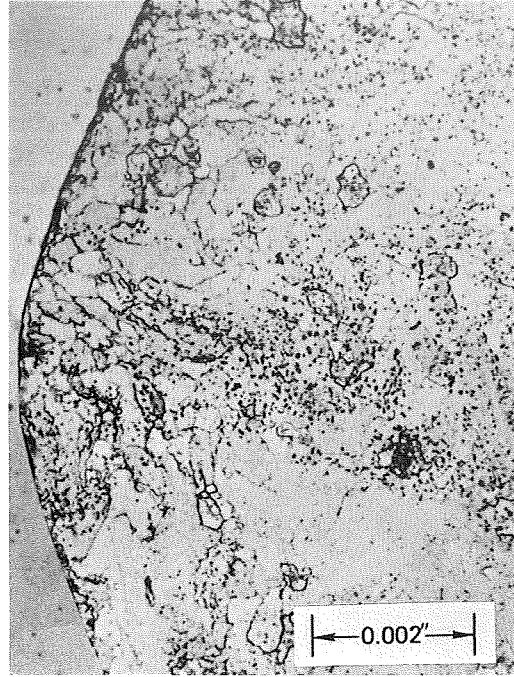
Figure 26. Cb-132M Alloy Sixth Stage Nozzle and Blade Turbine Simulator Following 10,000 Hours of Continuous Exposure to Potassium Vapor in the T-111 Rankine System Corrosion Test Loop.

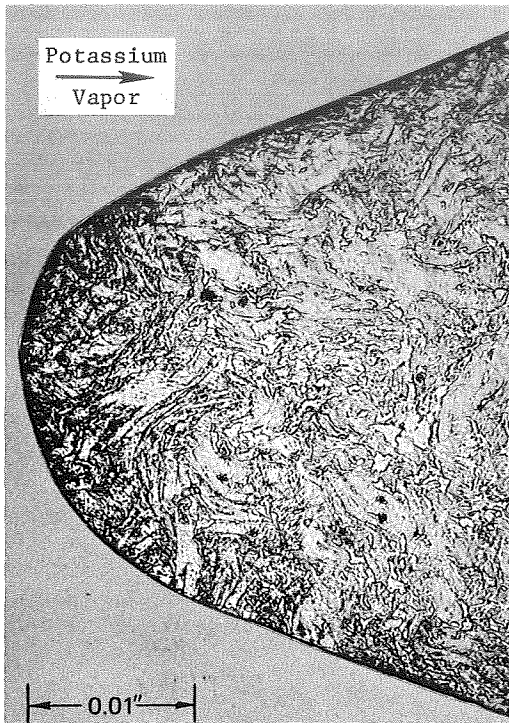
a. Blade

b. Nozzle

Figure 27. Mo-TZC Alloy Tenth Stage Nozzle and Blade Turbine Simulator Following 10,000 Hours of Continuous Exposure to Potassium Vapor in the T-111 Rankine System Corrosion Test Loop.

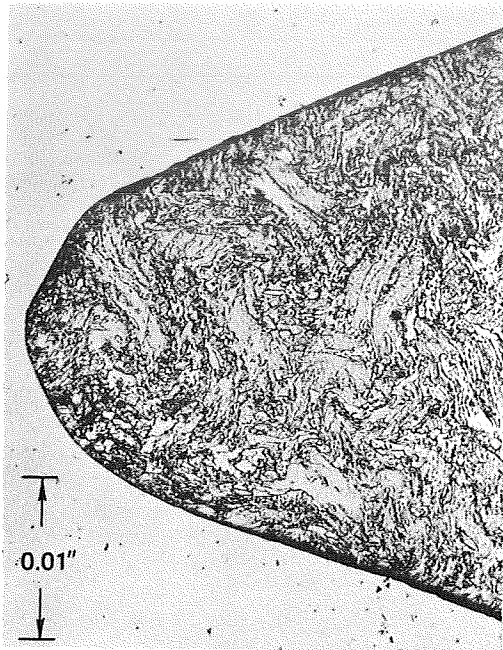
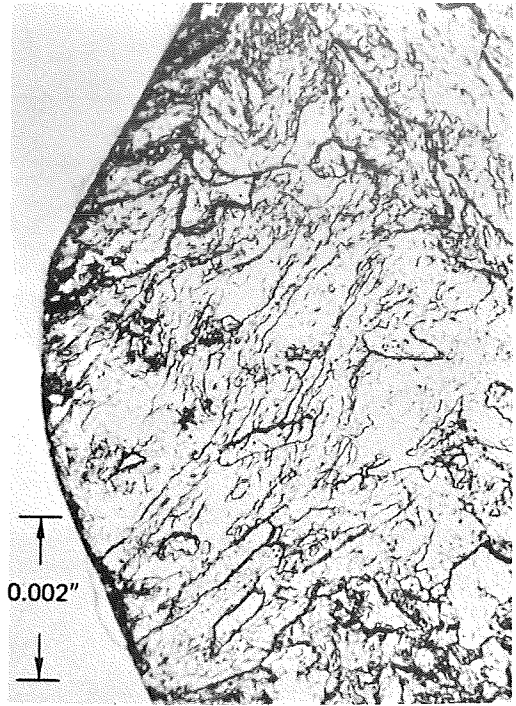
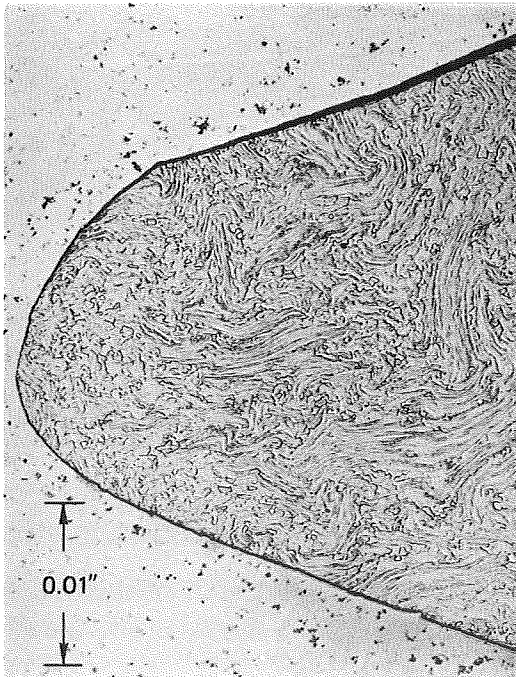
a. Mo-TZC Alloy

Figure 28. Pretest Microstructure of Materials Used for Turbine Simulator of the T-111 Rankine System Corrosion Test Loop.

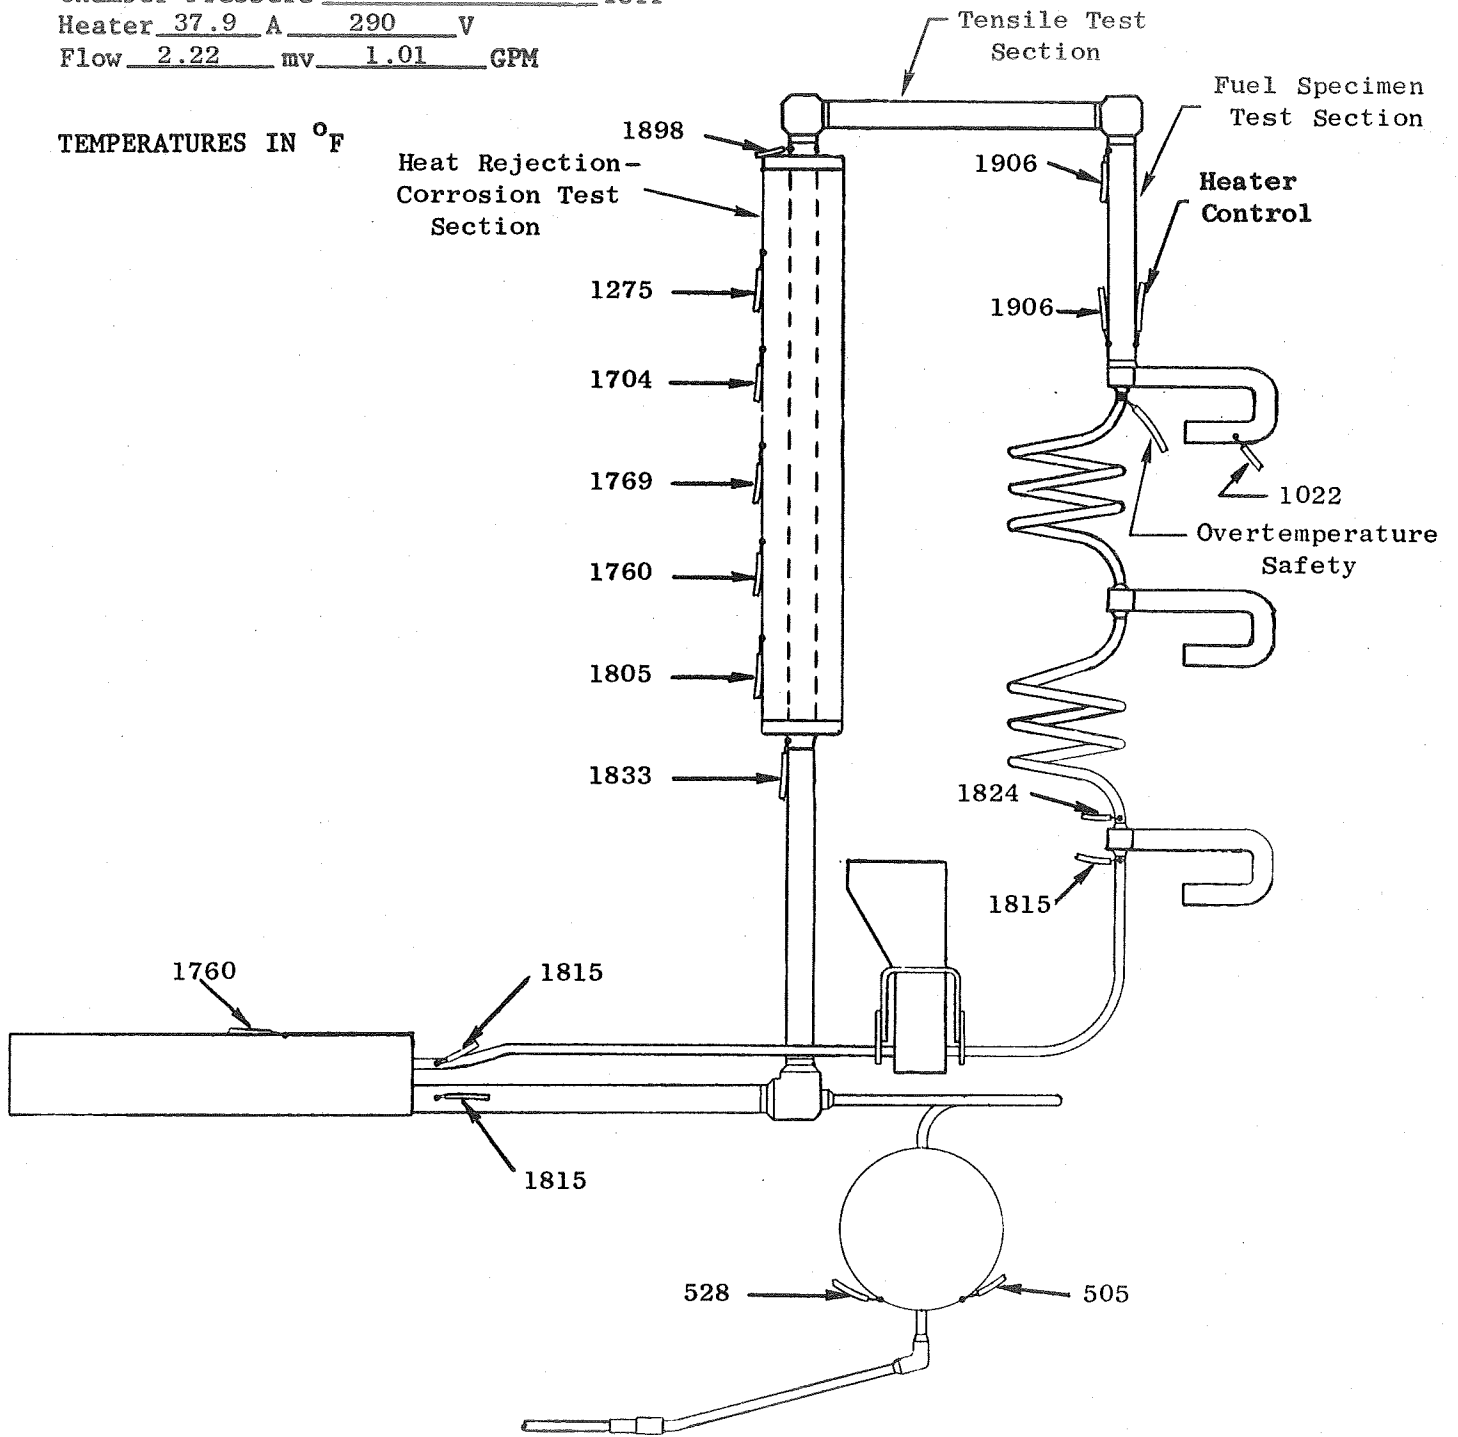
Date October 15, 1970 Test Time 4330 Hrs.  
 Chamber Pressure  $1.7 \times 10^{-9}$  Torr  
 Heater 37.9 A 290 V  
 Flow 2.22 mv 1.01 GPM

Figure 29. 1900°F Lithium Loop Operating Temperatures - 4330 Hours

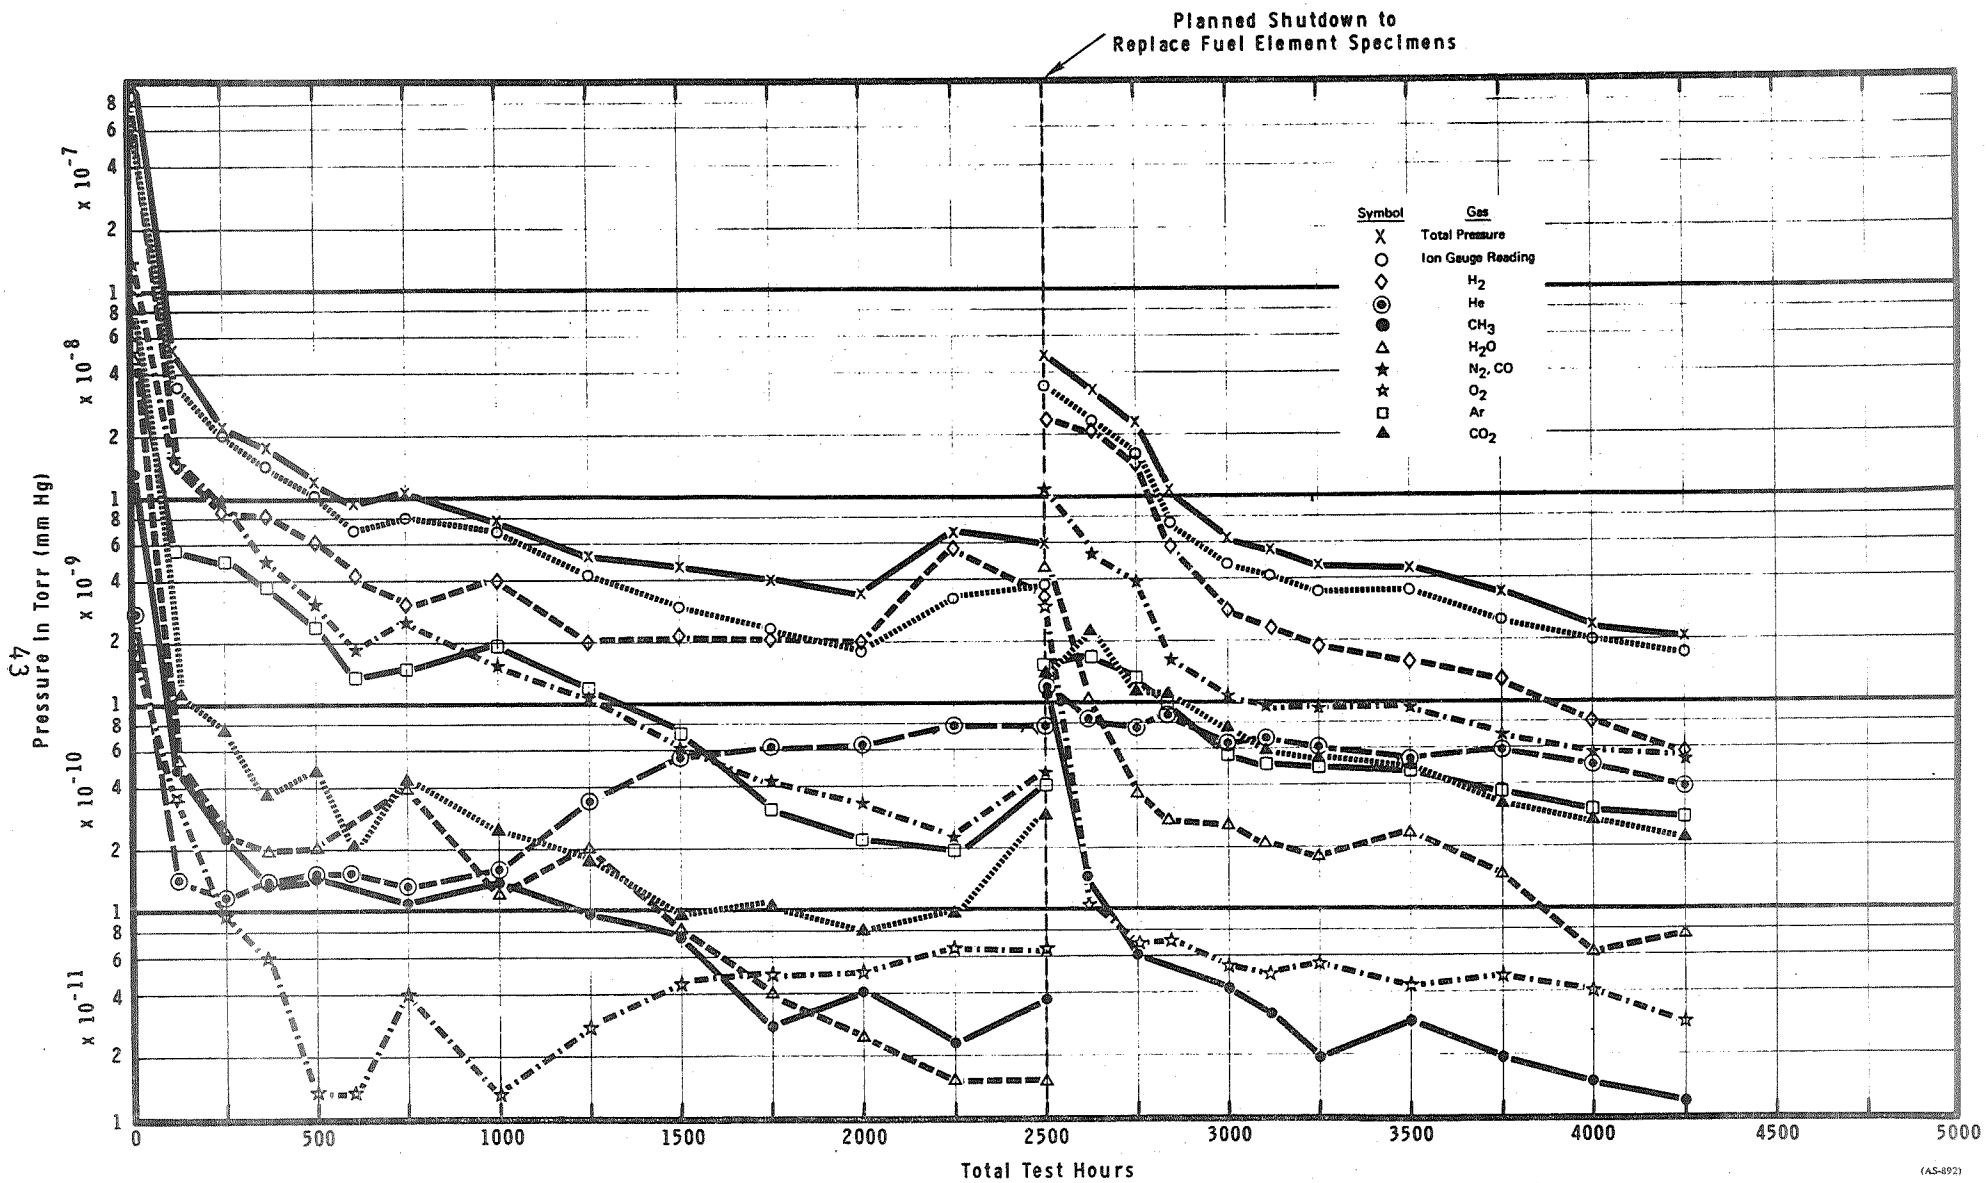
Figure 30. Test Chamber Environment During Testing of 1900°F Lithium Loop.

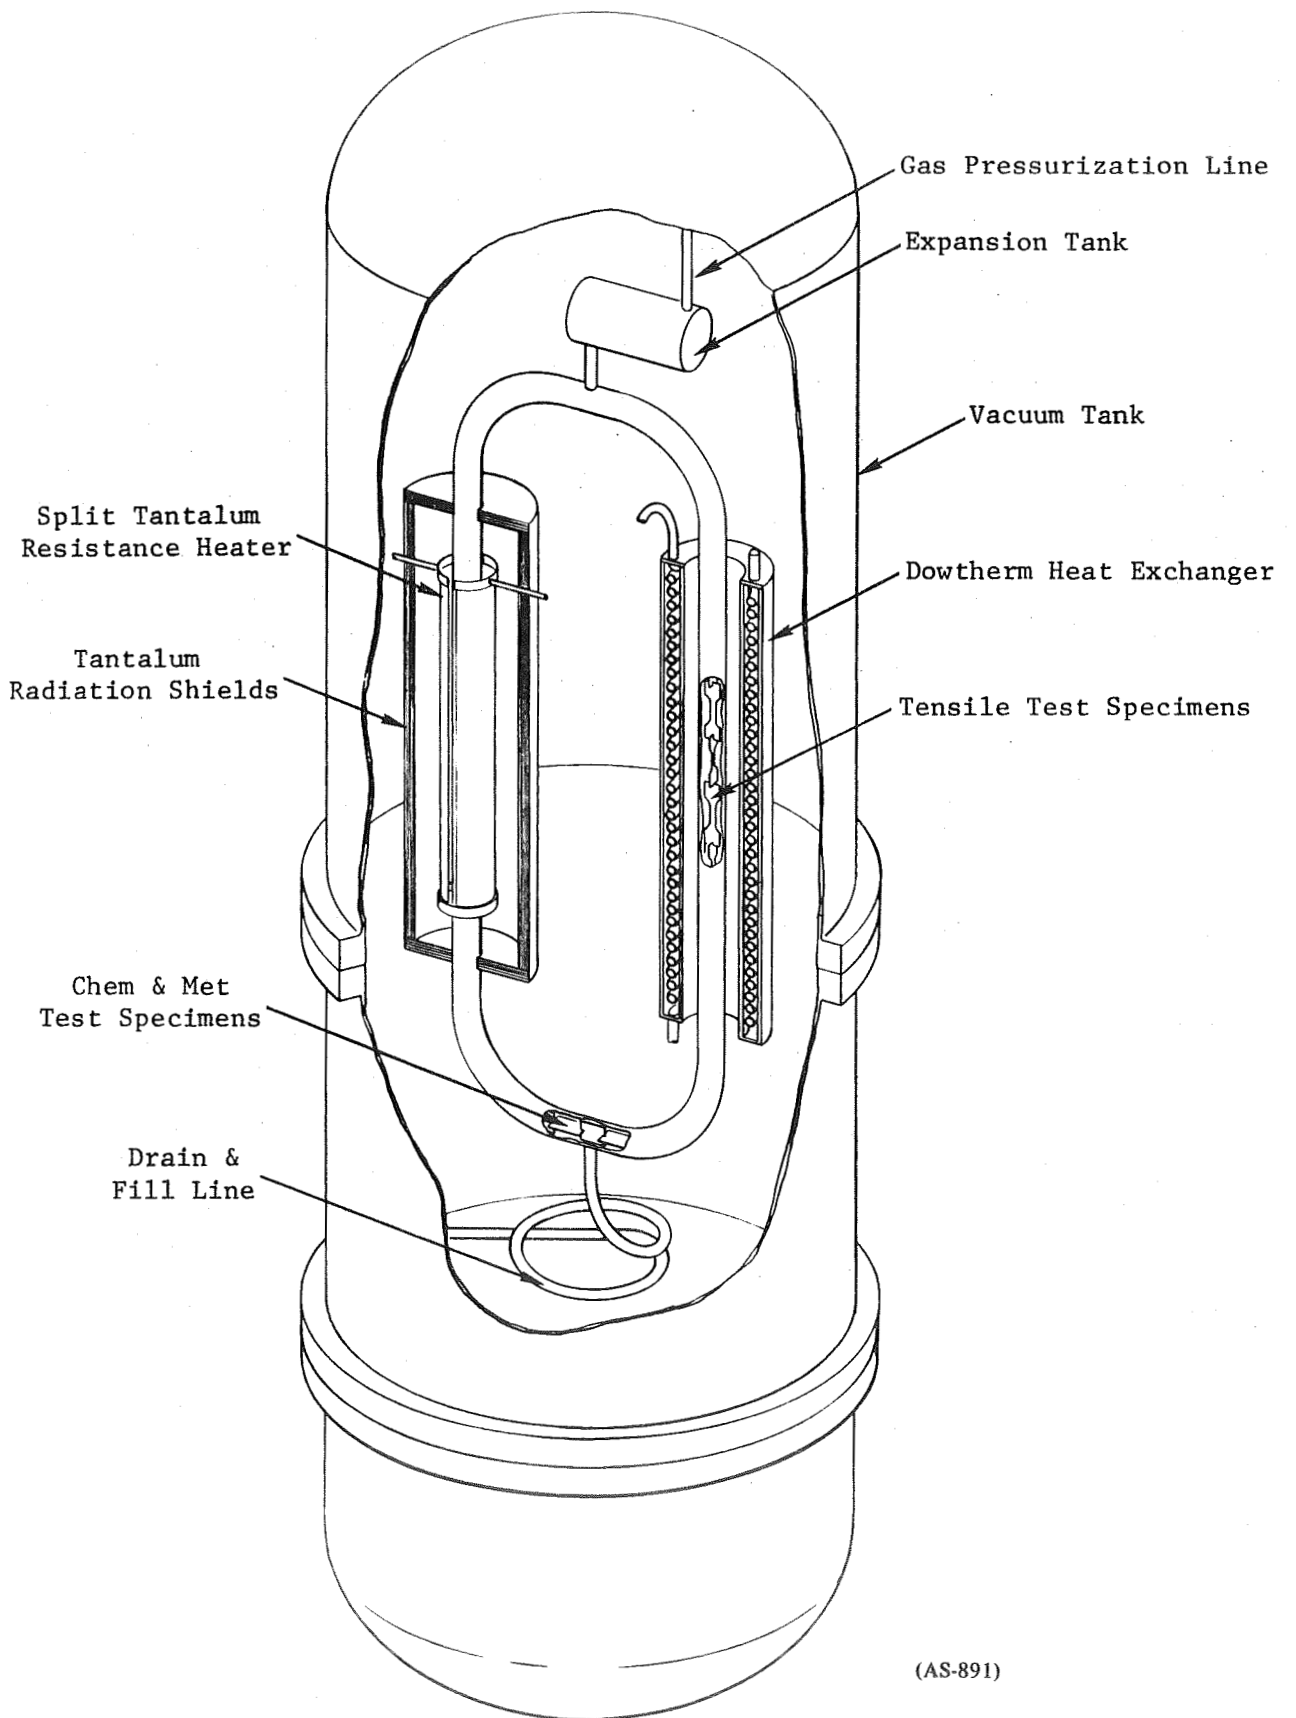
Figure 31. Isometric Drawing of Lithium Thermal Convection Test Loop.

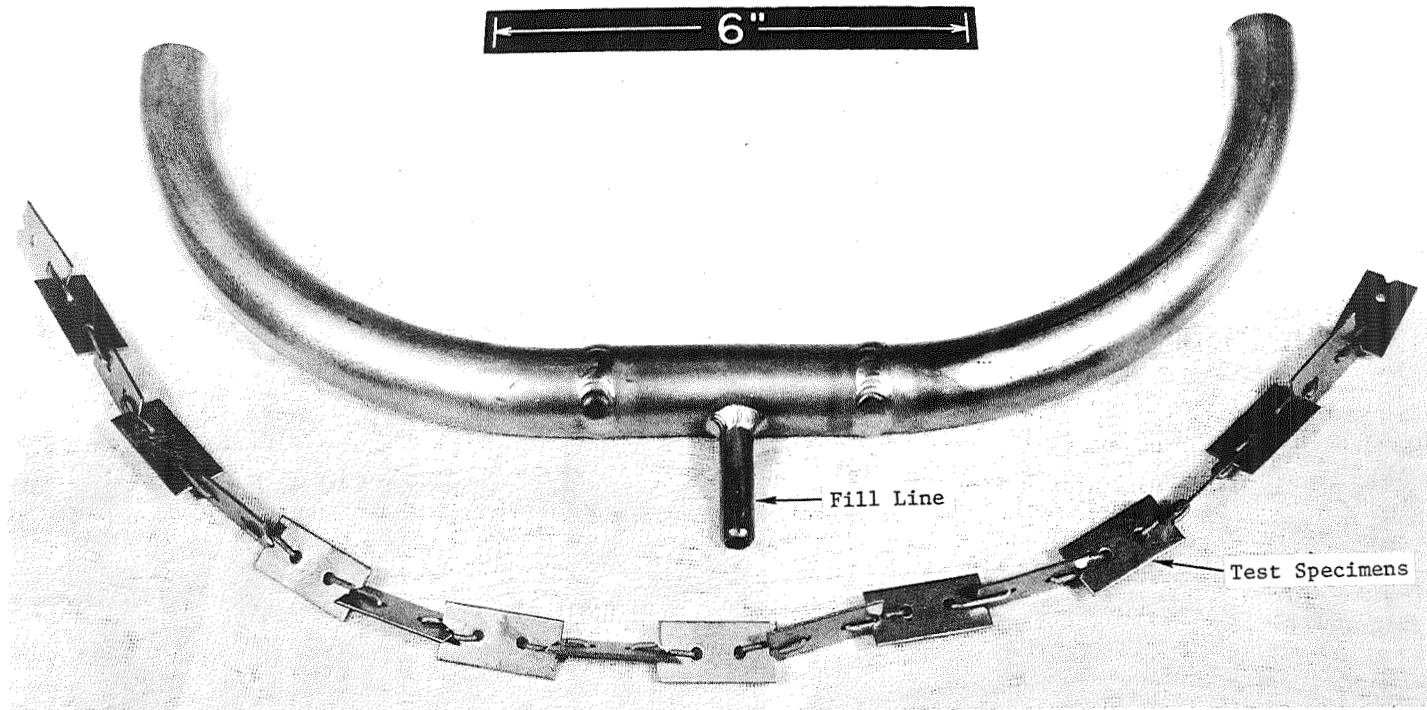
Figure 38. Lower Curved Test Section of Lithium Thermal Convection Loop with Typical Specimens to be Inserted Prior to Test. (P70-10-7F)

Figure 34. The lower curved test section with typical specimens to be inserted are shown in Figure 38. The specimens are lock wired together with unalloyed tantalum wire.
