**INVESTIGATION OF CRACK GROWTH THRESHOLD
OF INCONEL 718
EXPOSED TO HIGH PRESSURE OXYGEN**

FINAL REPORT

Prepared for
NATIONAL AERONAUTICS AND SPACE ADMINISTRATION
August 1970
Contract NAS 9-10913

Aerospace Group
THE BOEING COMPANY
Seattle, Washington

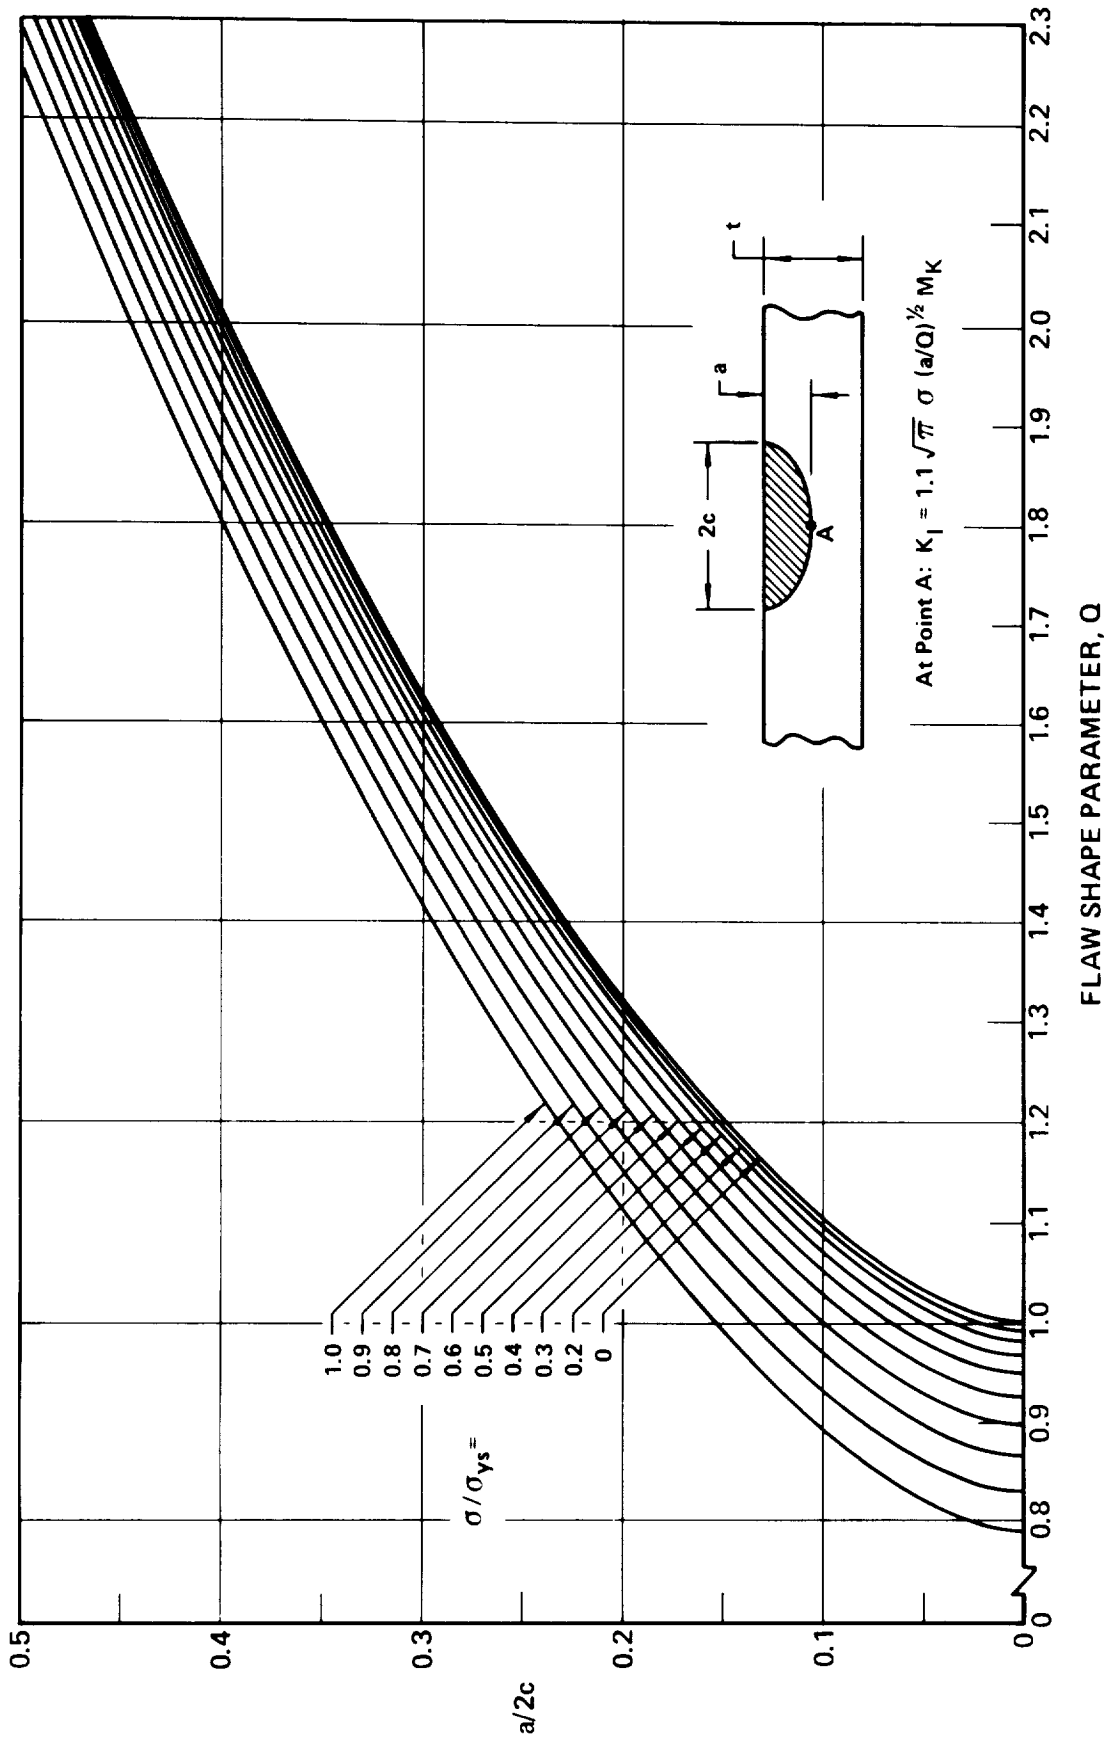
Figure 1 : SHAPE PARAMETER CURVES FOR SURFACE AND INTERNAL FLAWS

- a = depth (semi-minor axis) of a semi-elliptical surface flaw
- Q = flaw shape parameter (see Figure 1)
- σ = uniform stress applied perpendicular to the plane of crack
- K_{Ic} = plane strain stress intensity factor or fracture toughness of the material.

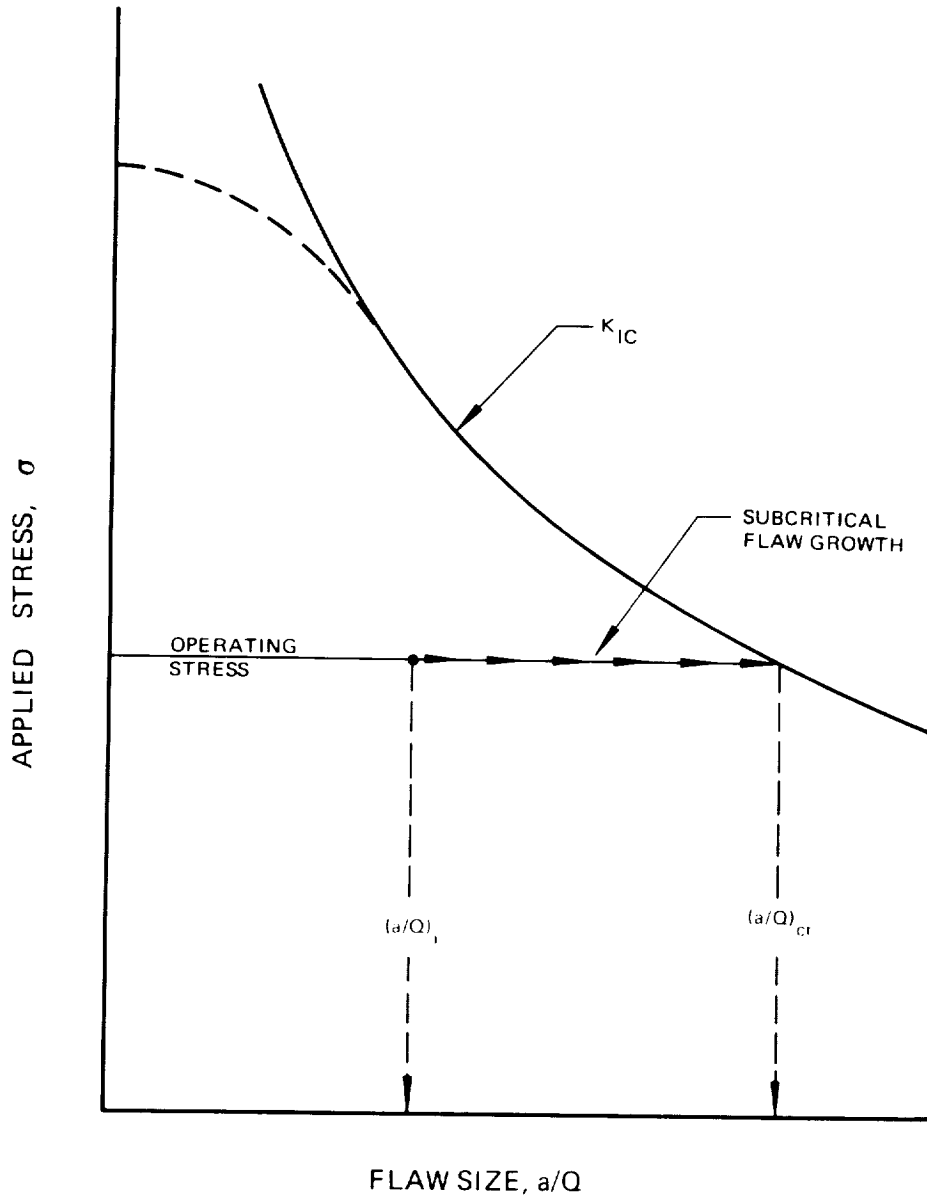
Figure 2: APPLIED STRESS VS. FLAW SIZE

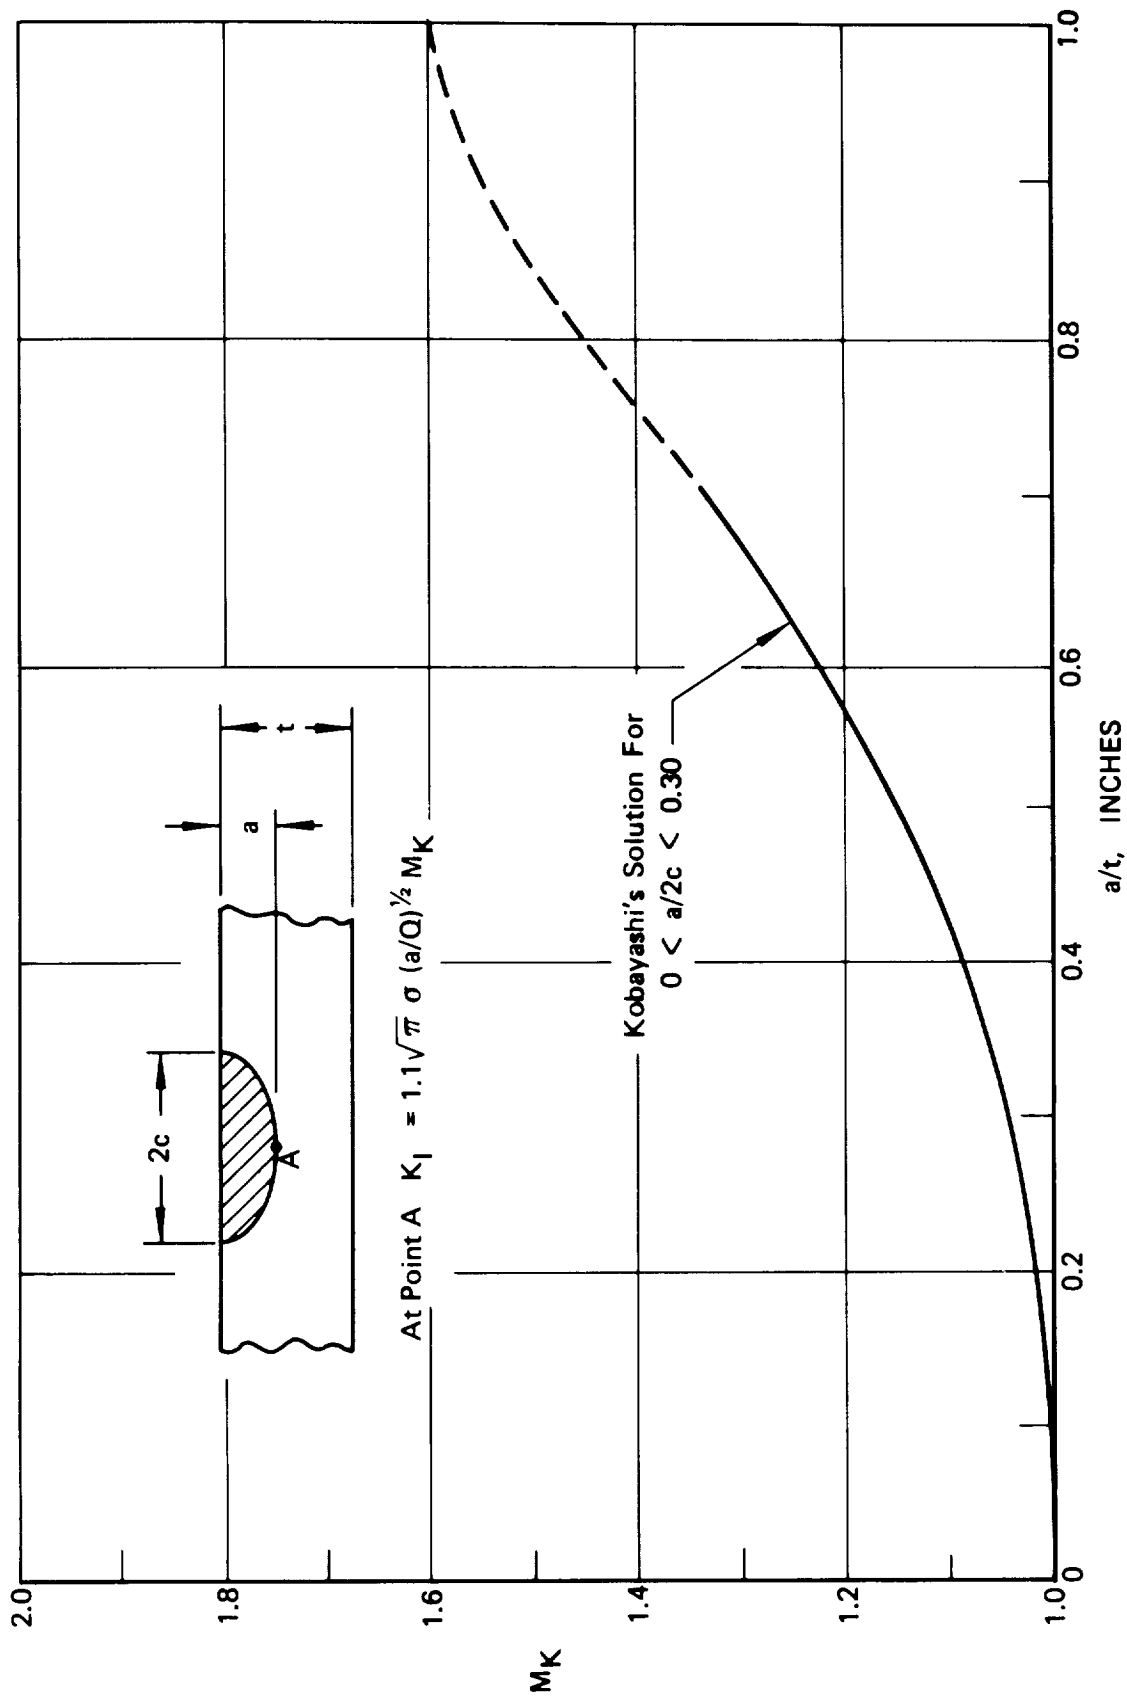
Figure 3: STRESS INTENSITY MAGNIFICATION FACTORS FOR DEEP SURFACE FLAWS

Kobayashi's original solution was limited to depth-to-thickness ratios (a/t) of 0.70. The curve was later extended to greater depths for engineering use (i.e., the dotted part of Figure 3) as substantiating data became available. In Reference 4 it was found that use of this type of a solution was practical up to the point where the plastic zone ahead of the flaw tip

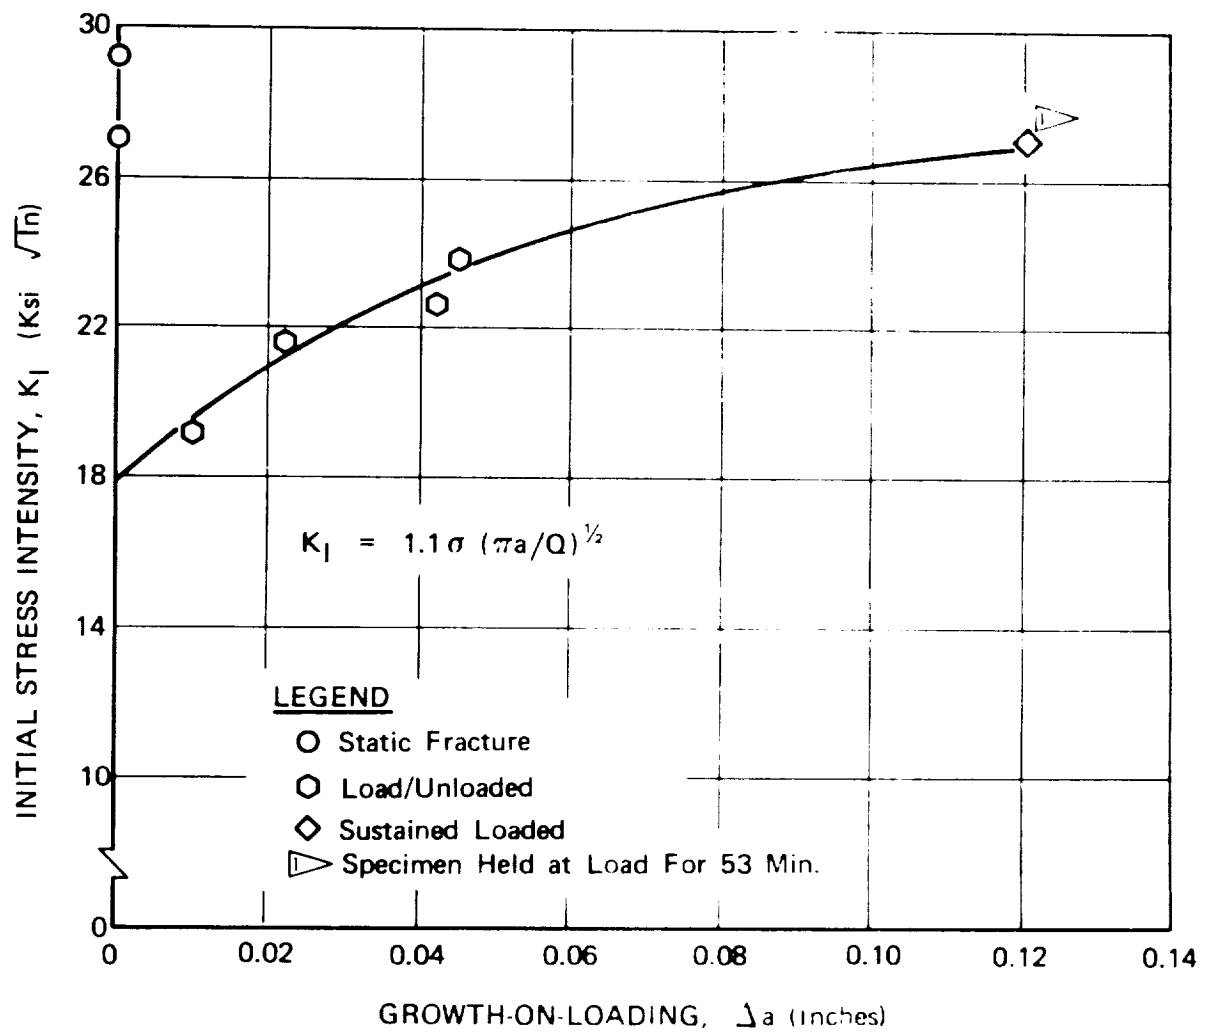
Figure 4: GROWTH-ON-LOADING IN 2219-T87 ALUMINUM WELDMENT IN AIR AT ROOM TEMPERATURE

was very large with respect to the remaining unbroken ligament (t_n). For shallow flaws in brittle materials, the fracturing process is very abrupt. The amount of flaw growth prior to failure, under a rising load, can usually be considered to be negligible. In this case, all important dimensions (i.e., a and ρ) are small with respect to thickness. However, as the plastic zone becomes large (e.g., $\rho/t_n \rightarrow 1.0$), important deviations occur. Foremost of these is that large amounts of stable crack extension can occur, under rising load, well before complete fracture. An example of this behavior is illustrated in Figure 4.

This figure, from Reference 5, shows the amount of flaw extension which takes place in 2219-T87 aluminum weldments. These specimens were loaded to a pre-determined stress level and then the load was rapidly dropped to zero. After fatigue marking the flaw front and failing the specimens, the growth-on-loading was measured directly from the fracture face. Significantly, in fatigue tests at constant maximum stress this growth-on-loading appears to occur only on the first cycle. Growth on subsequent cycles proceeds at a much lower rate. Similar observations have been made for 2219-T87 aluminum weldments at -320 and -423°F (Reference 4) and for titanium alloys (References 4 and 6). In the extreme case, this slow flaw growth can result in the flaw growing completely through-the-thickness. The specimen finally fails, upon a further increase in load as a through-the-thickness crack. In this instance, of course, the surface flaw solutions are not meaningful in describing the fracture process. As would be expected, predicted failure stresses based upon plane stress data and the original surface flaw length (not depth) correspond quite well (Reference 4). This is shown in Figure 5. The solid curve represents the conventional stress-flaw size relation for through cracks in a titanium alloy for an experimentally determined K_{CN} value of $104.7 \text{ ksi } \sqrt{\text{in}}$. The curve is based upon a finite width specimen of 4.0 inches, equal to the width of surface specimens tested. Data points for the surface flaw specimens are plotted in terms of gross failure stress versus initial flaw length ($2c$). The correspondence is seen to be good until, of course, net section stress begins to approach the yield strength.

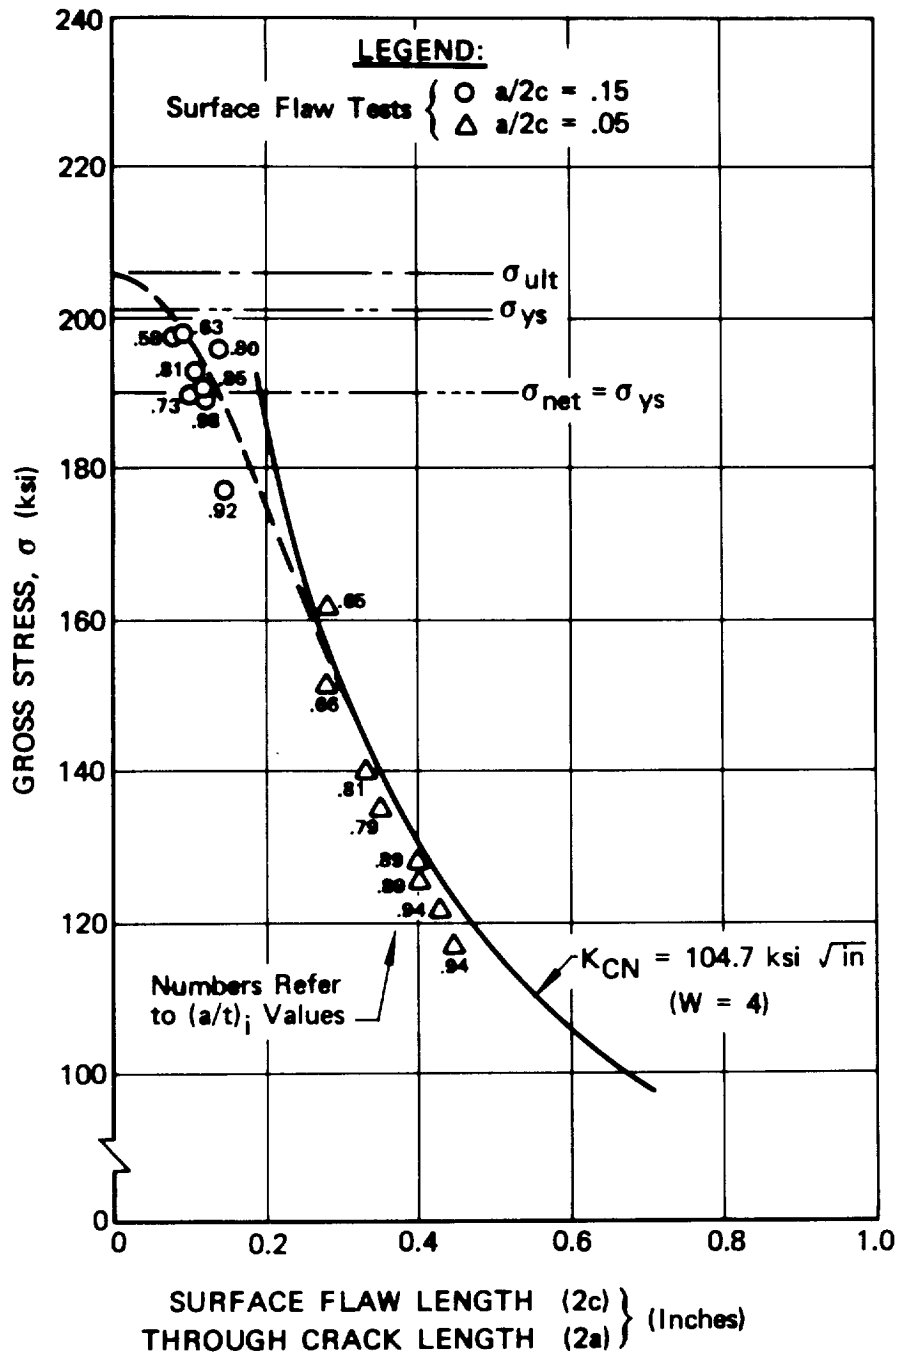
Figure 5: COMPARISON OF SURFACE FLAW & CENTER CRACK DATA
 (t = 0.020", 5Al-2.5Sn Titanium Base Metal @ -423 °F)

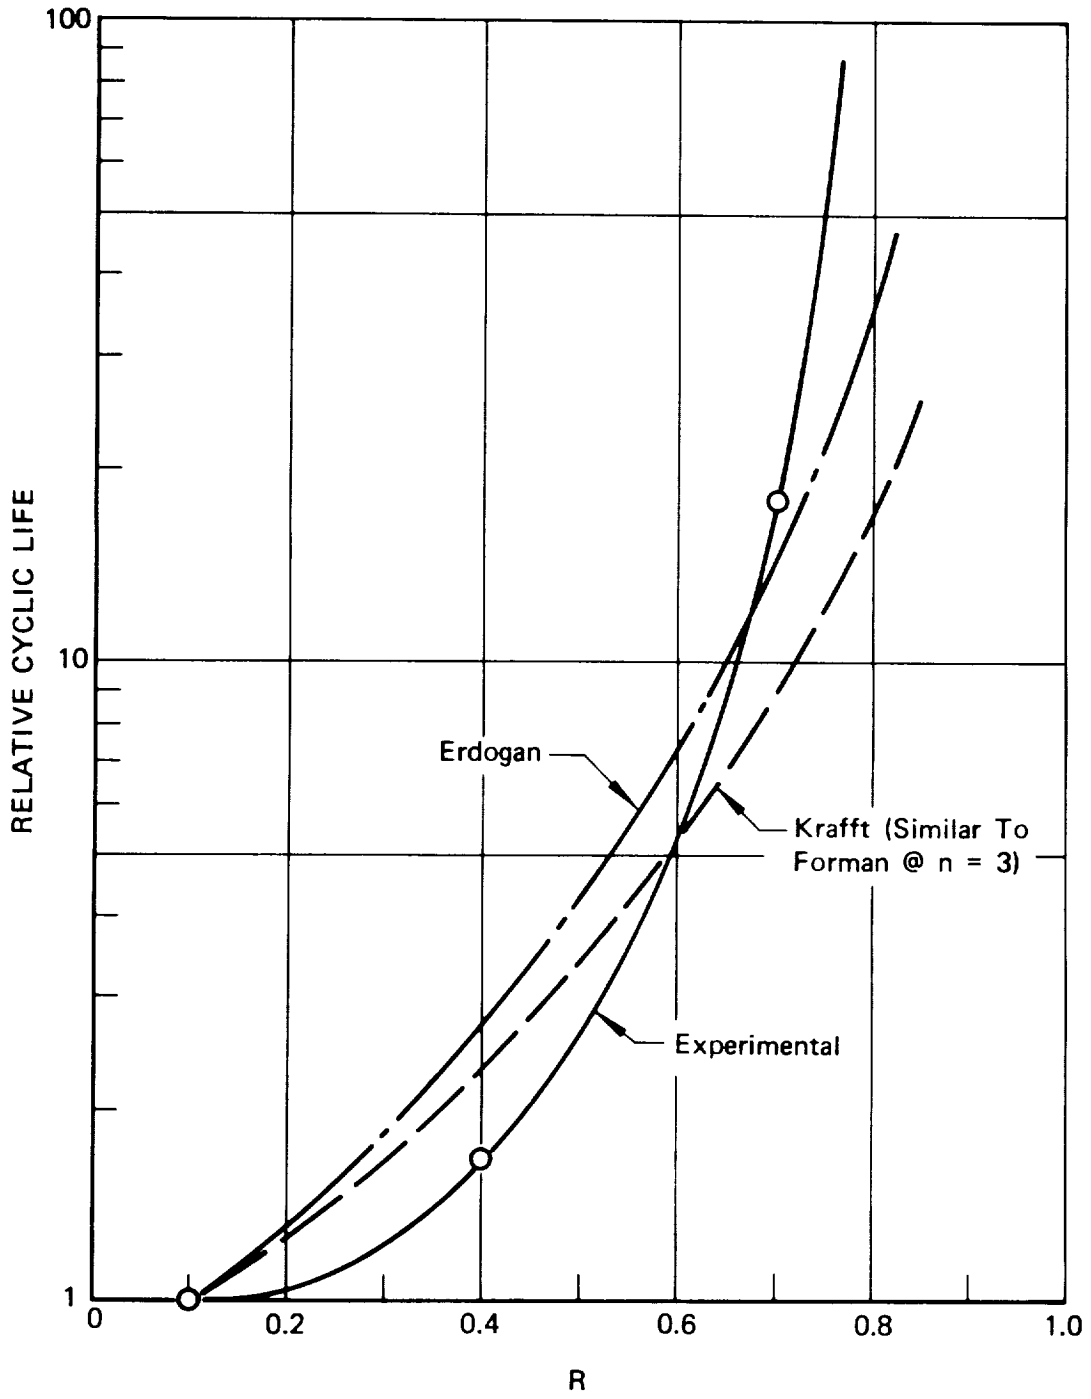
Figure 6: EFFECT OF R VALUE ON CYCLIC LIFE

Considerable experimental and analytical work has been performed on the problem of fatigue crack growth (References 7, 8, 9, 10, 11, 12, 13 and 14). Much of this work has involved study of the effect of varying stress intensity ratios, R (i.e., $R = K_{min}/K_{max}$). It has been observed that cyclic crack growth rates very rapidly decrease as R starts to exceed about 0.80 to 0.90. Figure 6 taken from Reference 14 illustrates this point. The experimental points shown are from thin surface flaw tests of 6Al-4V titanium.

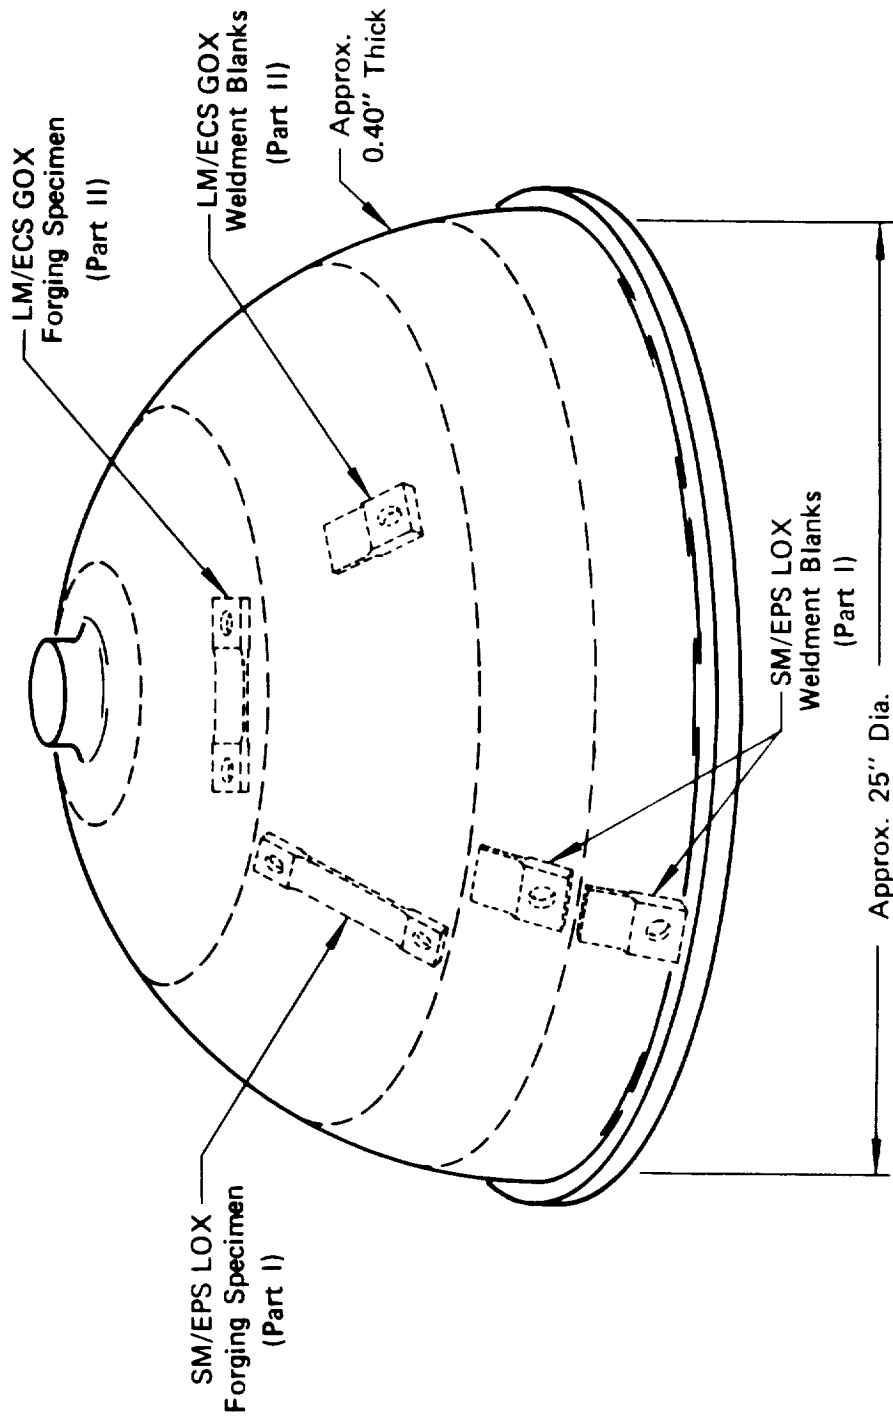
Figure 8: HEMISPHERICAL SM/EPS LOX TANK FORGING

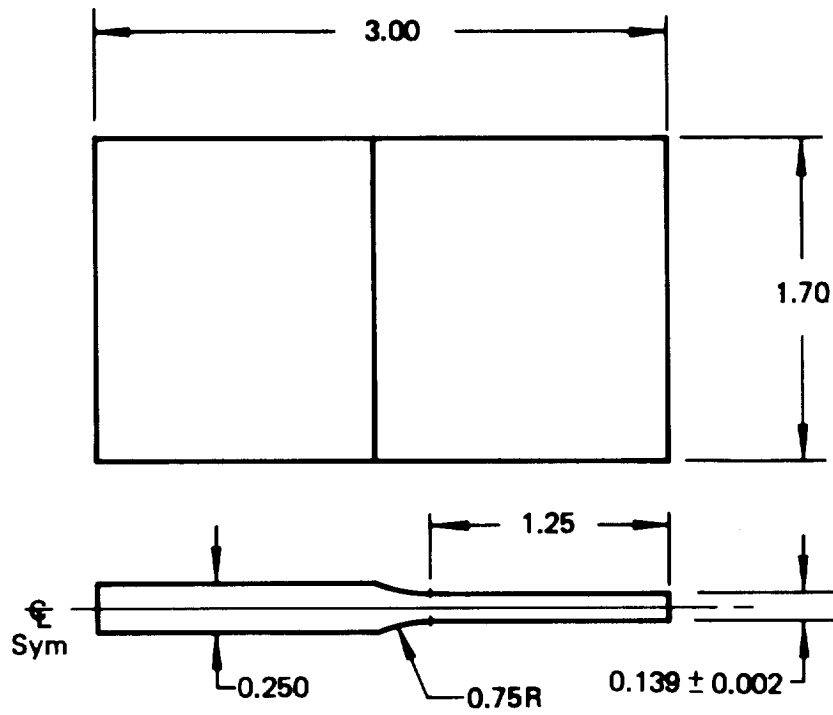
Figure 9a: WELD BLANK (PART I)

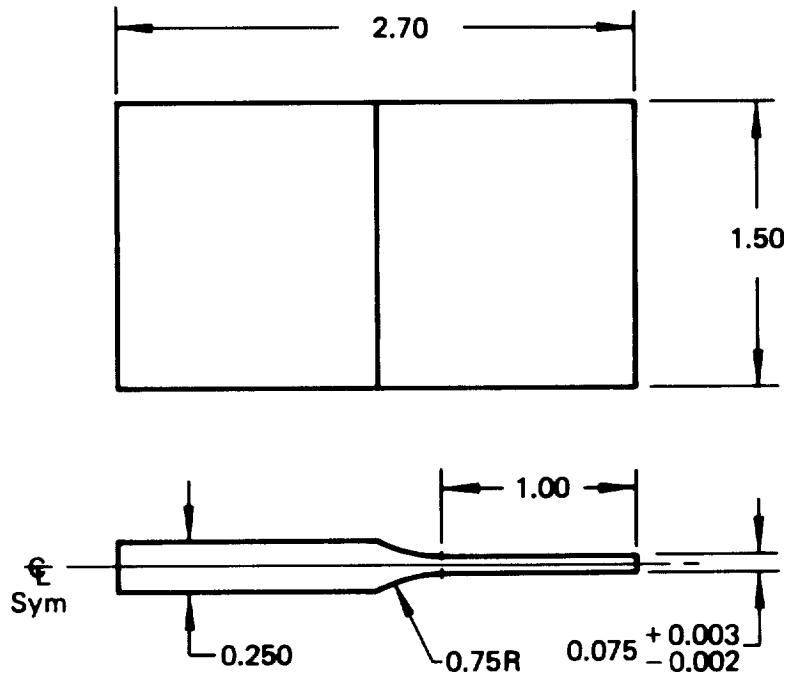
Figure 9b: WELD BLANK (PART II)

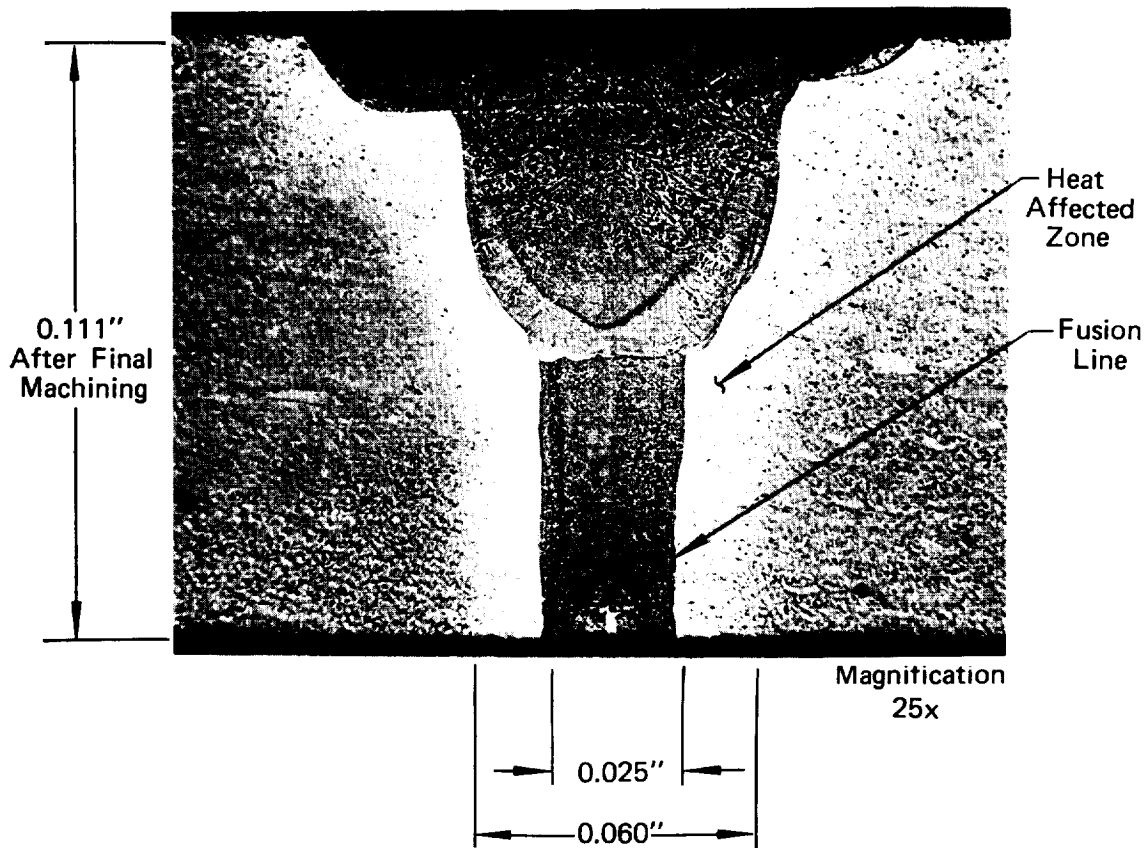
ELECTRON BEAM PASS	WELD DESCRIPTION	VOLTAGE (KV)	BEAM CURRENT (MA)	WELDING SPEED (IPM)	WELDING TECHNIQUE
1	Tack	50	10	45	---
2	Penetration	50	30	45	---
3	Partial Penetration	50	13	45	60 Cycle Circle Generator
4	Cover	50	12	45	3000 Cycle y Axis Oscillation

Figure 11: SM/EPS LOX TANK WELD SIMULATION (PART I)

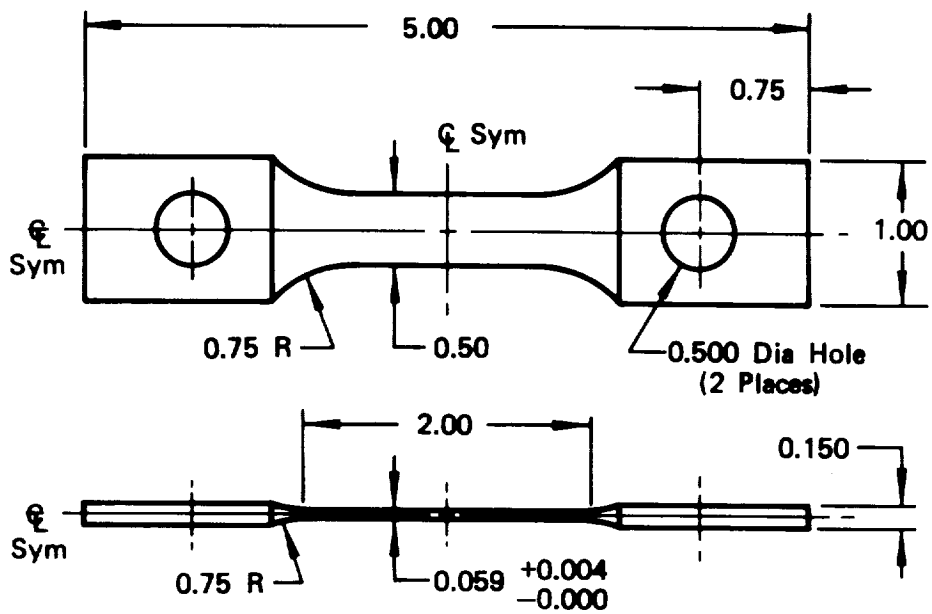
Figure 12a: FORGING TENSILE SPECIMEN (PART I)

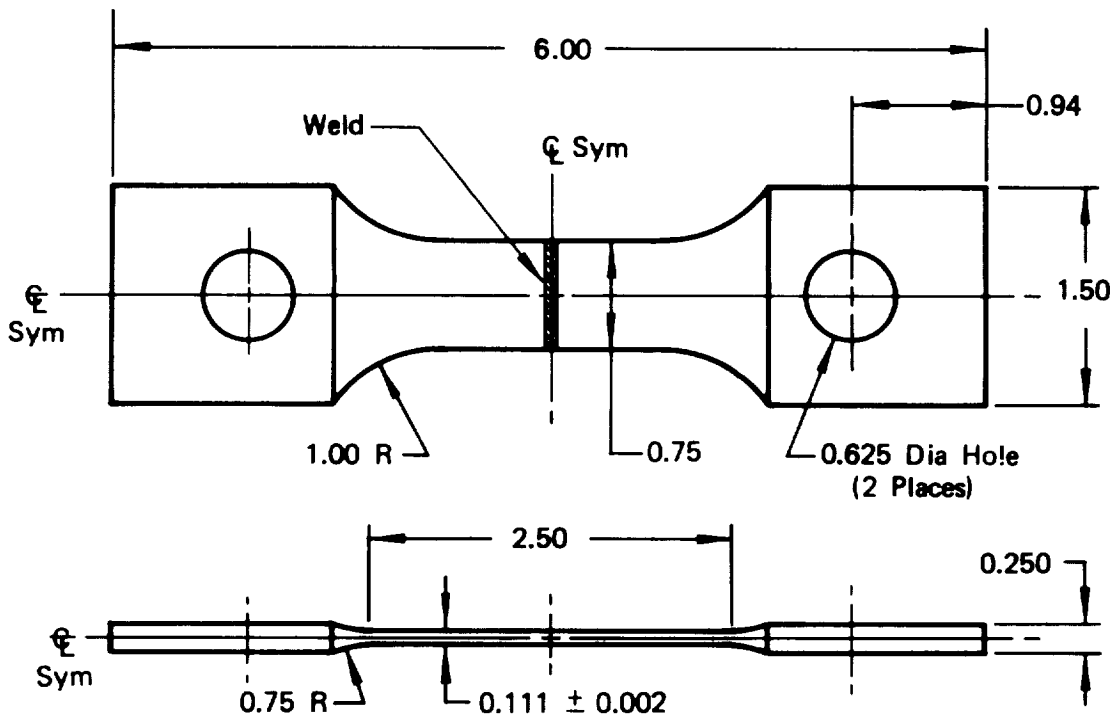
Figure 12b: WELDMENT TENSILE SPECIMEN (PART I)

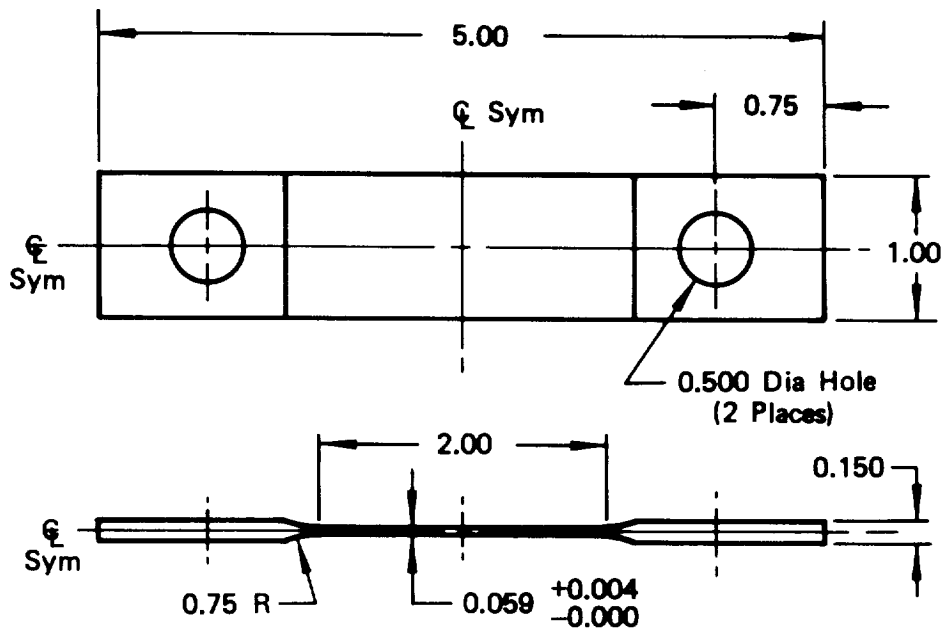
Figure 13a: FORGING FRACTURE SPECIMEN (PART I)

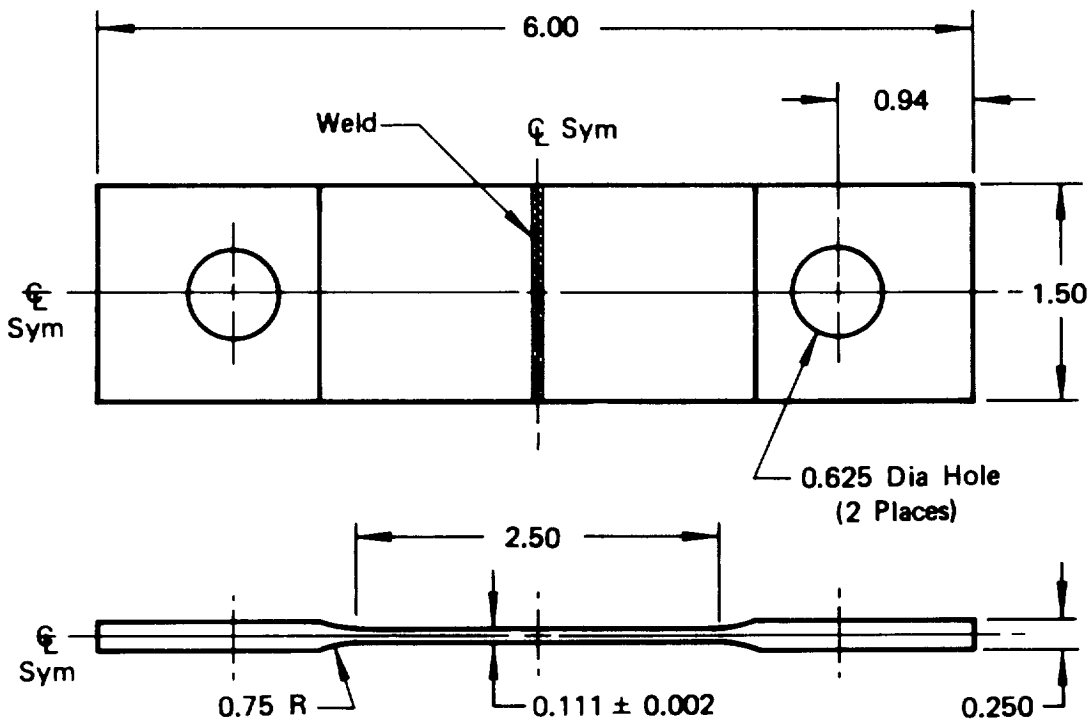
Figure 13b: WELDMENT FRACTURE SPECIMEN (PART I)

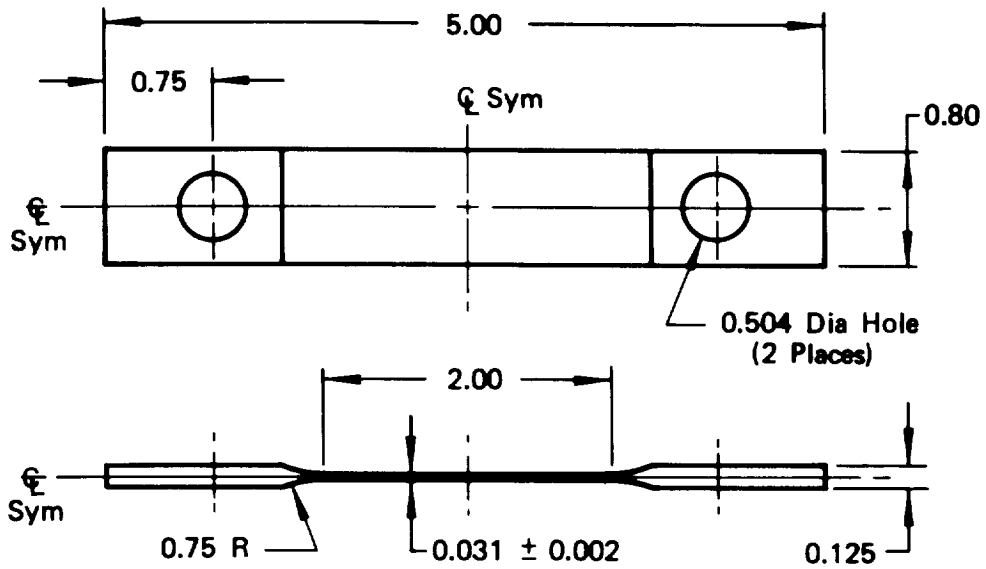
Figure 15a: FORGING TENSILE SPECIMEN (PART II)

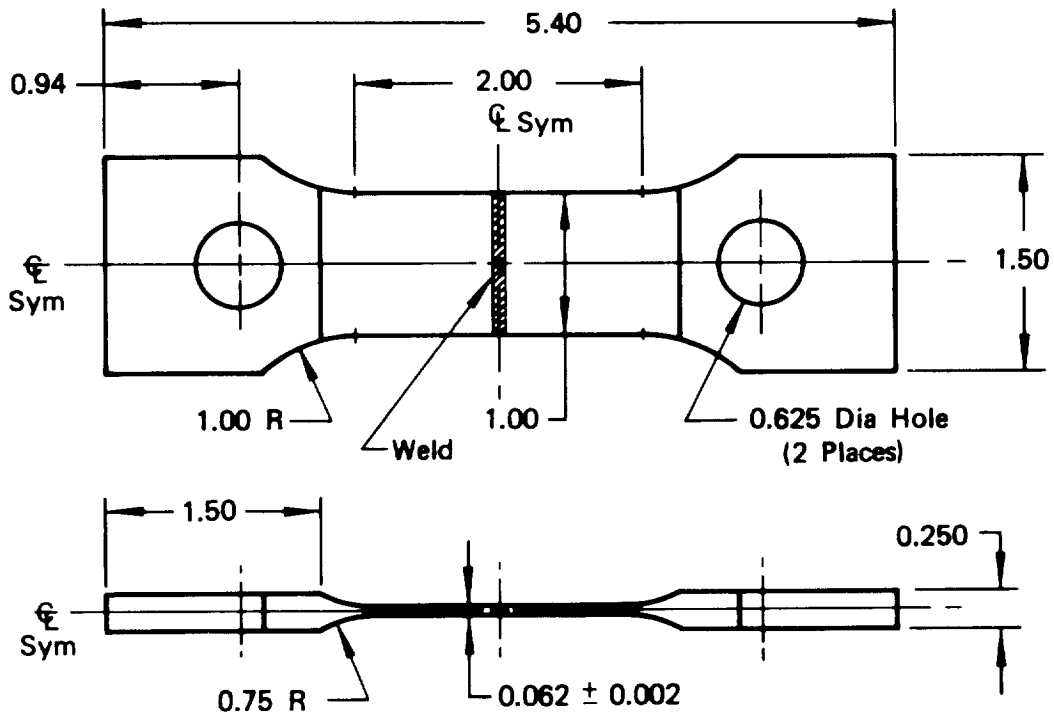
Figure 15b: WELDMENT TENSILE SPECIMEN (PART II)

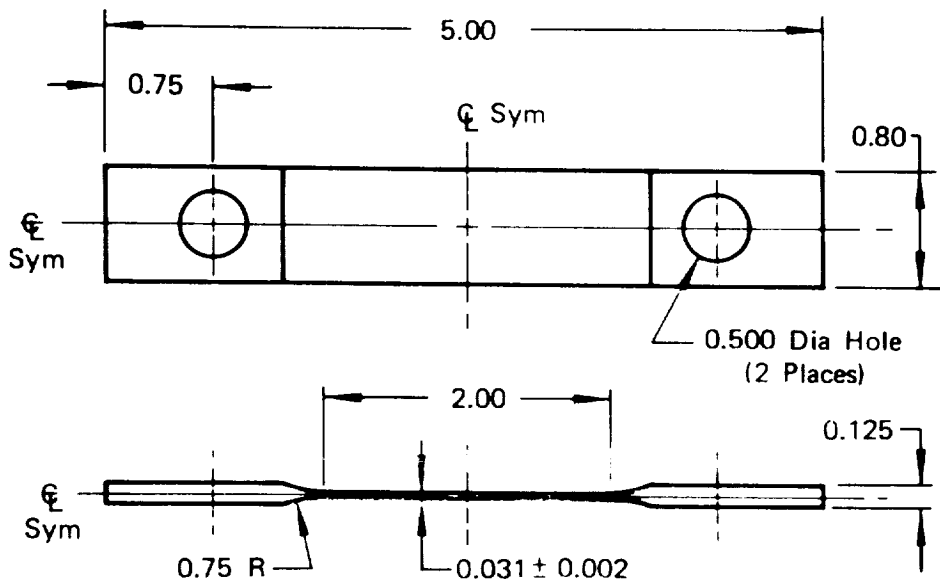
Figure 16a: FORGING FRACTURE SPECIMEN (PART II)

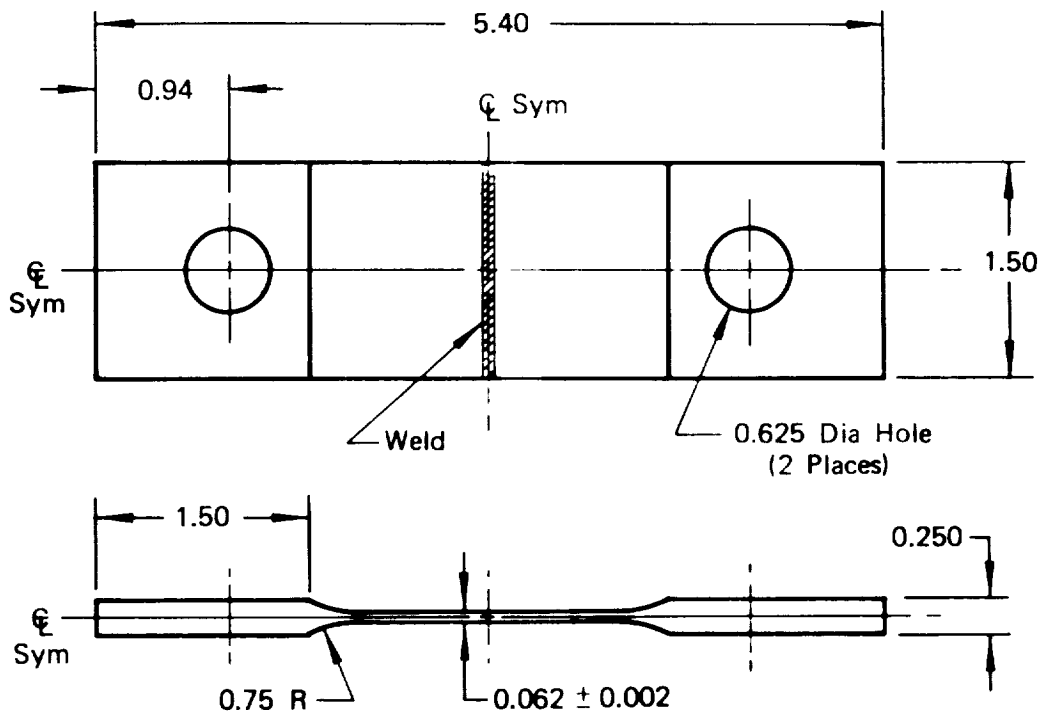
Figure 16b: WELDMENT FRACTURE SPECIMEN (PART II)

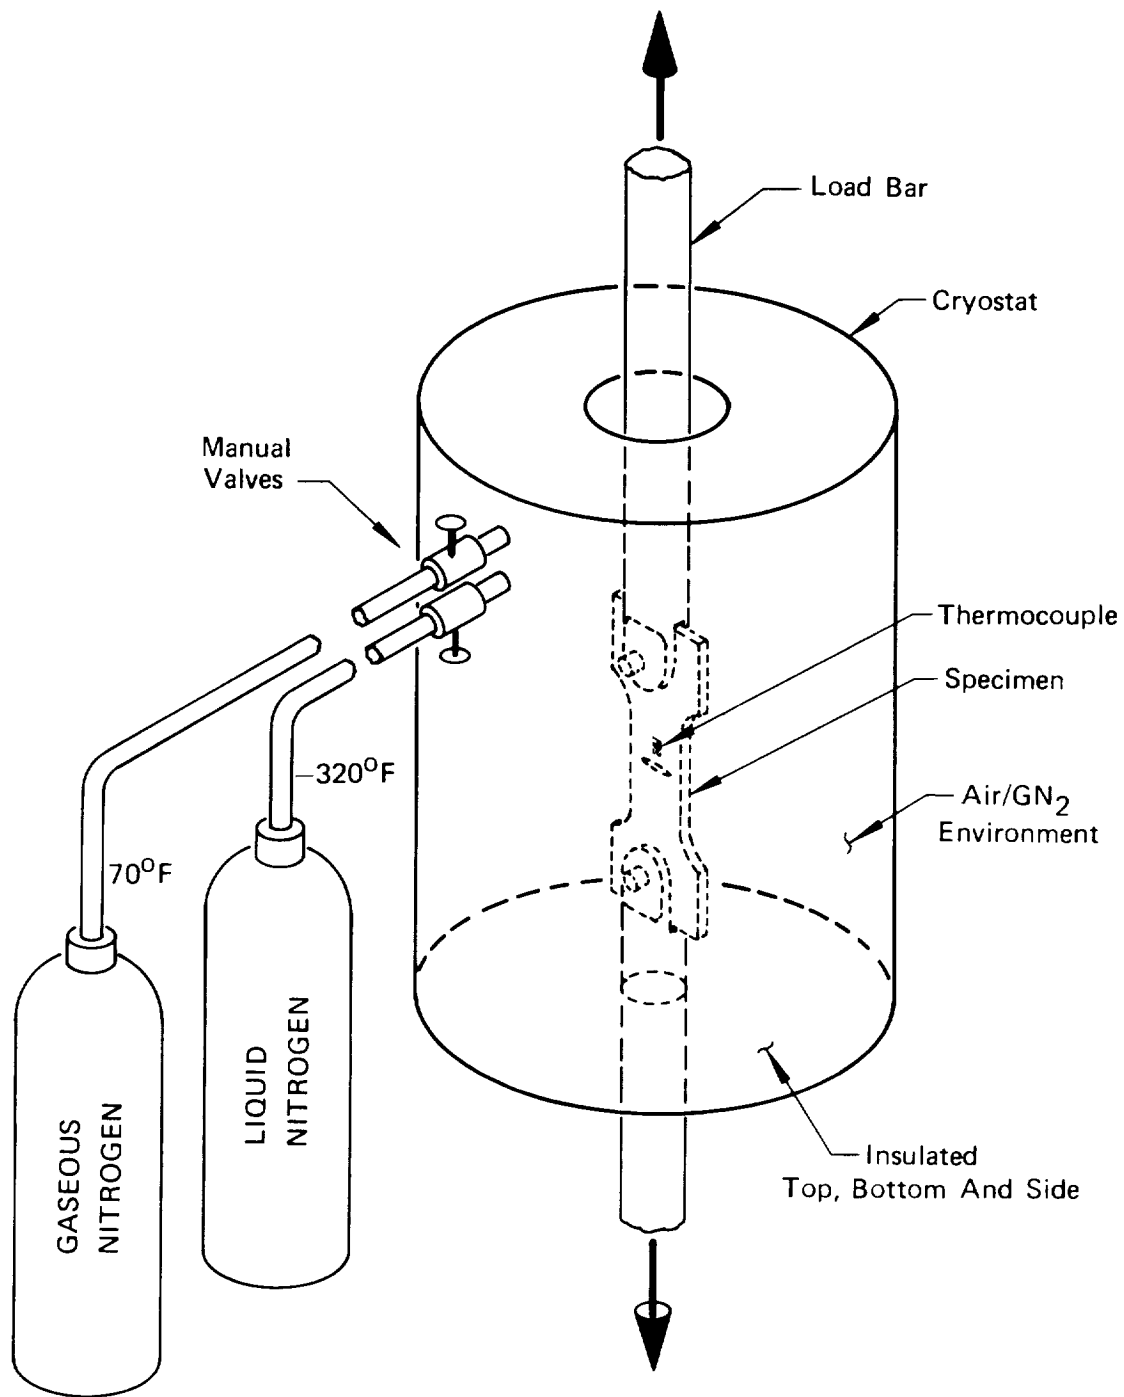
Figure 17: ENVIRONMENTAL TEMPERATURE CONTROL SYSTEM FOR NON-HAZARDOUS TESTS

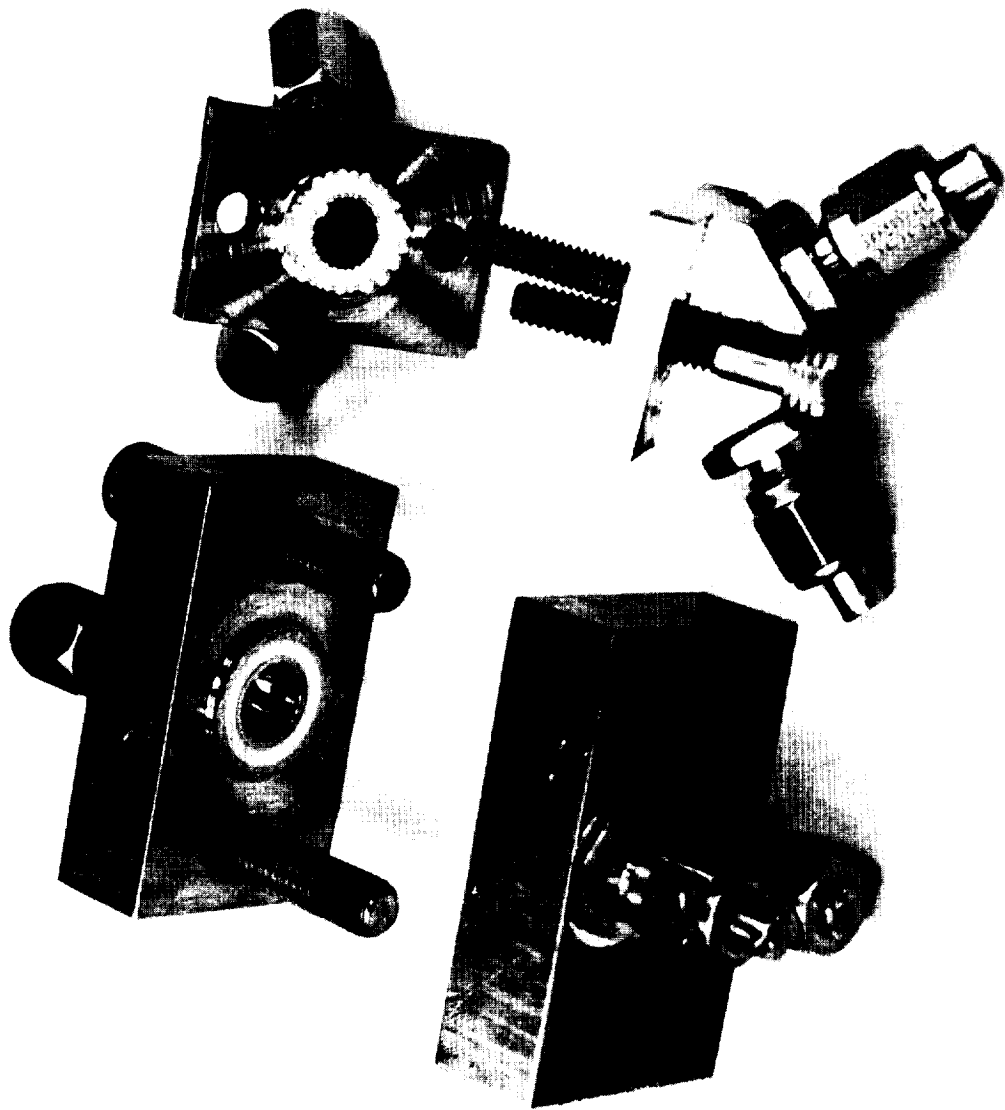
Figure 21: SPECIMEN MOUNTING PRESSURE CUPS

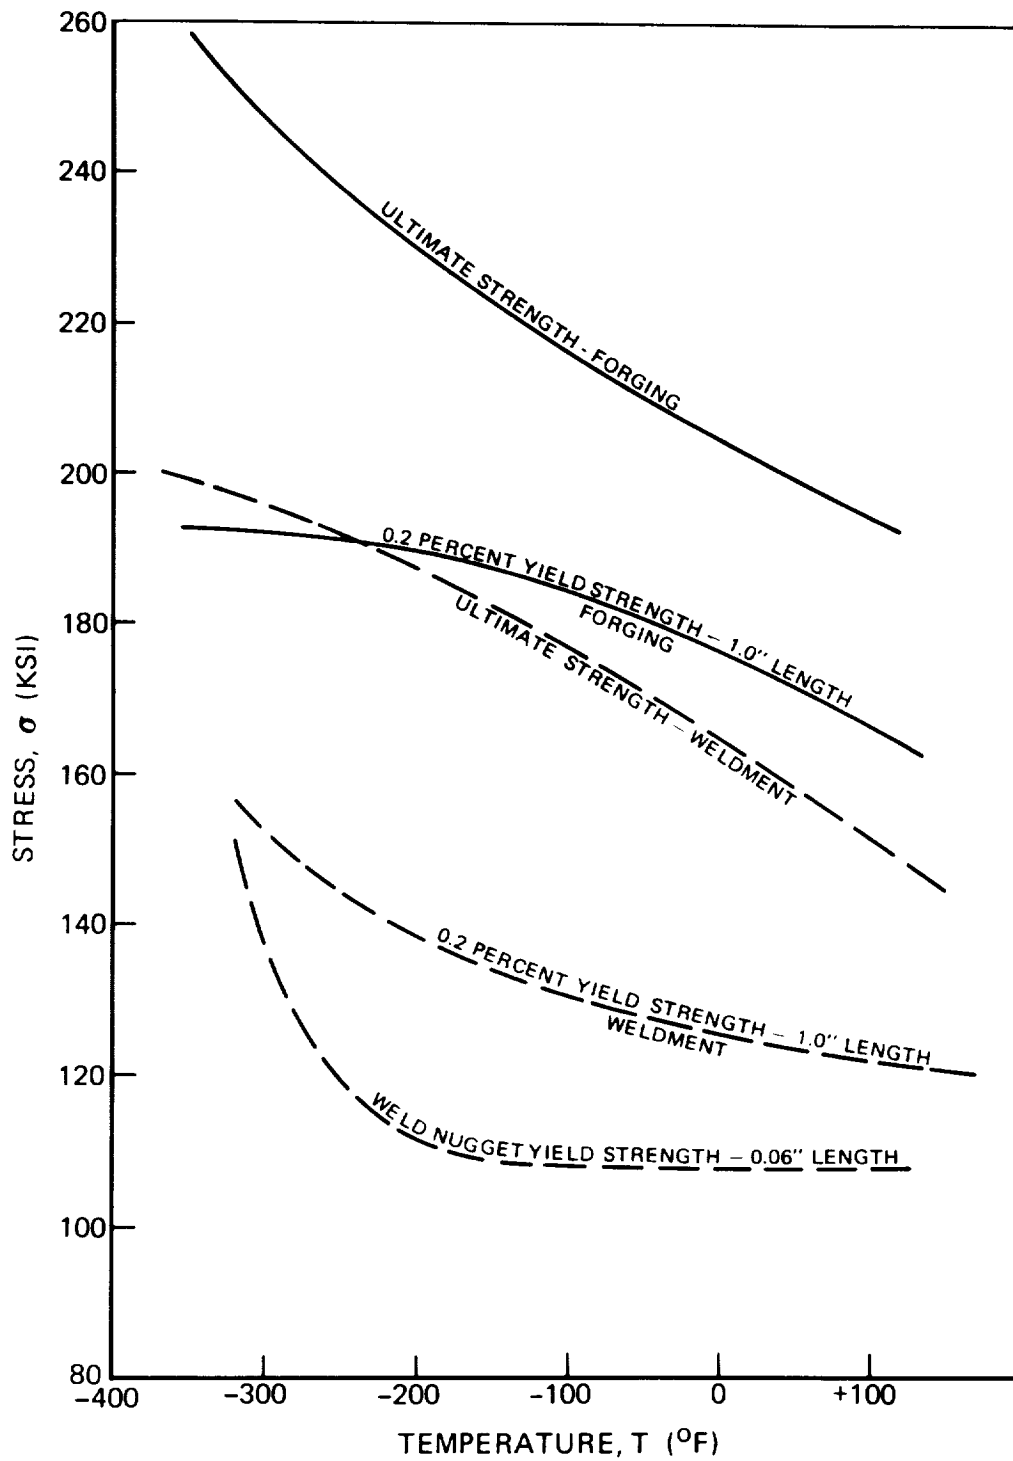
Figure 24: MECHANICAL PROPERTIES OF INCONEL 718 USED IN ASSESSMENT OF SM/EPS LOX TANK (PART I)
