**INVESTIGATION OF CRACK GROWTH THRESHOLD
OF INCONEL 718
EXPOSED TO HIGH PRESSURE OXYGEN**

FINAL REPORT

Prepared for
NATIONAL AERONAUTICS AND SPACE ADMINISTRATION
August 1970
Contract NAS 9-10913

Aerospace Group
THE BOEING COMPANY
Seattle, Washington

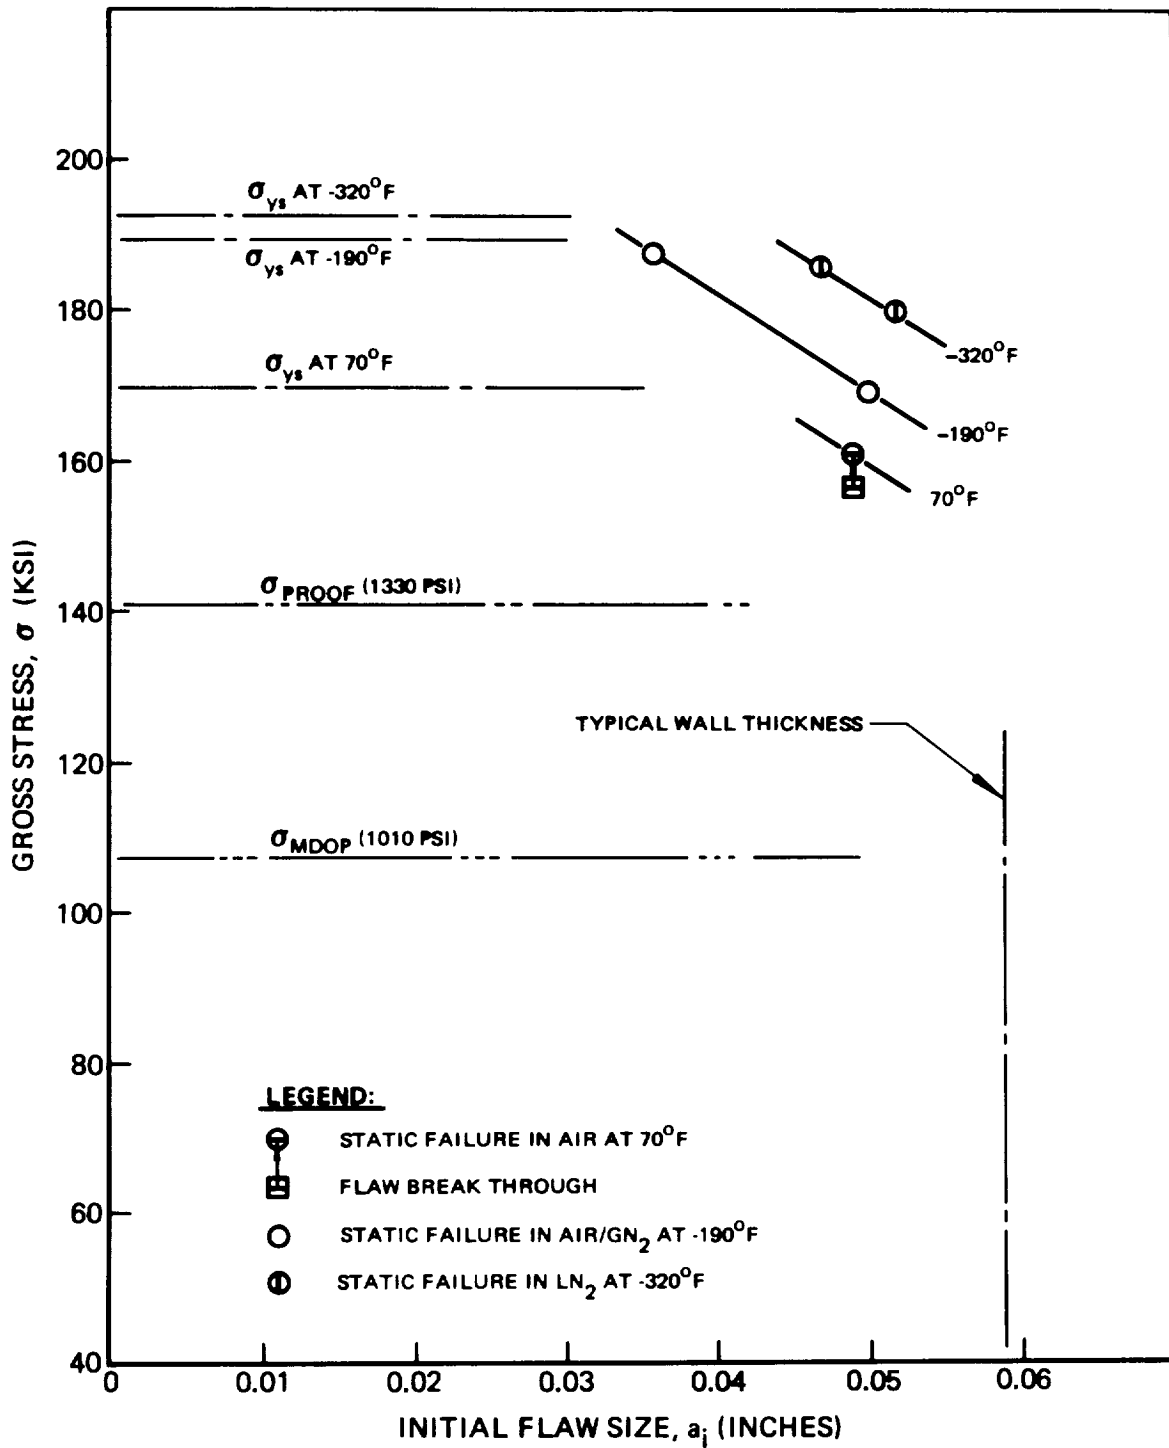
Figure 25: STATIC FRACTURE TESTS OF INCONEL 718 FORGING AT VARIOUS TEMPERATURES (PART I)

affected zone (HAZ). The results of these tests are presented in Figures 25 and 26 while the detailed data are presented in Tables IV, V and VI. As both figures indicate, the failure stress increases as the temperature decreases. The specimens tested at 70°F were visually observed to have the flaws extend through-the-thickness prior to failure in plane stress as a through-the-thickness crack. This condition also existed for the weldments tested at -190°F based on the results of several intended sustain loaded specimens which had flaws that grew through-the-thickness upon reaching maximum load as shown in Figure 28. Based on these data it is assumed that all of the static fracture specimens having very deep flaws (> 70 percent of the thickness) did not fail in plane strain but had significant flaw extension prior to failure, to the point of growing through-the-thickness. No plane strain fracture toughness values were obtained from the fracture specimens that were representative of tank wall and weld thicknesses. The failure stresses were above the local weld yield strength for the welded specimens tested at 70°F and -190°F.

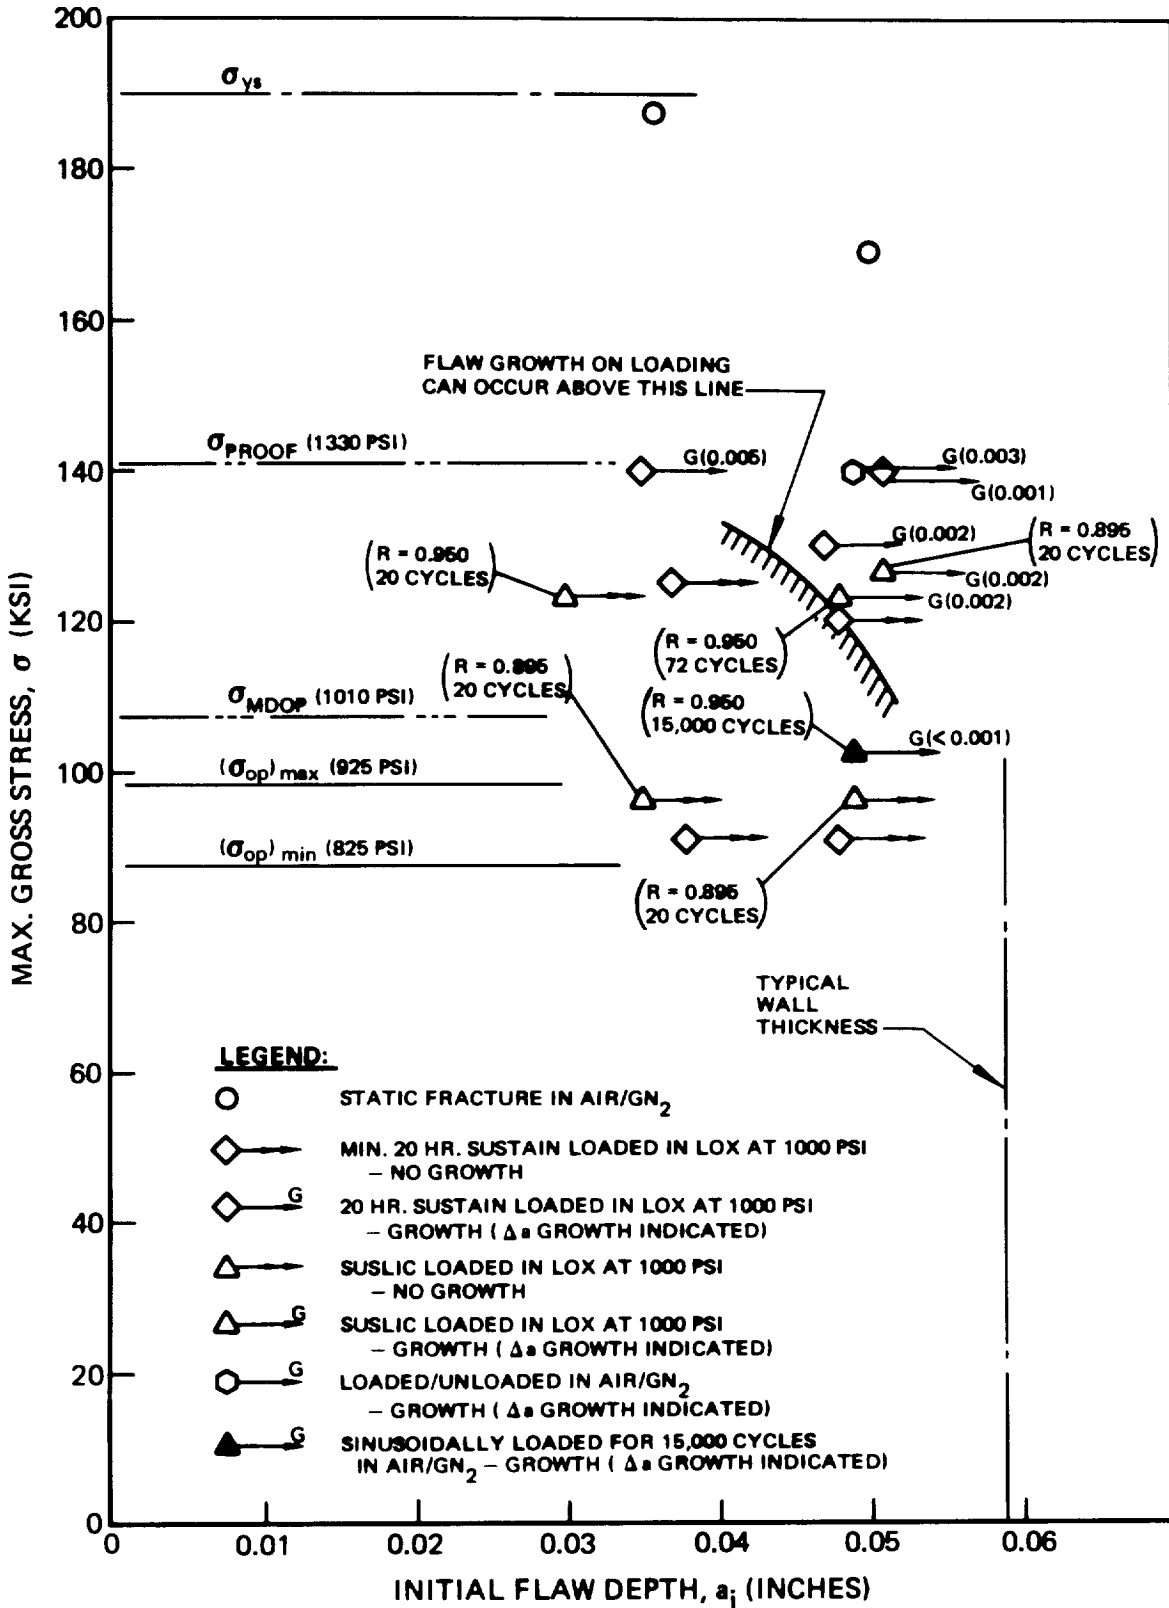
Figure 27: TEST RESULTS OF INCONEL 718 FORGING AT $-190^{\circ}F$ FOR SM/EPS LOX TANK ASSESSMENT (PART I)

Inconel 718 forging and weldment specimens were sustain loaded in LOX at -190°F and 1000 psi for a minimum of 20 hours. The weldment specimens either had flaws located in the ζ or HAZ. The results of these tests are presented in Figures 27, 28 and 29, while the detailed data are presented in Tables VIII, IX and X. Flaw growth was observed in both the forging and weldment materials for particular combinations of stress and flaw depth, but because of the growth through-the-thickness observed with the static fracture specimens additional tests were conducted to separate time dependent, sustained load flaw growth from growth-on-loading. Key specimens that showed flaw growth after being sustain loaded for a minimum of 20 hours were

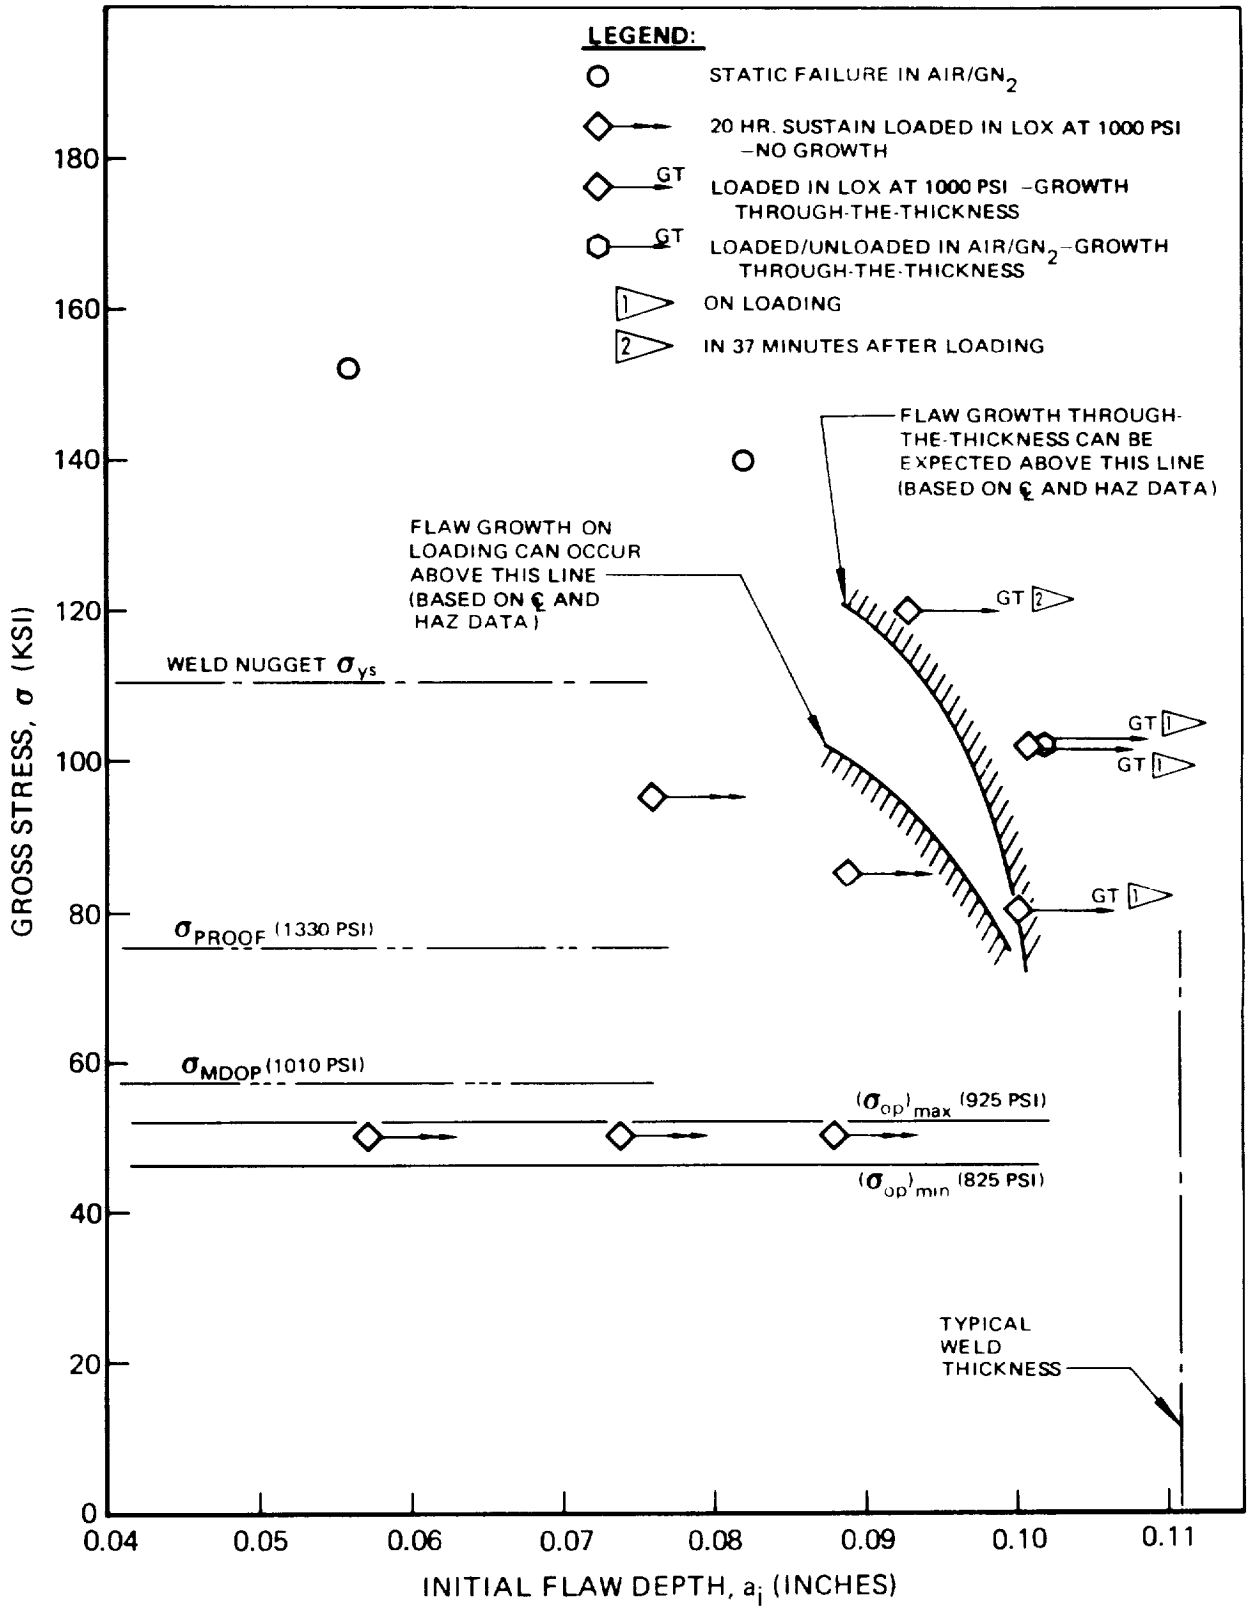
Figure 28: TEST RESULTS OF INCONEL 718 WELDMENT AT -190°F FOR SM/EPS LOX TANK ASSESSMENT—FLAWS IN ϵ (PART I)

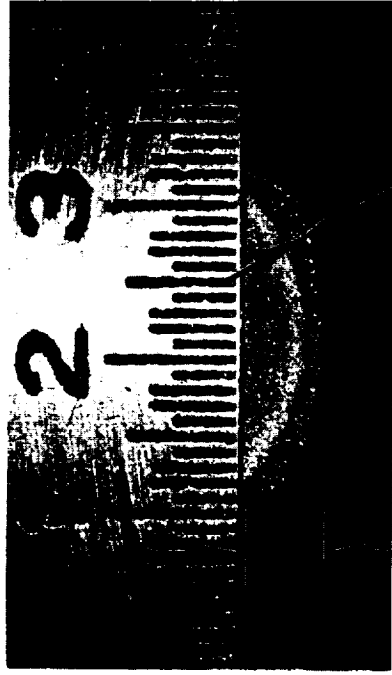
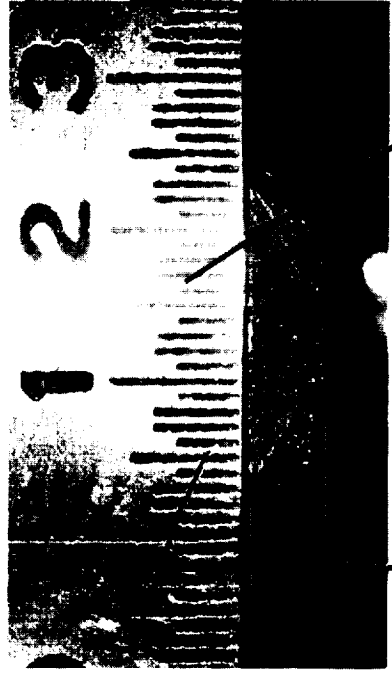
$a_i = 0.051''$ — Growth

Specimen B-6
Sustain Loaded For 20 Hrs. In
LOX at -190°F and 1000 psi

$a_i = 0.035''$ — Growth

Specimen B-13
Sustain Loaded For 20 Hrs. In
LOX at -190°F and 1000 psi

$a_i = 0.049''$ — Growth

Specimen B-15
Loaded/Unloaded In Air/ GN_2 At -190°F

Figure 32: FRACTOGRAPHS OF INCONEL 718 FORGING SPECIMENS STRESSED TO 140 KSI - 8X POLARIZED LIGHT (PART I)

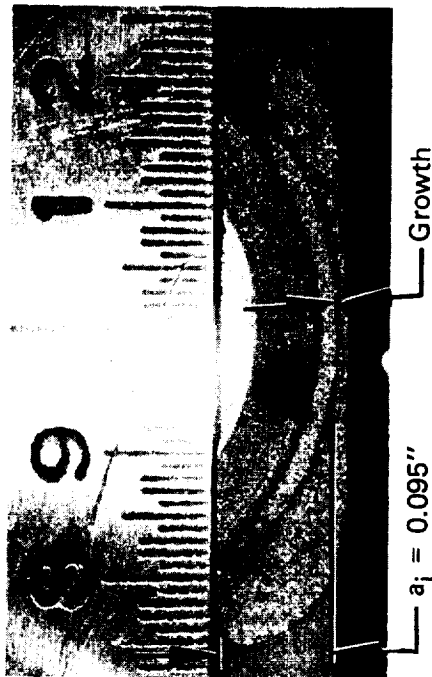
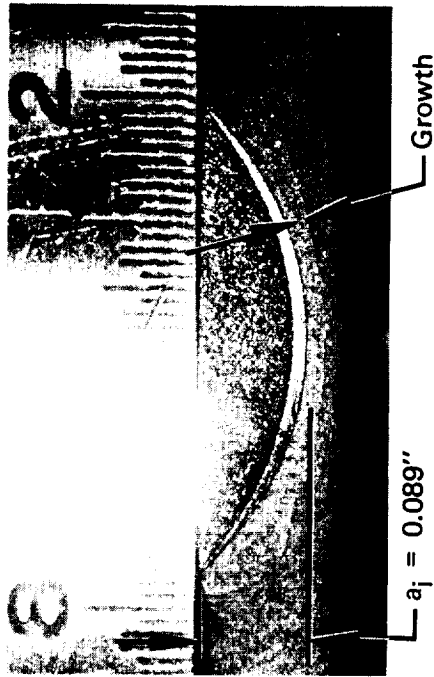
**Figure 33: FRACTOGRAPHS OF INCONEL 718 WELDMENT
 SPECIMENS STRESSED TO APPROXIMATELY 100 KSI
 -- 8X POLARIZED LIGHT (PART I)**

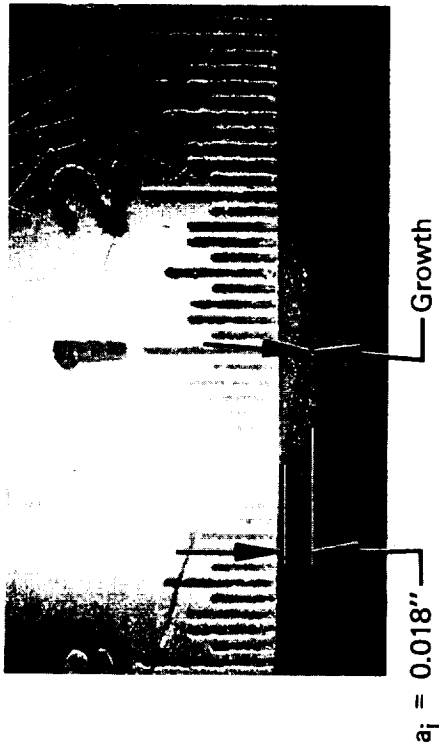
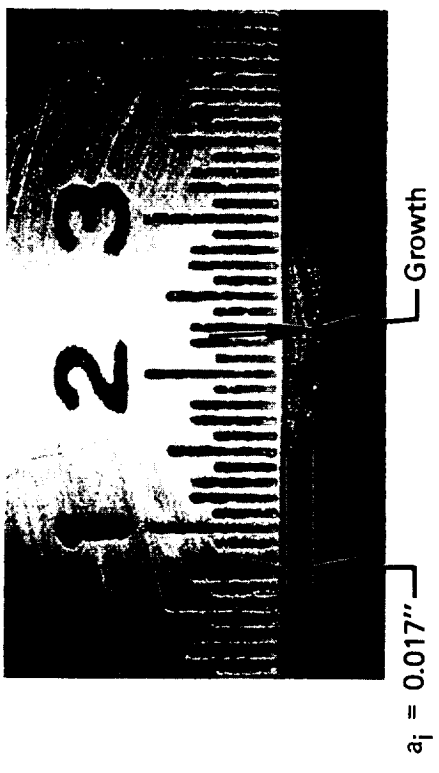
Specimen LB-1
 Sustain Loaded For 20 Hrs.
 In GOX At 70°F And 1000 psi

Specimen LB-5
 Loaded/Unloaded In Air At 70°F

Figure 34: FRACTOGRAPHS OF INCONEL 718 FORGING SPECIMENS
 STRESSED TO 140 KSI -- 8X POLARIZED LIGHT (PART II)

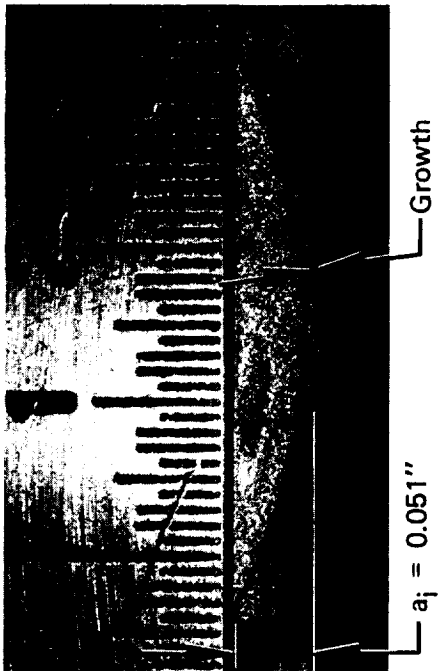
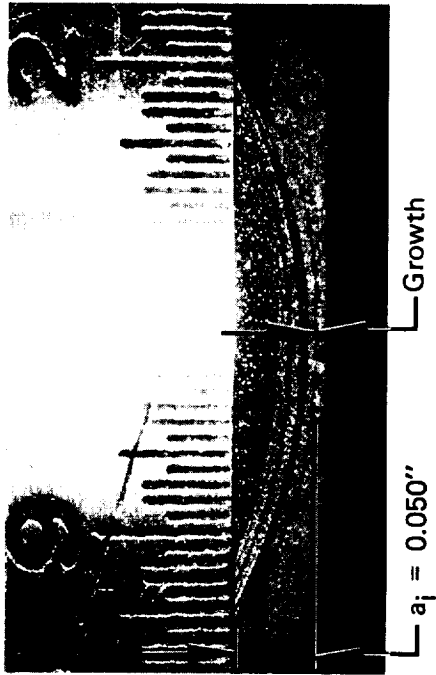
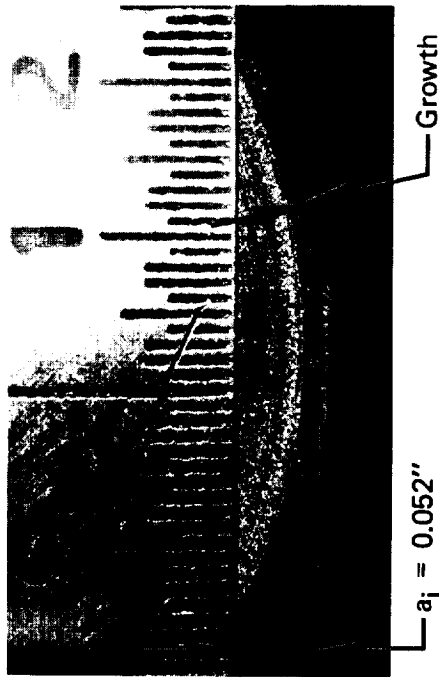
Specimen LW-1 (Flaw In ζ)
 Sustain Loaded For 20 Hrs. In
 GOX At 70°F And 1000 psi

Specimen LW-14 (Flaw In HAZ)
 Sustain Loaded For 20 Hrs. In
 GOX At 70°F And 1000 psi

Specimen LW-8 (Flaw In ζ)
 Loaded/Unloaded In Air At 70°F

Figure 35: FRACTOGRAPHS OF INCONEL 718 WELDMENT SPECIMENS
 STRESSED TO 100 KSI – 8X POLARIZED LIGHT (PART II)

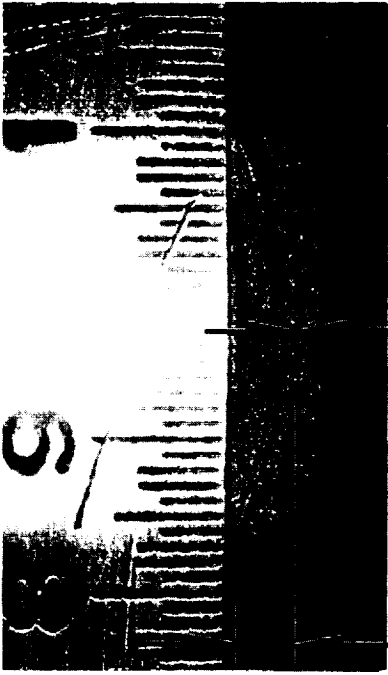
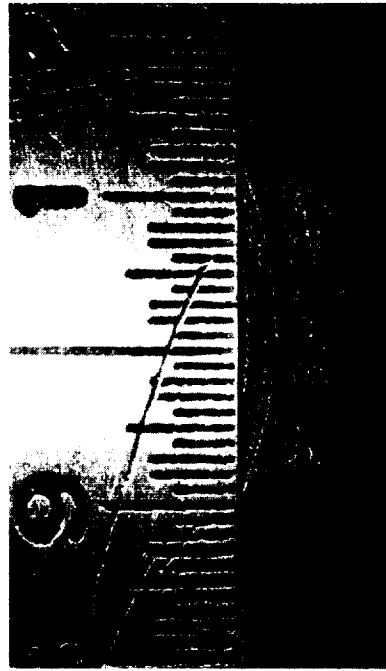
$a_i = 0.041''$
 Specimen LW-13 (Flaw In ϕ)
 Sustain Loaded For 20 Hrs.
 In GOX At 70°F And 1000 psi

$a_i = 0.041''$
 Specimen LW-2 (Flaw In HAZ)
 Sustain Loaded For 20 Hrs.
 In GOX At 70°F And 1000 psi

$a_i = 0.042''$
 Specimen LW-9 (Flaw In HAZ)
 Loaded/Unloaded In Air At 70°F

**Figure 36: FRACTOGRAPHS OF INCONEL 718 WELDMENT SPECIMENS
 STRESSED TO 120 KSI - 8X POLARIZED LIGHT (PART II)**

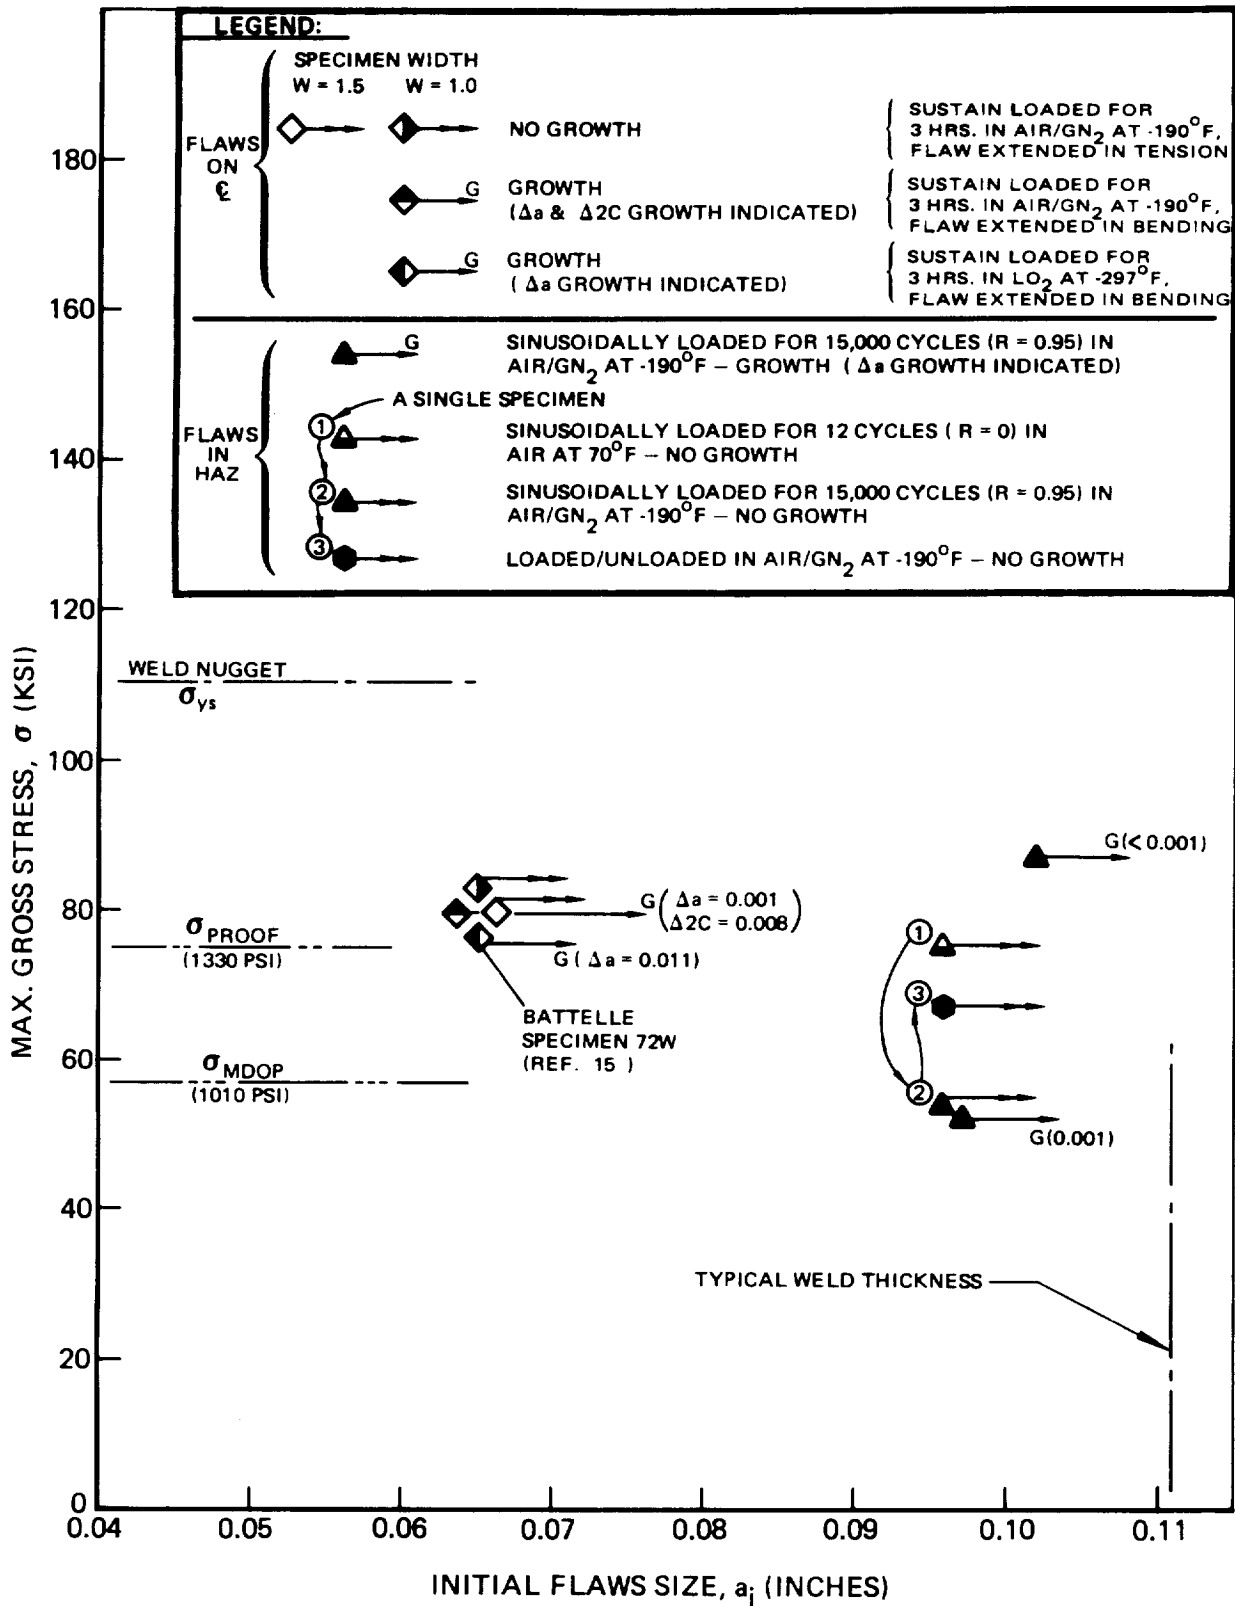
Figure 37: SPECIAL TESTS OF INCONEL 718 WELDMENTS (PART I)

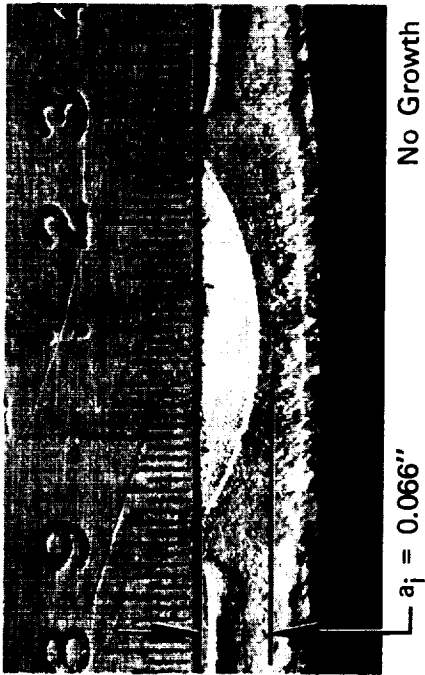
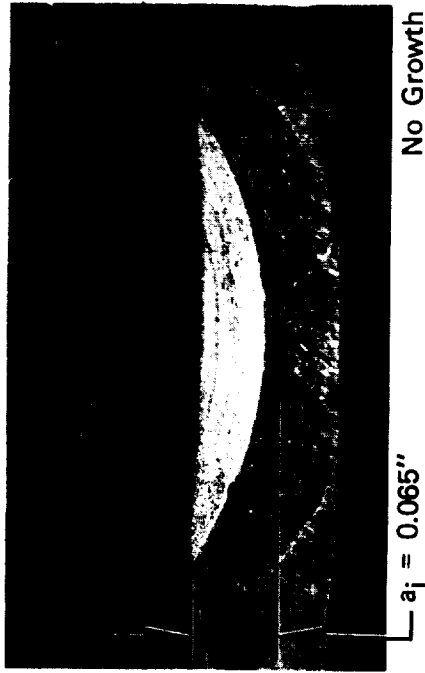
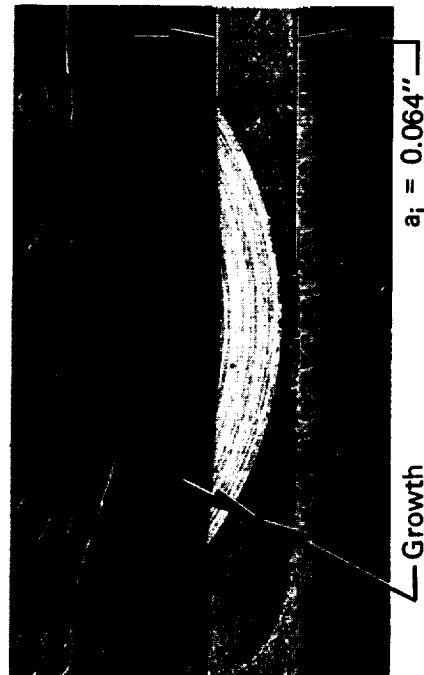
No Growth

Specimen W-33 (Width = 1.5)
Sustain Loaded For 3 Hrs. In Air/GN₂
At -190°F (Flaw Extended In Tension)

Specimen W-34 (Width = 1.0)
Sustain Loaded For 3 Hrs. In Air/GN₂
At -190°F (Flaw Extended In Tension)

Growth

$a_i = 0.064''$

Specimen W-35 (Width = 1.0)
Sustain Loaded For 3 Hrs. In Air/GN₂
At -190°F (Flaw Extended In Bending)

$a_i = 0.065''$

Battelle Specimen 72W (Width = 1.0)
Sustain Loaded For 3 Hrs. In
LOX At -297°F (Flaw Extended In Bending)

Figure 38: FRACTOGRAPHS OF INCONEL 718 WELDMENT SPECIMENS STRESSED TO 80 KSI - FLAWS IN ϕ - 8X WHITE LIGHT (PART I)

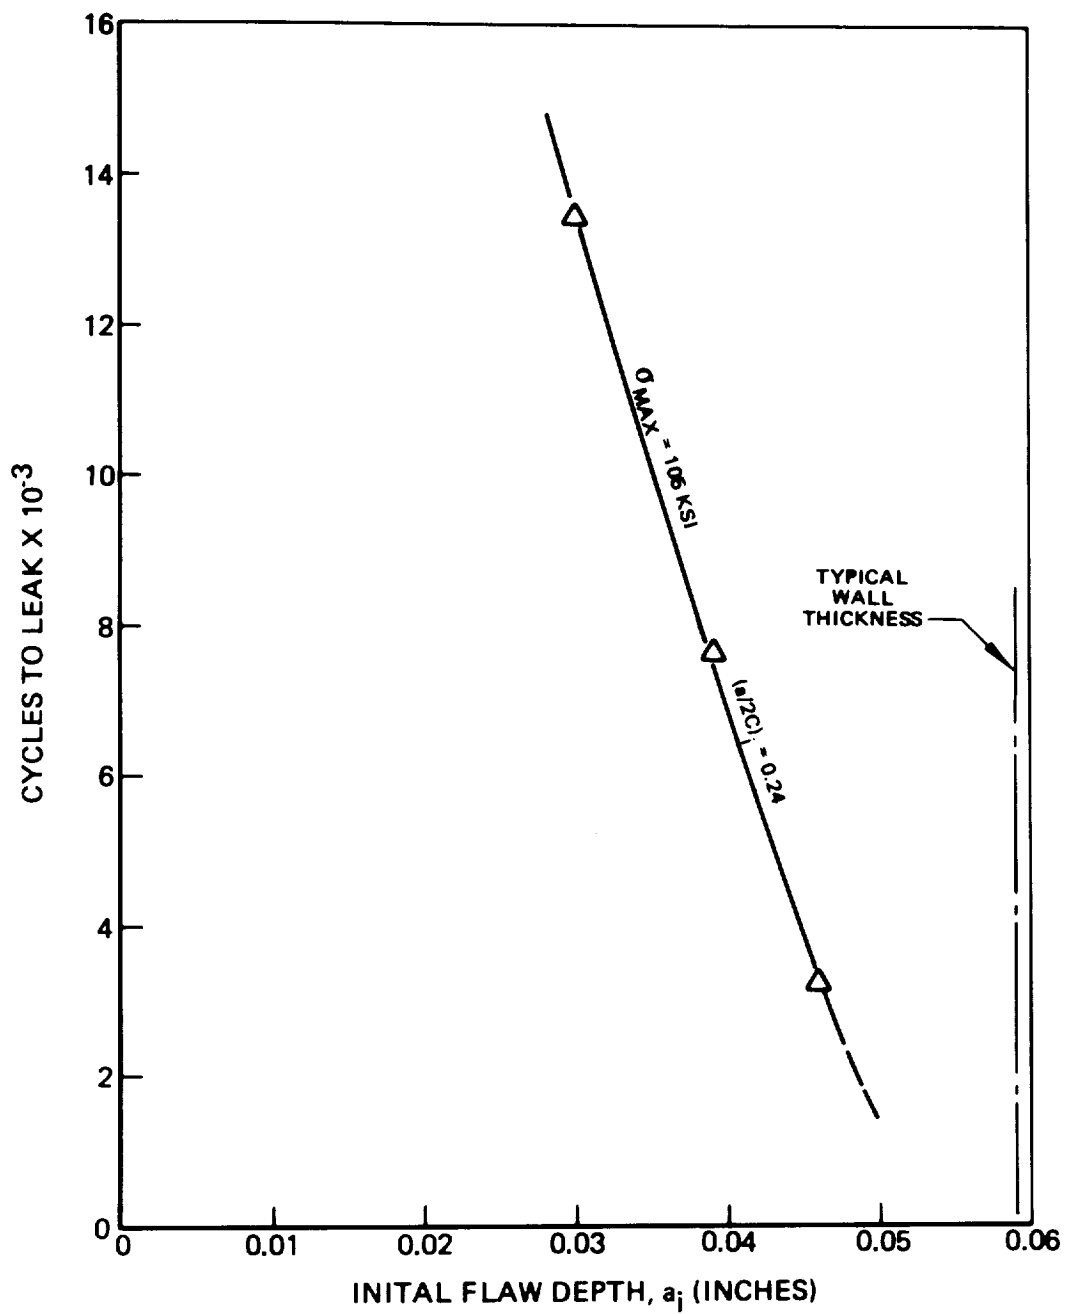
Figure 39: CYCLIC TESTS TO LEAKAGE AT R = 0 OF INCONEL 718 FORGING IN AIR AT 70°F (PART I)

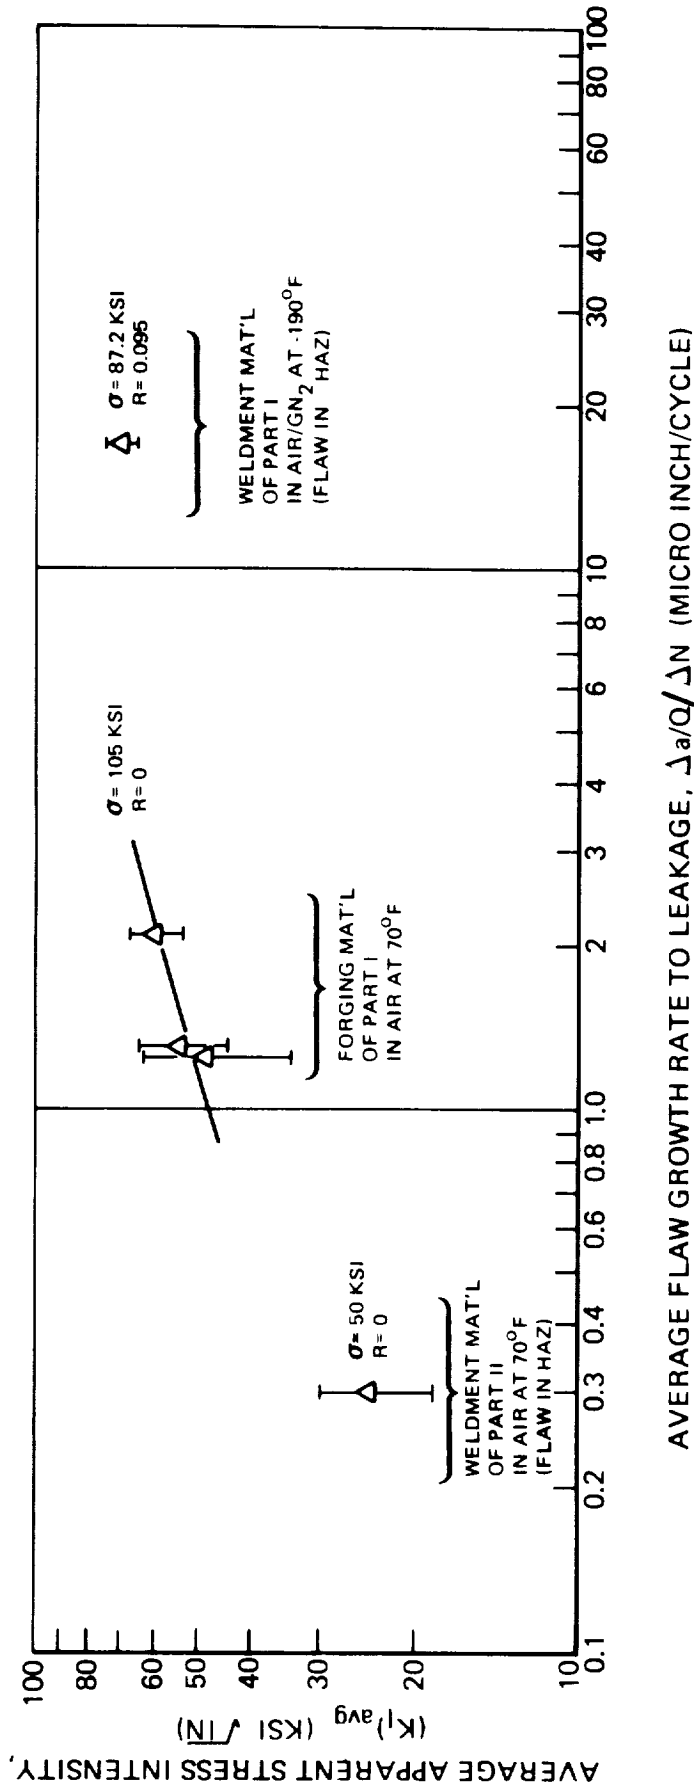
Figure 40: FLAW GROWTH RATES TO LEAKAGE FOR INCONEL 718 (PARTS I AND II)
