REPORT 6098

DESIGN STUDY AND EVALUATION
OF A HYPERGOLIC ENGINE
FOR A SPACE POWER SYSTEM

Final Report for Phase II
and Phase II, Modification I
for the Period 1 July 1964 to 10 February 1966

Contract: NAS 9-857
Phase II and Phase II, Modification I

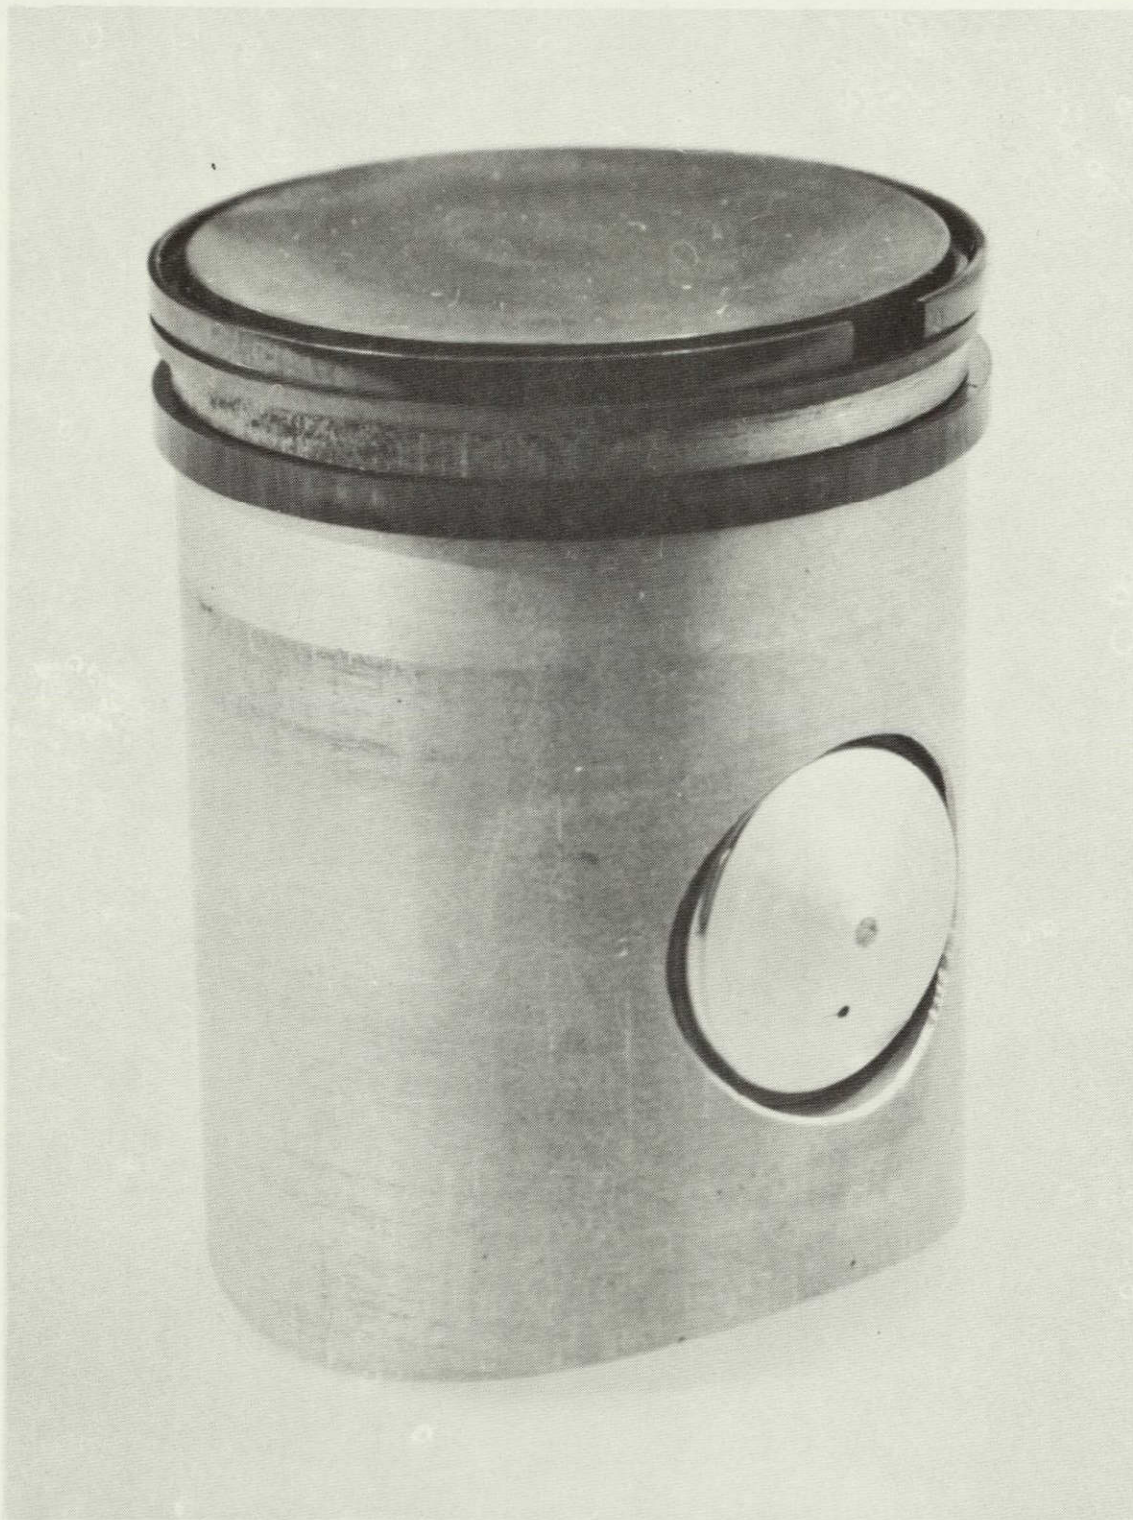
T 5151-19

FIGURE 12. Baseline Piston Assembly Used in the SPU-3 Engine,
After Test

Two successful piston and ring designs have been developed for the SPU-3 engine. Both designs feature a Rene' 41 crown, a D132 aluminum skirt, and piston rings fabricated from 440-C stainless steel. The two pistons are identified as the "Baseline" piston and the "Mod 1" piston.

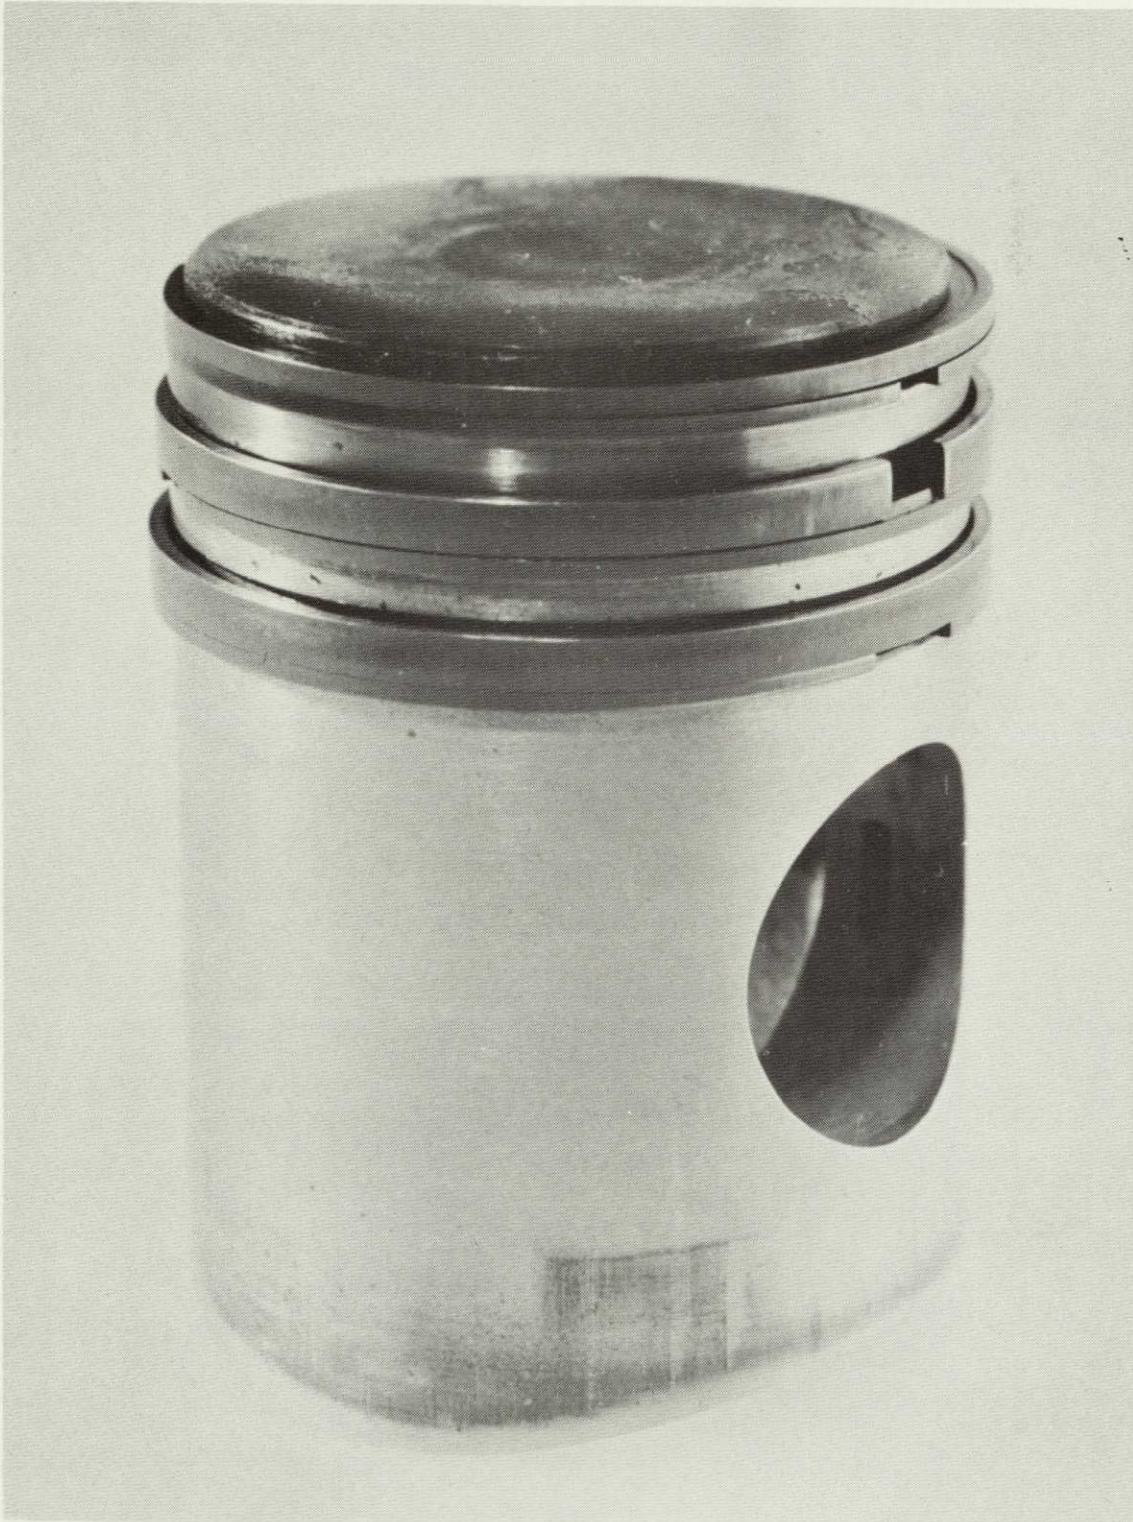
T 5149-11

FIGURE 29. Configuration D Piston after Operation for 17 minutes in the SPU-2A-3 Engine

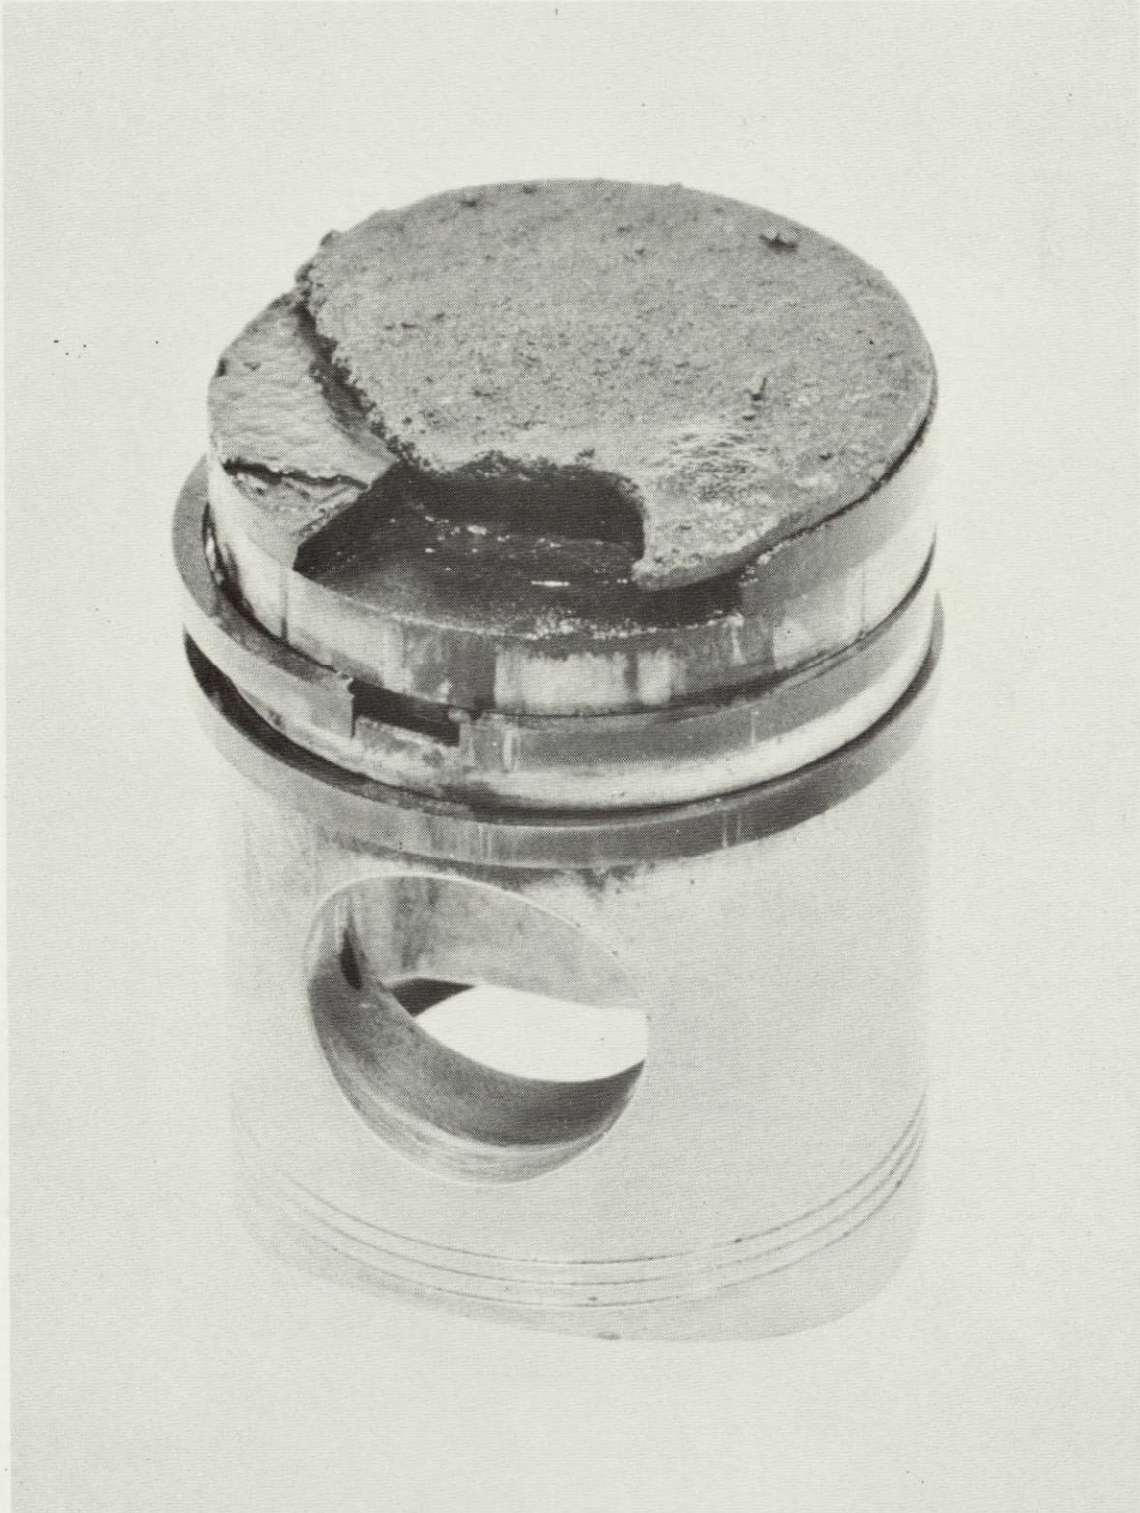
T 5151-10

FIGURE 31. Insulated Crown Piston Configuration F after
Operation for 0.3 hour

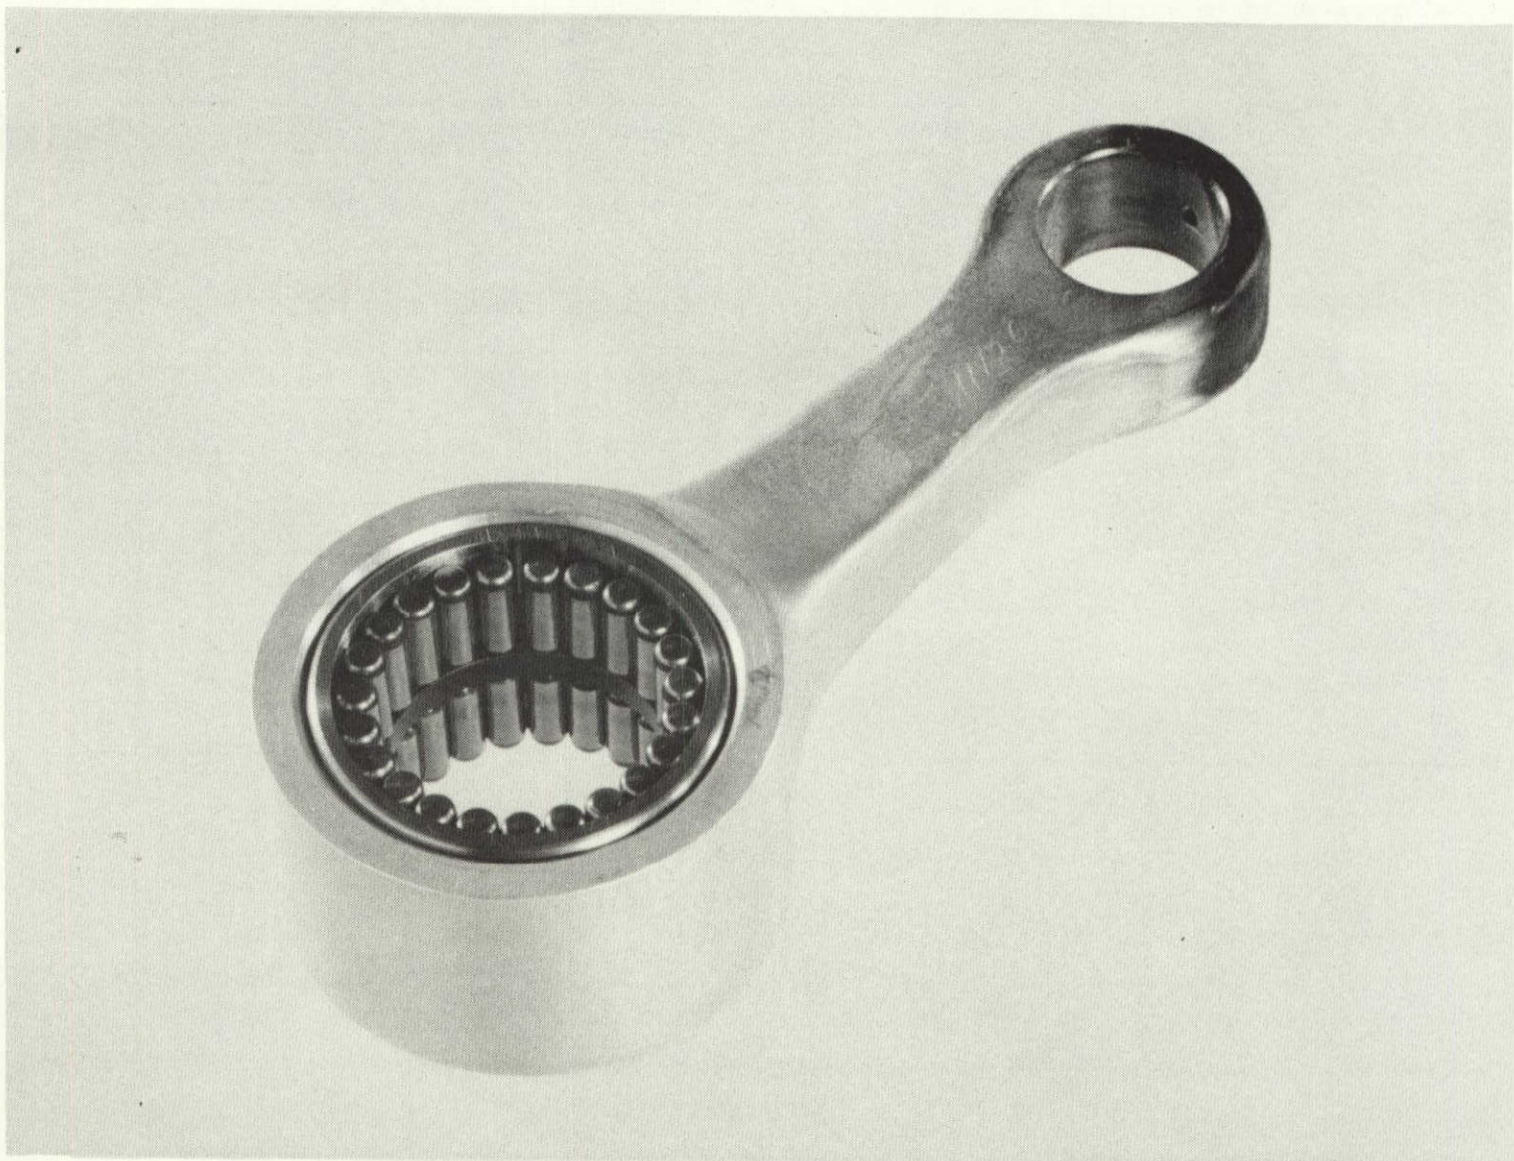
T 5167-14

FIGURE 44. Connecting Rod after 90-hour Endurance Test in the SPU-3A Engine
