INVESTIGATIONS OF THE POTENTIAL PERFORMANCE CHARACTERISTICS  
OF SELECTED CONTACT LUBRICANTS FOR APPLICATIONS IN  
MINIATURE SLIP-RING CAPSULES OF THE TYPE USED IN  
ST 124 M STABILIZED INERTIAL GUIDANCE PLATFORMS

FINAL TECHNICAL REPORT

Contract Number NAS 8-21323

J. B. Baker, G. B. Gaines, and K. E. Meiners

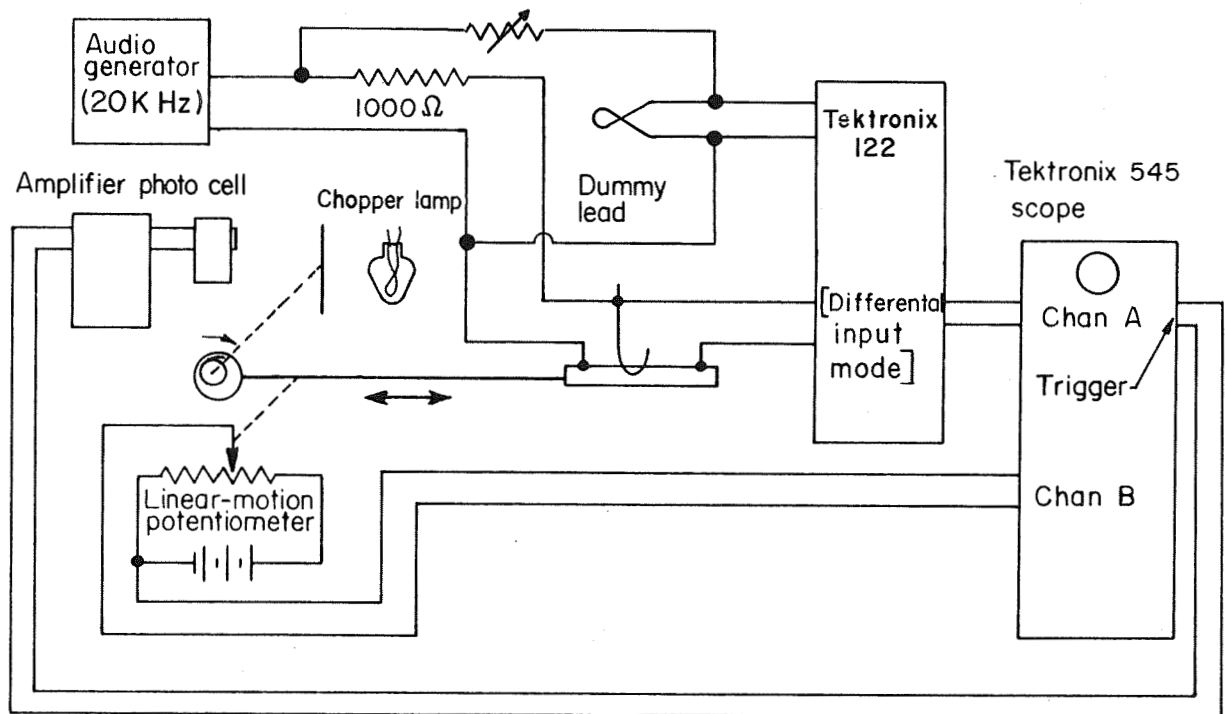
A-55764

FIGURE 2. SCHEMATIC REPRESENTATION OF CIRCUIT FOR MEASURING DYNAMIC CONTACT RESISTANCE

The dynamic-resistance behavior was observed by making an oscilloscopic display of the voltage across the contacts while they were conducting a constant current of 28.2 milliamperes. The equipment used to observe dynamic-resistance behavior was essentially the same as that used in the work described in Part I of this report on page 5.

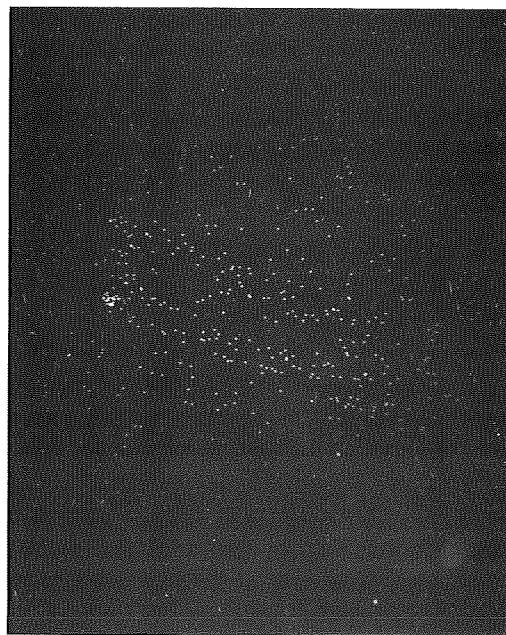
FIGURE 7. ELECTRON-MICROPROBE IMAGES OBTAINED FROM A PARTICLE REMOVED FROM SLIP RING DP 1506 SN 201 AT POINT 9 OF ITS LIFE

Figure 7 shows EMP results for a loose particle taken from the rotor of DP 1506 SN 201 at Point 9 of its life, that is just before the first brush wire was removed and Figure 8 shows a corresponding particle taken from the rotor at Point 16 of its life. Both particles clearly originated from the hard-alloy coating of the rotor. A second particle removed at Point 9 also had the composition revealed by Figures 7 and 8.

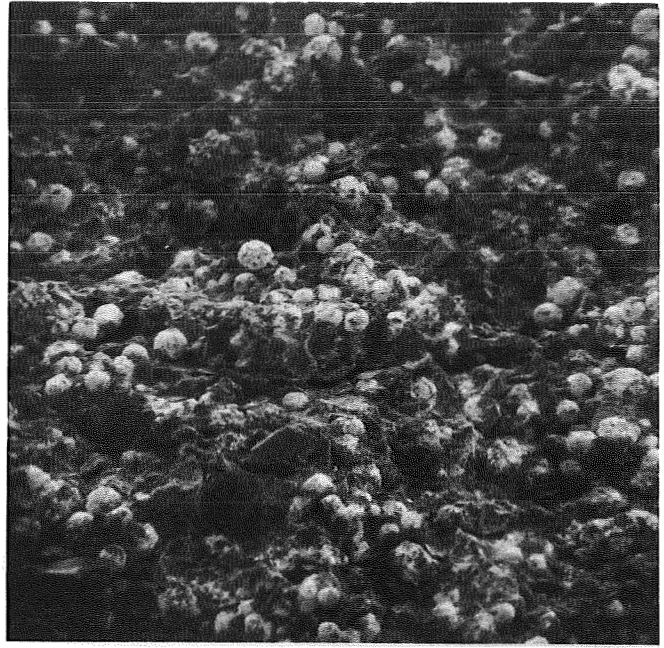
a. Normal Blending

b. Blending After Vacuum Drying

c. Ball Milled

FIGURE 10. GOLD-2.5Cu-15MoS<sub>2</sub> GREEN-PRESSED COMPACTS AFTER VARYING DEGREES OF BLENDING

Figure 10 illustrates the microstructure of the Au-2.5Cu-15MoS<sub>2</sub> blend for three succeeding stages of processing: normal blending, blending after vacuum drying, and ball milling. Homogeneity of the microstructure is seen to steadily improve throughout the processing schedule. It can also be noted that the dispersion achieved after simple blending, as in Step (3), was already relatively good. In this case, Step (3), the light-colored spherical particles of the gold-copper matrix material and the dark-gray layered particles of the lubricant approximate the dimensions of an opening in a 325-mesh sieve (44 microns).

clusters. More complete breakdown of the gold constituent than that shown in Figure 10c may be difficult to obtain due to the high ductibility of the material; the clusters may deform rather than fracture.

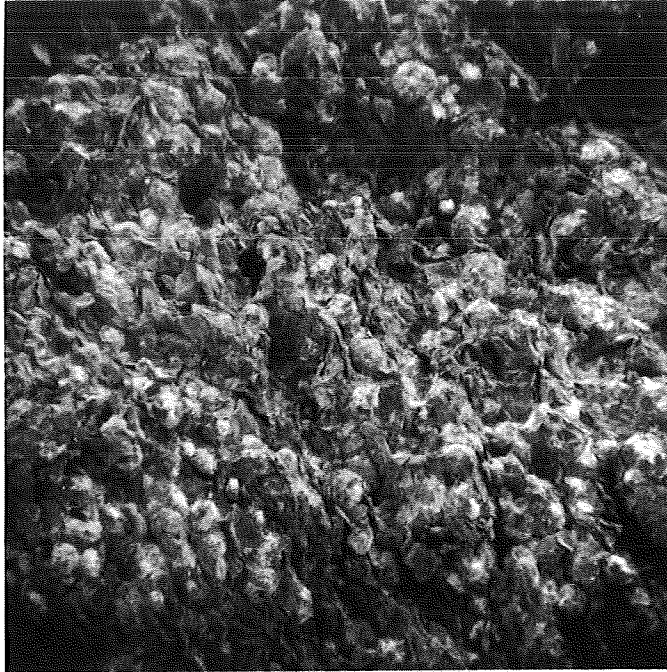
500X  
a. Electron Micrograph of a Fracture Surface  
Adjacent to the Polished Surface

500X  
b. Metallographically Polished Surface

100X  
c. Metallographically Polished Surface

FIGURE 13. GOLD-2.5Cu-15MoS<sub>2</sub> COMPACTS AFTER HOT PRESSING AT  
1000 F AND 10,000 PSI FOR 2 HOURS IN VACUUM

Following blending, the specimens were die pressed at 40,000 psi followed by a vacuum hot-pressing cycle of 538 C at 10,000 psi, held for 2 hours. Examples of the microstructure of a typical metallurgically polished surface and of the interior near the surface are shown, respectively, by the optical and SEM photomicrographs of Figure 13. By comparing Figure 10c with Figure 13a, it can be seen that the lubricant dispersion was not altered by the hot-pressing operation. The specimens produced utilizing the modified blending procedure were only 94 percent of theoretical density. Metallographic examination, as shown by Figure 13, revealed a structure apparently more open than had been obtained with the earlier, simpler blending process. The difference in hot-pressed densities at least partially explains the "open" areas, but the explanation for the difference in densities has not been determined. The density after die (cold) pressing was identical for the two types of specimens. Increasing the hot-pressing pressure to 30,000 psi did not increase the density of the second type of specimens.

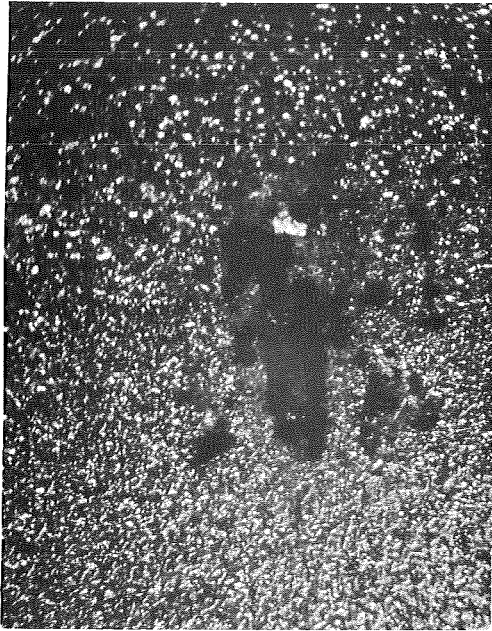
FIGURE 14. INDICATION OF EFFECT OF MATRIX COMPOSITION ON WEAR OF METAL/LUBRICANT COUPONS CONTAINING MoS<sub>2</sub>
