**EVALUATION OF  
TANTALUM/316 STAINLESS  
STEEL BIMETALLIC TUBING**

*by J. N. Kass and D. R. Stoner*

*Prepared by*  
**WESTINGHOUSE ELECTRIC CORPORATION**  
Pittsburgh, Pa.  
*for Lewis Research Center*

1. Report No. ✓ NASA CR-1575		2. Government Accession No.		3. Recipient's Catalog No.	
4. Title and Subtitle ✓ EVALUATION OF TANTALUM/316 STAINLESS STEEL BIMETALLIC TUBING <i>add E-T: Tantalum/316 stainless tubing.</i>		5. Report Date ✓ May 1970		6. Performing Organization Code

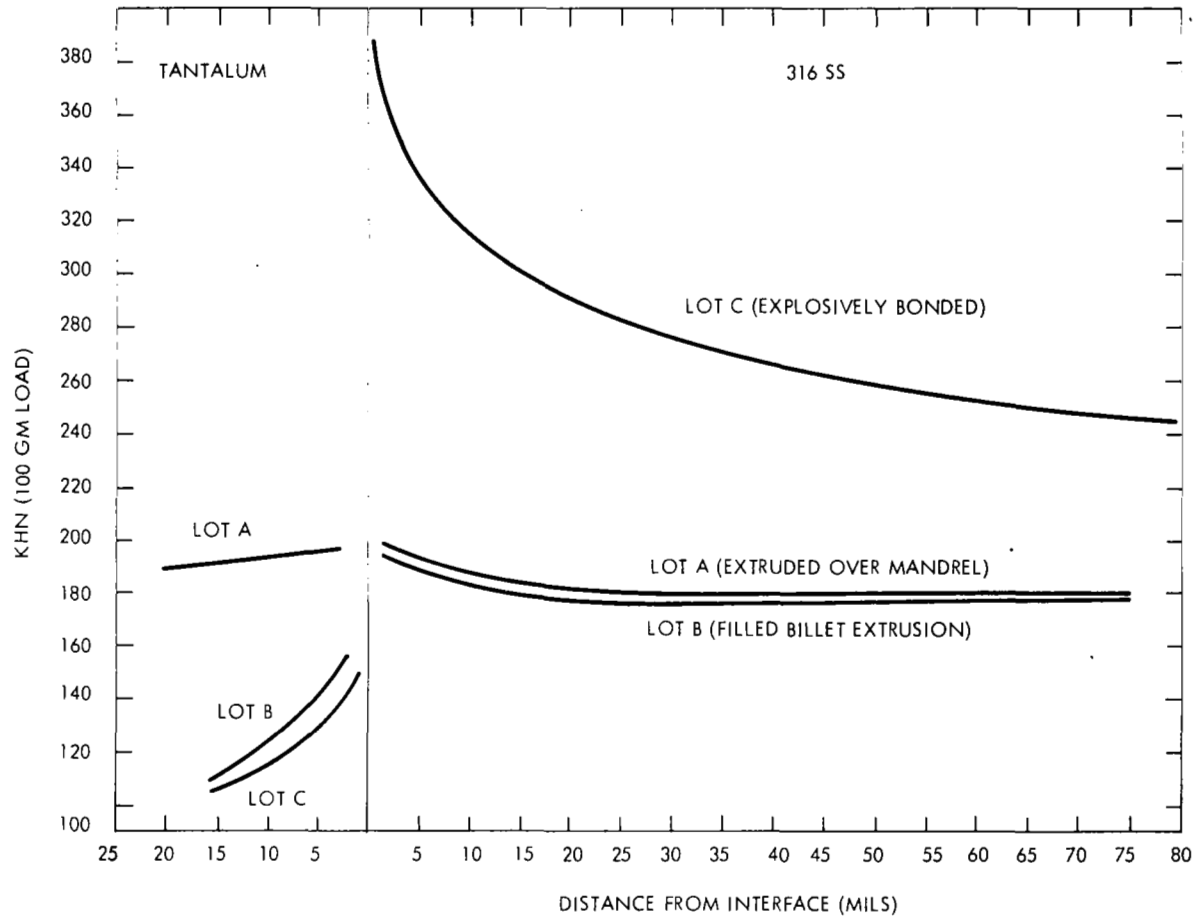
FIGURE 9 - Hardness Traverse of the As-Fabricated Tantalum/316SS Bimetal Layers

The high hardness values exhibited by the Lot A tantalum liner indicate that very little recovery and essentially no recrystallization occurred during extrusion; in contrast, the hardness level of the Lot B coextruded tubing is typical of partially recrystallized tantalum. The extrusion temperature of the Lot B tubing was 50 to 100F<sup>o</sup> higher than that of Lot A. This increment may account for the difference in the as-extruded hardness. The hardness gradient exhibited by the Lot C tantalum component was normal and this gradient is caused by localized plastic flow at the interface as discussed earlier. The hardness gradient in the Lot B tantalum liner may be caused by interstitial diffusion (C, O and N) from the stainless steel during heating for extrusion. The chemical analyses of the starting and as-fabricated carbon, oxygen and nitrogen levels are in Table 9. The as-fabricated Lot A and B tubing show only minor changes in the interstitial level. Although no starting analyses were available for the Lot C tubing, the very nature of the process would preclude significant chemistry changes during fabrication.

As shown in Figure 16, the tantalum and 316 SS components exhibit uniform equiaxed grains except near the interface which corresponds to the sharp increase in hardness shown in Figure 9.

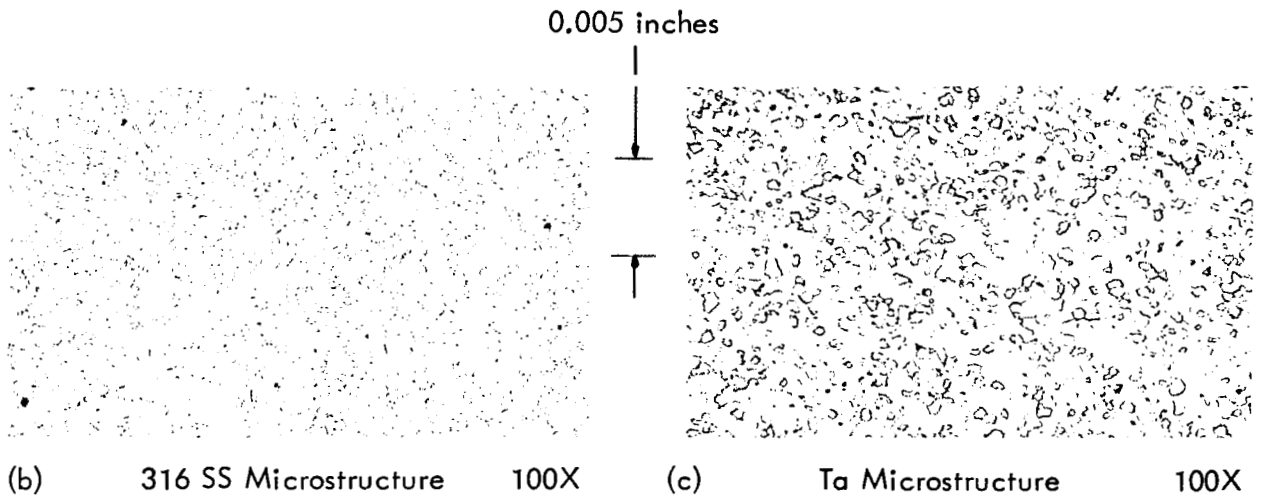
FIGURE 13 - ID Surface and Microstructure of Lot B (Filled Billet Extrusion) Bimetal Tubing

(a) ID Surface

(b) 316 SS Microstructure 100X

(c) Ta Microstructure 100X

Lot B (Filled Billet Extrusion). The ID surface was rough and was formed of striations 2-3 mils deep as shown in Figures 12a and 13a. The OD surface was smooth. Both the OD and ID surfaces contained fissures of varying depths as shown in Figures 12b and 12c. The majority of ID cracks were about 2-3 mils deep. The 316 SS and Ta were fine grained and recrystallized as shown in Figure 13b and 13c.

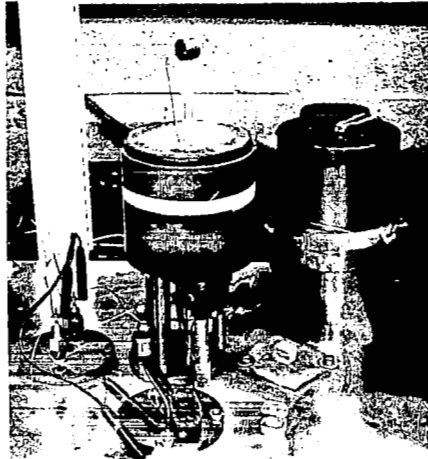
FIGURE 17 - Thermal Expansion Test Equipment

Thermal Expansion Apparatus

Thermal Expansion Schematic
