RESISTANCE WELD MONITORING  
CENTAUR TANKS 55-0501-22, 55-0501-23  
(AC-21, AC-22)  
CONTRACT NAS 3-8711

GDC-AGD-68-002A

PRELIMINARY REPORT

NOVEMBER 1968

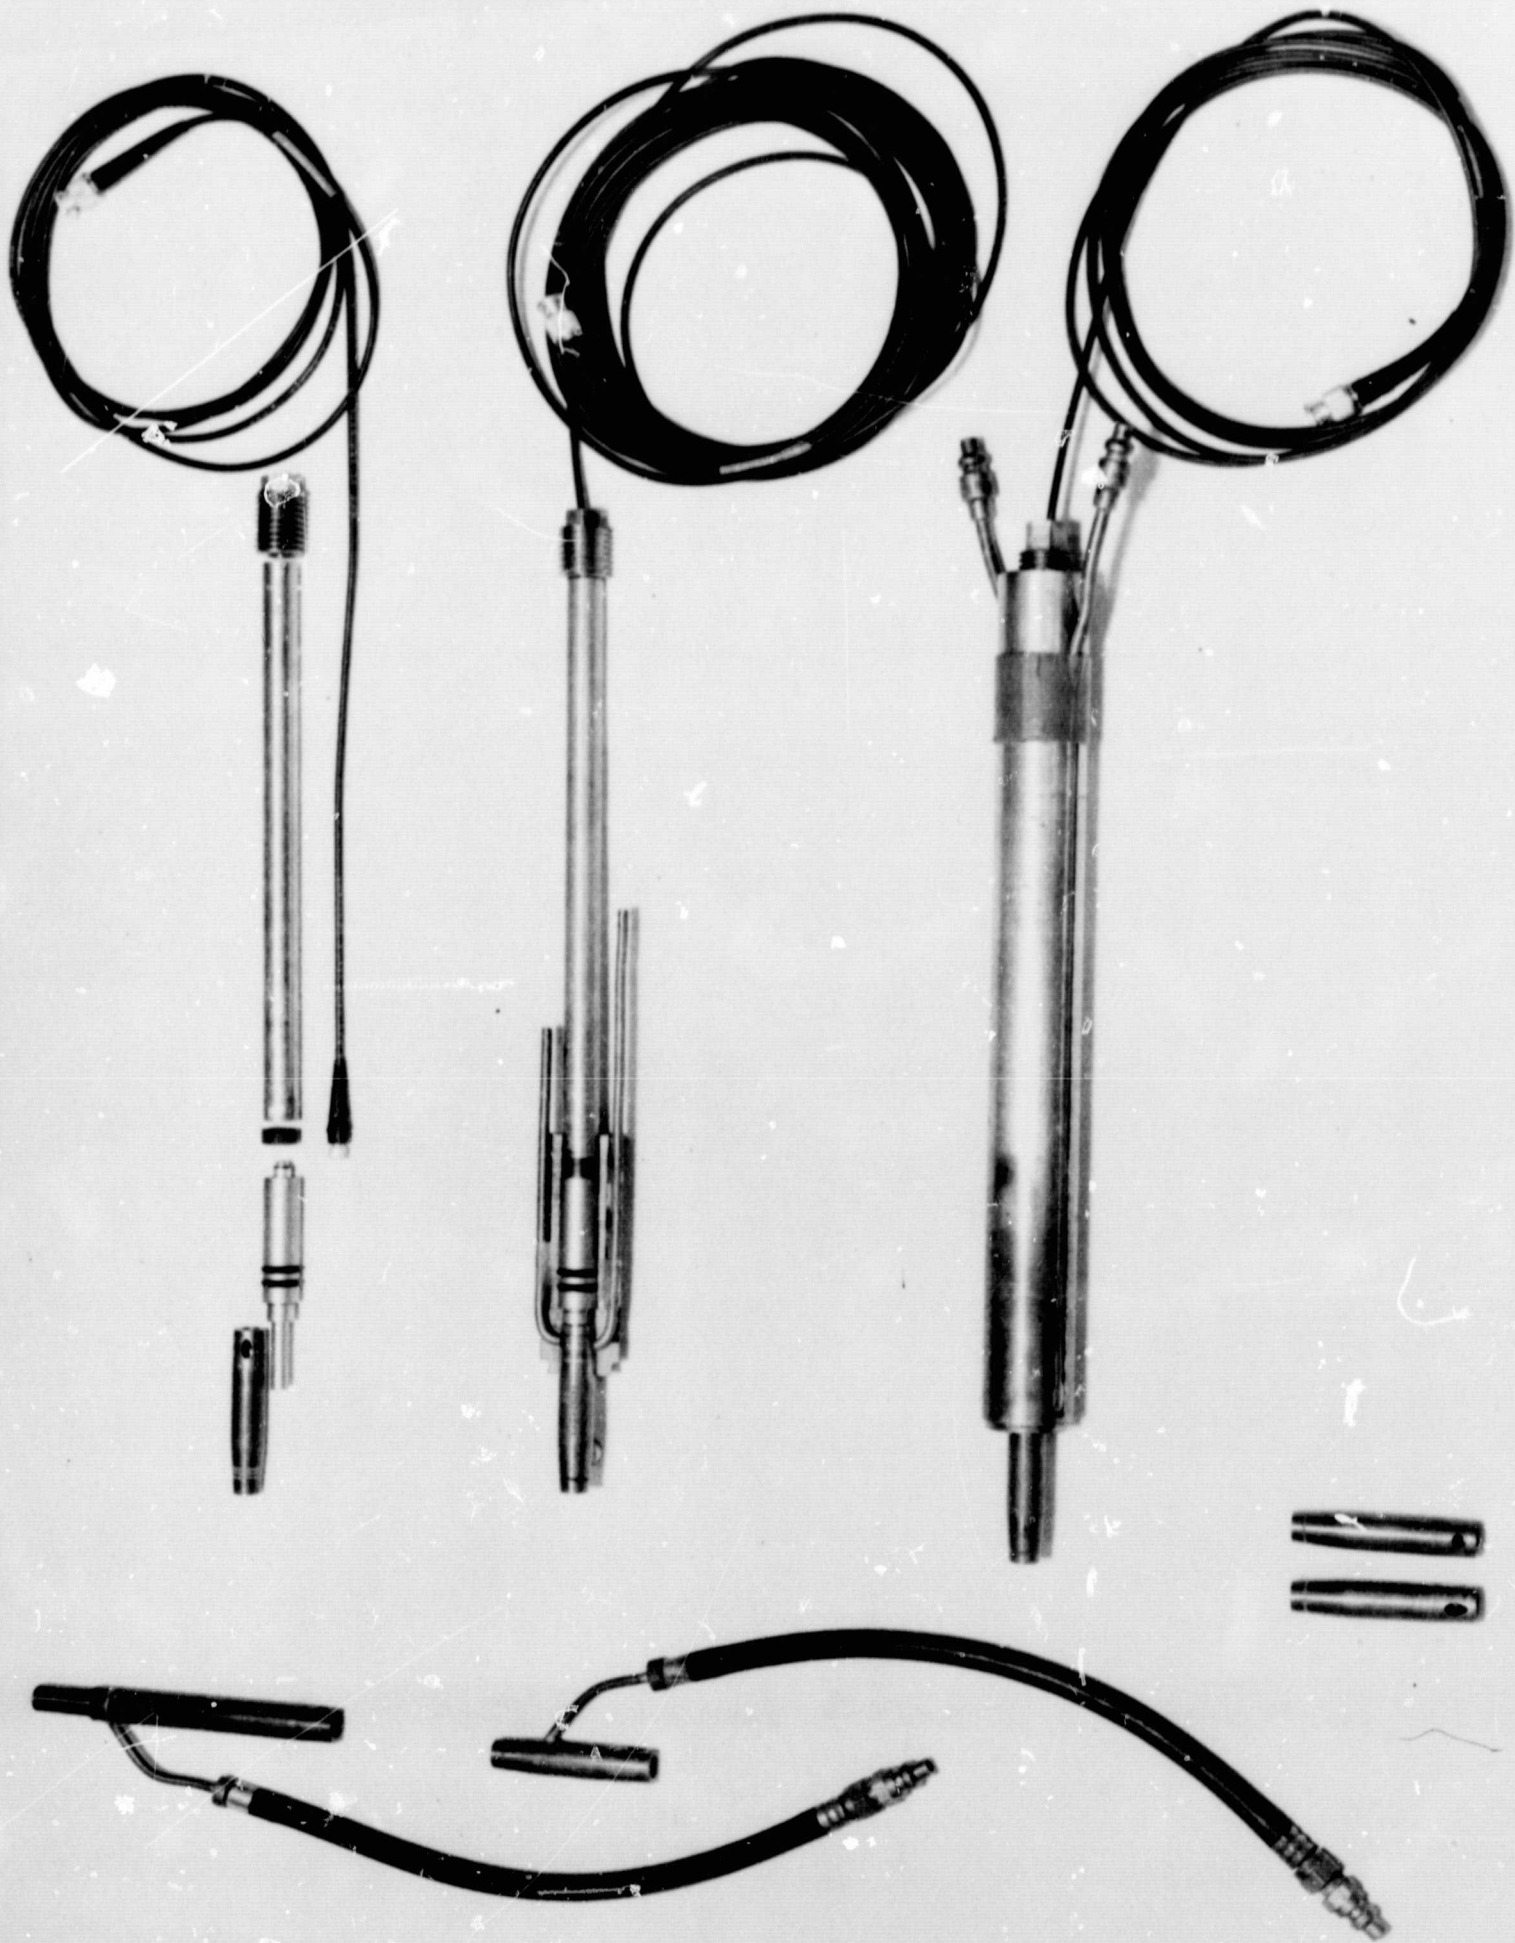
FIGURE 5  
ULTRASONIC TRANSDUCER INSTALLATION IN HOLDERS

Ultrasonic through transmission is accomplished by the use of two transducers, one acting as the pulser and the other as the receiver (as pictured). The weld pressure negates the need for a wet couplant between the electrodes and the work piece. Each electrode cavity is checked for the presence of air bubbles by switching to pulse echo mode of transmission and examining the first returned signal. In this mode, each ultrasonic transducer acts as both pulser and receiver. The echo returning from the flat bottom hole of the electrode will indicate the presence of air bubbles by loss of amplitude or signal instability. When both electrode cavities check satisfactorily, the monitor is returned to the through-transmission mode and preweld signal amplitude is established. This is accomplished by inserting test samples representative of the joint between the electrodes and bringing the electrodes

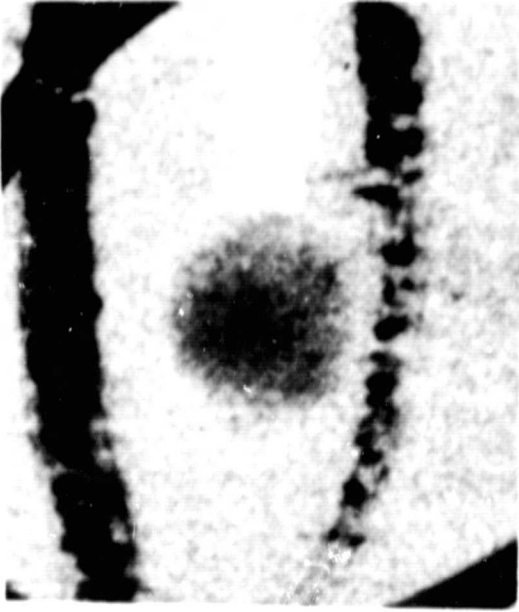
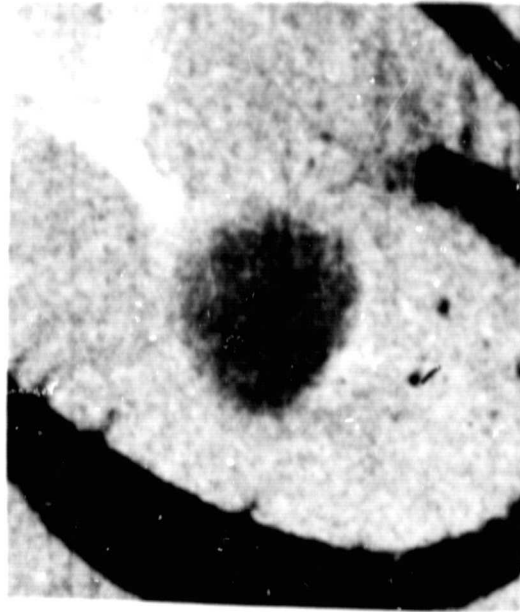
FIGURE 14

A & B - ULTRASONIC SIGNAL TRACES OF TYPICAL WELDS AND THE TRACES OF TWO "SPIT" WELDS.

C & D - PHOTOGRAPHS OF THE X-RAY RESULTS DEPICTING THE TWO "SPIT" WELDS.

DEFECTS JOINT "E"

Figure 14, Row "E" also contained two defective welds and the ultrasonic traces show a drastic response. It would appear that the spit in the upper left hand trace occurred somewhat earlier in the weld cycle than the other. No significant change was noted in the expansion rate. The rates recorded for both Joints "E" and "F" (shown in Figure 15) indicate that the count was completed prior to the spits.

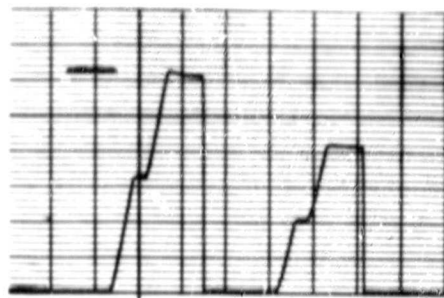
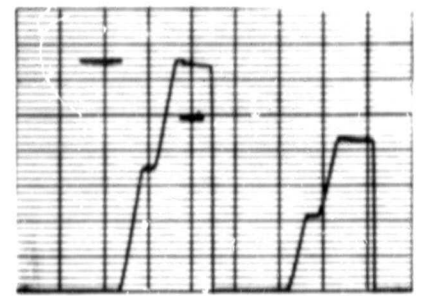
ENERGY LEVELS FOR "A" PRODUCTION HARDWARE,  
 "B" REWELD OF TACKWELD ON PRODUCTION HARDWARE,  
 AND "C" FINAL TEST SAMPLE.

E - EXPANSION READINGS FOR FINAL TEST.

Figure 22 shows a comparison of energy levels and expansion rates for the production part and final test sample. The same trend of reduced energy level from that obtained on the test sample is noted. Data identified as "2" is the result of rewelding a tackweld.
