MARGUAROLT  
 CORPORATION  
 VAN NUYS, CALIFORNIA

FINAL REPORT

APOLLO SM-LM RCS ENGINE DEVELOPMENT  
PROGRAM SUMMARY REPORT

Contract NAS 9-7281

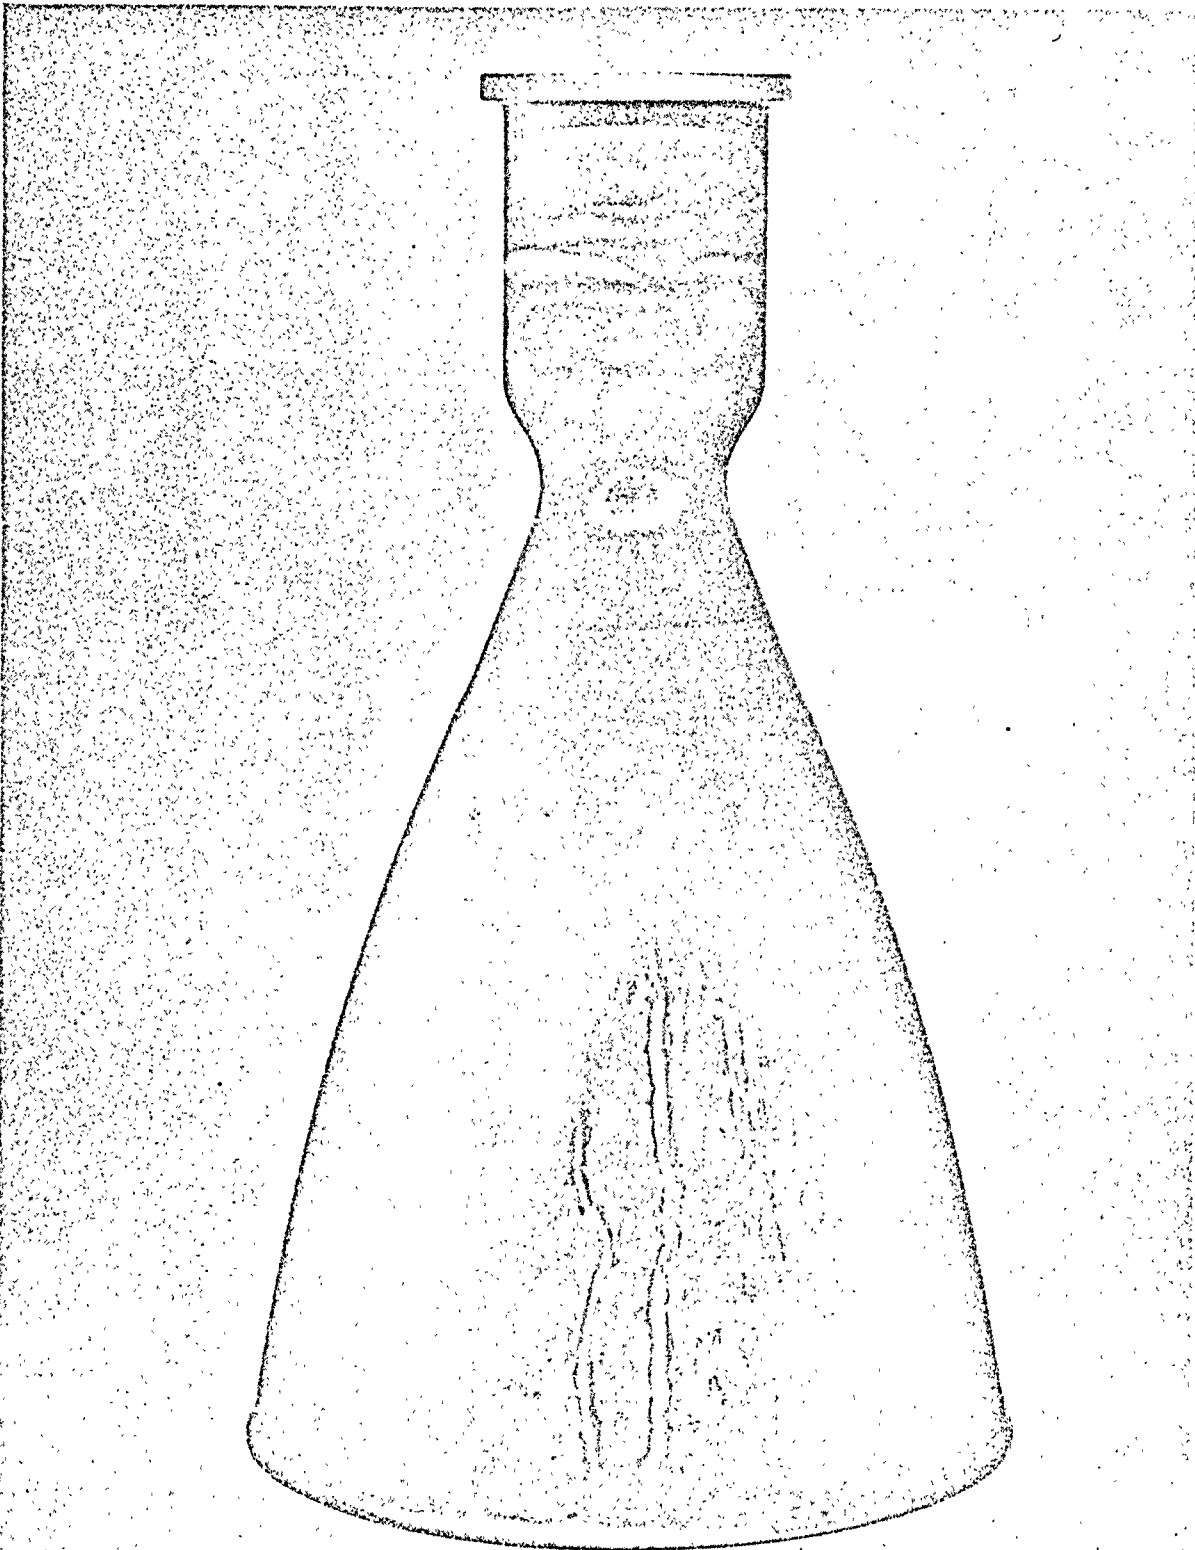
NEG. 6162-1

MD 1141, S/N 001 Disilicide Coated 90 Ta-10W Altitude Combustion Chamber
