XII. Science Data Systems

SPACE SCIENCES DIVISION

A. High-g Testing Multilayer Laminate Packaging, J. H. Shepherd

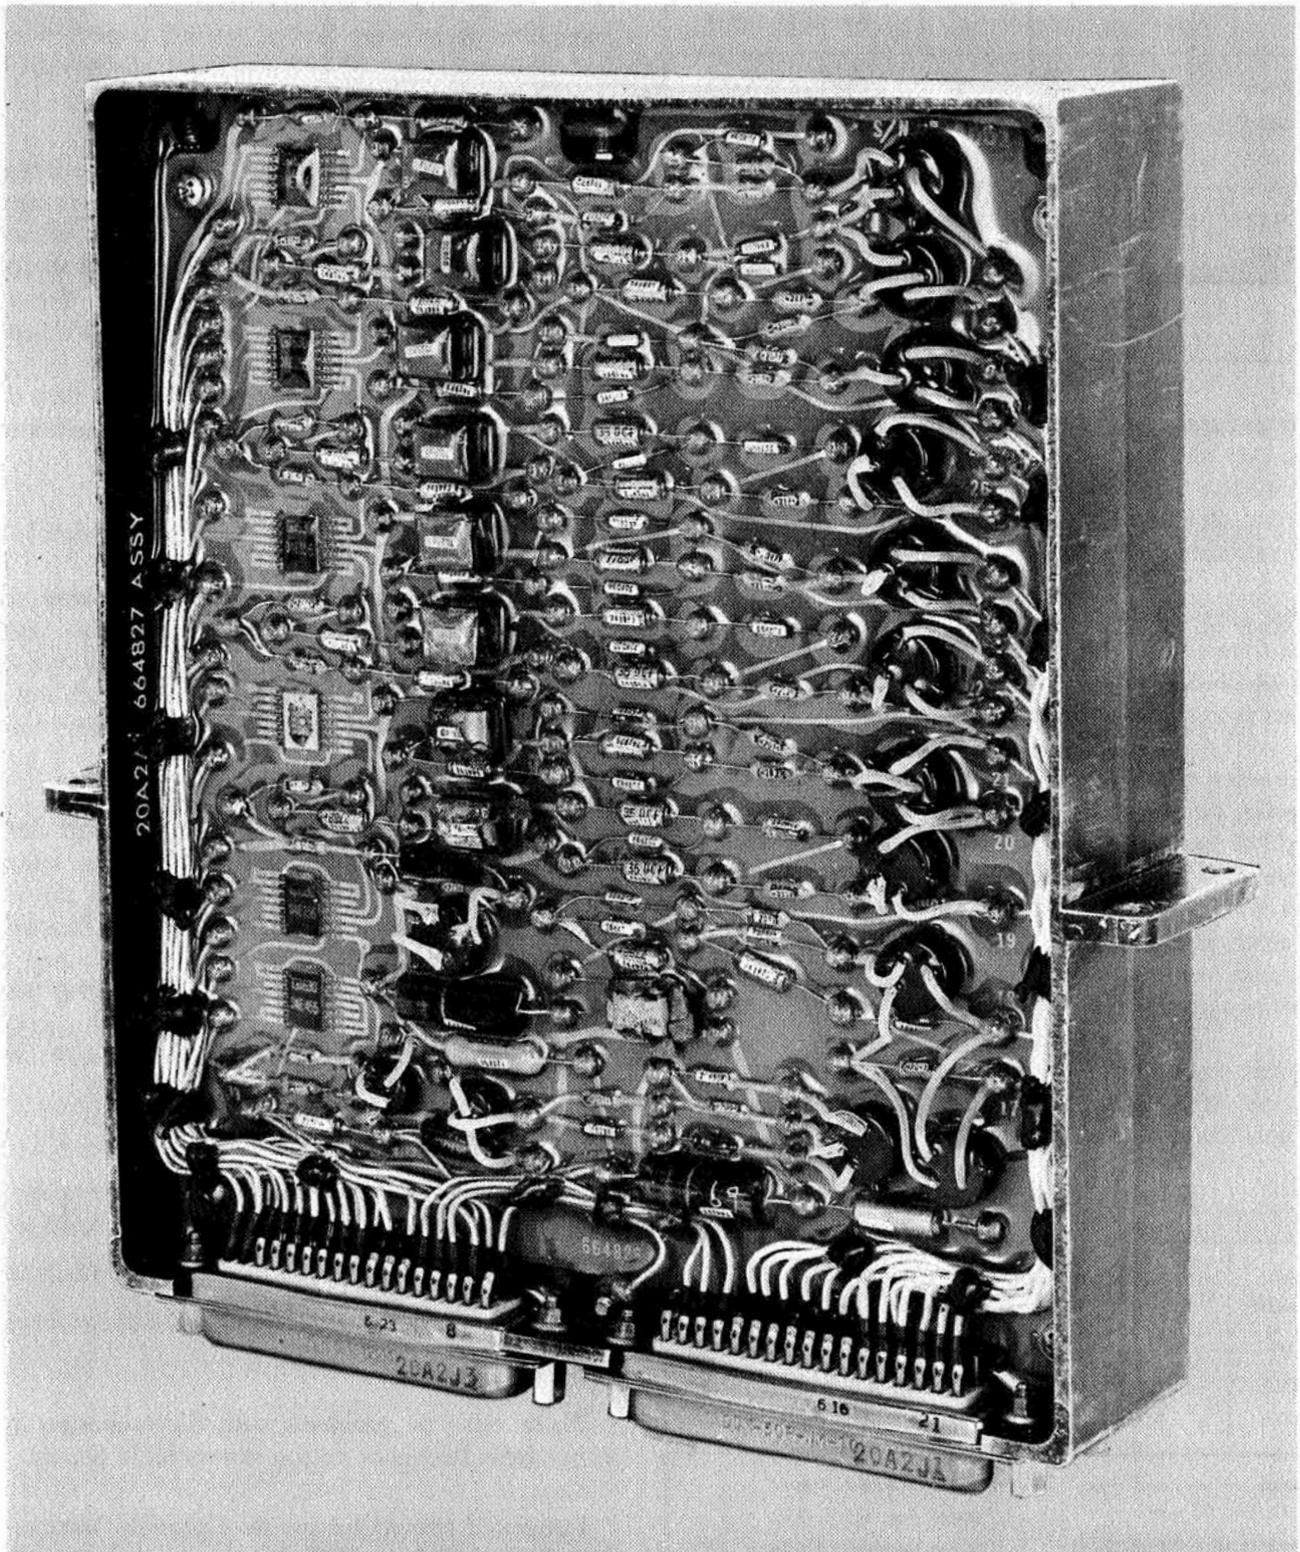
Visual examination after the slingshot test showed the chassis were bent on all four walls (Figs. 1 and 2); subassemblies webs were bowed toward impact sides 2A1 and 6A1; connectors J-1 through J-4 shells were bent; and pin holding blocks were broken.

Subassembly 20A2 lost the lid from one integrated circuit, and one side of a lid was loose on another. The glass case of the integrated circuit with the lid off was cracked on the inside of the package around the pad to which the die is attached. Due to the web flexing, five of the pulse transformers' cases were crushed, and ten transistors' leads bent against the transipads by coming in contact with the tooling fixture. Fourteen glass diodes' cases cracked on the 2A1 side, and one cracked on the far side (2A2) of the subassembly.

Fig. 1. Damaged DAS discrete assembly 2A1

Two changes are suggested for the subassembly structure to enable it to withstand shock at the 4,525 g level:

- (1) A thicker or reinforced web for the subchassis.
- (2) A conformal coating thick enough to cover the components entirely.

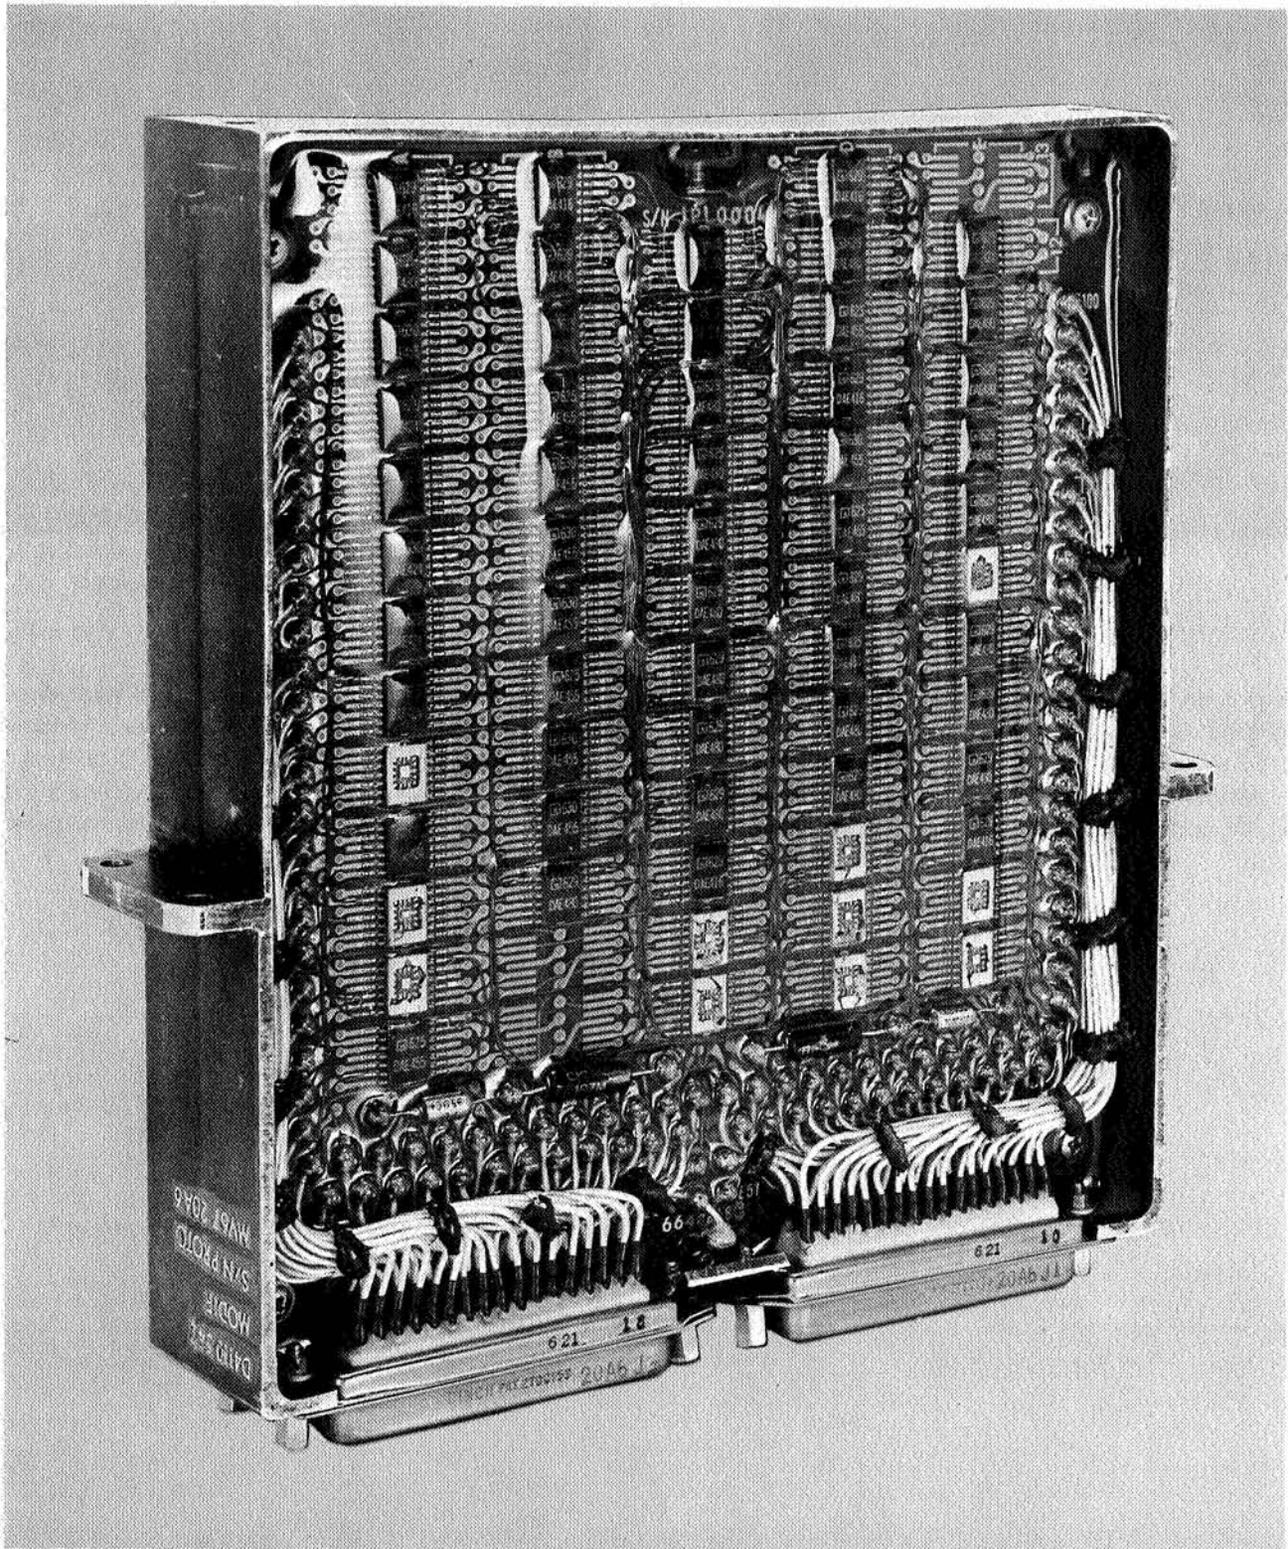
Subassembly 20A6 had the case cracked on one filter capacitor, and the lids came off of eleven integrated circuits on the 6A1 side. The glass around the pad to which the integrated circuit die is attached was cracked on these eleven integrated circuits, and the pad raised on some of them. This subassembly functioned properly without changing any components, and the prototype passed a complete subsystems test without malfunctions.

Fig. 2. Damaged DAS logic assembly

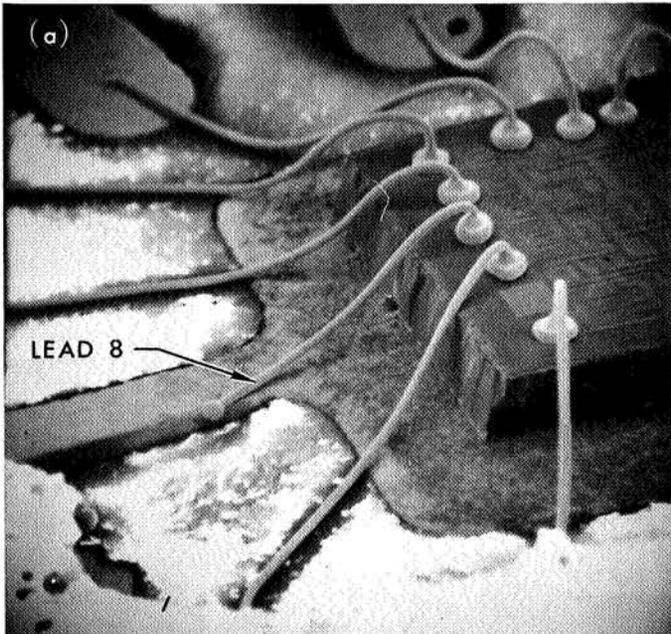
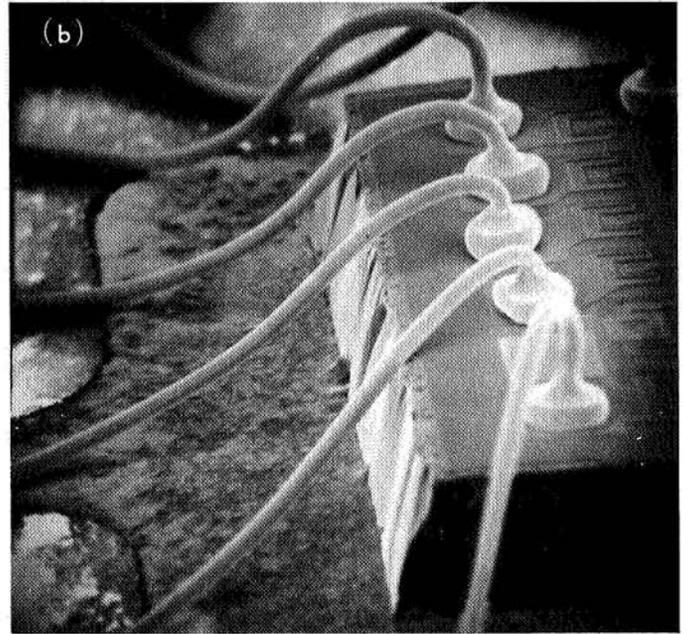
Subassembly 20A2 did not function properly until nine of the fifteen damaged diodes and three integrated circuits were replaced. One of the integrated circuits replaced was on the far side of this assembly; the gold bond wires internal to the integrated circuits had sagged down against the edge of the die, and lead eight was open where it had shorted to ground, melting the wire (Fig. 3a).

**Fig. 3. Integrated circuit photographed by scanning electron microscope showing wire sag:
(a) magnified 50 times, (b) magnified 100 times**

Integrated circuits for use on a possible *Mariner* Mars 1971 flight will most likely have a strengthened ceramic package with a gold-plated molybdenum-manganese die

attach area instead of the gold-plated kovar die attach pad used on the *Mariner Venus 67* system. This change should prevent the die attach area from separating from the bottom of the package. Aluminum wire will probably be used instead of gold, since it has less mass and

does not have a loop in it as the gold wire does. This should solve the sagging wire problem. Stringent environmental and mechanical tests are in process at the integrated circuit manufacturer at this time to qualify the aluminum wire interconnect and ceramic package.
