DOUGLAS REPORT SM-49105-F2

STRESS CORROSION CRACKING OF TITANIUM
ALLOYS AT AMBIENT TEMPERATURE
IN AQUEOUS SOLUTIONS

YEARLY SUMMARY REPORT
JULY 1967 THROUGH JUNE 1968
UNDER CONTRACT NAS 7-488

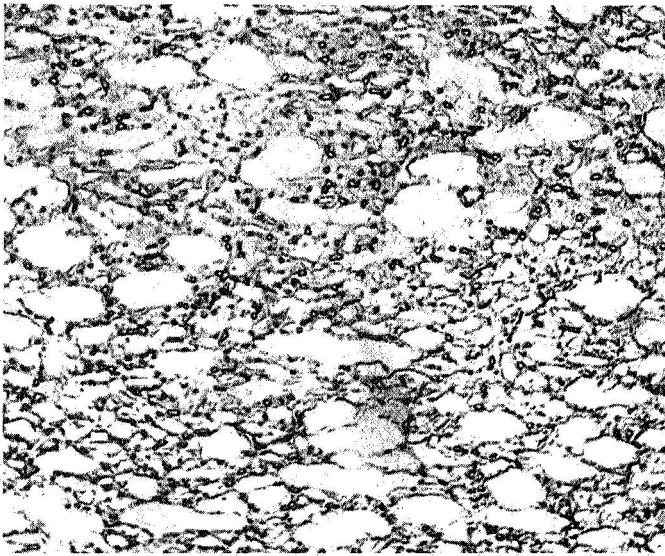
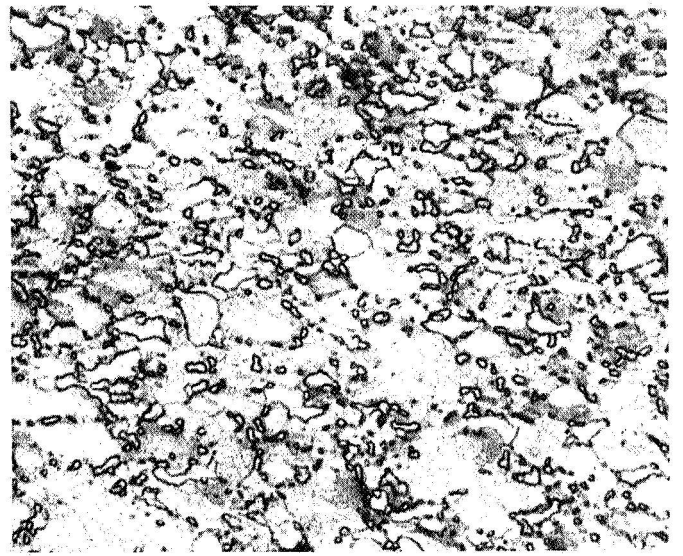
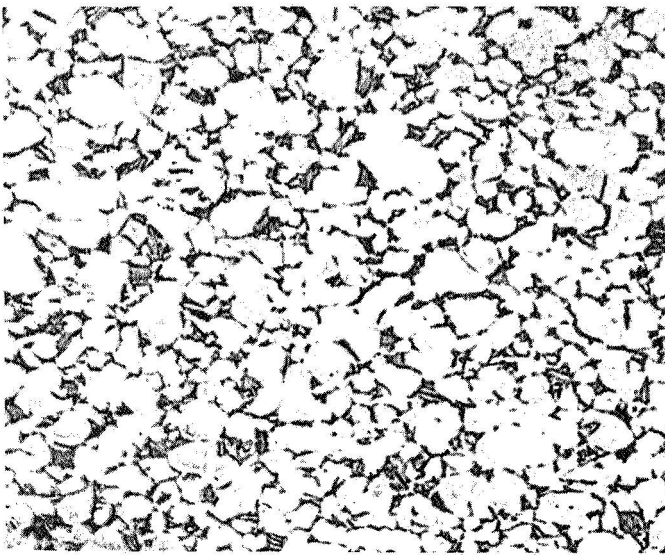
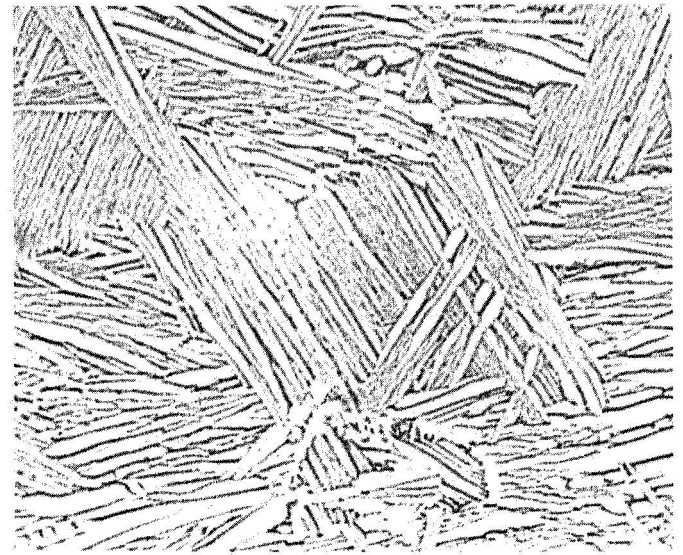
- (a) As-received
- (b) 1600°F Solution Heat Treatment, Air Quench
- (c) 1800°F Solution Heat Treatment, Air Quench
- (d) 2000°F Solution Heat Treatment, Air Quench

Figure 1. Microstructure of Ti-8Al-1Mo-1V Following Different Solution Heat Treatments. Etch: Kellers Reagent (600X Reduced 23% for Printing)

Heat treatments of Ti-8Al-1Mo-1V have been made at 1600°F, 1800°F, and heat treatments were conducted in vacuum in quartz tubes employing 10^{-4} or 10^{-6} torr. The microstructure of the as-received material and different vacuum heat treatments are shown in Figure 1.

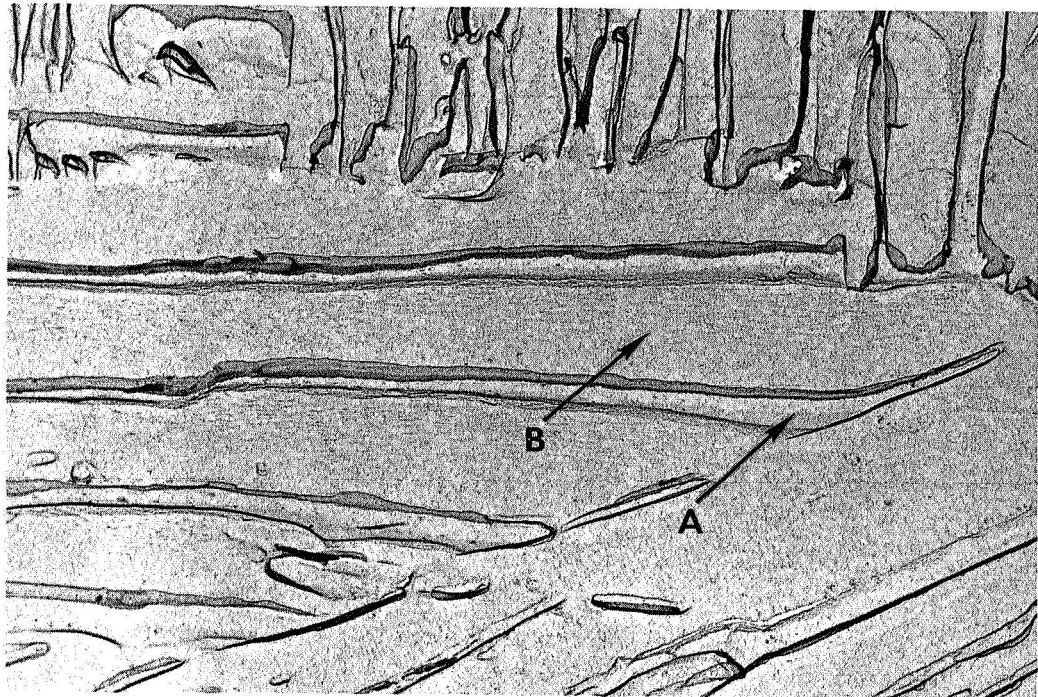
Figure 2. Electron Micrograph Illustrating the Fine Details of the Acicular Structure Shown in Figure 1d. Note (A) is retained beta, and (B) is martensitic alpha lamella. Magnification 11,500X

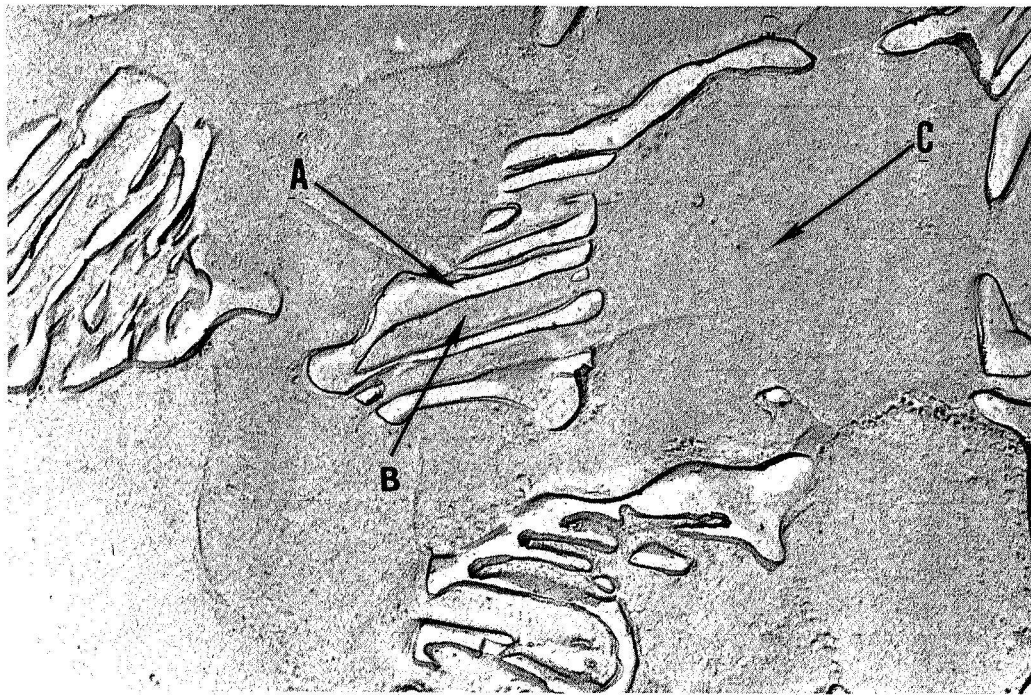
Figure 3. Electron Micrographs Illustrating the Islands of Acicular Structure of Retained Beta (A) and Martensitic Alpha (B) in Equiaxed Alpha Matrix (C) as in Figure 1c. Magnification 11,500X

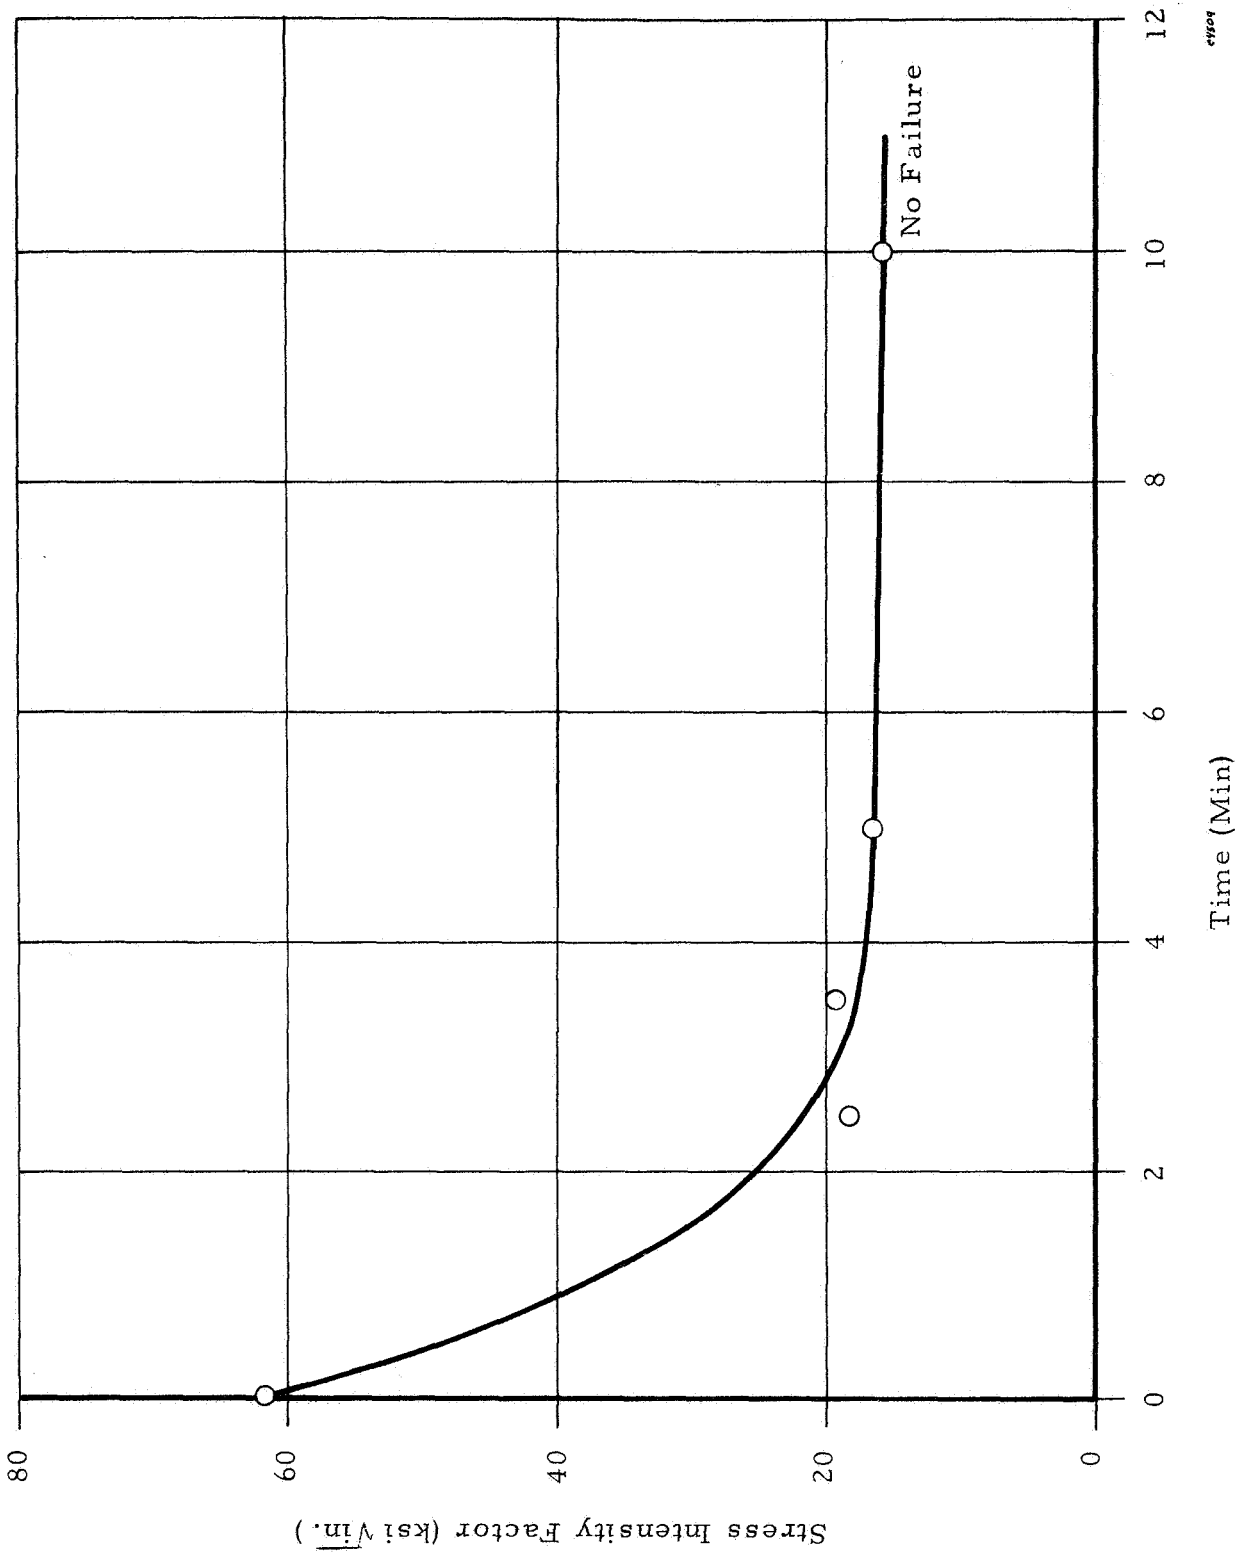
Figure 4. Effect of Stress Intensity on Time-to-Fracture for Ti-8Al-1Mo-1V, 1600°F Heat Treatment with 110 ppm Added H₂ in 3% NaCl Solution

For heat treatment of Ti-8Al-1Mo-1V at 1600°F in which 110 ppm of hydrogen was charged into the alloy, the value of initial stress intensity factor was plotted versus the time for fracture in Figure 4. An examination of the curve shows a minimum value of 16 ksi $\sqrt{\text{in.}}$ below which no stress corrosion failure is observed. This is designated K_{Isc} after Brown.⁽⁷⁾ Ti-8Al-1Mo-1V solution heat at 1800°F was immune to SCC with hydrogen contents as high as 100 ppm.

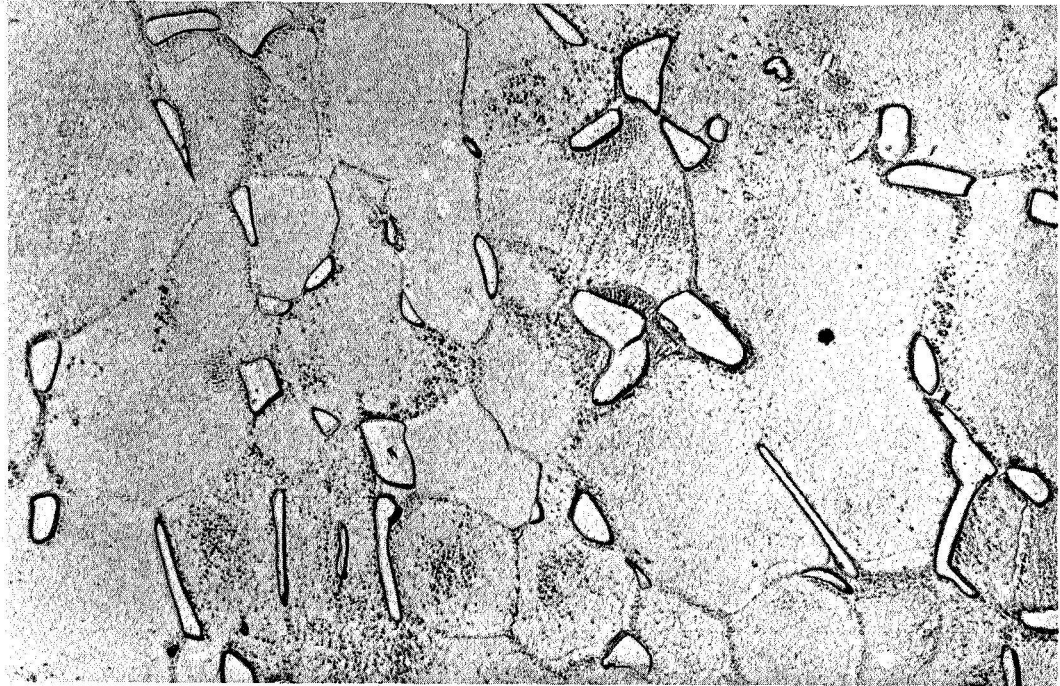
Figure 5. Electron Micrograph of Alloy Sample Solution-Annealed at 1800°F and Aged at 1450°F. Note partial spheroidization of beta particles. Magnification 4000X

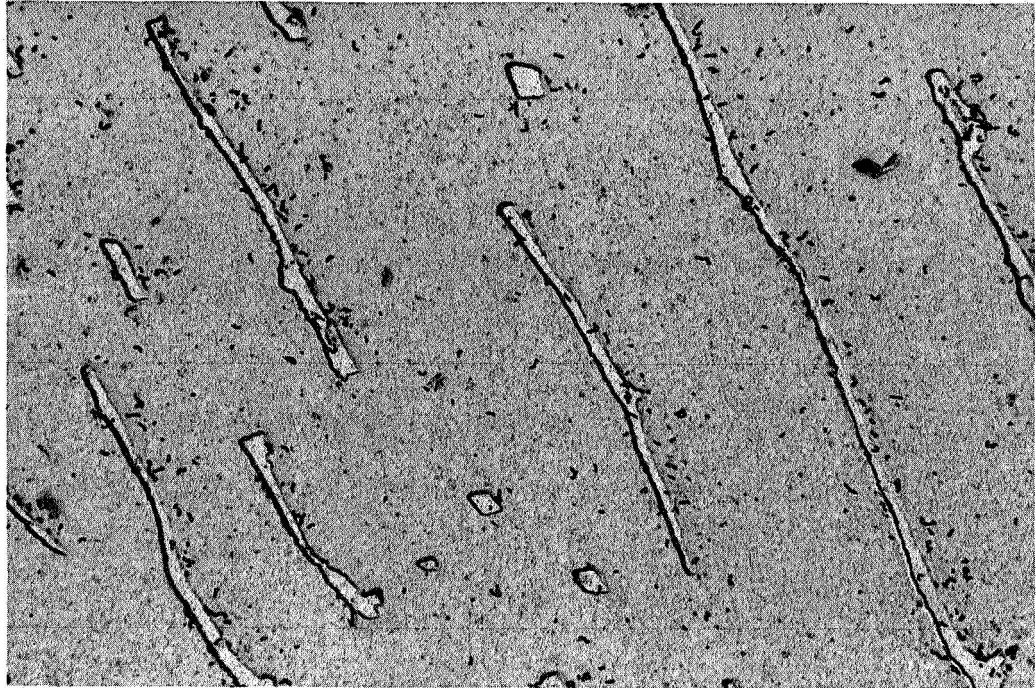
Figure 6. Microautoradiograph of Tritium in Ti-8Al-1Mo-1V, 2000°F, 2 Hours, A.Q. + 1600°F, 2 Hours, A.Q. Containing 13 ppm. Magnification 11,500X

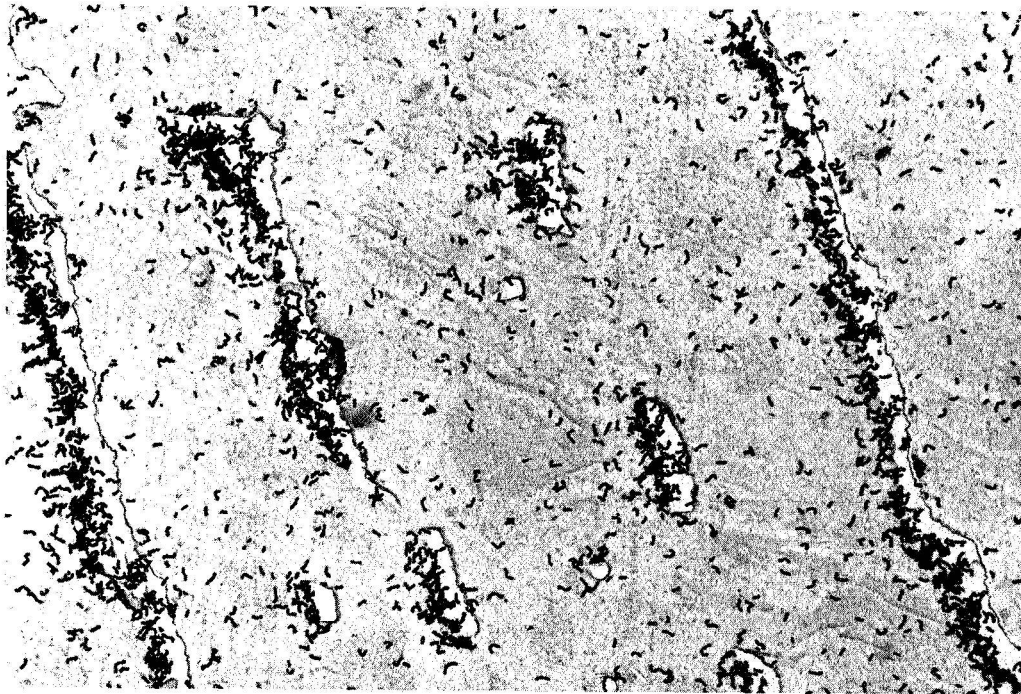
Figure 7. Microautoradiograph of Tritium in Ti-8Al-1Mo-1V, 2000°F, 2 Hours, A. Q. + 1600°F, 2 Hours, A. Q. Containing 40 ppm. Tritium is highly concentrated in beta phase and at alpha-beta boundaries. Magnification 11,500X

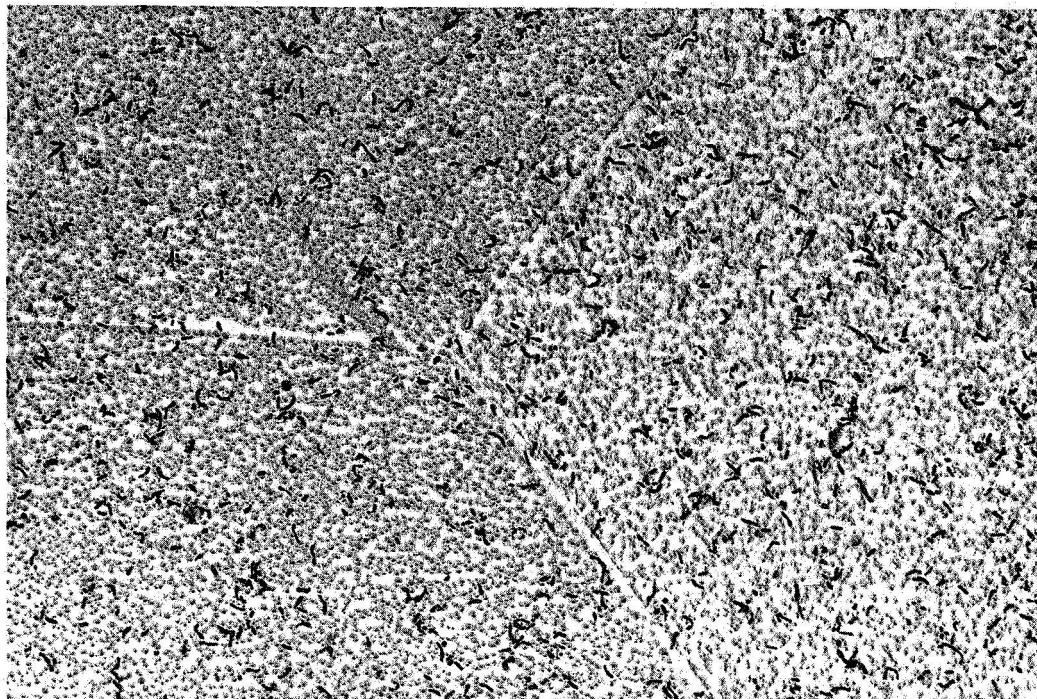
Figure 8. Microautoradiograph of Tritium in Ti-3.1Al.
Magnification 28,000X

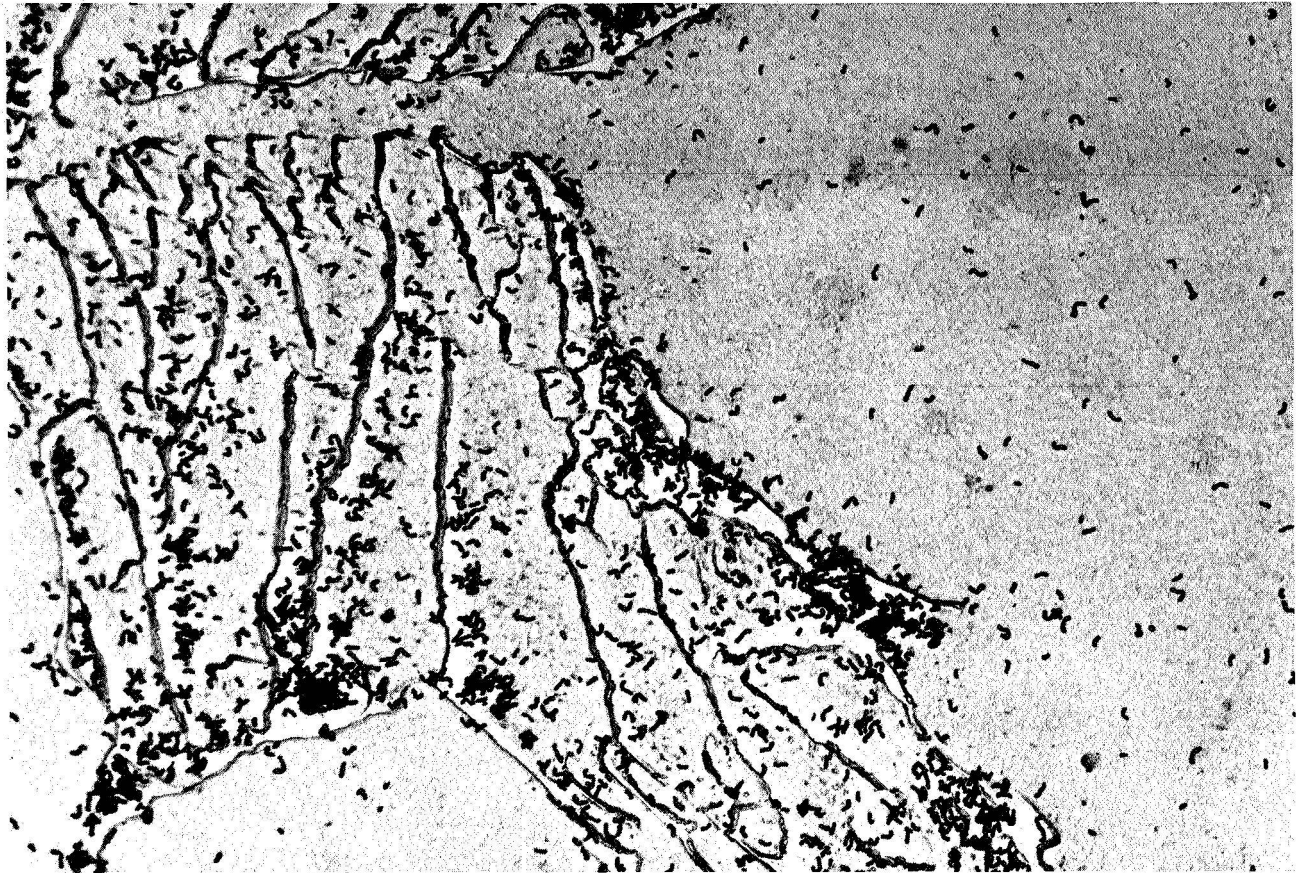
Figure 9. Electron Microautoradiograph of Ti-8Al-1Mo-1V Alloy Containing 40 ppm Tritium in 1800°F Solution Annealed Condition. Note concentration of tritium in alpha-beta boundaries and in beta-martensitic alpha regions. Magnification 11,500X

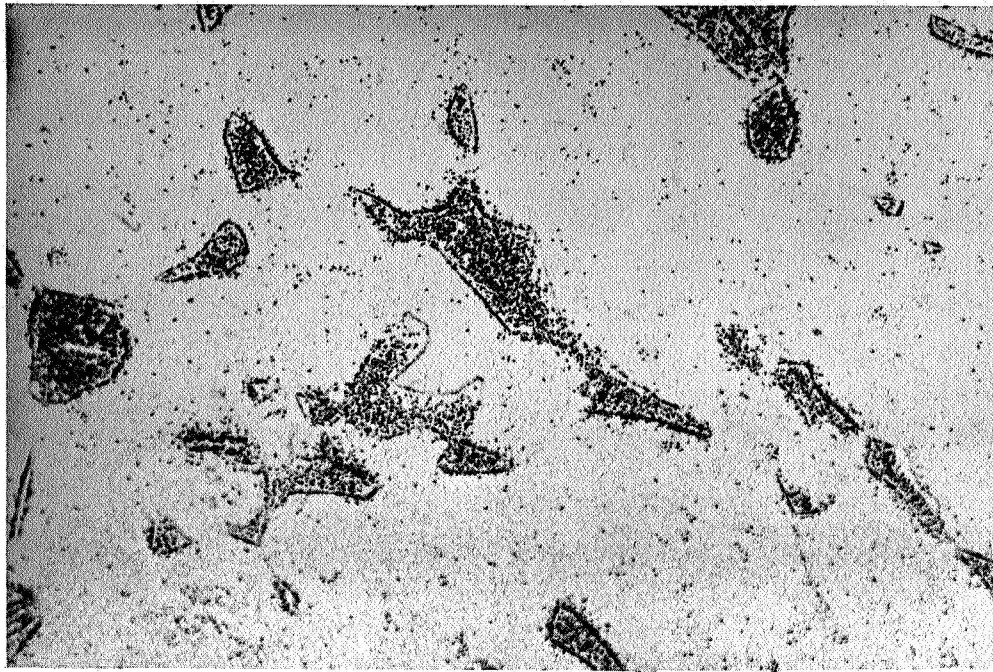
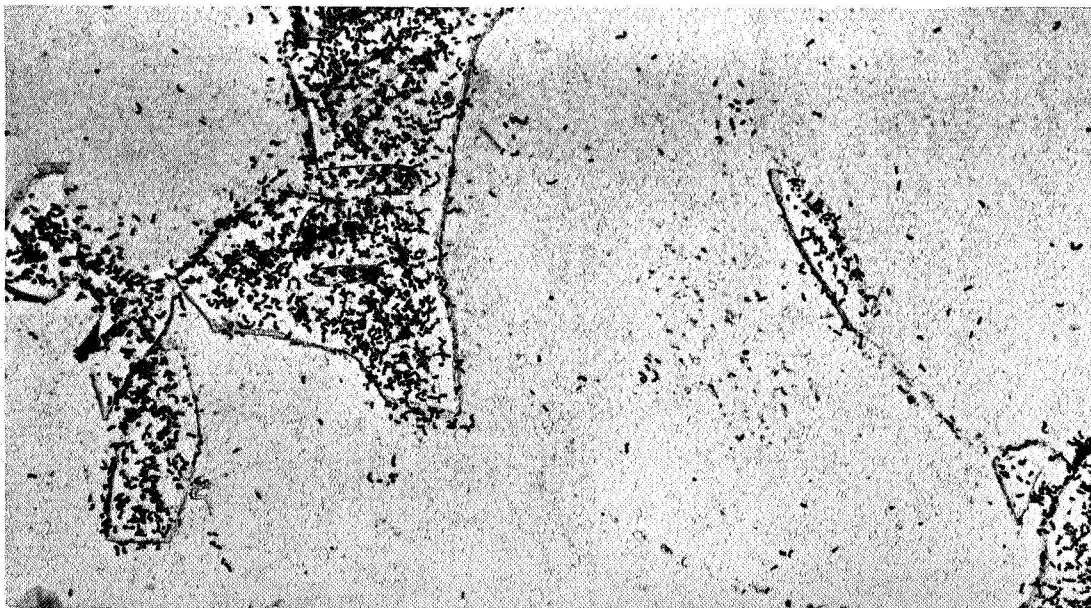
Figure 10. Electron Microautoradiograph of Tritium in Ti-8Al-1Mo-1V Alloy Solution Annealed at 1800°F and Stabilized at 1450°F, Then Tritium Charged at 1450°F. Note tritium is concentrated in spheroidized beta.

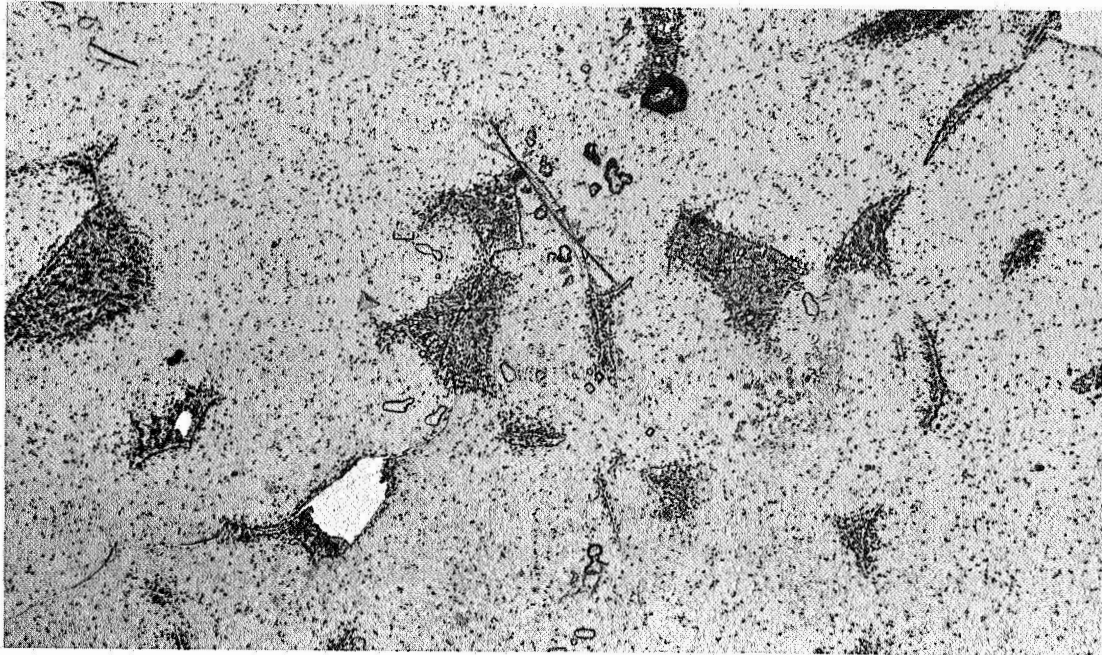
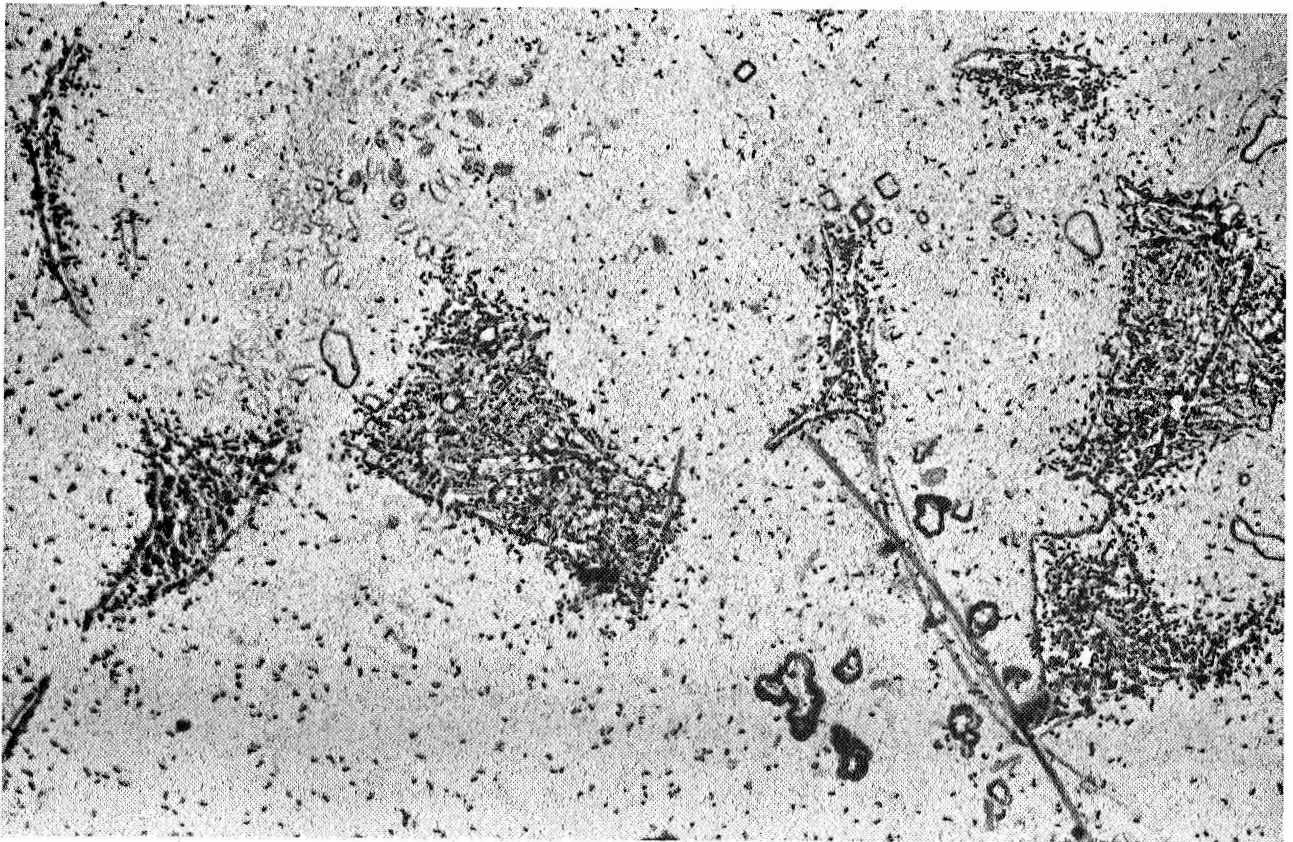
Figure 11. Electron Microautoradiograph of Tritium in Ti-8Al-1Mo-1V Alloy Solution Annealed at 1800°F and Aged at 900°F, Then Tritium Charged at 900°F. Note, the tritium is concentrated in acicular martensitic islands.

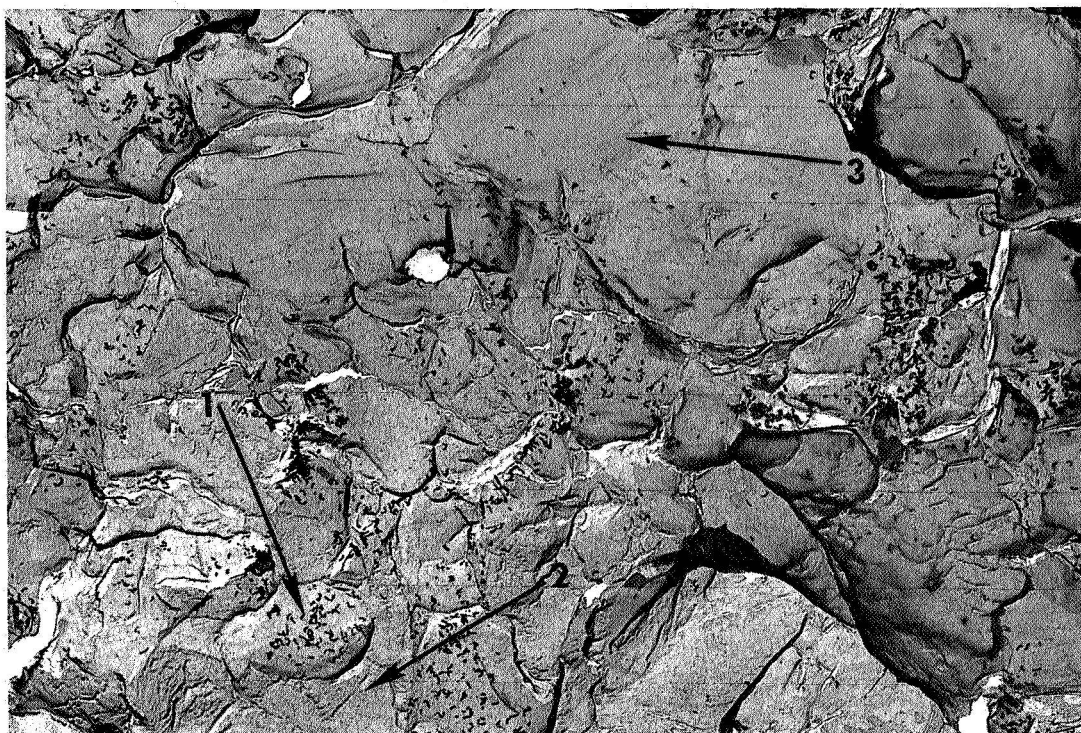
Figure 12. Electron Microautoradiograph Illustrating Tritium Segregation in Fractured Beta Grain Surface of Ti-6Al-4V Alloy, 30 ppm Tritium Gas Charged and Fractured in Air. Note tritium containing beta phase (1), cleavage regions with river patterns (2), and ductile glide region (3). Magnification 6,000X

A single-edge notch specimen of Ti-6Al-4V which had been previously charged with 30 ppm tritium was fractured in air and used to check the technique described above. A microautoradiograph of the fractured surface is shown in Figure 12. The tritium segregation in the beta phase is clearly seen.

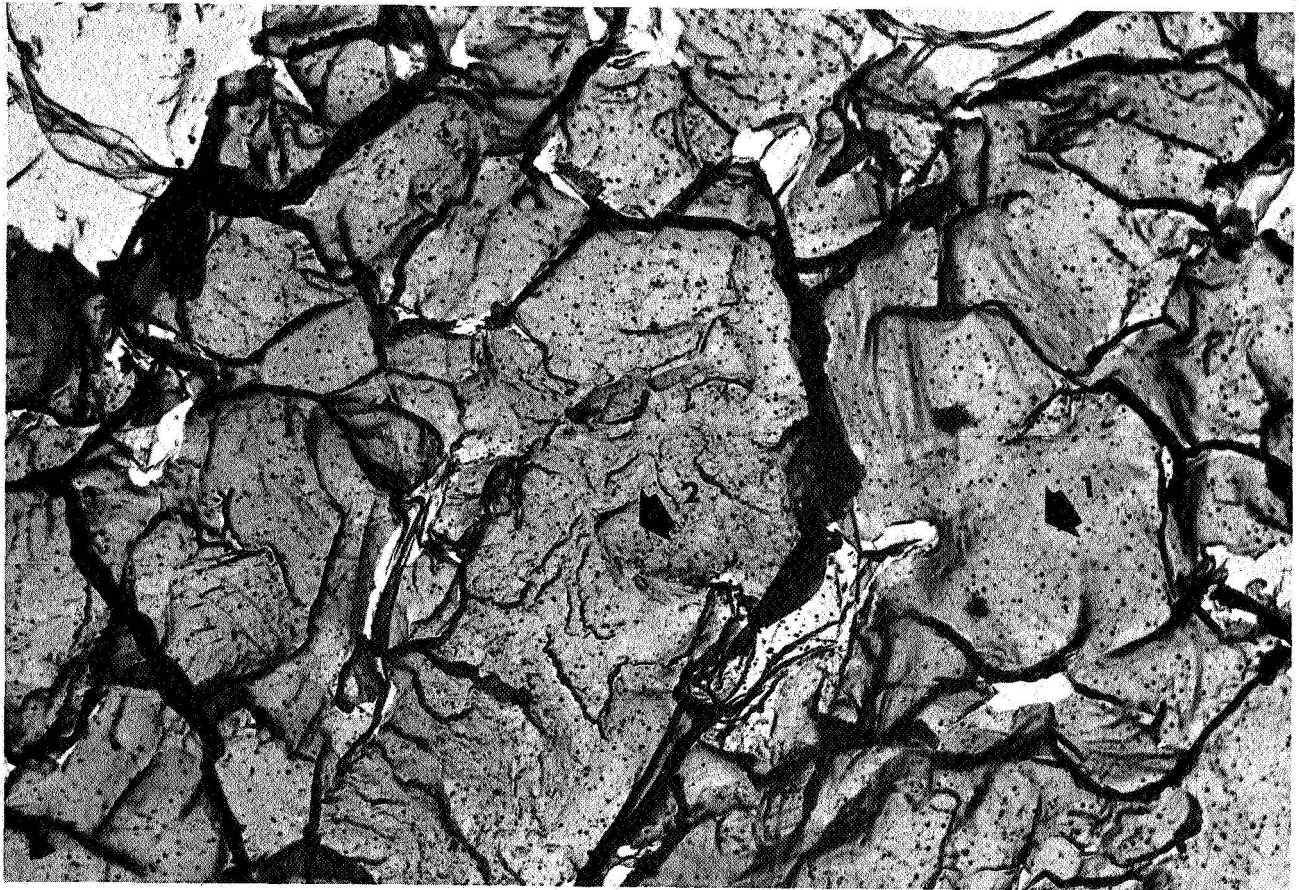
Figure 13. Electron Microautoradiograph of Ti-8Al-1Mo-1V Alloy, Duplex Annealed, Fracture Face Stress Corrosion Cracked in 2% Tritiated Water. Note ductile glide region, arrow 1, and cleavage region, arrow 2, and absence of tritium. Magnification 12,000X

Figures 13 and 14 show microautoradiographs of fractured surfaces of single-edge notch specimens of Ti-8Al-1Mo-1V (duplex annealed) which were stress corrosion cracked in distilled water and 3% NaCl, respectively. Figure 15 shows a microautoradiograph of a fractured surface Ti-8Al-1Mo-1V, solution heat-treated at 1600°F, 2 hours, AQ, fractured in 3% NaCl.

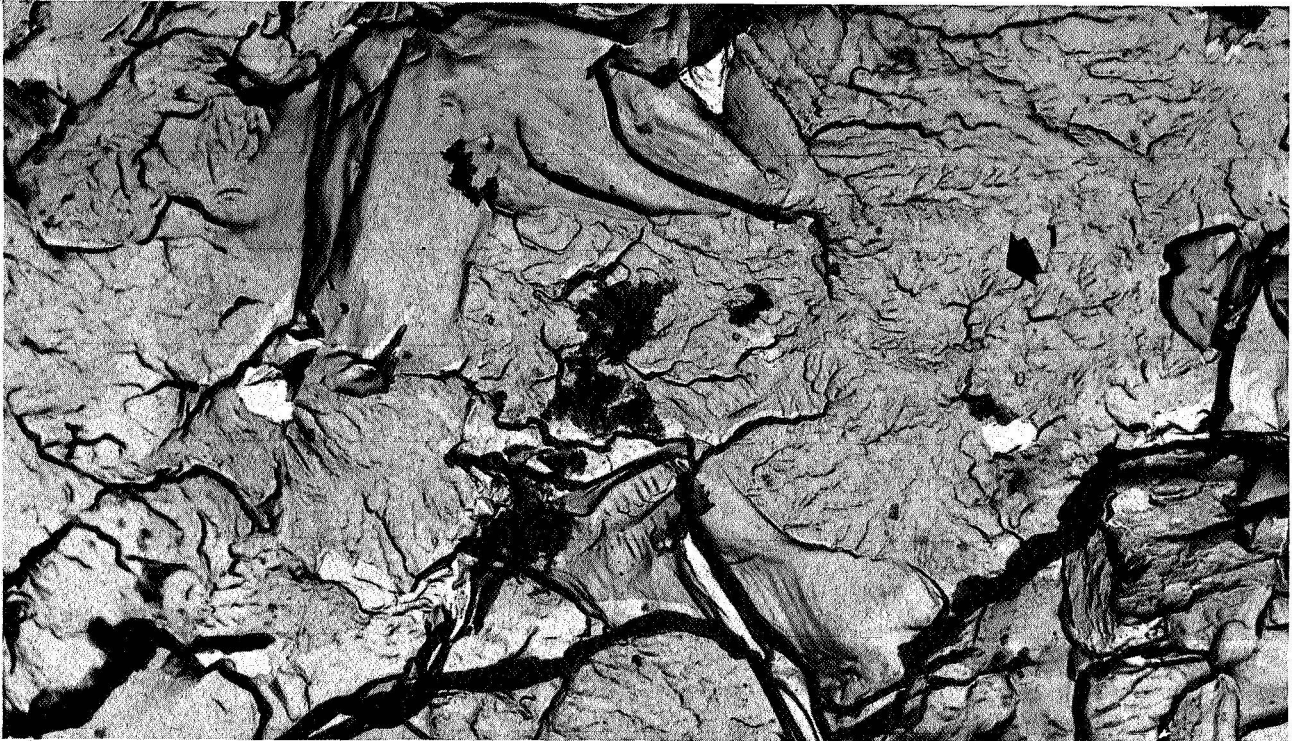
Figure 14. Electron Microautoradiograph of Ti-8Al-1Mo-1V Alloy, Duplex Annealed, Fracture Face Stress Corrosion Cracked in 3% Aqueous Salt Solution with 2% Tritiated Water. Note cleavage region, arrow 1 and absence of tritium. Magnification 1200X

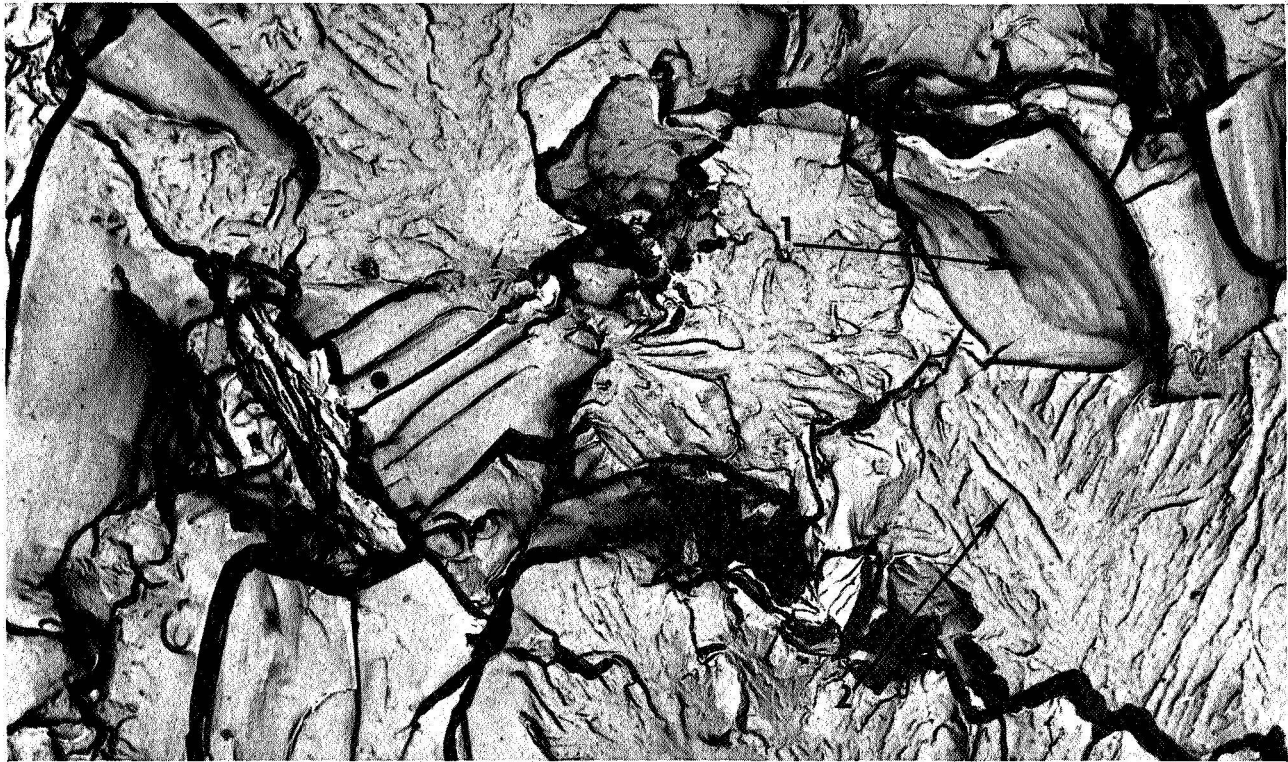
Figure 15. Electron Microautoradiograph of Ti-8Al-1Mo-1V Alloy, 1600°F Solution Annealed, Fracture Face Stress Corrosion Cracked in 3% Aqueous Salt Solution with 2% Tritiated Water. Note ductile glide region, Arrow 1, and cleavage region, Arrow 2, and absence of tritium. Magnification 12,000X

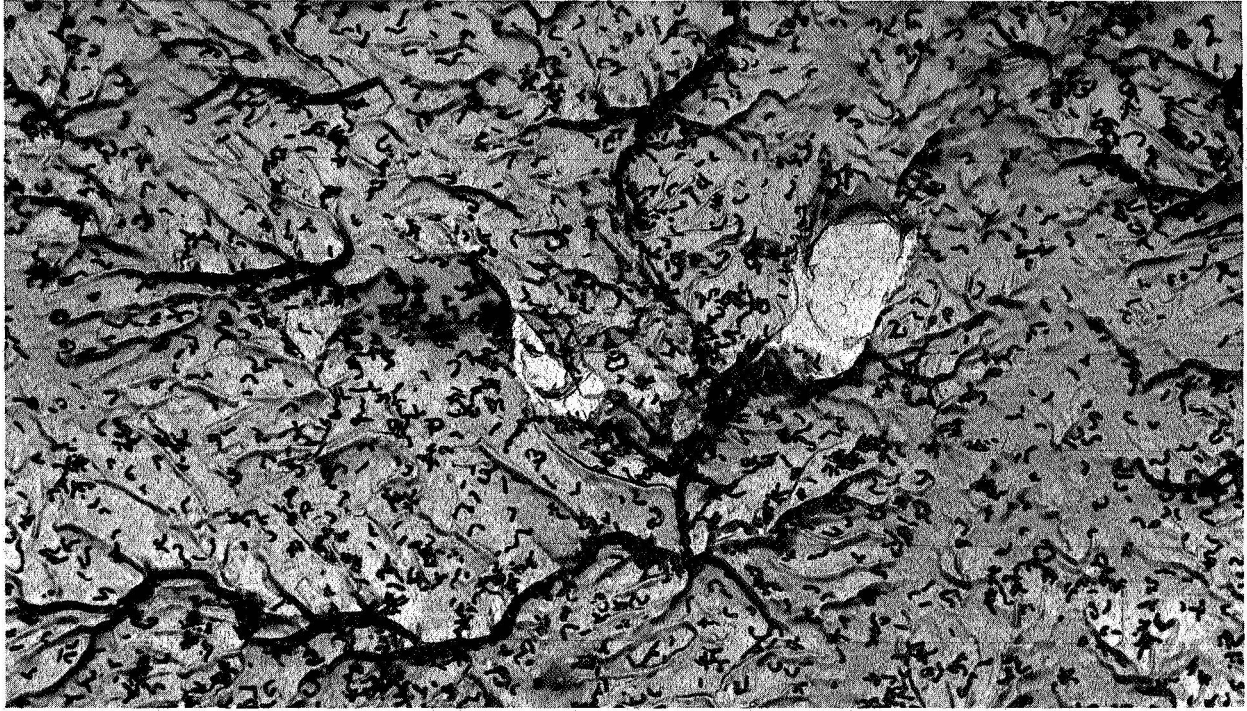
Figure 16. Electron Microautoradiograph of 5 Al-2.5
Charged with 40 ppm Tritium at 1450°F,
Fracture Face Stress Corrosion Cracked in
3% Aqueous Salt Solution. 18000X

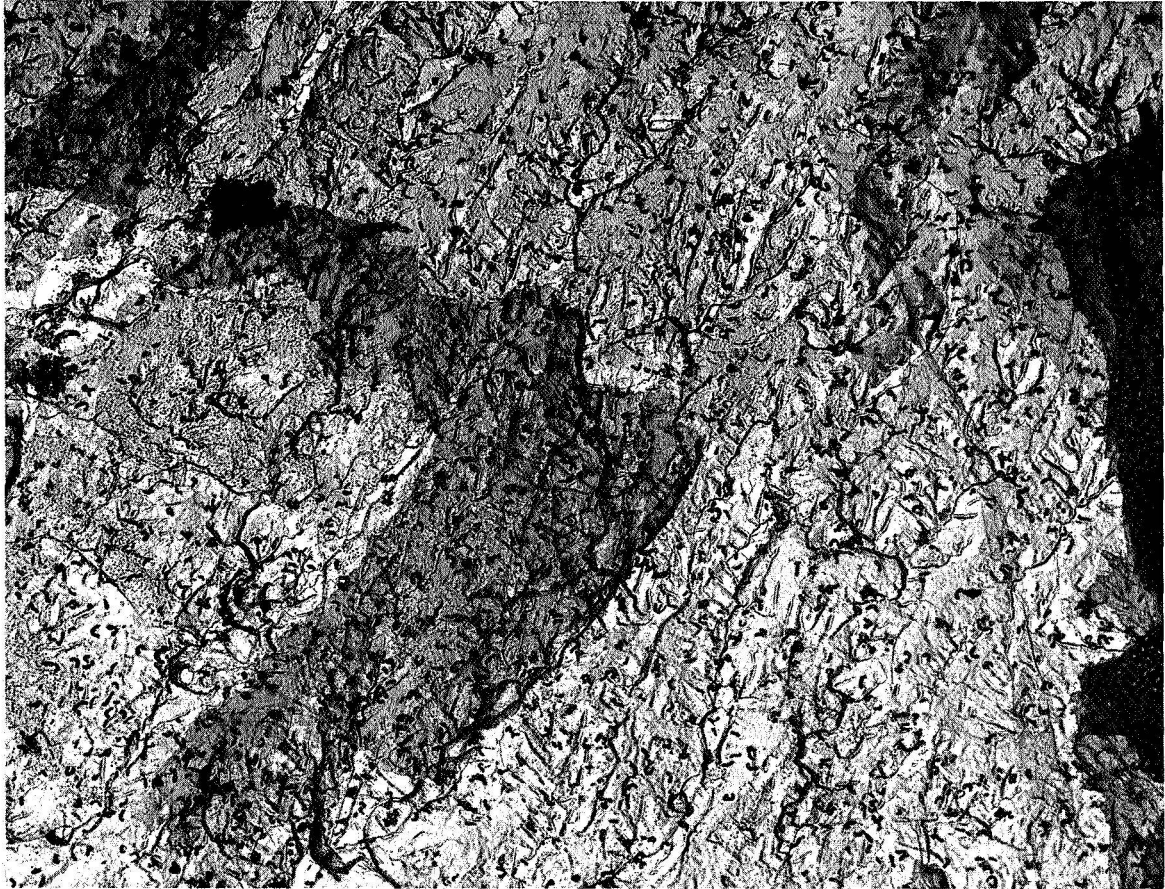
Figure 17. Electron Microautoradiograph of Ti-8Al, Charged with 30 ppm of Tritium at 1450°F, Fracture Face Stress Corrosion Cracked in 3% Aqueous Salt Solution. 12000X

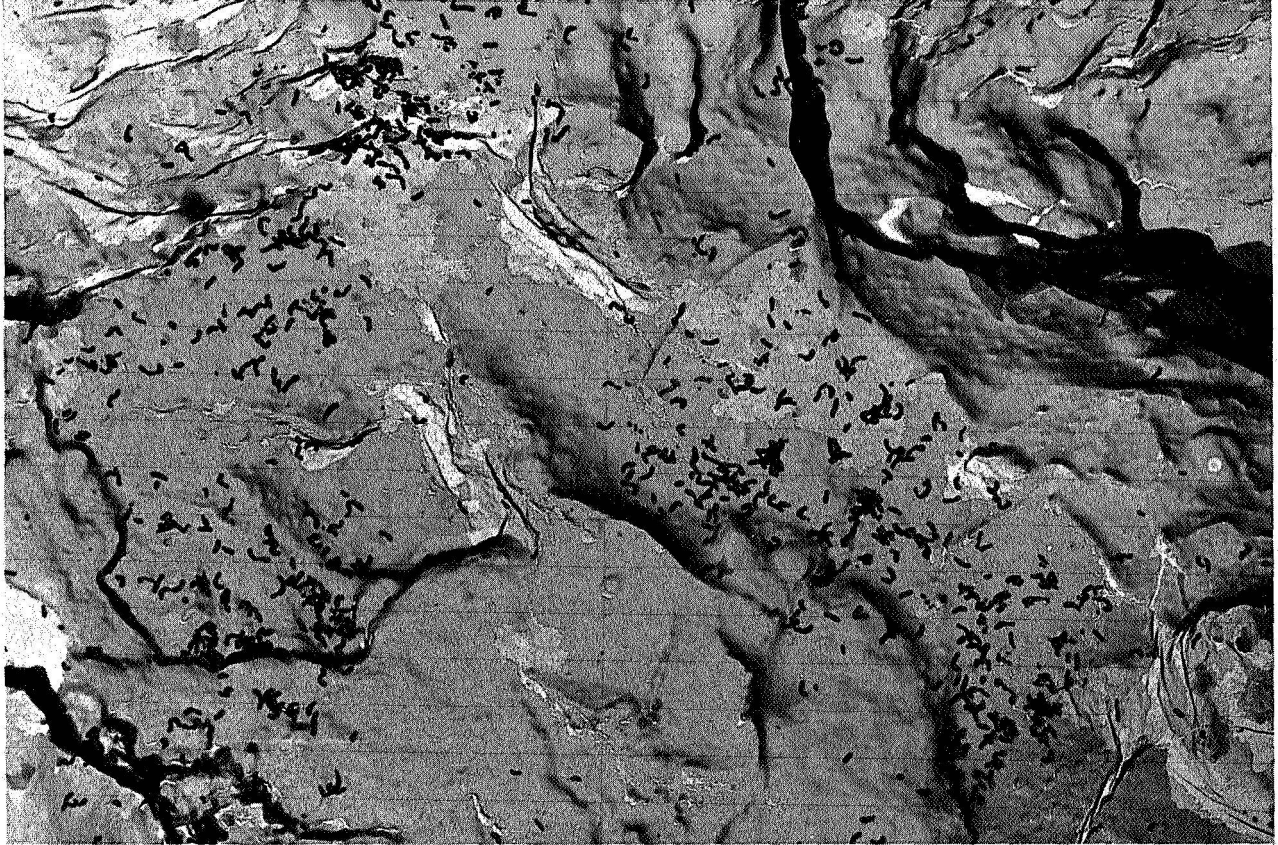
Figure 18. Electron Microautoradiograph of Ti-8Al-1Mo-1V, Charged with 30 ppm Tritium at 1450°F, Fracture Face Stress Corrosion Cracked in 3% Aqueous Salt Solution. 18000X

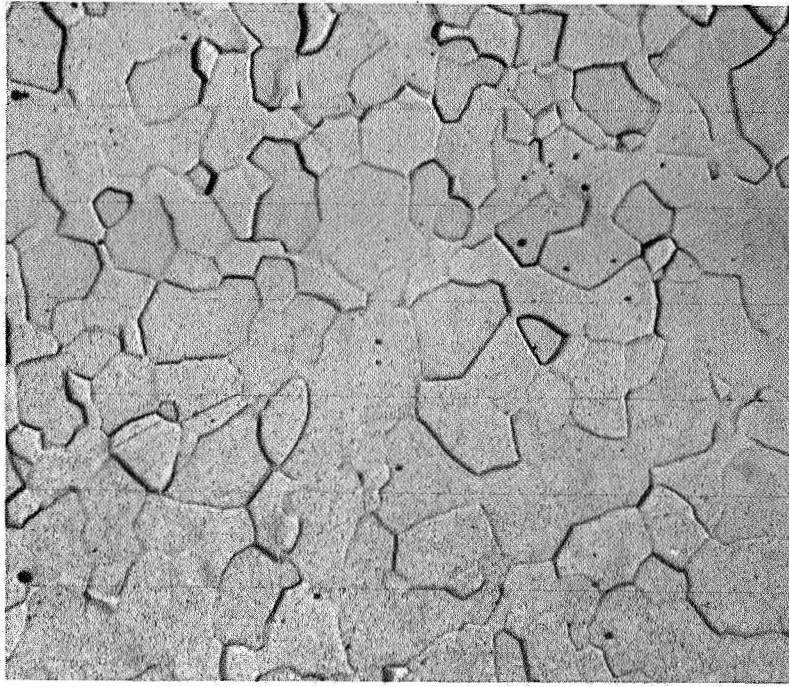
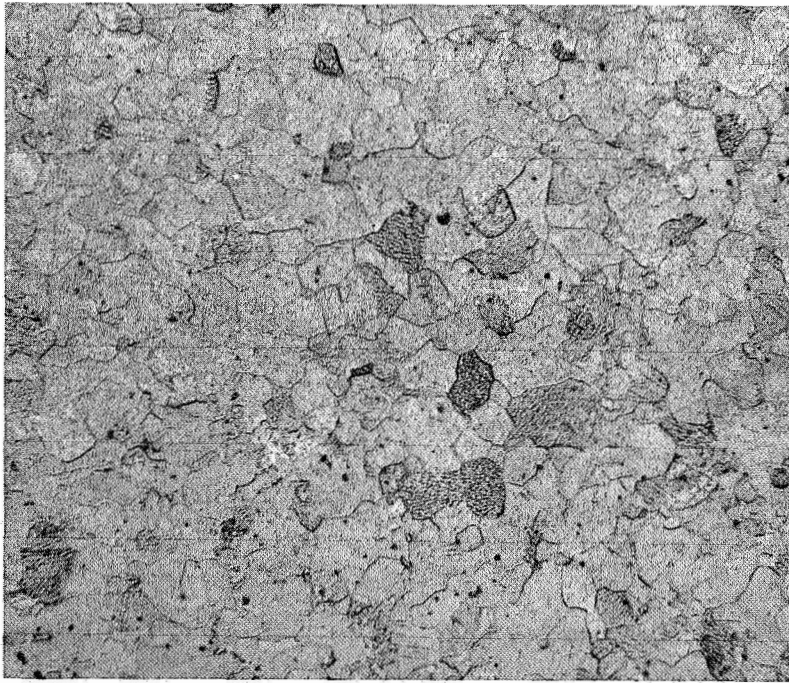
(a) Ti-4Al

Figure 19. Microstructure of Titanium-Aluminum Alloys
Magnification 200X

Alpha titanium alloys Ti-4Al and Ti-8Al and a near alpha alloy Ti-8Al-1Mo sheet were obtained from a program at Battelle Memorial Institute. The alloys were given a six-hour vacuum anneal at 1450^oF to remove hydrogen. For Ti-4Al and Ti-8Al the hydrogen and oxygen impurity levels were determined as 26 ppm H₂, 0.74 w/o O₂, and 8 ppm H₂, 0.76 w/o O₂ respectively. The microstructure of these alpha alloys is shown in Figure 19. The mechanical properties of the Ti-4Al and Ti-8Al are shown in Table V.

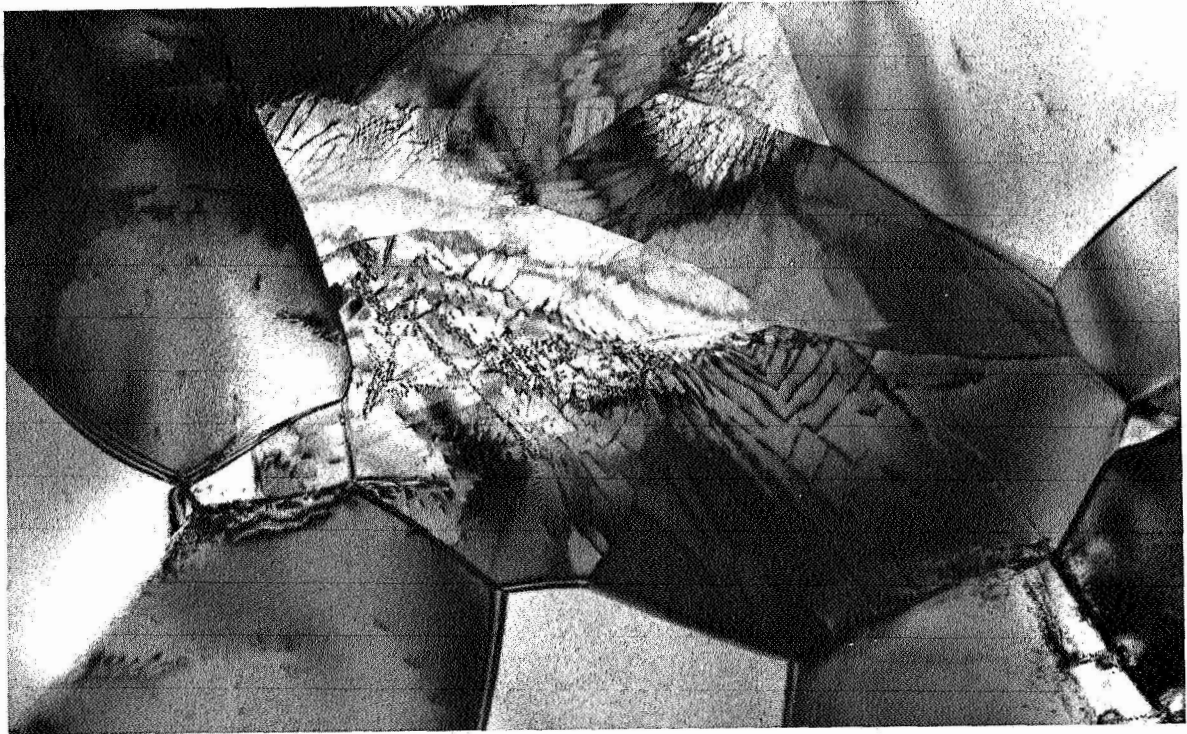
Figure 20. Transmission Electron Micrograph of Ti-8Al-1Mo-1V, Duplex Annealed. 28,000X
