DOUGLAS REPORT SM-49105-F2

STRESS CORROSION CRACKING OF TITANIUM
ALLOYS AT AMBIENT TEMPERATURE
IN AQUEOUS SOLUTIONS

YEARLY SUMMARY REPORT
JULY 1967 THROUGH JUNE 1968
UNDER CONTRACT NAS 7-488

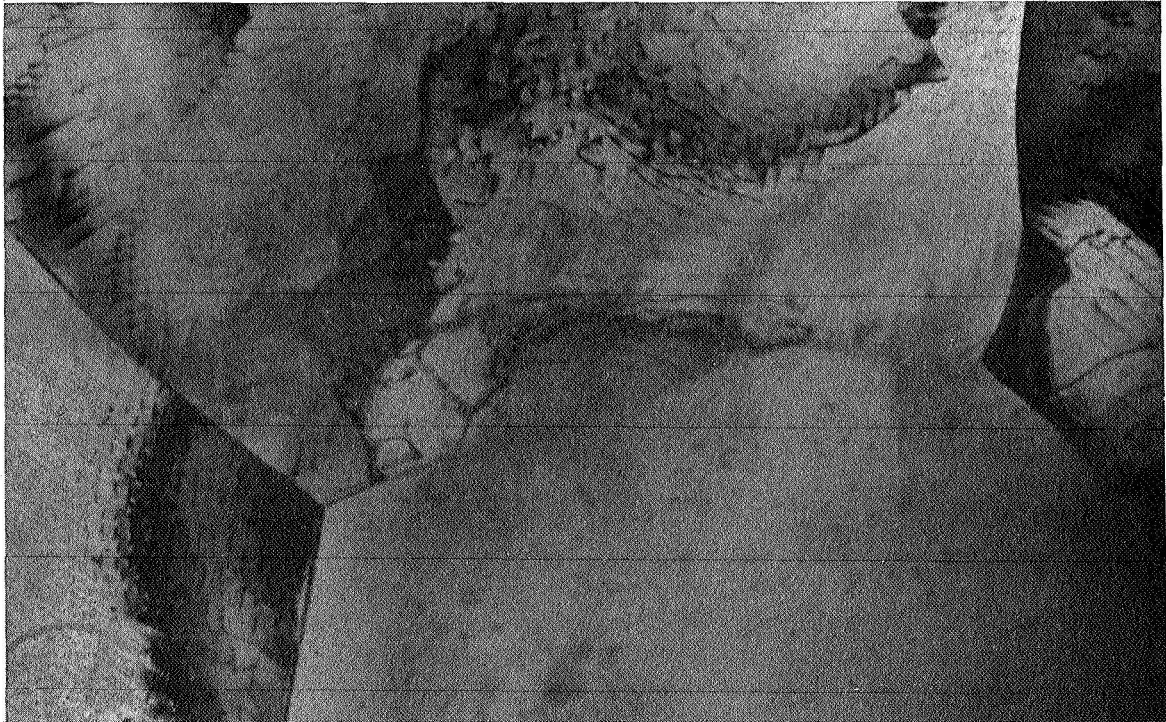
Figure 21. Transmission Electron Micrograph of Ti-6Al-4V. 28,000X

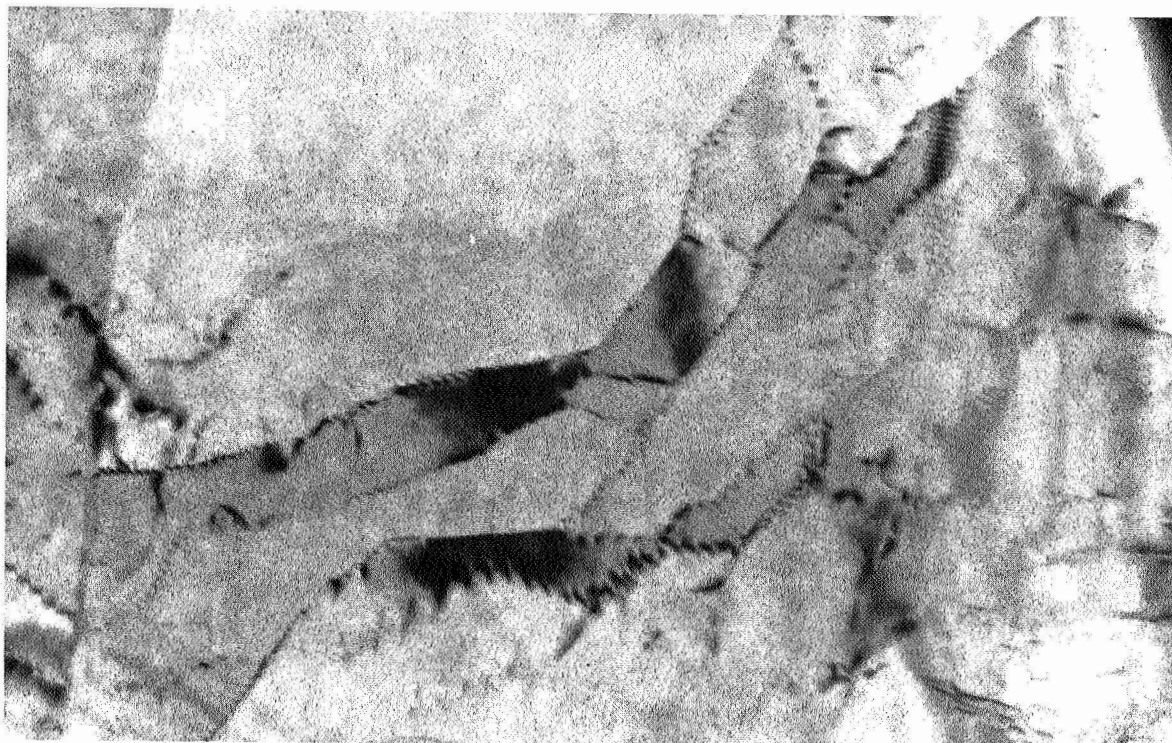
Figure 22. Transmission Electron Micrograph of
Ti-5Al-2.5Sn. 28,000X

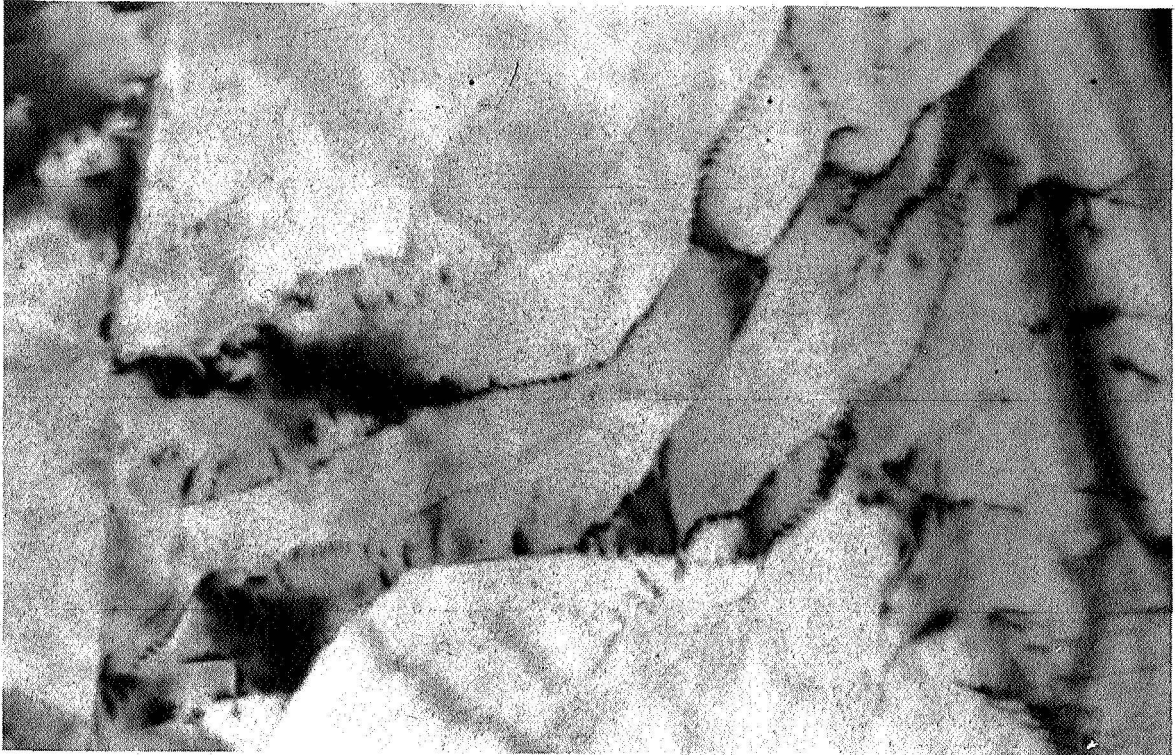
Figure 23. Transmission Electron Micrograph of Ti-5Al-2.5Sn Following Stress and 2-Minute Immersion in 5% NaCl Solution. 28,000X

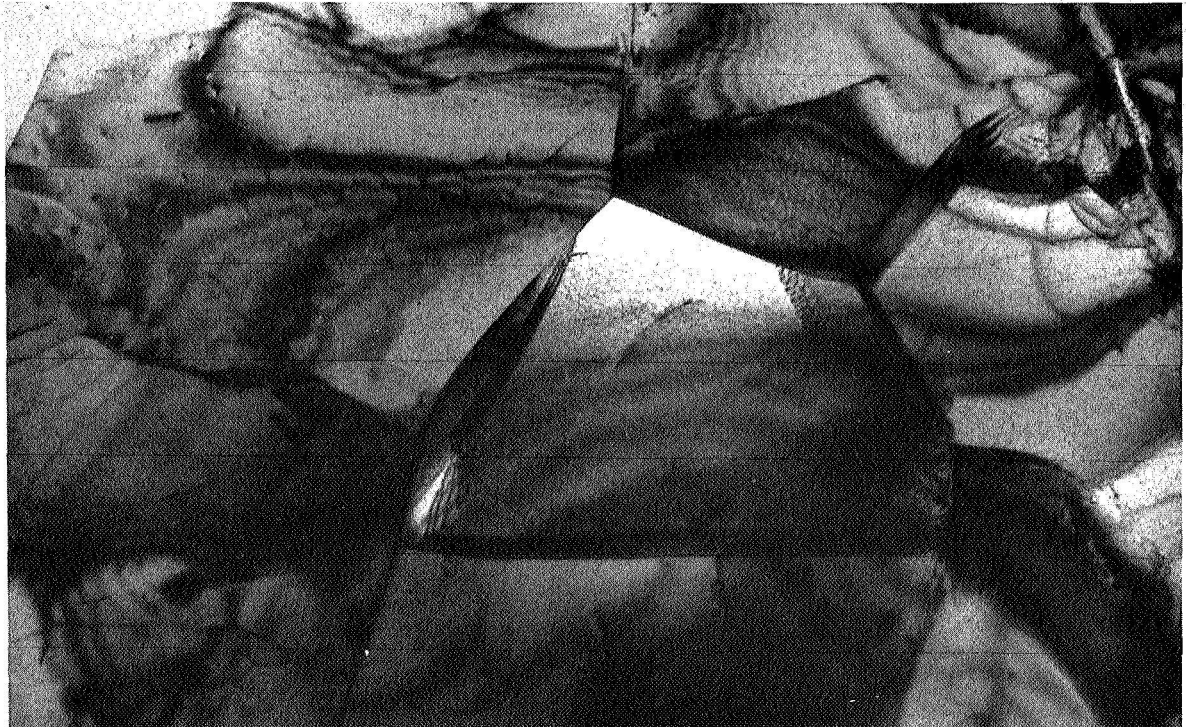
Figure 24. Transmission Electron Micrograph of Ti-8Al-1Mo-1V Following Stress and 8-Minute Immersion in 5% NaCl Solution. 28,000X

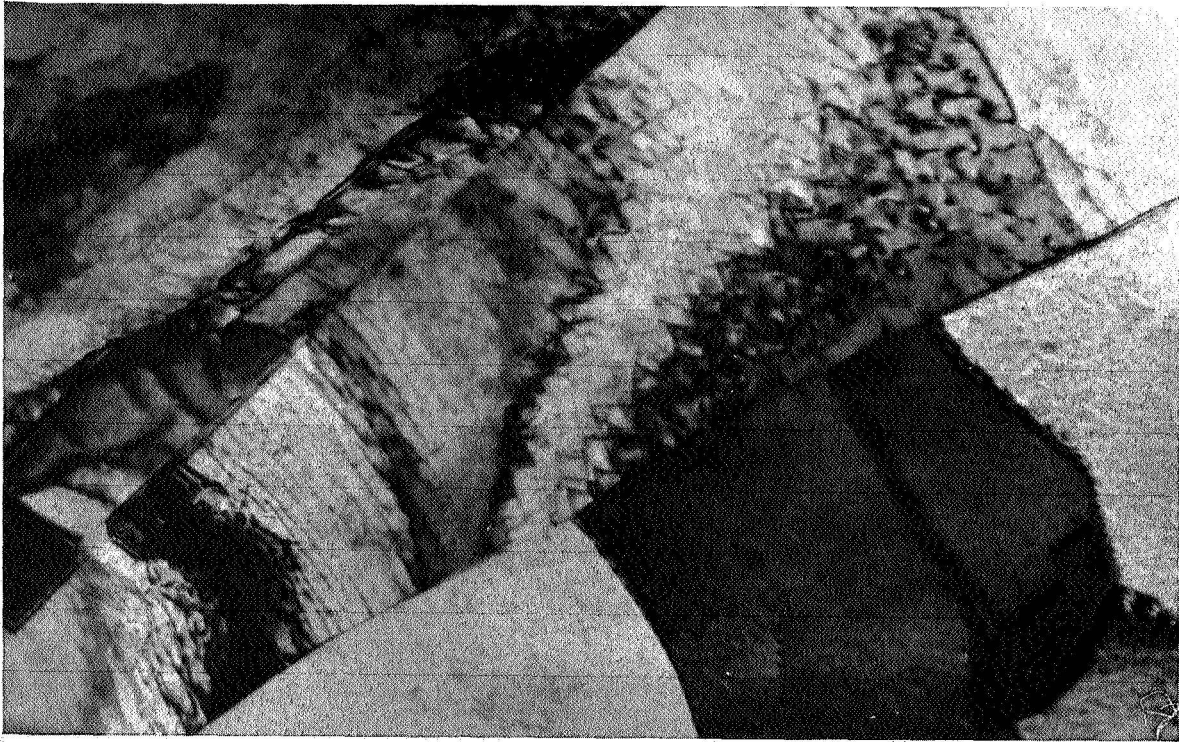
Figure 25. Transmission Electron Micrograph of Stressed Ti-6Al-4V Following Stress and 45-Minute Immersion in 5% NaCl Solution. 28,000X

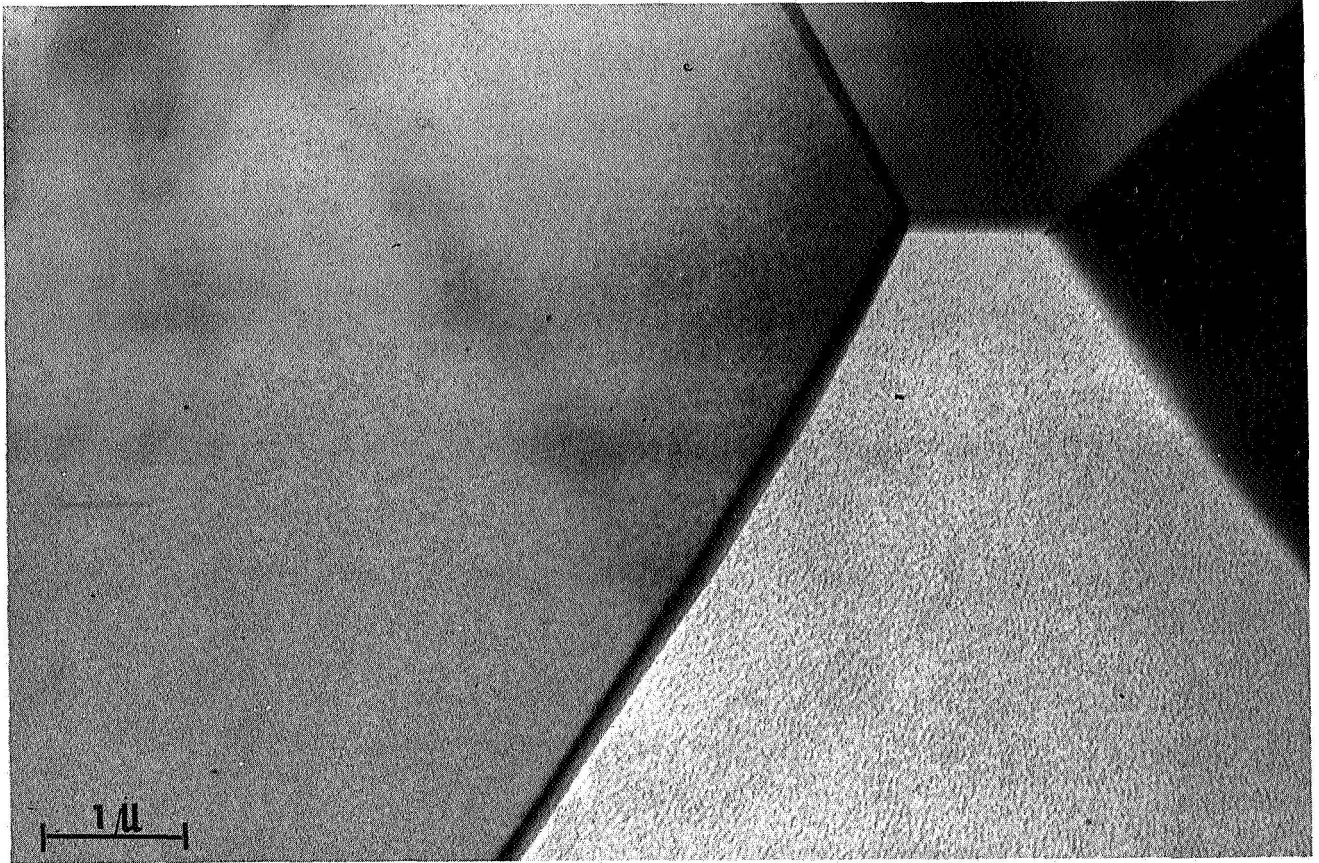
Figure 26. Transmission Electron Micrograph of Annealed Ti-4Al Alloy. Note Dislocation Free Structure.

Figures 26 and 27 show transmission electron micrograph of annealed Ti-4Al and Ti-8Al respectively. The dislocation free alpha alloy is typical for both Ti-4Al and Ti-8Al. Figures 28 and 29 show dislocation tangles for Ti-4Al which had been deformed approximately 10%. Figure 30 shows dislocation arrangement in Ti-8Al following 10% deformation. The planar groups of dislocation are typical for this alloy in disordered state. The dislocation arrangement for Ti-8Al-1Mo-1V duplex annealed with approximately 15% strain is shown in Figures 31 and 32. The planar dislocation arrangement in alpha phase of Ti-8Al-1Mo-1V duplex annealed was similar to Ti-8Al alloy. Figure 33 shows transmission electron micrograph of dislocation free Ti-8Al-1Mo-1V beta annealed from 2000°F. The dislocation arrangement for this alloy when deformed approximately 5% is shown in Figure 34. The planar dislocation arrangement in acicular martensitic alpha phase is pinned by the retained beta phase. Figure 35 shows transmission electron micrograph at approximately 8% deformation; slip is observed across several grains of retained beta and martensitic alpha phase. This type of slip is also observed in script type islands of Ti-8Al-1Mo-1V quenched from 1800°F (see Figure 36).

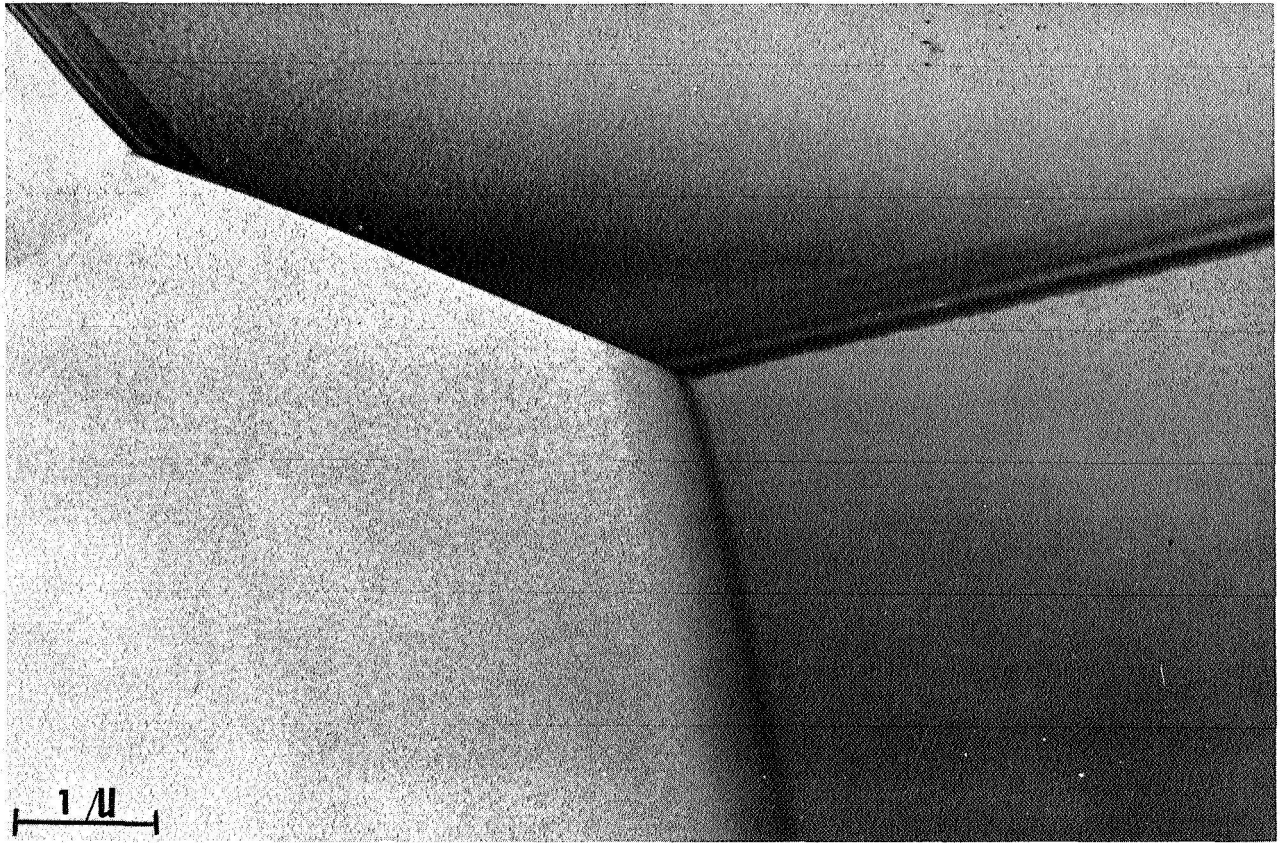
Figure 27. Transmission Electron Micrograph of Annealed Ti-8Al Alloy. Note Dislocation Free Structure.

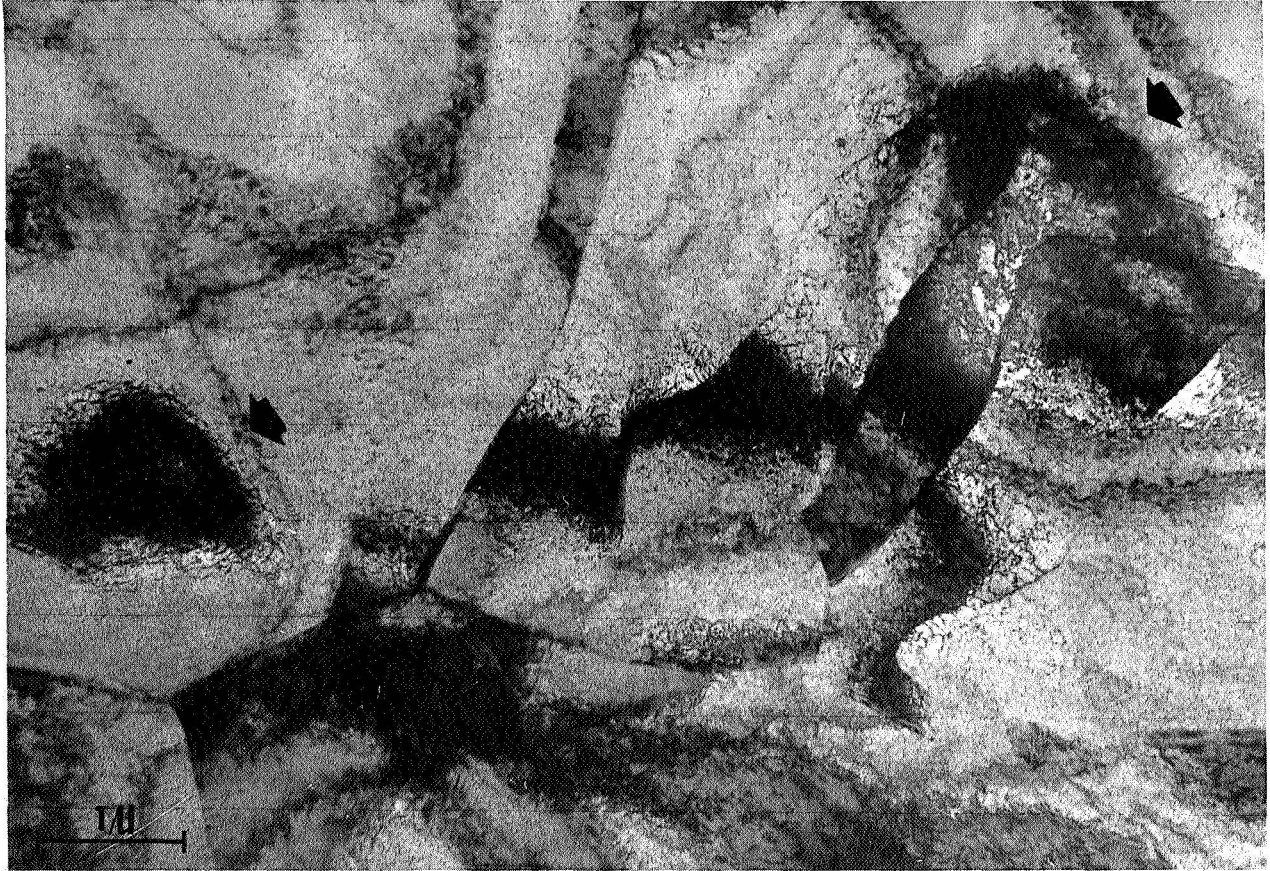
Figure 28. Transmission Electron Micrograph of Ti-4Al Strained Approximately 10%. Note Dislocation Tangles - Arrows.

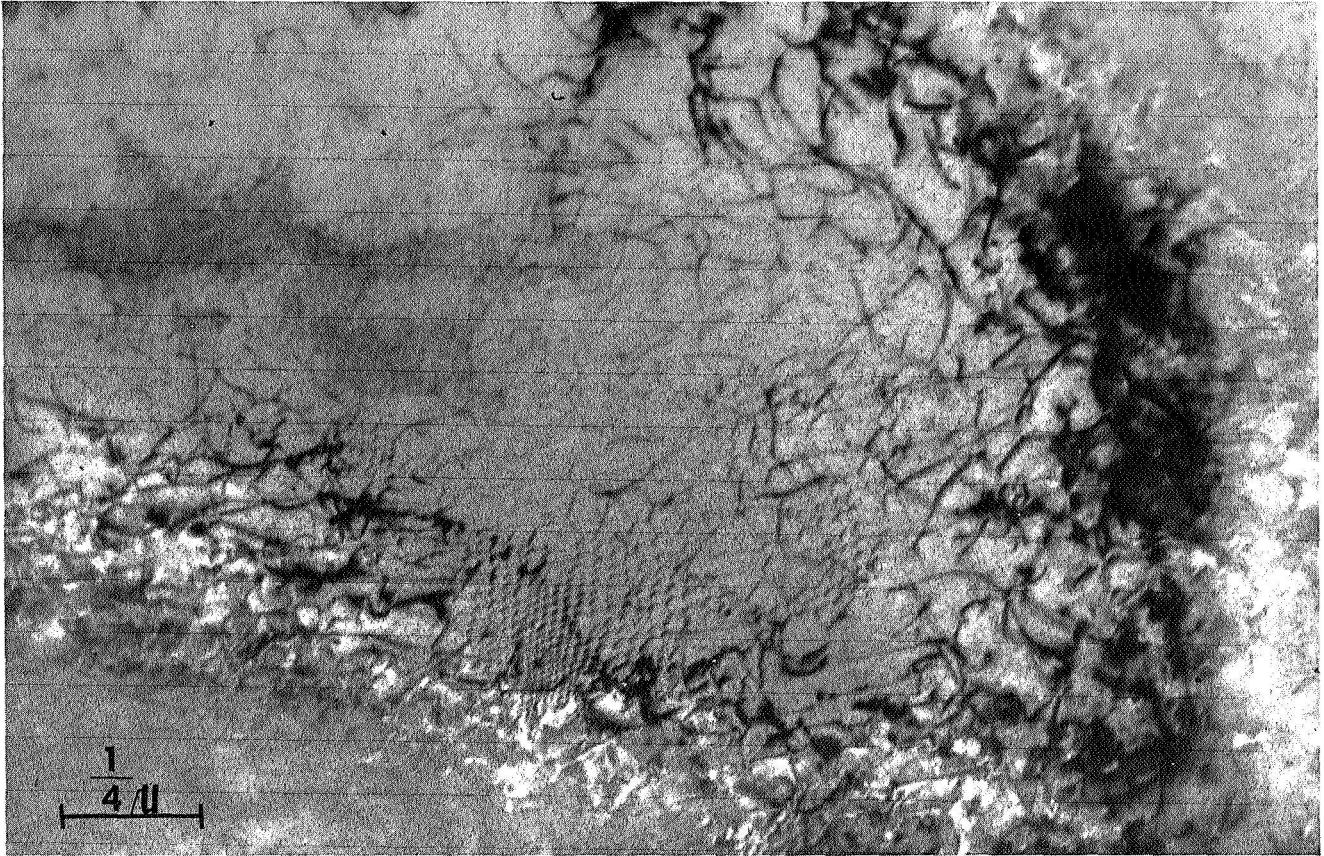
Figure 29. Transmission Electron Micrograph of Ti-4A Strained Approximately 10%. Note Dislocation Tangles.

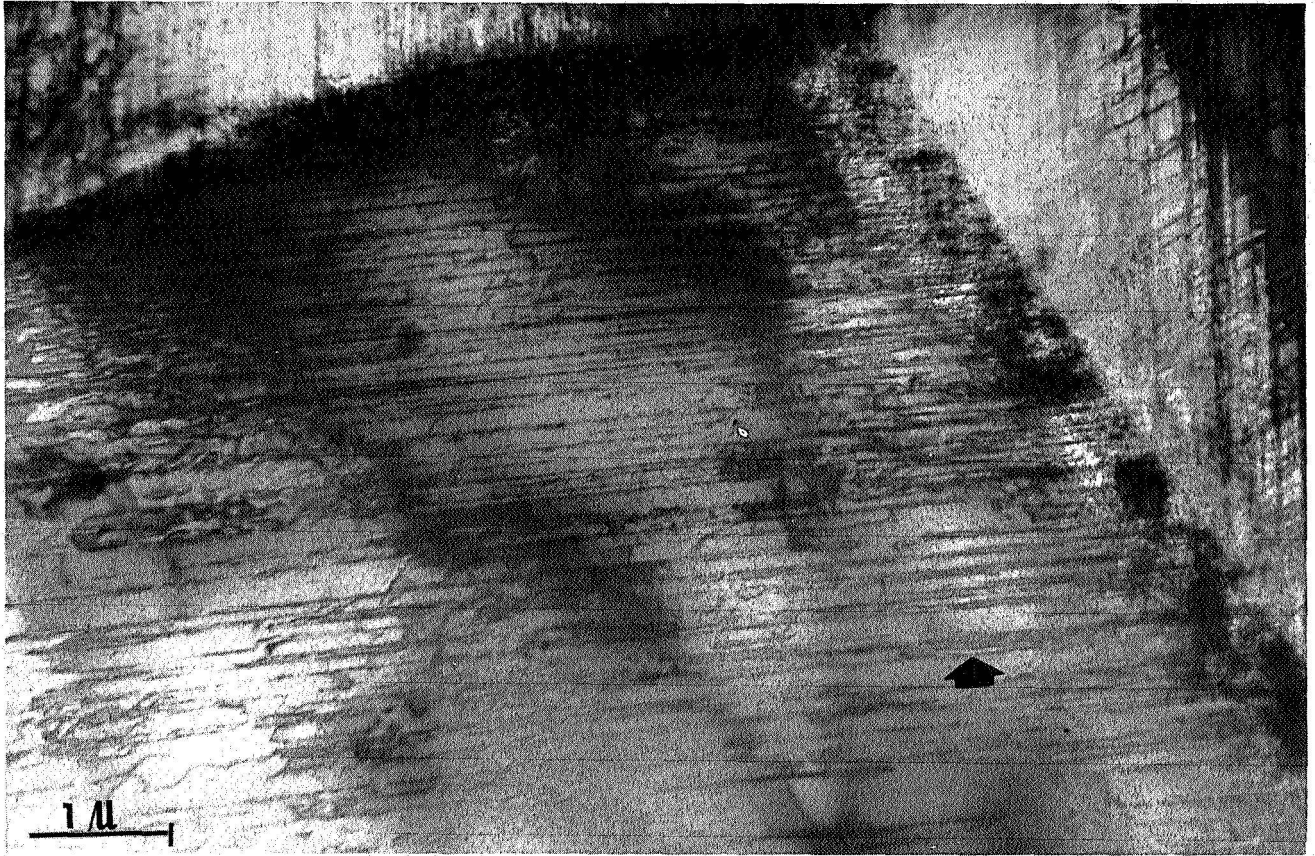
Figure 30. Transmission Electron Micrograph of Ti-8Al Deformed Approximately 10%. Note Slip Planes - Arrow.

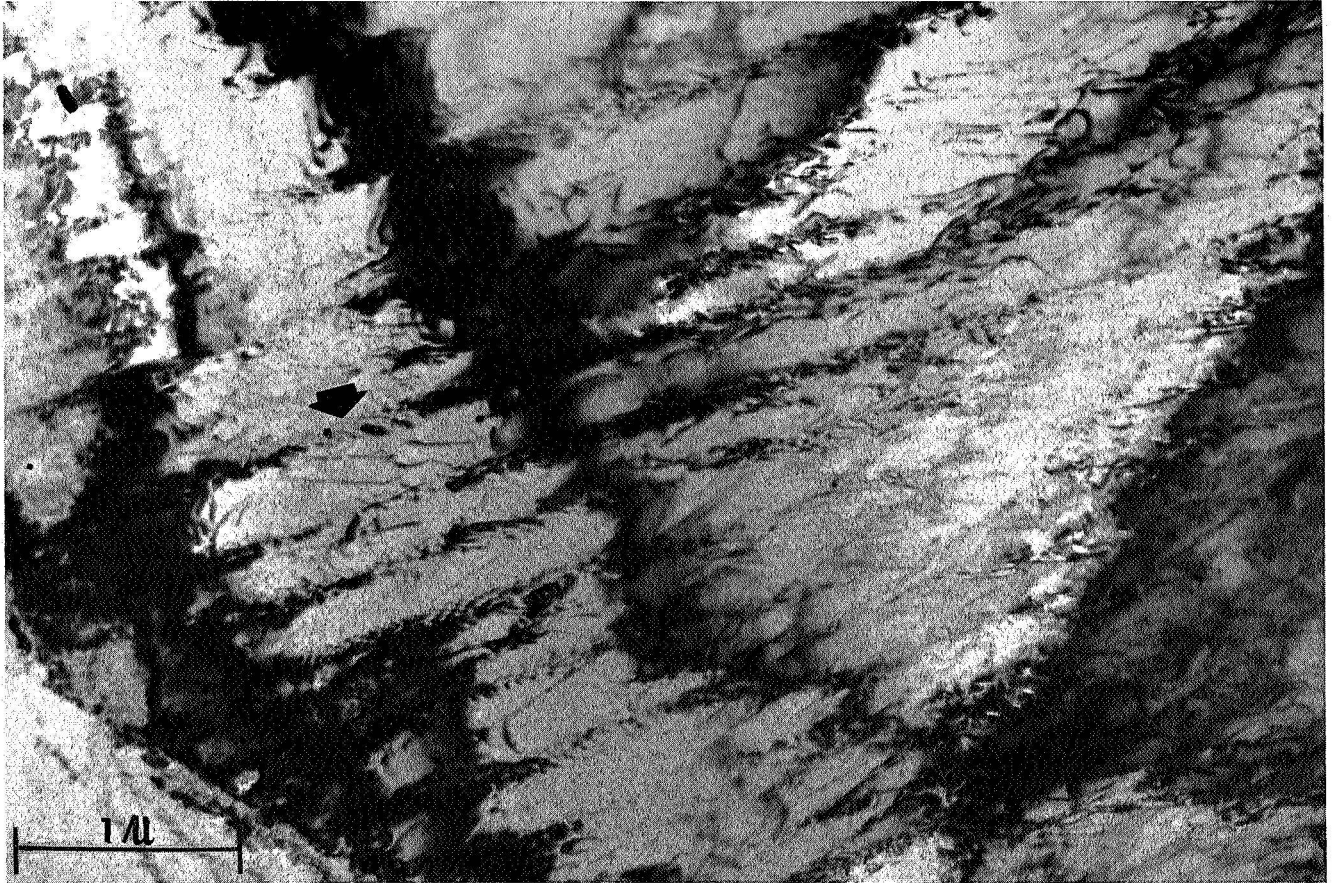
Figure 31. Transmission Electron Micrograph of Ti-8Al-1Mo-1V Duplex Annealed, Strained Approximately 15%. Note Slip Planes - Arrow.

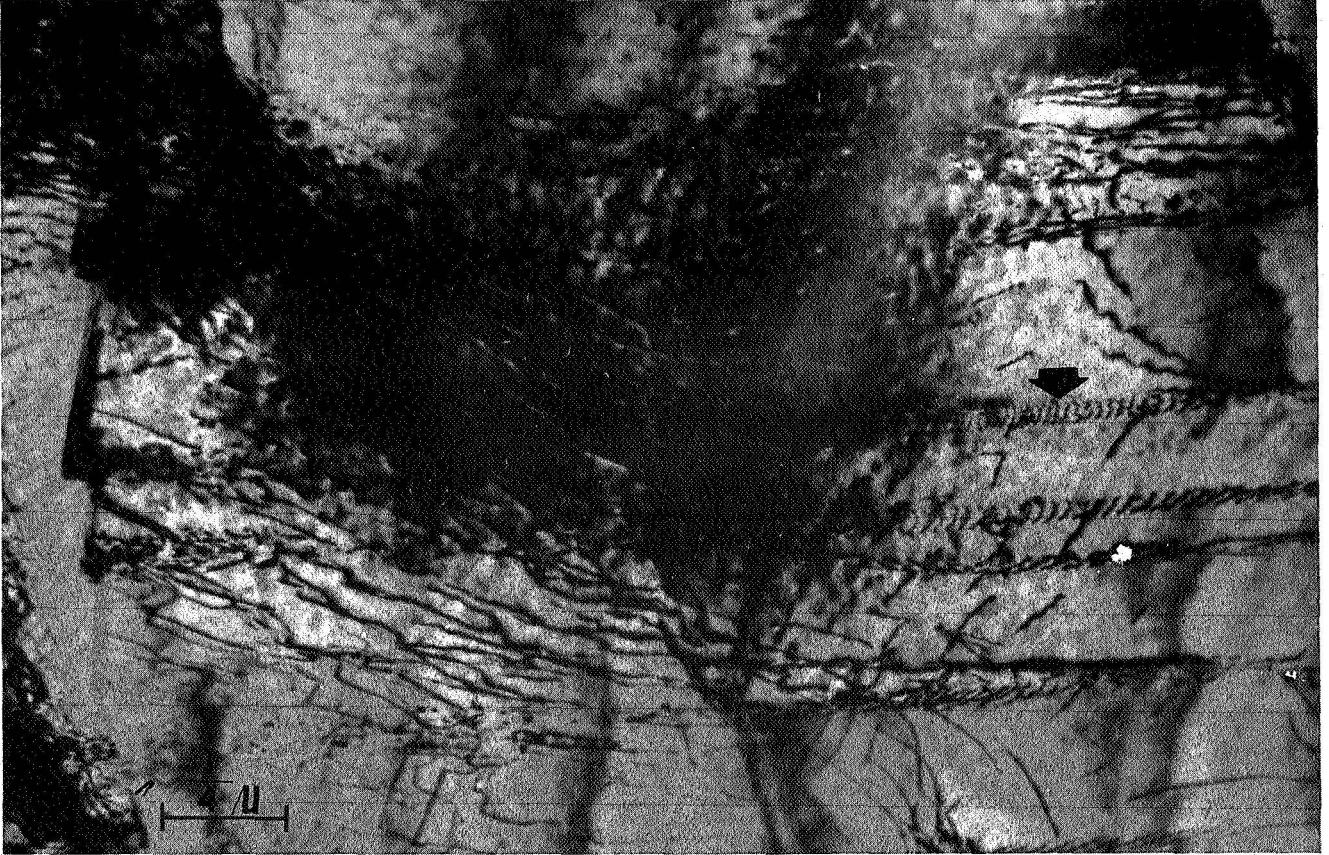
Figure 32. Transmission Electron Micrograph of Ti-8Al-1Mo-1V Duplex Annealed Strained Approximately 15%. Note Coplanar Array of Dislocations - Arrow.

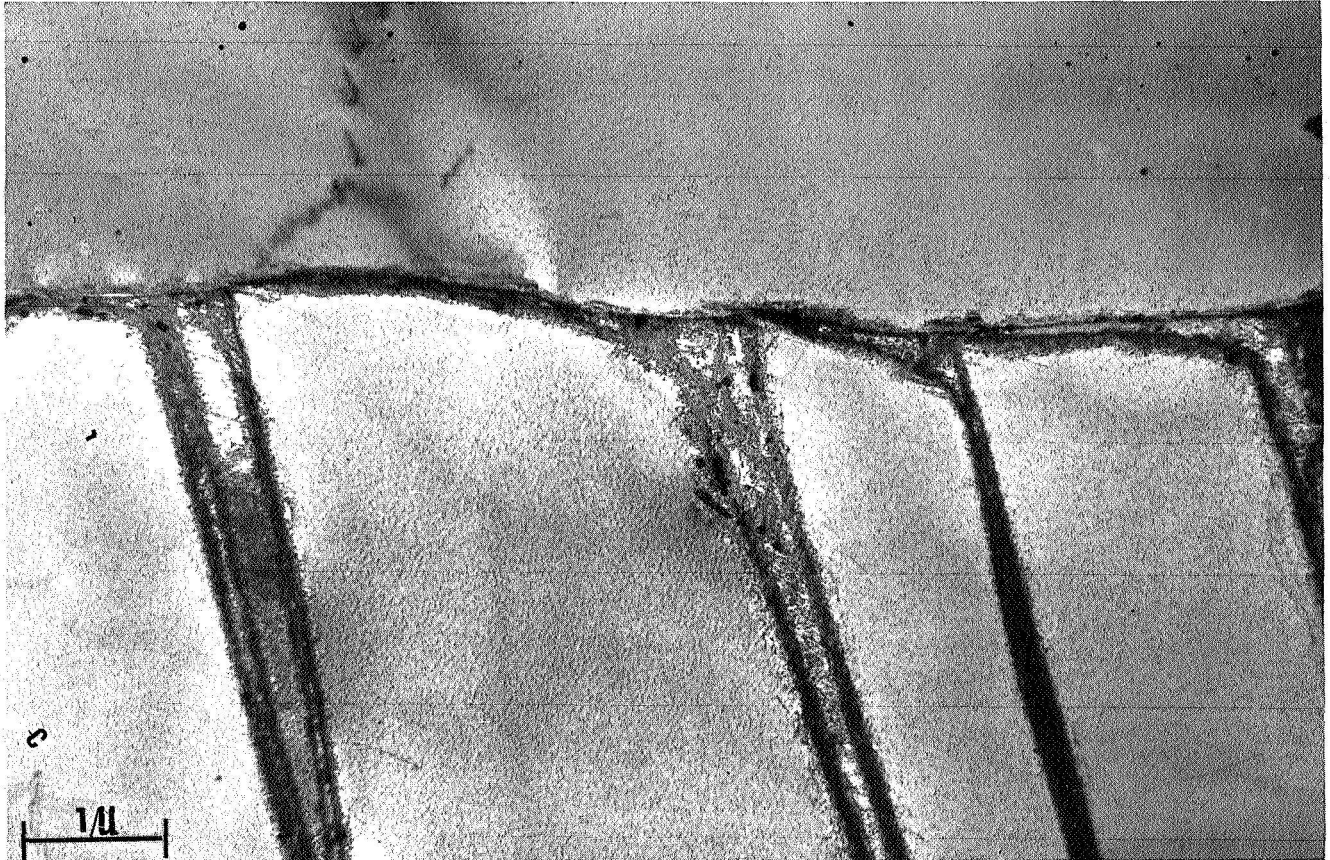
Figure 33. Transmission Electron Micrograph of Ti-8Al-1Mo-1V Solution Annealed at 2000°F, Air Quenched. Note Dislocation Free Material.

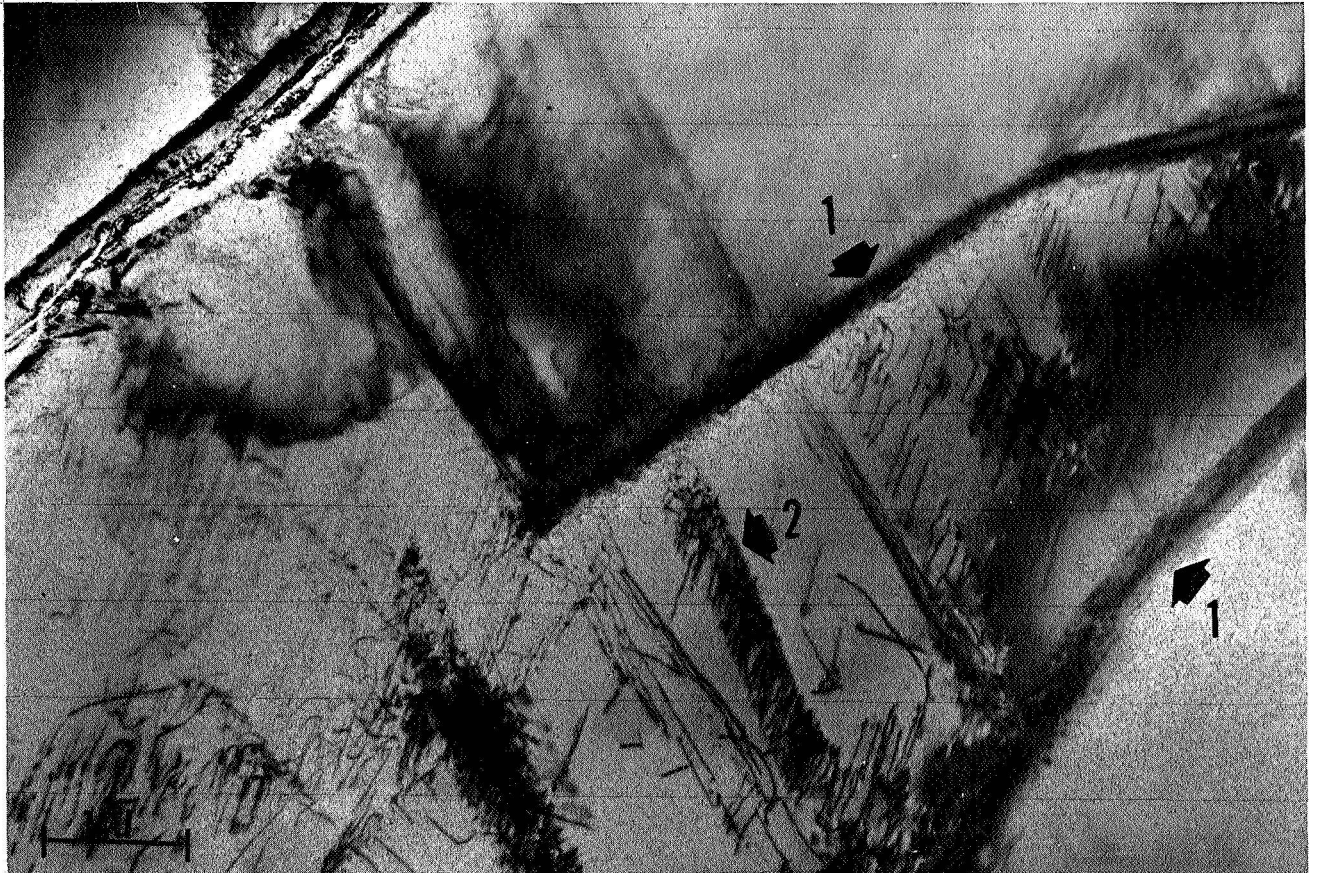
Figure 34. Transmission Electron Micrograph of Ti-8Al-1Mo-1V Solution Annealed at 2000°F, Air Quenched, Strained Approximately 5%. Note Retained Beta, Arrow 1, Coplanar Dislocation Arrangement, Arrow 2.

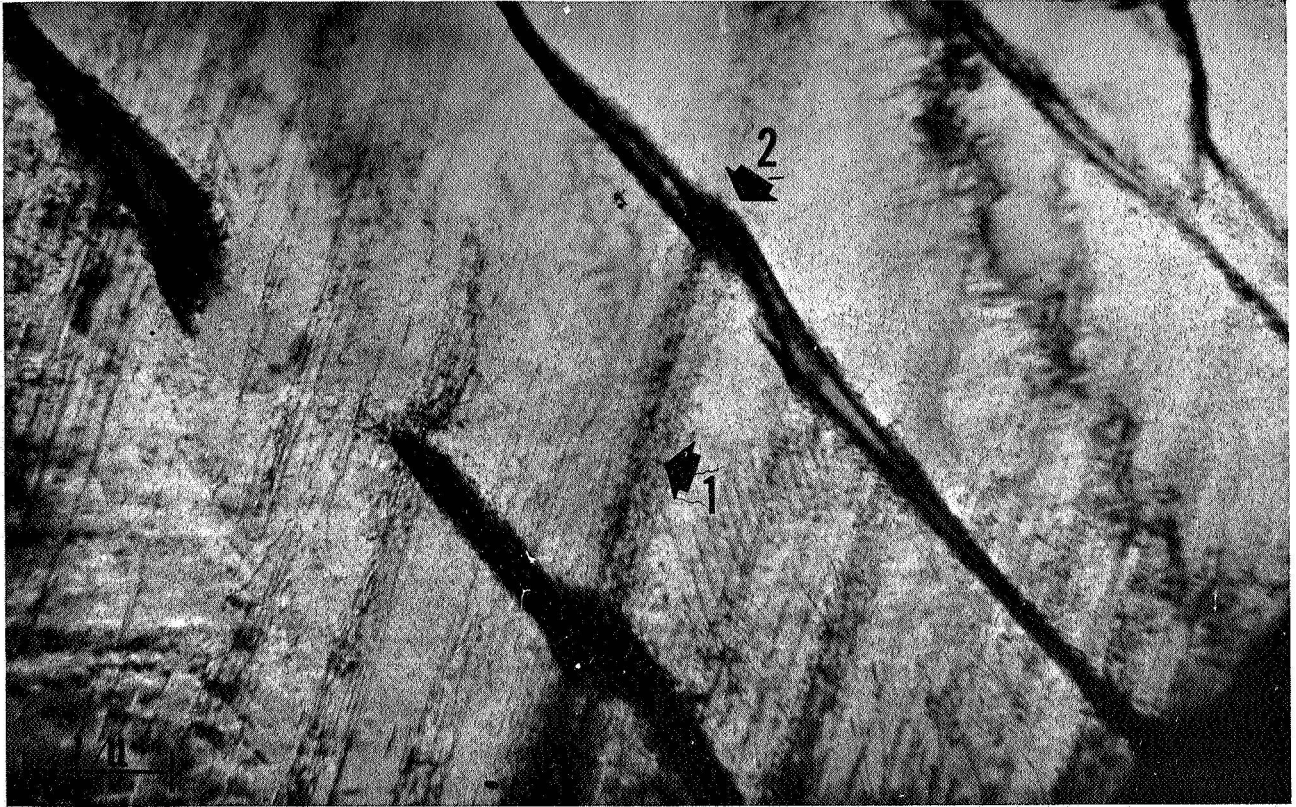
Figure 35. Transmission Electron Micrograph of Ti-8Al-1Mo-1V Solution Annealed at 2000°F, Air Quenched, Strained Approximately 8%. Note Slip Planes in Martensitic Alpha, Arrow 1, Deformation in Retained Beta, Arrow 2.

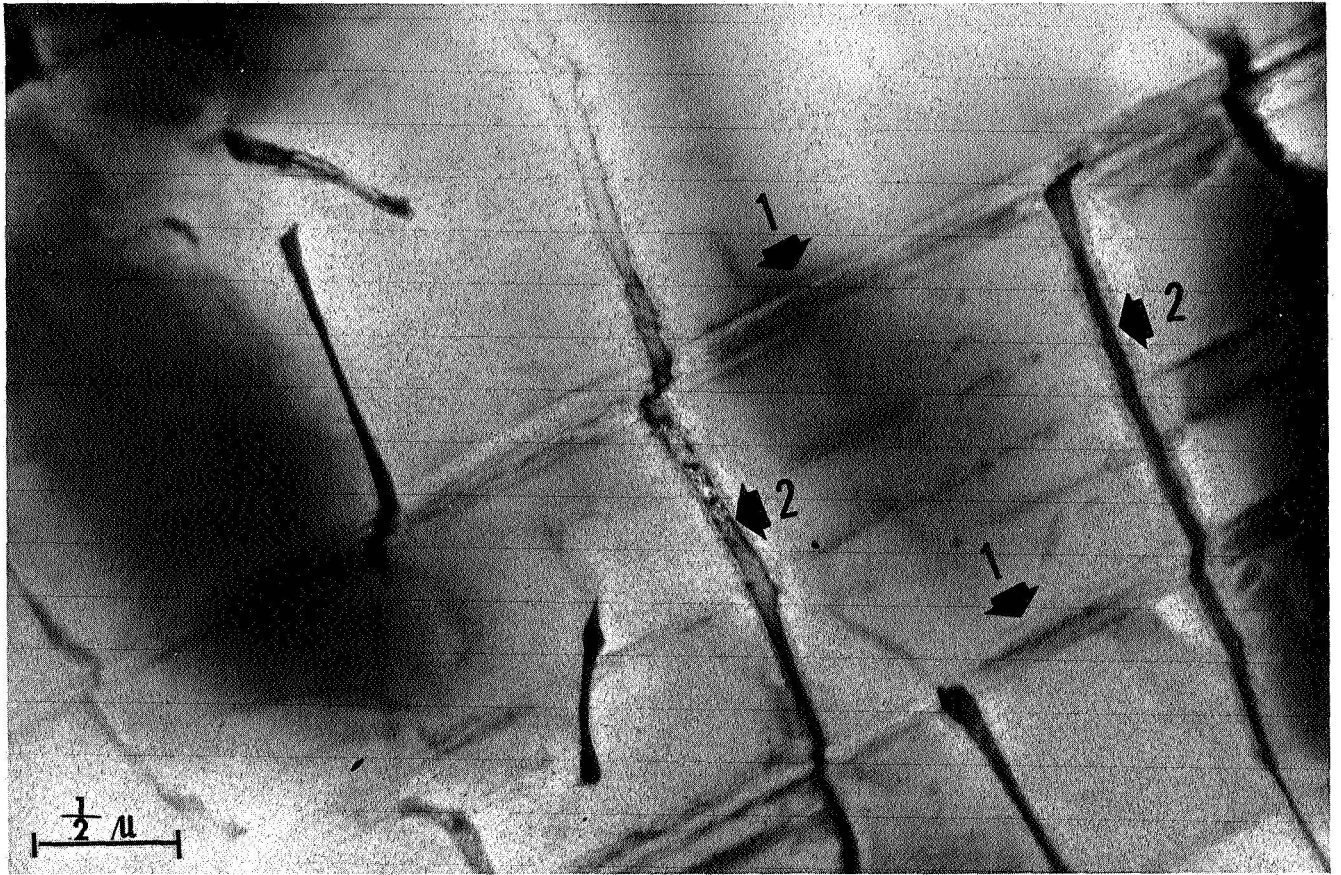
Figure 36. Transmission Electron Micrograph of Ti-8Al-1Mo-1V Solution Annealed at 2000°F, Air Quenched, Deformed Approximately 8%. Note Slip Planes, Arrow 1, Retained Beta, Arrow 2.
