SUMMARY REPORT, TASK V

Contract Number JPL 951720

HUGHES AIRCRAFT COMPANY
SPACE SYSTEMS DIVISION
EL SEGUNDO, CALIFORNIA

CALIFORNIA INSTITUTE OF TECHNOLOGY
JET PROPULSION LABORATORY
4800 OAK GROVE DRIVE
PASADENA, CALIFORNIA

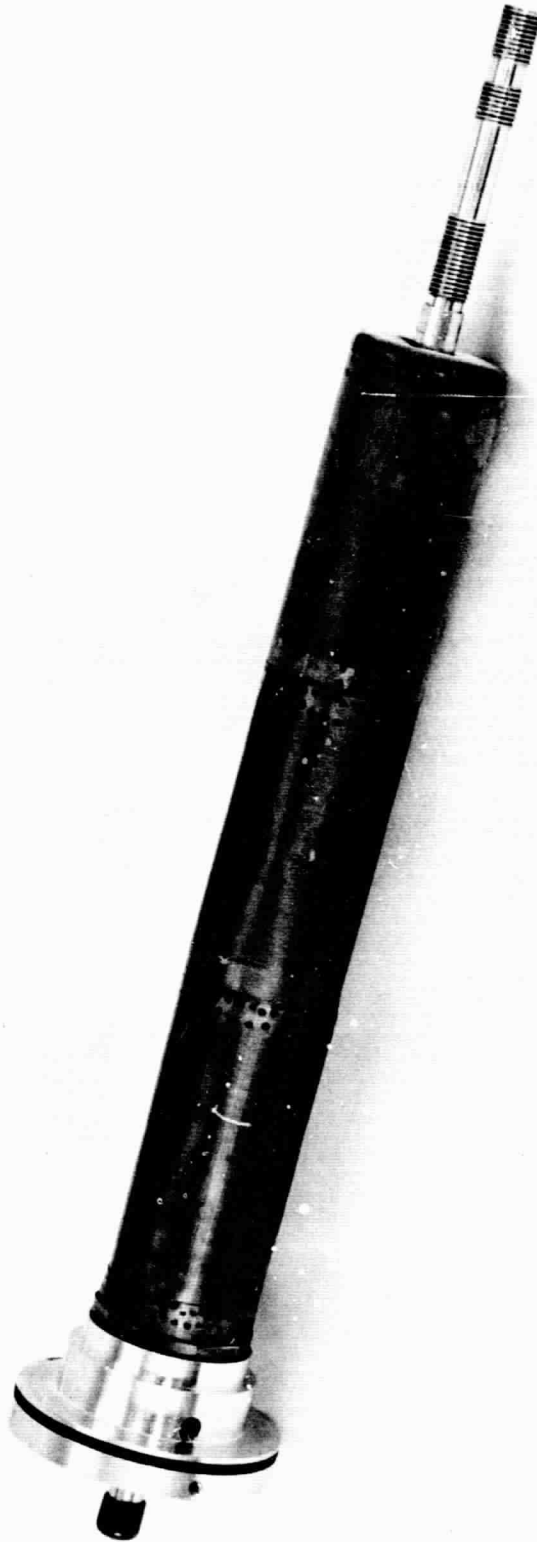
FIGURE 5

The electrodes are concentric cylinders with the anode on the inside and the cathode on the outside. The electrodes are separated by a layer of glass cloth which acts as a wick and extends beyond the end of the electrodes into areas of known liquid location in the tank. This provides a liquid feed to the electrodes regardless of the tank attitude. The anode is a hollow cylinder of fine grain graphite (ATJ) with longitudinal grooves along the full length of the outside surface to provide for passage of the gas liberated at the surface. The cathode is a 30 mesh aluminum screen (alloy 5056). Previous experiments indicated that 304L corrosion resistant steel is satisfactory but aluminum was used here as part of a continuing effort to investigate other materials. Likewise, the mounting flange and top cap were made from 6061 T6 aluminum. The electrodes are held between two end caps and are electrically insulated from each other and from the surrounding structure. The cathode is insulated but may be grounded to the tank if desired. The mounting of the electrodes was slightly modified from that shown in Figure 2 to make fabrication and assembly easier. The revised electrode mounting configuration is shown in sketch of Figure 3. The seal between the outer shell and the cathode screen, which is coated with polyethylene film in the seal area, is shown to be an O ring. This seal is not critical and has also been accomplished successfully by a Teflon tape wrapping. The electrodes are enclosed in an annular space formed between two shells made of aluminum tubing. The outer shell forms the outside enclosure of the electrode subassembly and is separated from the cathode screen by a small gas passage space. The inner shell is inside the anode and forms the outer enclosures for the zero g gas venting device. The gas compartment screens were prefabricated into cup shaped assemblies which are located and retained by Teflon spacers along the central support/gas vent tube. Figure 4 is a photograph of the actual parts and Figure 5 through 8 shows the module in various stages of assembly.
