NASA CONTRACTOR REPORT

NASA CR-11133

ROLE OF HYDROGEN CHLORIDE IN HOT-SALT STRESS CORROSION CRACKING OF TITANIUM-ALUMINUM ALLOYS

E. I. DU PONT DE NEMOURS & COMPANY

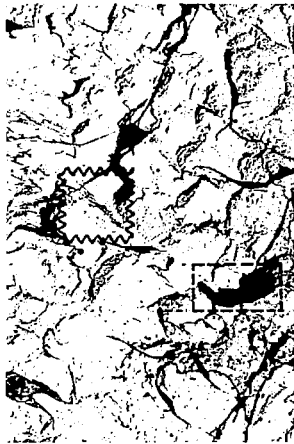
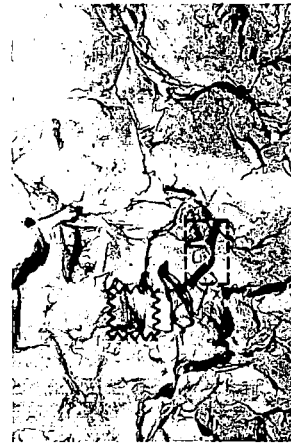
a. SnCl_2 at 343°C (650°F)

b. NaCl at 343°C (650°F)

c. Anhydrous HCl at 343°C (650°F)

d. Moist HCl at 343°C (650°F)

e. SnCl_2 at 25°C (77°F)

FIG. 5 TYPICAL FRACTOGRAPHS OF HOT-SALT CRACKS IN Ti-8Al-1Mo-1V Intergranular cracking is shown by the presence of grain shapes in the above fractographs. Note general roughening or pitting of grain surfaces (a, b, c) compared to smooth surfaces (d, e).

Typical fractographs of samples cracked under five different conditions are shown in Figure 5. The topography of the fracture surfaces is quite similar, and several features are found in common in most of the samples.

- A. Intergranular cracking, shown by grain shapes revealed on the fracture surface. Little evidence of ductile failure is apparent.

- B. Secondary cracking.
- C. Rough grain surfaces with areas of more or less regular striations, steps, or folds.
- D. Surface roughening, probably resulting from corrosion after cracking was also observed in some samples (Figures 5a, b, c), while others did not show the roughening (Figures 5d, e).

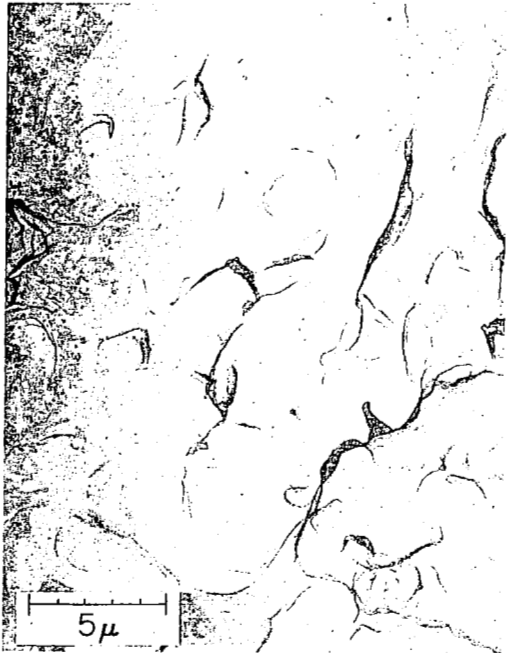
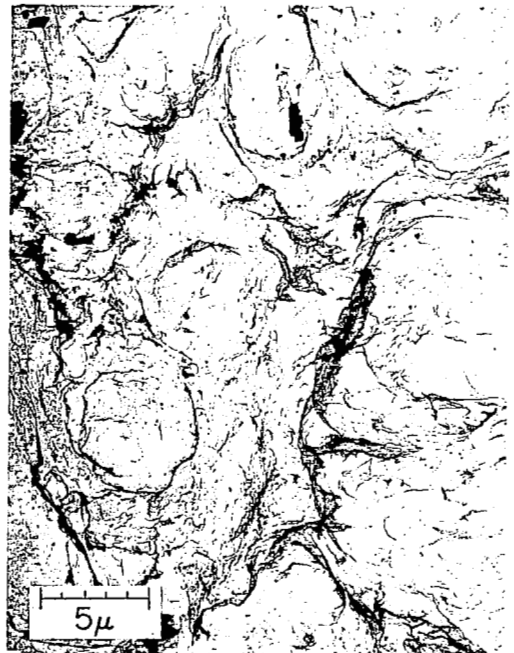
a. Fractograph Showing Ductile Characteristics of Sample Containing 1400 ppm H_2 .

b. Fractograph Showing Brittle Characteristics of Sample Containing 4000 ppm H_2 .

c. Microstructure of Surface of Sample containing 4000 ppm H_2 .

FIG. 9 EFFECT OF HYDROGEN CHARGING ON STRUCTURAL CHARACTERISTICS

Samples containing 1400 and 4000 ppm hydrogen were mechanically ruptured to provide a fractographic comparison with hot-salt and HCl fractures. The sample containing 1400 ppm hydrogen failed by both brittle and ductile mechanisms, but mainly by ductile mechanisms (Figure 9a); the sample with the higher hydrogen content failed almost entirely by brittle mechanisms (Figure 9b). The rough appearance of the fracture surface was due to the twisting path required for the crack to follow the almost continuous network of hydrides lying along the α - α and α - β grain and phase boundaries, shown in the polished microstructure (Figure 9c). These observations show that fracture near a metal-hydride interface was brittle and had a very rough surface due to hydride precipitation. The fractographic appearance of these samples was quite different from that of cracks caused by hot-salt and HCl (compare Figure 5), although isolated regions with

similar features were observed in one crack produced by exposure to SnCl_2 at 343°C (650°F). These studies indicate that hot-salt cracking does not occur by hydride formation and subsequent fracture along or through the hydride platelets.
