# JOINING REFRACTORY / AUSTENITIC BIMETAL TUBING

Supplemental Report

Lewis Research Center  
Space Power Systems Division

Under Contract NAS 3-7621

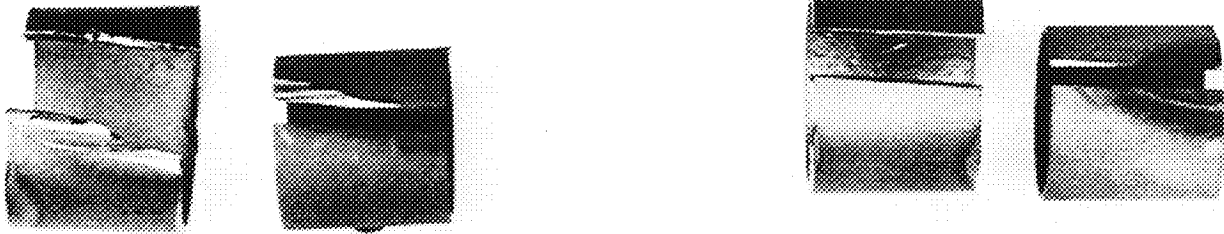
FIGURE 1 - Bimetal Tubing Heat Exchanger

This tubing was coated in the form of a small sized heat exchanger. Figure 1 shows the completed heat exchanger comprised of three, 20 inch long bimetal tubes. Some distortion occurred during the coating process due to a pressure build-up in the protective can. The coating processing sequence was as follows:

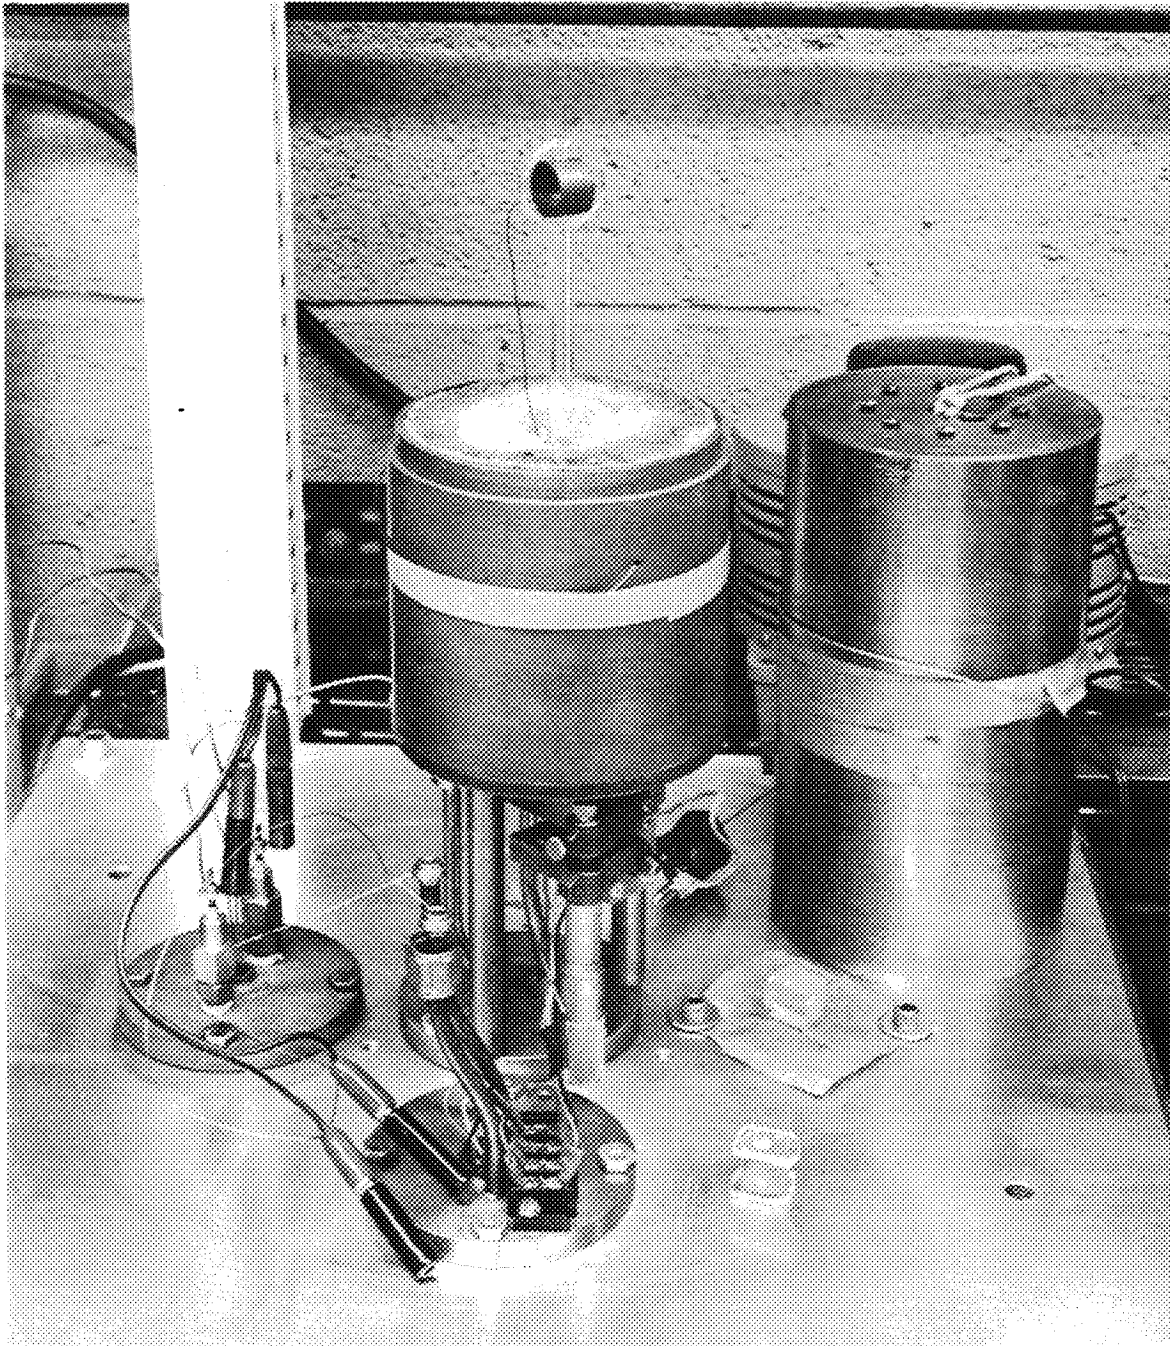
FIGURE 6 - Thermal Expansion Measurement Apparatus

1. The apparatus used to perform the measurements is shown in Figure 6. Since the thermal expansion was measured from room temperature to 1350°F, the apparatus is enclosed in a vacuum chamber to prevent atmospheric contamination of the refractory metal component above 500°F. The diffusion pumped test chamber was maintained at a vacuum of  $10^{-6}$  torr.

The unit utilizes a modified form of the standard quartz push rod and tube (See Figure 6.). A vertical quartz tube with a flat polished upper end and a slit forms the pedestal. The quartz push rod is formed into a ring to surround and contact the tubular specimen opposite the pedestal. The change in specimen diameter is thus transferred directly to push rod motion. Push rod motion is measured and recorded by an electro-mechanical transducer.

The transducer employed is a linear variable differential transformer with the chopper, oscillator, and demodulator integrated into the transducer, requiring only a stable DC input while providing a high level (~1V) output for its  $\pm 0.050$  inch, full-scale deflection. The furnace was fitted with a loose fibrous quartz thermal insulator to help provide temperature uniformity.

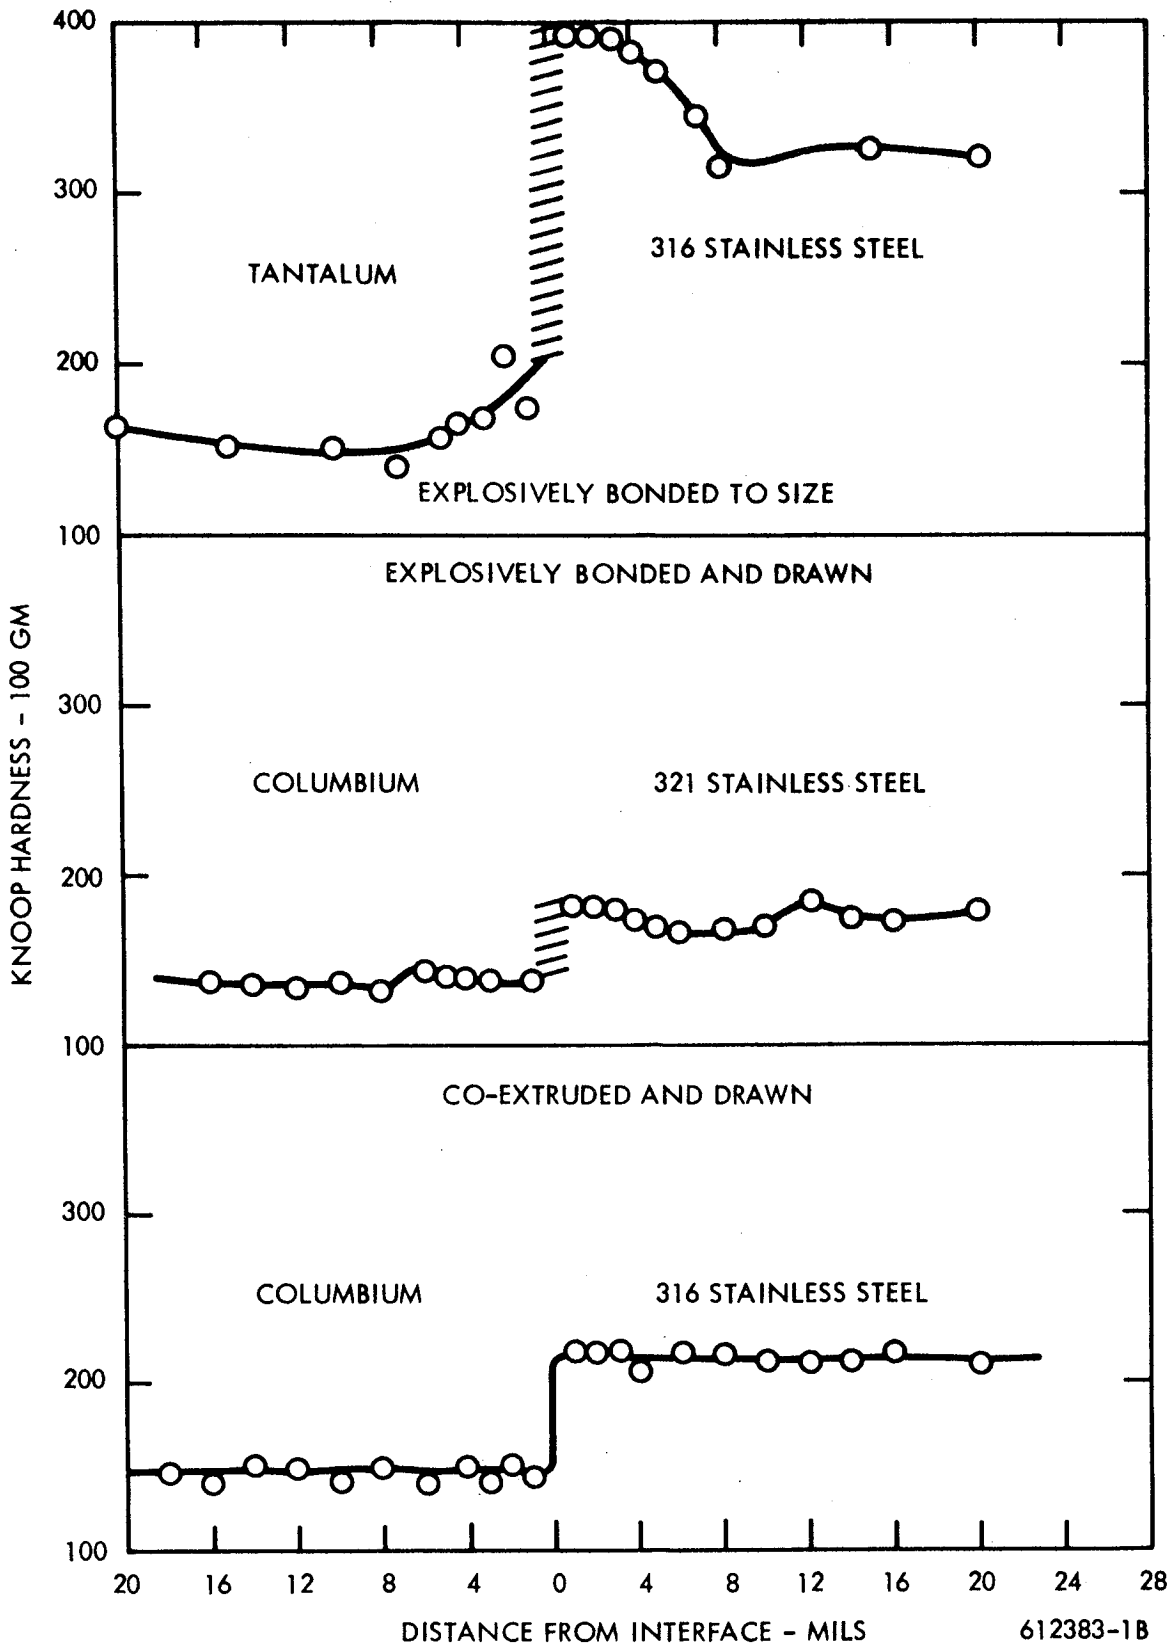
FIGURE 8 - Bimetal Interface Hardness Traverses

The results of bimetal interface hardness traverses are shown in Figure 8. The explosively bonded to size tubing is significantly different than the other tubing in that the stainless steel is much harder through the entire cross section and the hardness of both the tantalum liner and the stainless steel builds up to a maximum at the bimetal interface. This behavior is typical of explosively bonded material and has been previously observed. The stainless steel is severely work hardened by the explosive bonding operation. Several annealing steps were used in producing the explosively bonded and drawn tubing, thus lowering the hardness to the values shown. Since the co-extruded product is extruded at  $\sim 1800^{\circ}\text{F}$  and the tubing is also annealed between the drawing operations, a moderate hardness in the stainless steel results.

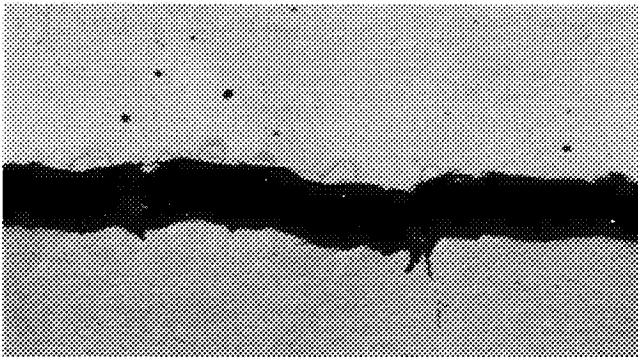
(c) Unbond at center of dimple width 2.5 mils 100X  
Transverse Section
