**DEVELOPMENT OF PROTECTIVE COATINGS
FOR CHROMIUM-BASE ALLOYS**

NATIONAL AERONAUTICS AND SPACE ADMINISTRATION

Contract NAS 3-7612

DEVELOPMENT OF PROTECTIVE COATINGS
FOR CHROMIUM-BASE ALLOYS

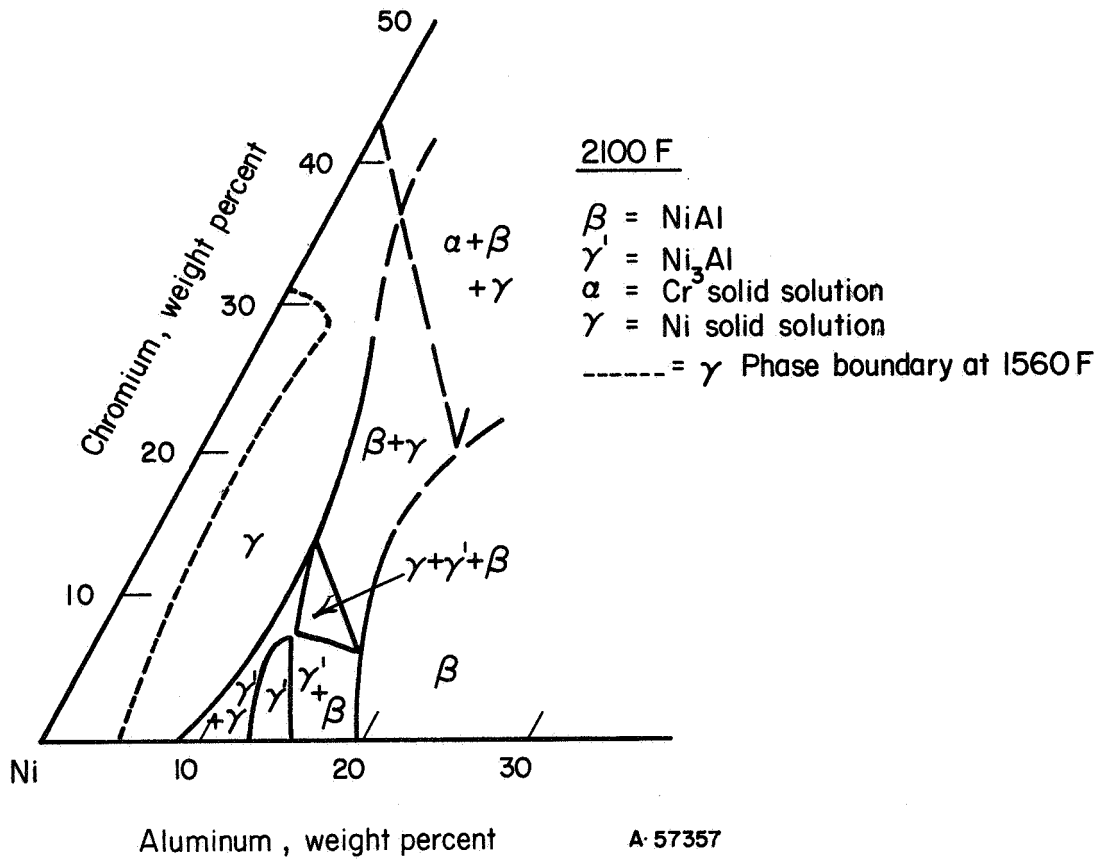
FIGURE 1. THE Ni-Cr-Al PHASE DIAGRAM(8, 9)

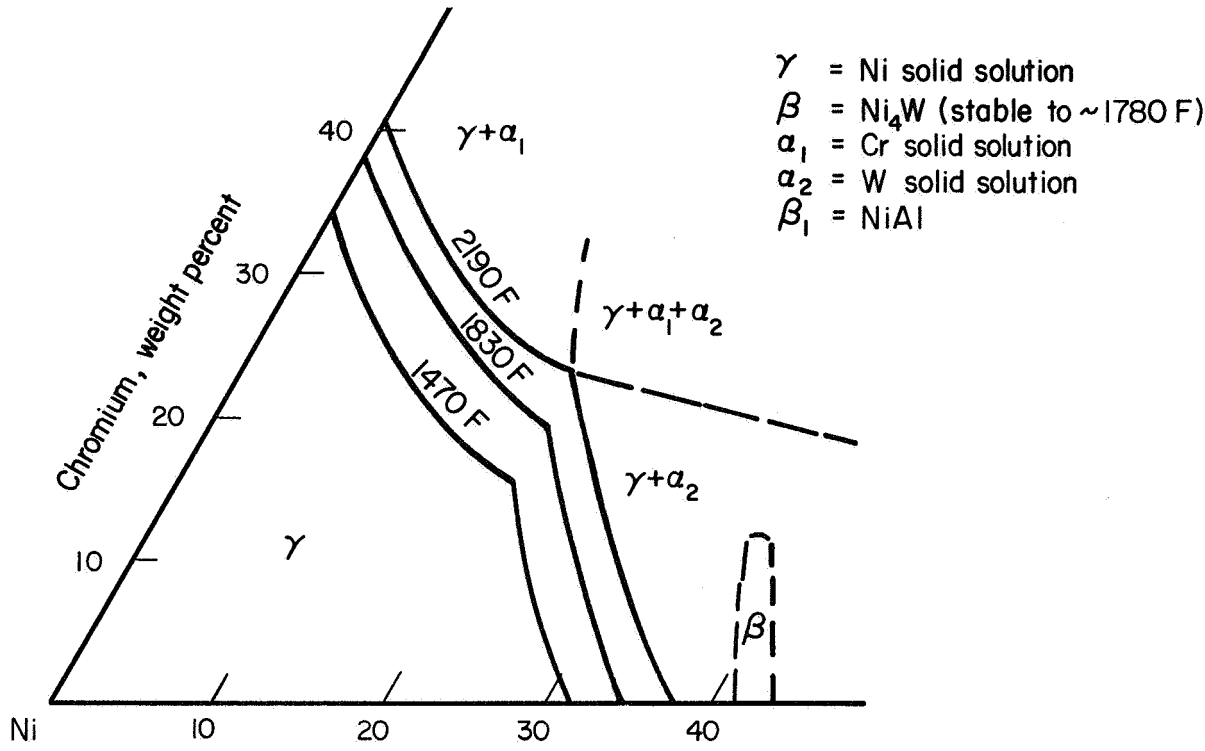
a. Tungsten, weight percent

b. Tungsten Plus Aluminum, weight percent
(W:Al ratio = 3:1) A-57358

FIGURE 2. Ni-Cr-W AND Ni-Cr-W-Al PHASE DIAGRAMS(10, 11)

The diffusion of tungsten into the Ni-30Cr or Ni-20Cr-20W was considered a potentially greater problem than its diffusion into chromium. In this case, little was known about diffusion kinetics. As tungsten diffused into either alloy, a second phase would be stabilized, and embrittlement might be developed. Thermal expansion differences between the tungsten barrier layer and the nickel-base cladding alloy also appeared to be a potential source of trouble. Altering the interface region between the tungsten barrier and the nickel cladding alloy by providing a layer of platinum was considered as a possible method of overcoming these problems because of (1) suppression of the tendencies to form intermetallic phases during service, and (2) thermal expansion (of platinum) intermediate between chromium (or tungsten) and the nickel alloy clad. This platinum layer is referred to as a compatibility layer. The usefulness of vanadium as a compatibility layer was also examined briefly.

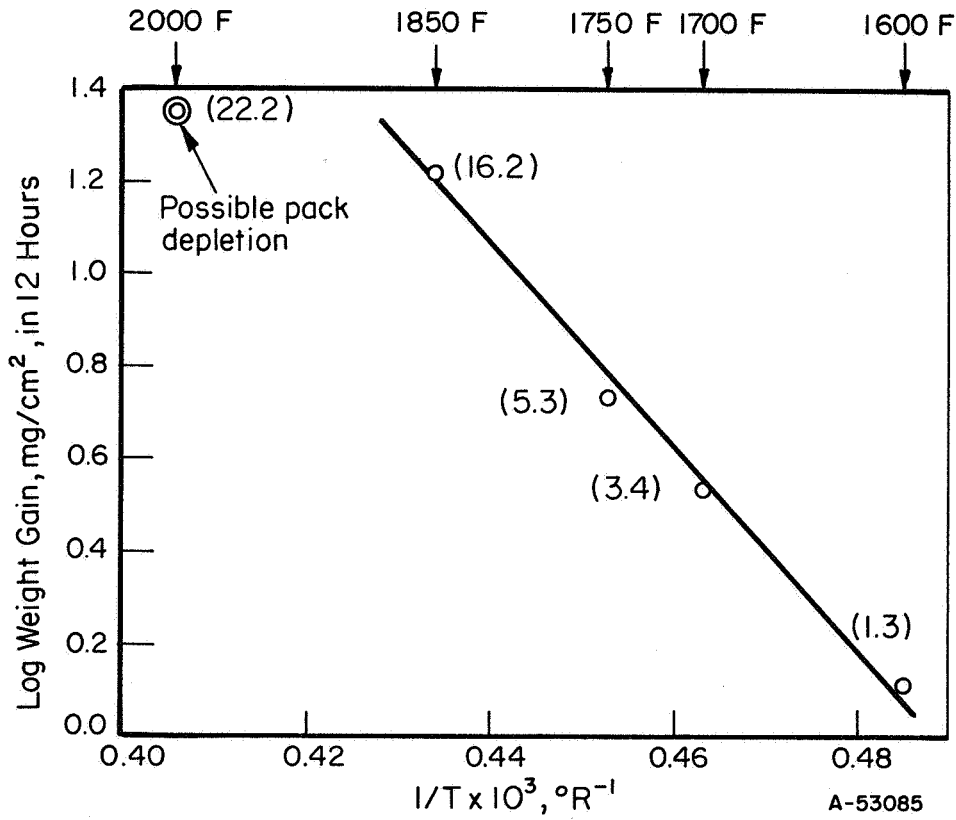
FIGURE 6. AVERAGE WEIGHT GAIN AS A FUNCTION OF ALUMINIZING TEMPERATURE

All samples aluminized for 12 hours. Numbers in parentheses are aluminum weight gain in mg/cm².

The weight gain observed as a function of aluminizing temperature is shown in Figure 6. Except for the run at 2000 F, the results show a linear relationship on an Arrhenius plot. Thus, weight gain can be controlled quite readily by controlling the aluminizing temperature. The somewhat low aluminum adsorption at 2000 F probably resulted from aluminum depletion of the pack mixture. Assuming a sample thickness of 10 mils aluminized on both sides (or 5 mils aluminized on one side) and alloy densities of 8.3 gm/cc for Ni-30Cr and 9.5 gm/cc for Ni-20Cr-20W an aluminum addition of 5 weight percent would necessitate a weight gain during aluminizing of 5.5 mg/cm² for Ni-30Cr and 6.4 mg/cm² for Ni-20Cr-20W.

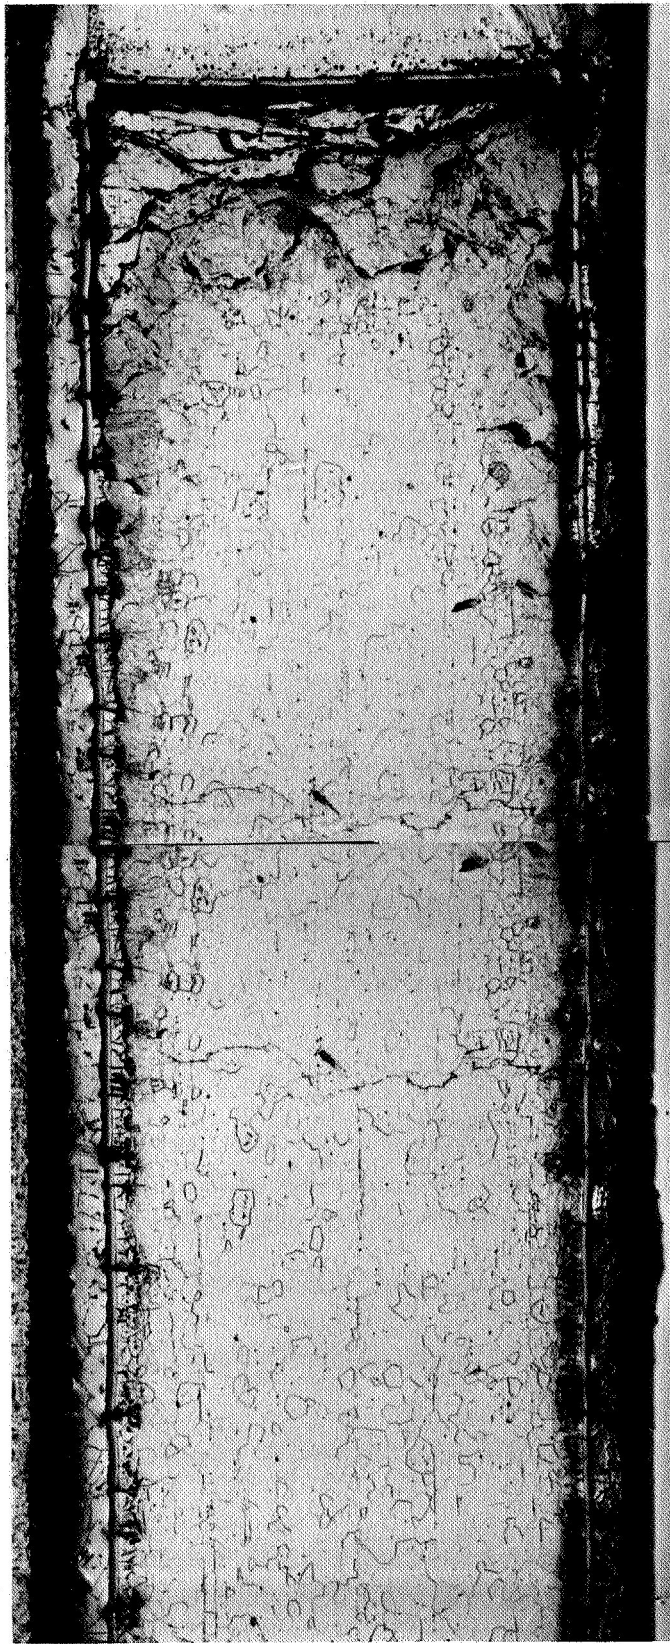
FIGURE 37. NITRIDING IN A SYSTEM 1b SAMPLE
CYCLICALLY OXIDIZED 40 HOURS AT 2300 F
Electrolytic oxalic acid etch.
