FINAL REPORT

PROTECTIVE COATINGS FOR CHROMIUM ALLOYS

NATIONAL AERONAUTICS AND SPACE ADMINISTRATION

CONTRACT NAS 3-7273

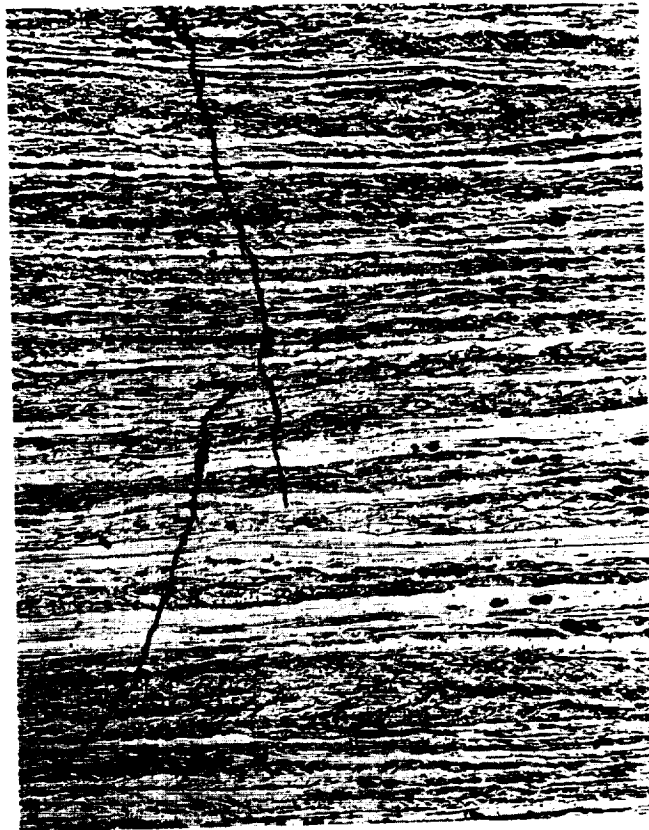
ETCH: 10% OXALIC ACID      MAG: 250X

FIGURE 3-1 AS RECEIVED Cr-5W-Y SUBSTRATE SHOWING HEAVILY WORKED STRUCTURE, TRANSGRANULAR CRACKING AND A HIGH INCLUSION (NON-METALLIC) DENSITY

Figure 3-1 shows a typical photomicrograph of as-received Cr-5W-Y sheet. A heavily worked microstructure was noted along with some non-metallic inclusions. It is not known whether the cracks seen resulted from metallographic preparation or were in fact prevalent in the as-received material. However, there were repeated cases of observed substrate cracking (throughout the program) in the as-received sheet prior to metallographic preparation.

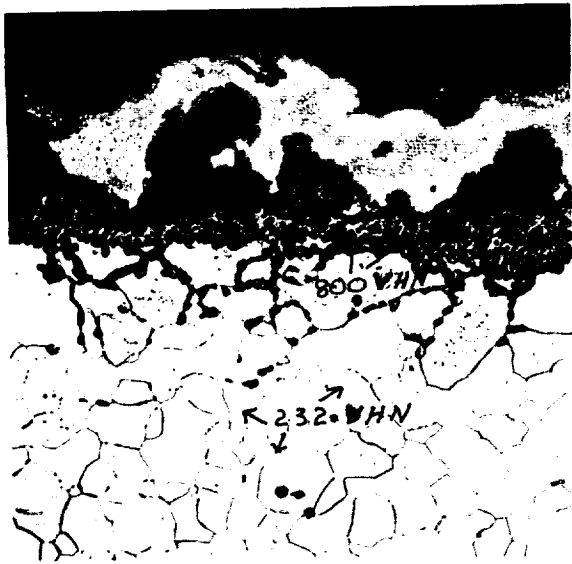
ETCH: 10% OXALIC ACID      MAG: 250X

FIGURE 3-2      2100°F/100 HRS

Figures 3-2 and 3-3 show photomicrographs of the bare material after 100 and 1350 hour exposures (10 hour cycles) at 2100°F., while Figure 3-4 shows the relative effects of exposure to 100 hours at 2100°F and 2400°F. It should be noted that these oxidation tests were conducted such that weight changes were recorded every 10 hours (to 100 hours) and every 24 hours subsequently. Microhardness data (direct reading-10 gram Vickers) are indicated on the photographs. Note the

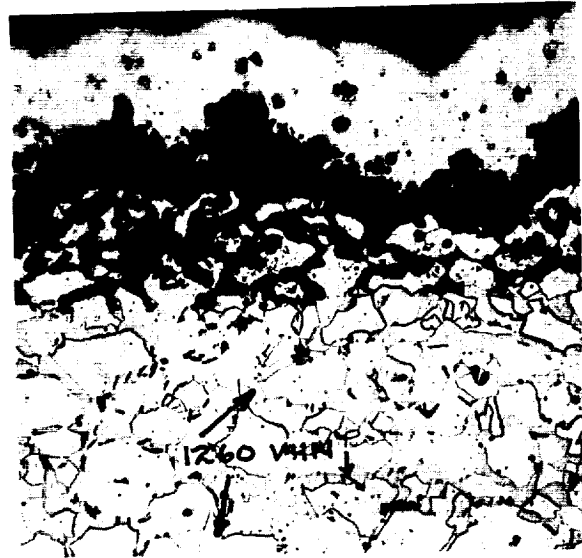
FIGURE 3-3      2100°F/1350 HRS

ETCH: 10% OXALIC ACID      MAG: 250X

PHOTOMICROGRAPHS OF BARE Cr-5W-Y ALLOY AFTER EXPOSURE AT 2100°F AND 2400°F FOR VARYING LENGTHS OF TIME. NOTE EXTENT OF INTERGRANULAR NITROGEN ATTACK SHOWN IN FIGURE 3-3 AND EXTENT OF TOTAL ATTACK IN FIGURE 3-4.

severity of the attack on the specimen exposed at 2400°F and, although nitrogen has diffused extensively, the lack of surface spalling and exfoliation on the bare material tested at 2100°F. The adherence of the scale is usually attributed to the formation of an Y-Cr<sub>2</sub>O<sub>3</sub>- type spinel which according to many investigators inhibits cation (Cr<sup>+3</sup>) diffusion.

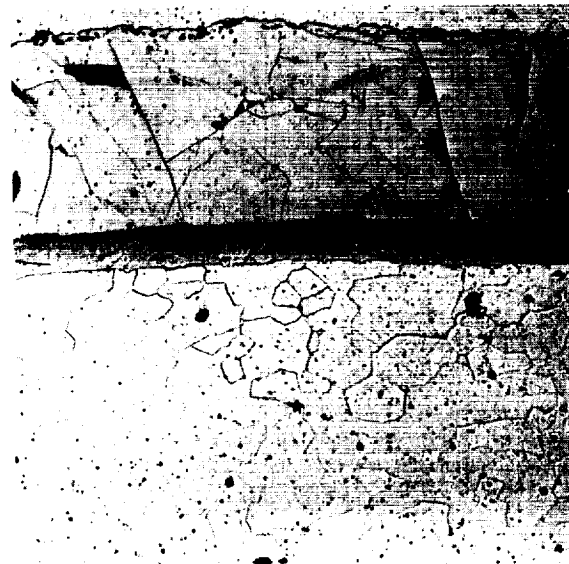
As indicated in the previous section, coatings of higher aluminum composition were more resistant to corrosive attack. To this end, aluminizing from packs richer in aluminum were attempted. Figure 3-19 shows a photomicrograph typical of the 2 $\phi$  coating (XP19044). It is most significant to observe that this coating consists of two distinct phases in the as-coated condition. Figure 3-20 shows 2 $\phi$  coating after exposure of 140 hours at 2400°F. Although the diffusion of aluminum into the substrate has extended approximately 0.016 inches, no nitrogen contamination of the substrate was observed. The striations and inclusions examined by microprobe scanning techniques proved to be high in aluminum. This necessarily suggests internal oxidation of the aluminum to Al<sub>2</sub>O<sub>3</sub>. Figure 3-21 shows quantitative Electron-beam microprobe analyses of an as coated (2 $\phi$ ) specimen from the above experiment. As can be seen, the aluminum content in the outer phase is much higher (40%) than that of the UK coating (22%). Examination of the Cr-Al phase diagram shown in Figure 3-22 reveals that according to the microprobe trace the outer phase seen in this coating conforms to the  $\eta$  or  $\eta^1$  phase (Cr<sub>5</sub>Al<sub>8</sub>) while the inner phase falls within the solid solution field. It is of further interest to note that the chemical analysis (by probe techniques) of this inner phase is equivalent to that obtained on the UK system (solid solution of Al in Cr).

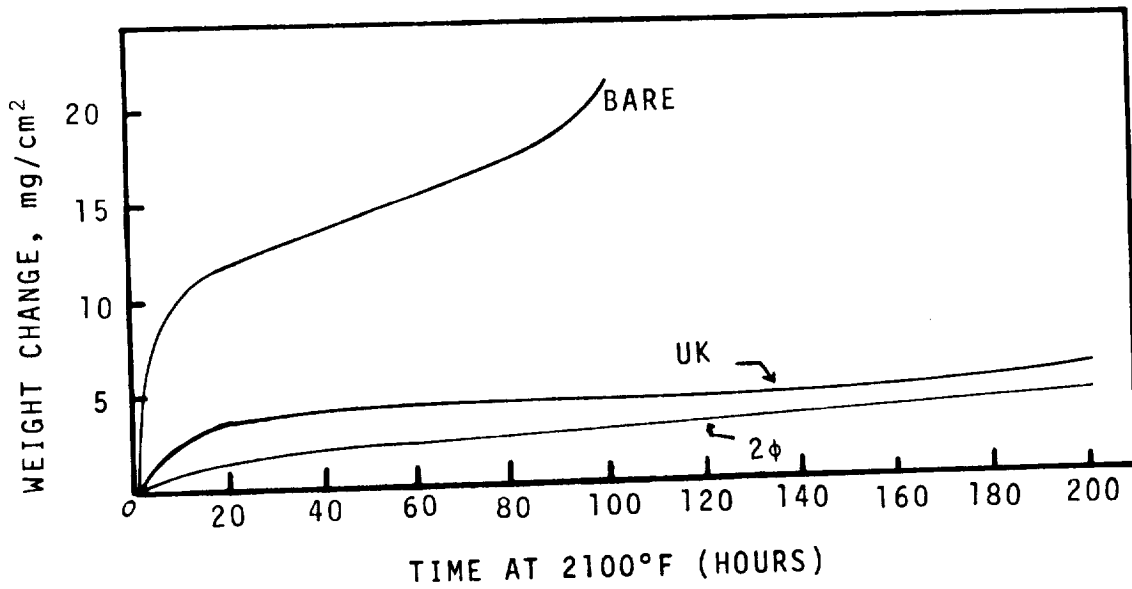
FIGURE 3-23

ADVANCED CYCLIC OXIDATION CURVES OF THE BARE,  $K_2SiF_6$  ENERGIZED ALUMINUM COATED AND TWO PHASE ALUMINUM COATED TEST SPECIMENS. 47

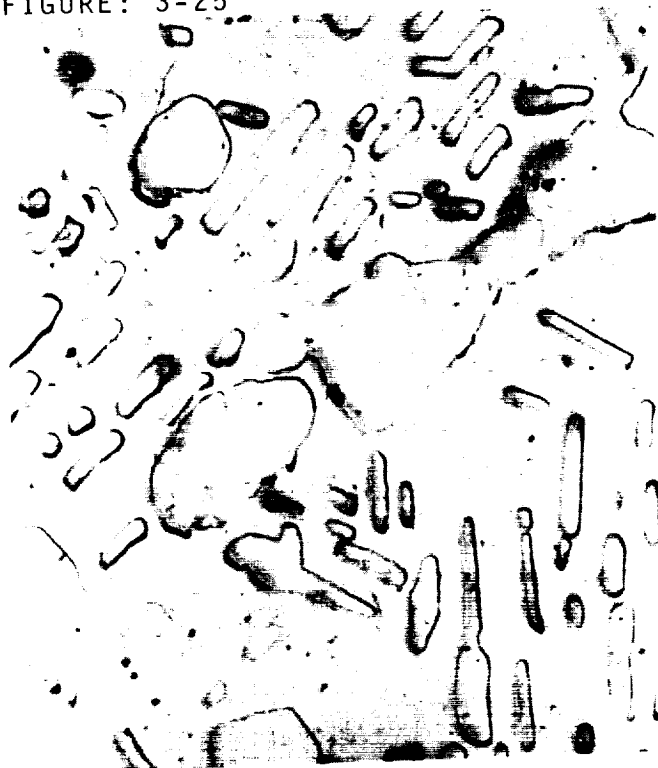
FIGURE: 3-25

LIGHT AND ELECTRON MICROPHOTOGRAPHS OF A  
2 $\phi$  COATING AFTER 140 HOURS @ 2400 $^{\circ}$ F  
SHOWING NEEDLE-LIKE STRUCTURE PROBABLY  
AlCrO<sub>4</sub>

Although several coated specimens were examined by use of electron microscopy, few instances revealed anything significant. Figure 3-24, 3-25 shows both electron and light microscopic photographs of the  $2\phi$  coating after 140 hours at  $2400^\circ\text{F}$ . The needle-like structure seen in Figure 3-25 is probably  $\text{AlCr}_2\text{O}_4$ .

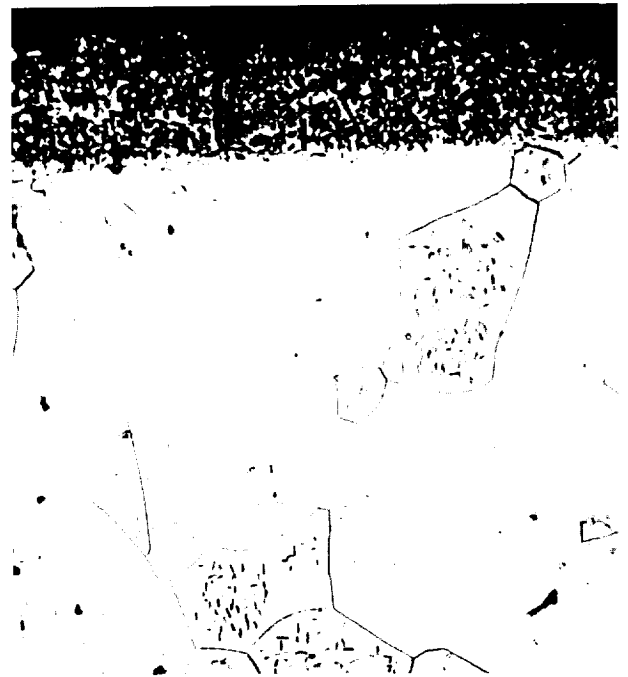
FIGURE: 3-31

LEADING EDGE

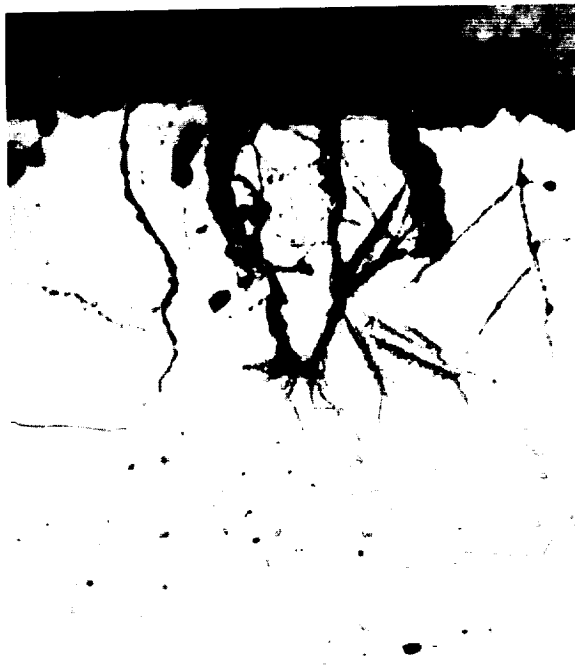
FIGURE 3-33

by several investigators employing similar facilities. Figures 3-32 to 3-34 show similar illustrations for 2 $\phi$  coated specimens tested 160 hours at 2100<sup>0</sup>F. As can be seen, this system although more oxidation-nitrification resistant than the UK coating, also shows more pronounced coating attack at the trailing edge. However, no nitrogen attack of the substrate was noted.

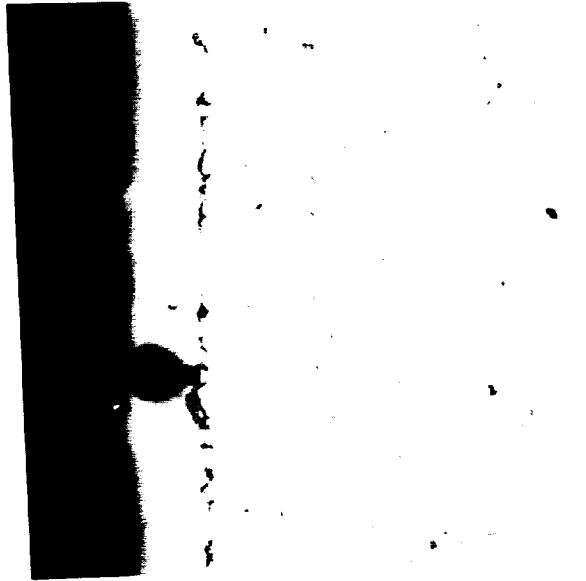
FIGURE: 3-37  
 BARE Cr-5W-Y DBTT SPECIMEN  
 AFTER 100 HOURS AT  
 2100°F IN ARGON WITH A  
 2,2,2,16 HOUR CYCLE EXPOSURE.  
 NOTE SUCCESSFUL DBTT AT  
 1000°F AND BRITTLE FRACTURE  
 AT 800°F

DBT  
 800°F

D B T  
 1000°F

A further look at the data shows that a cyclic (2,2,2, -16) 100 hour exposure (2100°F) produces a condition (83 ppm-N , and 1250°F successful bend) significantly poorer than that seen with an iso-thermal 100 hour exposure (63 ppm) and 1000°F successful bend). The same type of results were obtained with 10 hour exposures i.e., poorer bend results with cyclic exposure at 2100°F. It also becomes obvious at this point that diffusion of aluminum into the substrate has a pronounced effect in increasing the DBTT of the coated material. Figures 3-37 through 3-41 show photomicrographs and macrographs of some of the conditions tested. Most significant in these photographs are the cracks seen extending from the coating to the substrate, and the enhanced diffusion of aluminum (into the substrate) due to the thermal cycling imposed, the surface cracking seen even under conditions where a 105° bend was obtained, and some of the fractures obtained with no bending noted.

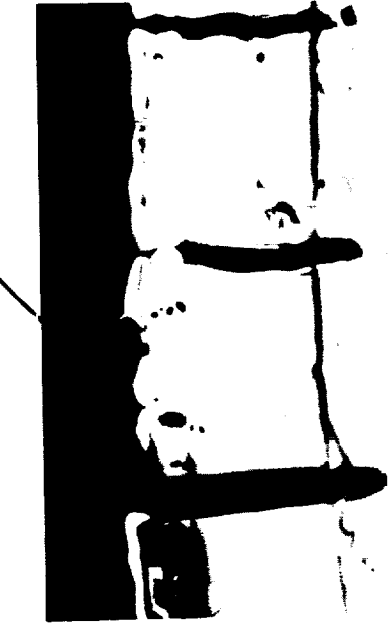
FIGURE 3-40

2 $\phi$  COATED Cr-5W-Y DBTT SPECIMEN  
AFTER 10 HOURS AT 2100°F IN ARGON.  
NOTE HIGH DBTT AND COATING CRACKING

100X DBT 1500°F

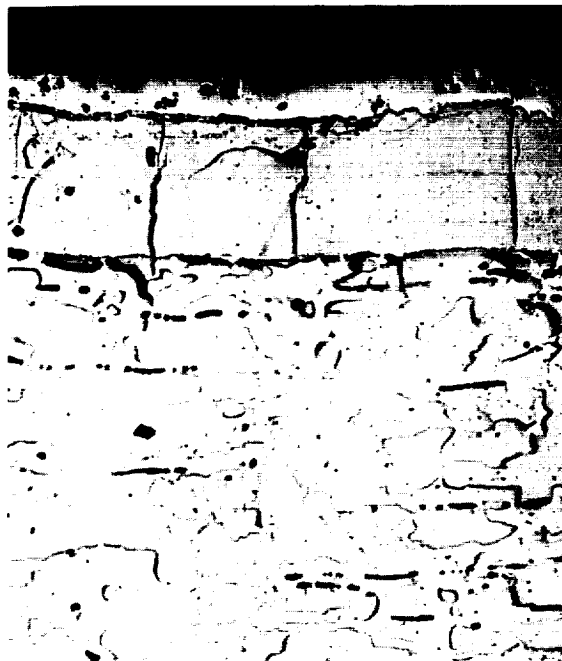
FIGURE 3-65

3.0 mils

ETCH: OXALIC ACID MAG: 250X

Although quite similar to the Al-Co-Ti system, deposition of the three elements proceeded with iron first and subsequently followed by deposition of aluminum and titanium, respectively, in separate processes. Through the course of this program, difficulty was experienced in depositing Co and Fe in halide atmospheres unless aluminum was deposited first. As can be seen from Table IX, ironizing was performed in an inert atmosphere. This has been found to be necessary to produce sound iron coatings. Figure 3-65 shows a photomicrograph of an Al-Fe-Ti coated Cr-5W-Y.

This system (Figure 3-65) produced a two phase coating which, unlike the Al-Co-Ti, was uniform and free from oxide scale and intergranular attack. Electron Beam Microprobe analysis, Table X, revealed the outer coating layer to be rich in titanium and iron (titanium 49.7 W/o, iron 23.3 W/o), with moderate percentages of aluminum. Total coating penetration was approximately 3 mils, with the iron and titanium decreasing significantly after 2 mils. Specimens were cyclic oxidation tested at 2100°F and 2400°F with failure occurring after the first ten hour cycle. Combined oxidation, nitrification and exfoliation of the coating prevented metallographic evaluation of the specimens. Figure 3-62 shows the weight change, oxidation curves for this coating alloy system.

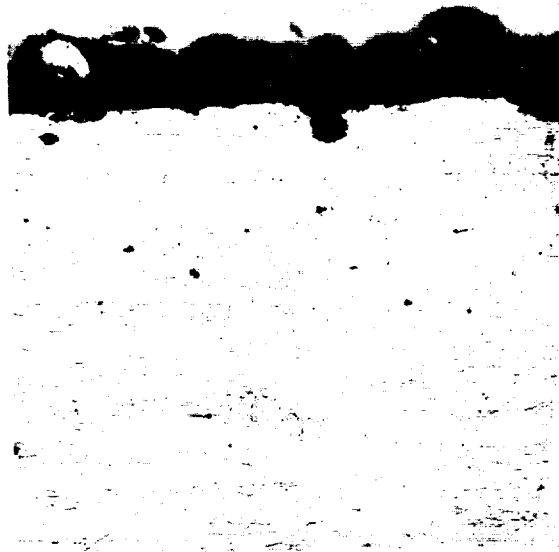
FIGURE 3-75 AS COATED

PHOTOMICROGRAPHS OF AN Fe-Al (FIG. 3-74) AND AN Fe (FIG. 3-75) COATING ON Cr-5W-Y. NOTE OXIDE BUILD UP IN BOTH CASES.

Table XII shows the experimental coating trials conducted on the iron-aluminum system. Figures 3-74 and 3-75 show photomicrograph coated as per XP 19016 and 19025 showing oxide build-up at the surface. Note that the substrate in the specimen from XP 19025 has not undergone recrystallization. Subsequent to these experiments it was decided to attempt coating the substrate from packs containing ferrous halides. It was felt that the use of iron in the form ( $\text{FeI}_2$ ) would preclude the formation of chromous iodide since during pack heat up, the iodide would first decompose thermally. Subsequent iron deposition would then take place and upon reaching the coating temperature, the diffusion of iron into the substrate would necessarily lower the activity of the chromium and minimize any possible weight losses due to chromium reaction with iodine. As can be seen from the comments in Table XI, only mixed success was achieved. Excessive contamination was seen on the surface of specimens from these experiments. This contamination consisted of both oxide and iodine products. To eliminate this contamination, probably caused by an inadequate purge and over-activity of the iodide, additional sets of experiments were designed using the less active bromides, and an argon purge. This procedure (XP 19052, XP 19065) was employed on both bare and pre-aluminized specimens. Figures 3-76 and 3-77 show photomicrographs from speci-

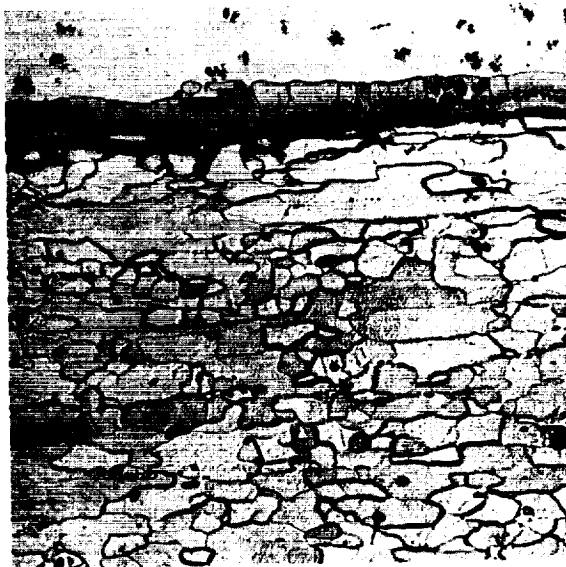
ETCH 10% OXALIC ACID    MAG: 250X  
FIGURE 3-76

PHOTOMICROGRAPHS SHOWING RESULTS OF DEPOSITION OF Fe FROM  $\text{FeBr}_2$  PACKS ON BARE (FIG. 3-76) AND PRE-ALUMINIZED (FIG. 3-77) SPECIMENS. NOTE THAT COATING SEPARATION TOOK PLACE. NO ALUMINUM IS PRESENT IN THESE COATINGS.

iron, chromium, and aluminum. Note the inclusions present in the aluminum X-Ray photograph. These likely indicate high aluminum content and probably are in fact  $Al_2O_3$ . The same inclusions can be seen in the photomicrograph shown in Figure 3-77.

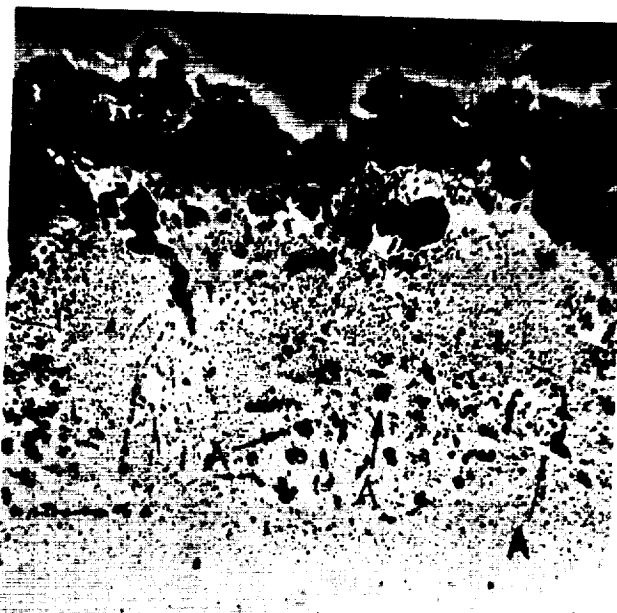
— 474 VHN  
— 404 VHN  
— 313 VHN  
— 271 VHN

ETCH: 10% OXALIC ACID MAG: 200X  
EXPOSURE TIME (2400°F/100 hrs.)

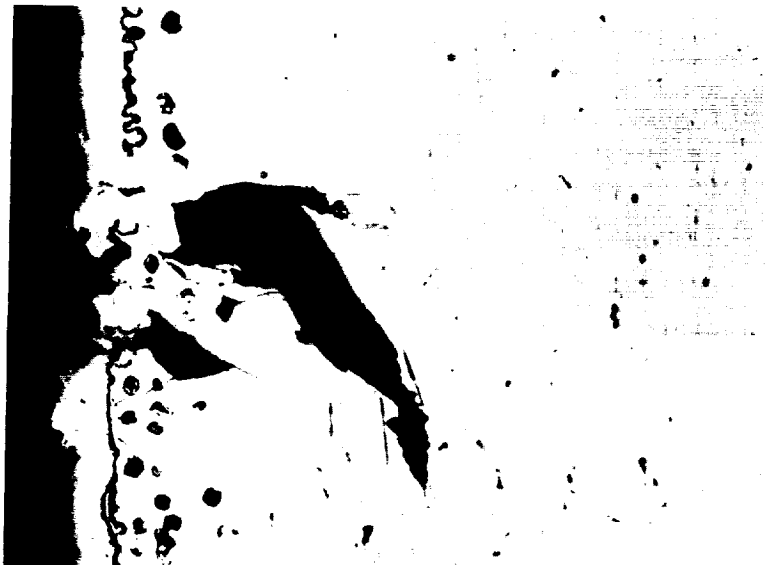
FIGURE 3-106

MAG: 250X

COATED AND EXPOSED IN ARGON AT 2100°F FOR 100 HOURS

DBTT: 1500°F

preparation, i.e., only partial removal (mechanically) of coating and/or oxide would obviously show false results due to the tremendous quantities of nitrogen in the coated surfaces after exposure. Figures 3-106 to 3-108 show photomicrographs of specimens after a successful bend test ( $105^{\circ}$ ) at the temperatures indicated. As can be seen, the cracks in the coating (perpendicular) to the surface appear to be the primary cause of the high DBTT. Specimens bent at temperatures less than those indicated in the above mentioned series of pictures show these cracks propagating into the substrate. It appears that this coating system although having greater diffusion stability than the  $2\phi$  system, is poorer with regards its DBTT after exposure. It is significant to also note, that the Fe-Al-coated specimen exposed to pure nitrogen showed results significantly improved over that seen with the  $2\phi$  coating. Although no successful bend tests ( $105^{\circ}$ ) were performed, the Fe-Al system, at least at  $2400^{\circ}\text{F}$ , shows superior resistance to nitrogen attack. Further an acicular precipitate (Figure 3-108) can be seen in this coating after exposure. This phase although extremely rich in aluminum was not clearly identified. As in the case of the  $2\phi$  coating system this Fe-Al system also owes its

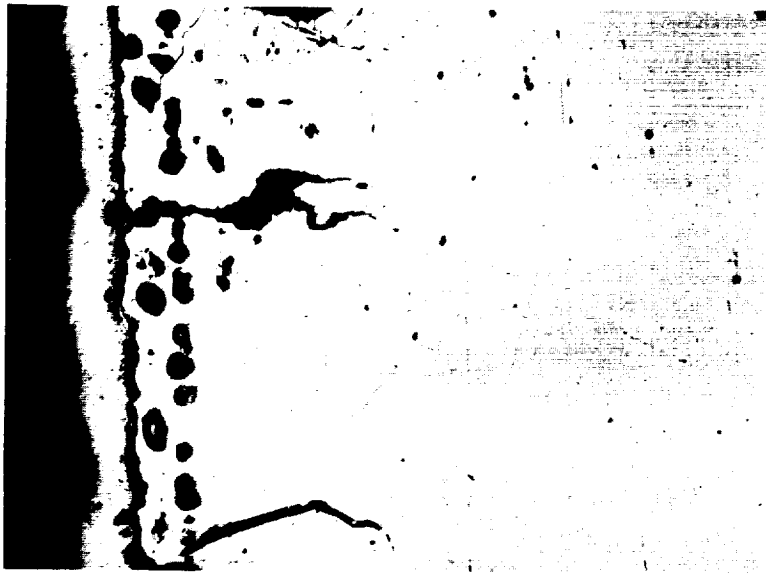
FIGURE 3-107

MAG: 250X

COATED AND EXPOSED IN ARGON AT 2100 F FOR 100 HOURS (2,2,2,16 HOUR CYCLE)
