SATURN/APOLLO SYSTEMS OFFICE

THE MERCURY-REDSTONE PROJECT

December 1964

SATURN/APOLLO SYSTEMS OFFICE
GEORGE C. MARSHALL SPACE FLIGHT CENTER
NATIONAL AERONAUTICS AND SPACE ADMINISTRATION
HUNTSVILLE, ALABAMA

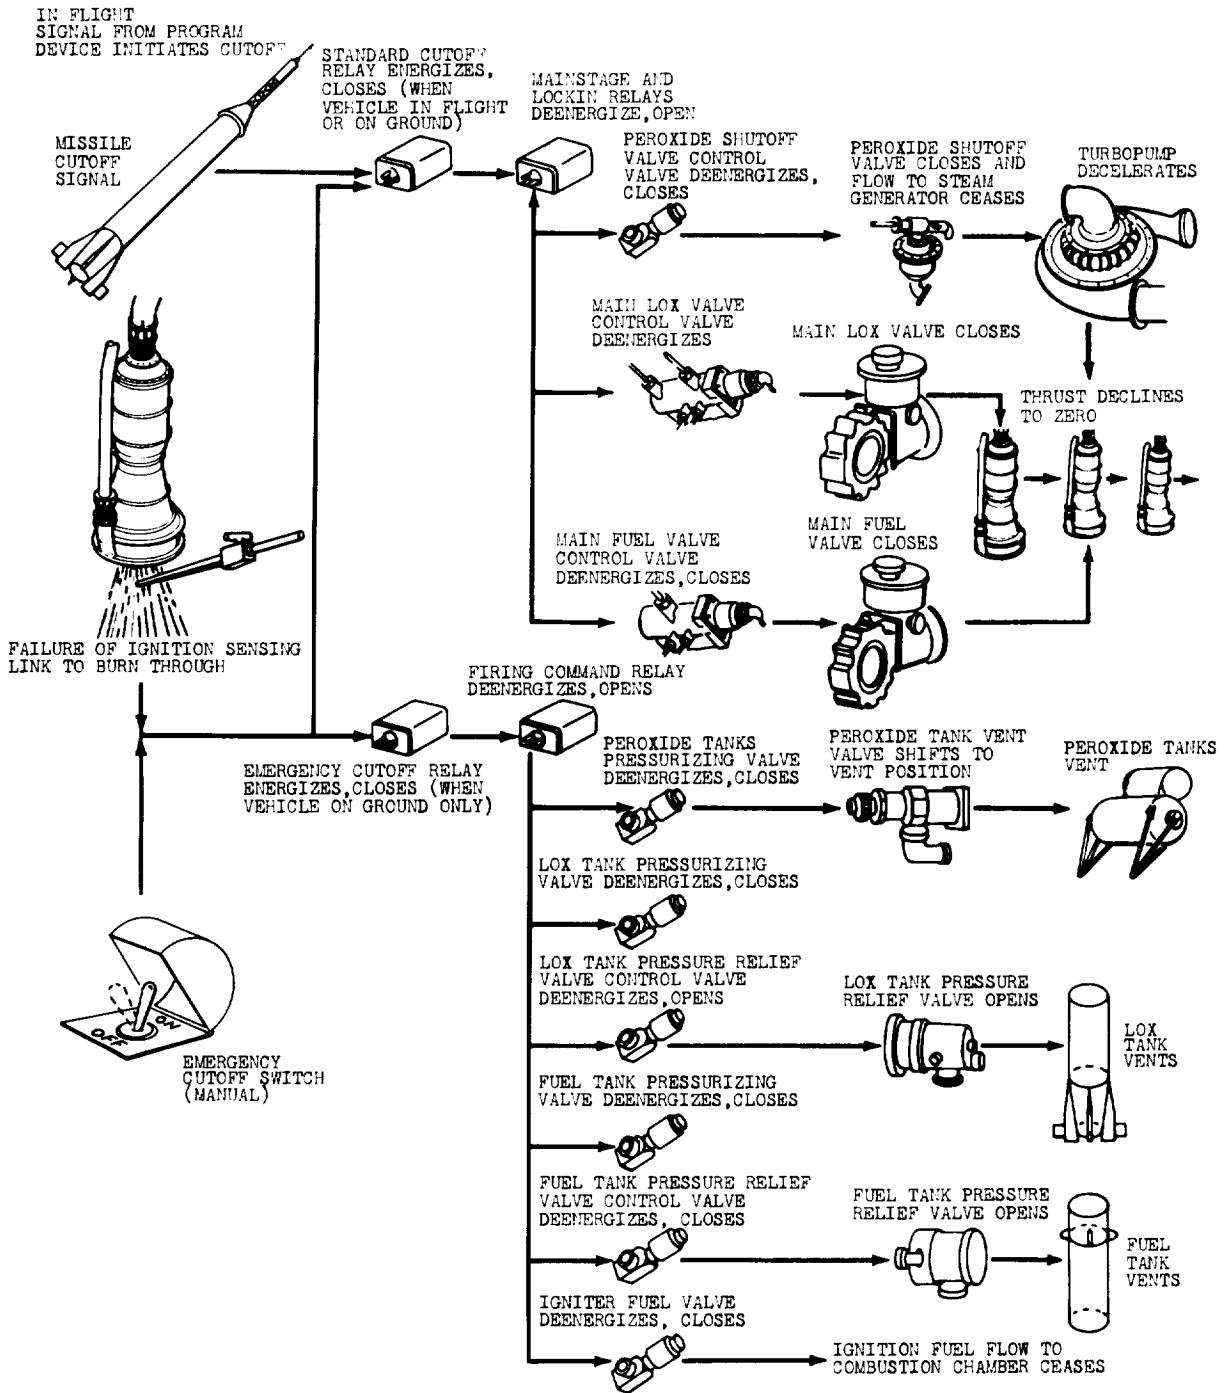
Figure 4-5. Engine Cutoff Sequence Diagram

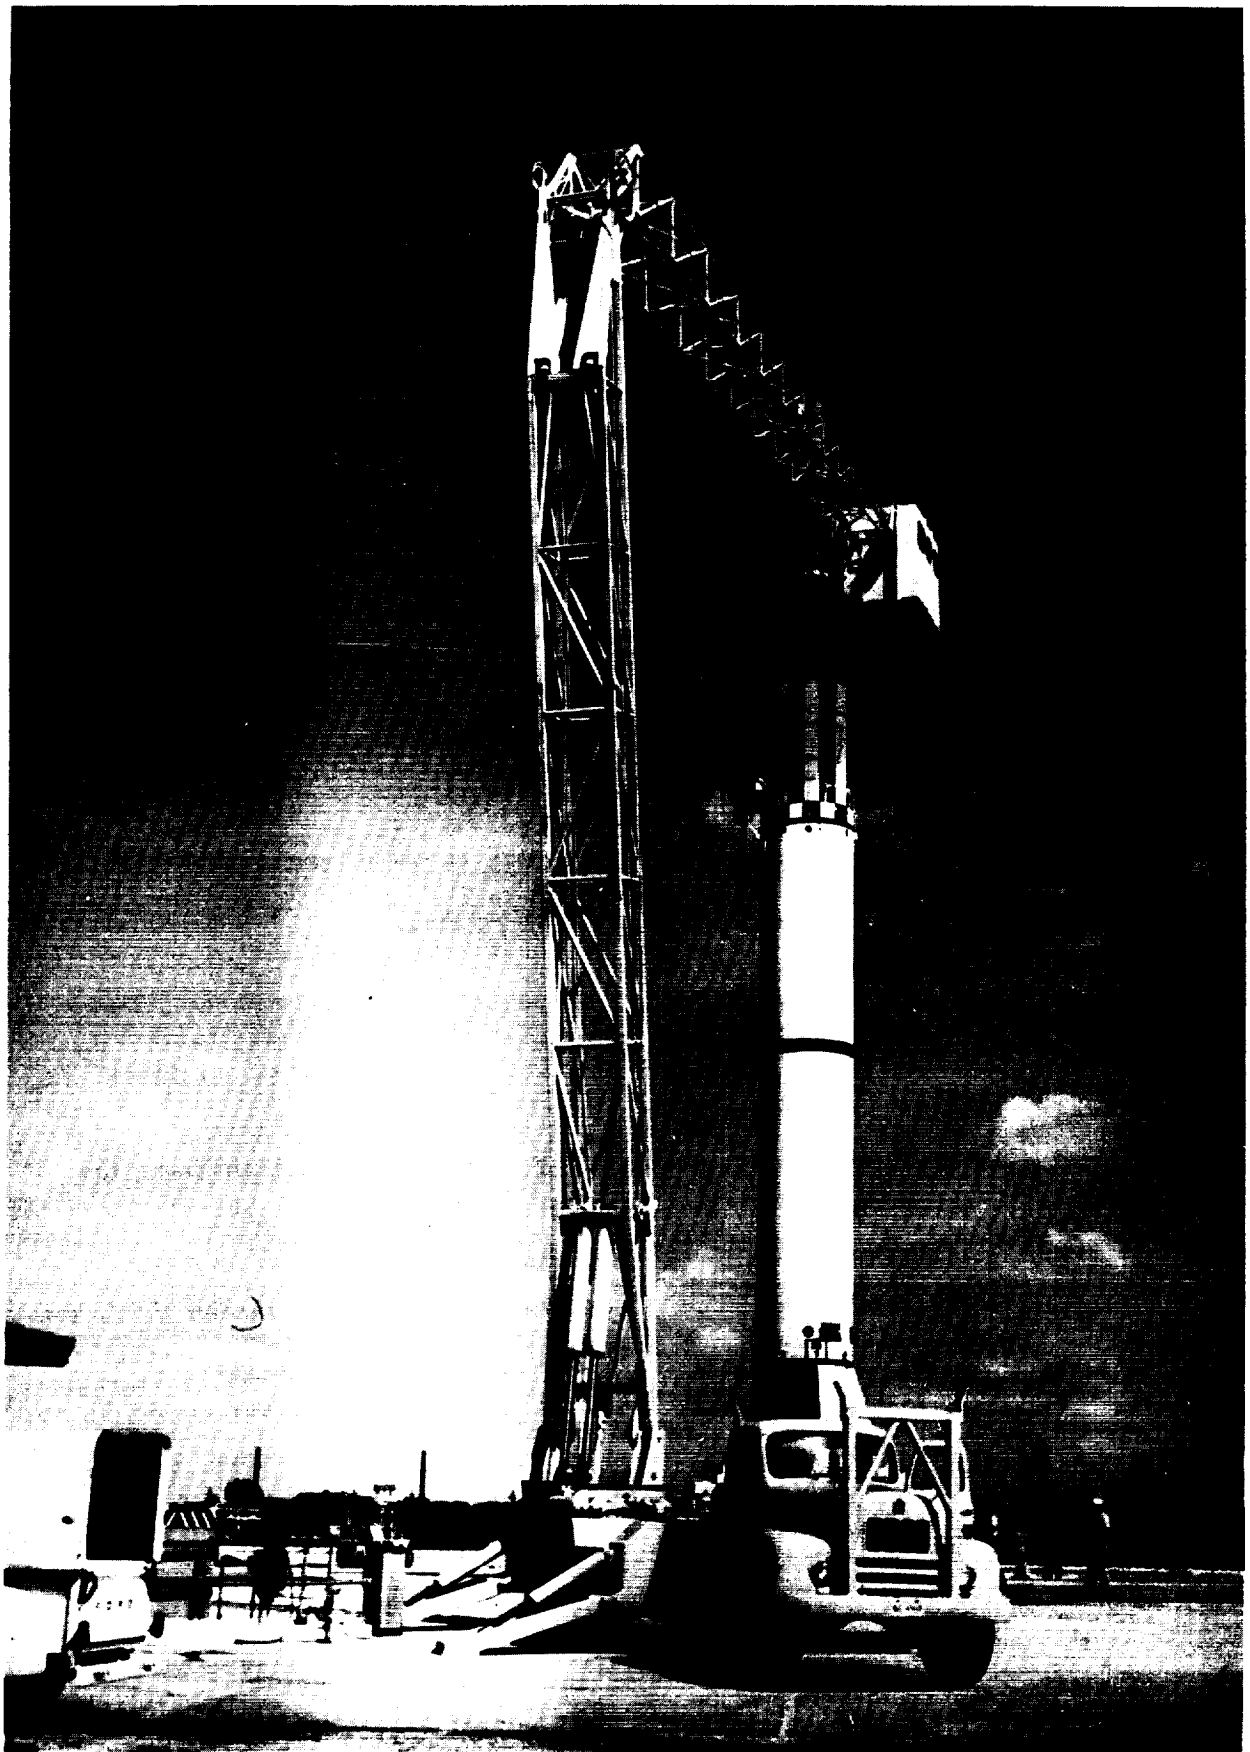
Figure 7-5. Mobile Tower (Cherry Picker)
