NASA CR-72282
GEST-2099

HIGH TEMPERATURE COMPATABILITY OF UO_2
WITH W-25 Wt % Re

R. A. Ekvall and J. O. Hegland

May 1967

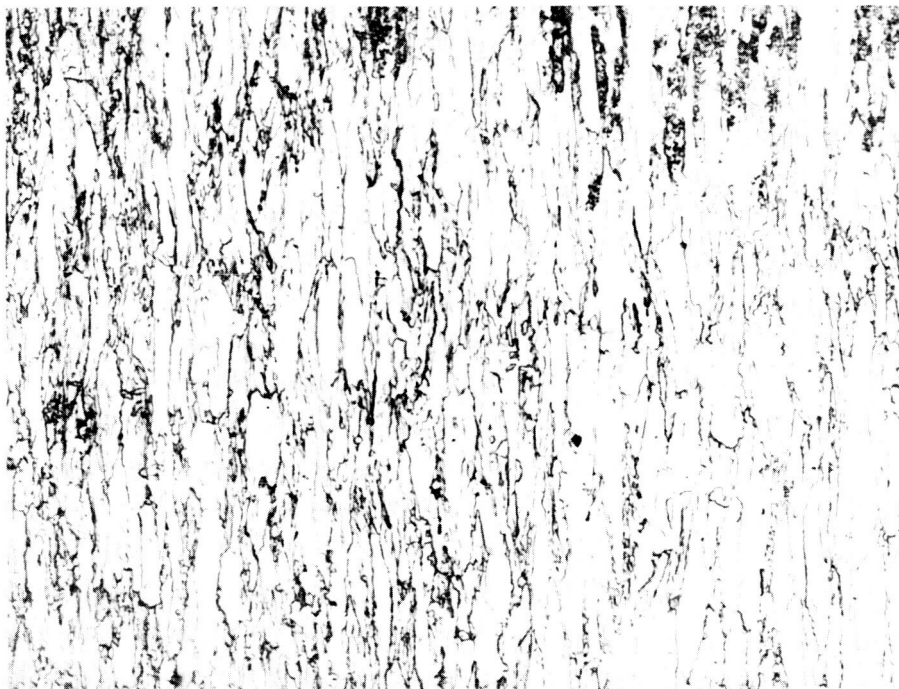
FIGURE 5. TYPICAL AS-RECEIVED W-25% RE ROD FROM HOSKINS

b. Transverse Section

a. Longitudinal Section

examined metallographically. No sigma phase was detected at 500X. Microstructures of the longitudinal and transverse sections are illustrated in Figure 4. A typical microstructure of the Hoskins W-25 wt % Re rod is shown in Figure 5. Chemical and spectrographic analyses of the material were made, and the data obtained are given in Table II. Both the rod and tube material were inspected with fluorescent penetrant (Zyglol); the tube material also was leak checked with a helium mass spectrometer leak detector.

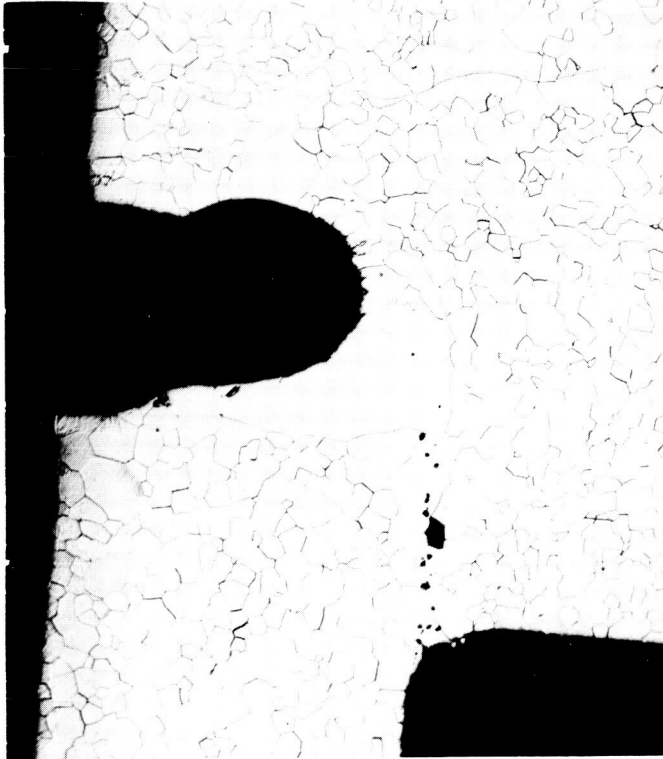
a. Capsule 3 - 500 hours

b. Capsule 4 - 1000 hours

Capsules 3 and 4, tested at 1800°C for 500 and 1000 hours, respectively, were examined. These capsules were fabricated by brazing the end caps to the tube section with a Mo-50 wt % Re alloy. There was no evidence of any UO_2 /W-25 wt % Re interactions or evidence of sigma phase. The braze areas of the capsules were examined and porosity was observed in these regions. The microstructures are shown in Figure 10. There was no

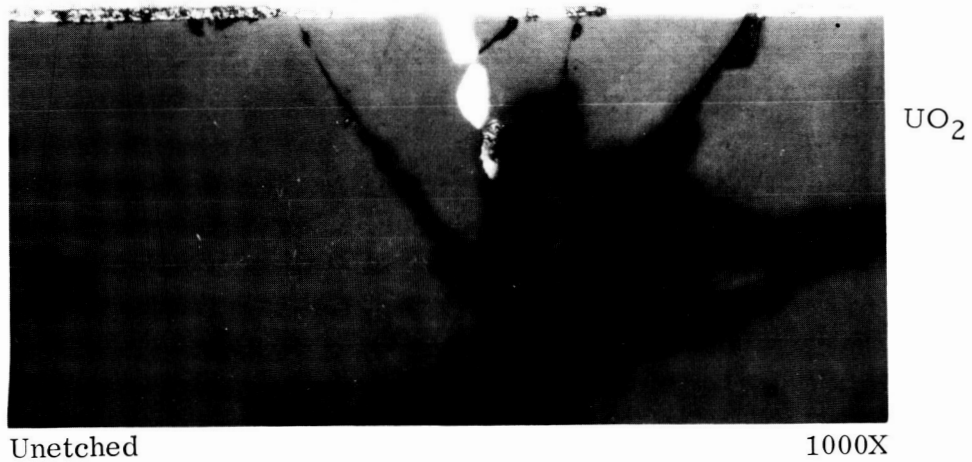
FIGURE 14. THIN LAYER OF METALLIC APPEARING PHASE ALONG THE INTERFACE BETWEEN UO₂ AND END CAP CAPSULE 11 (2200°C - 500 hours)²

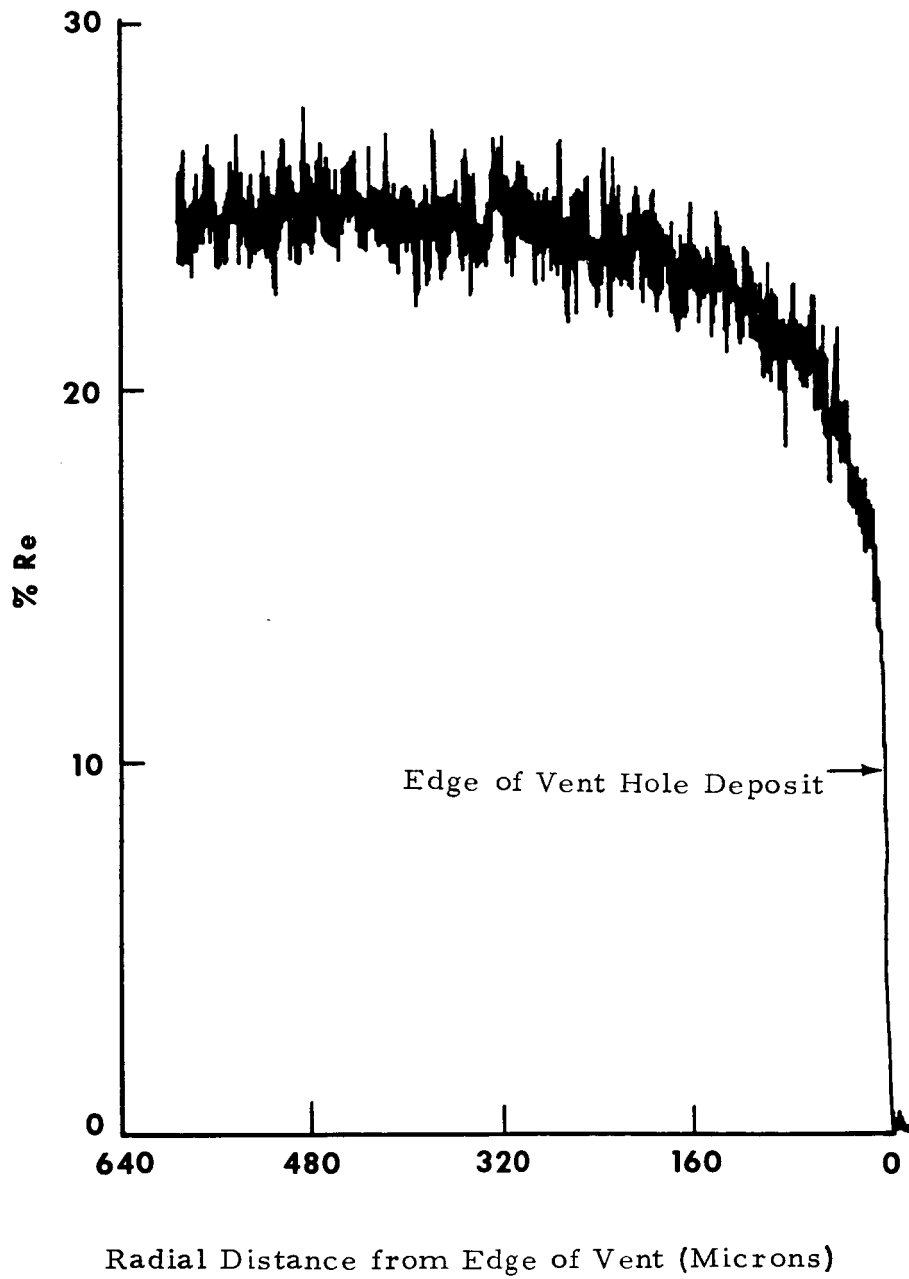
FIGURE 22. ELECTRON MICROPROBE SCAN OF RHENIUM IN TUNGSTEN/RHENIUM CAP OF CAPSULE NO. 10. (2000°C - 3000 hours)

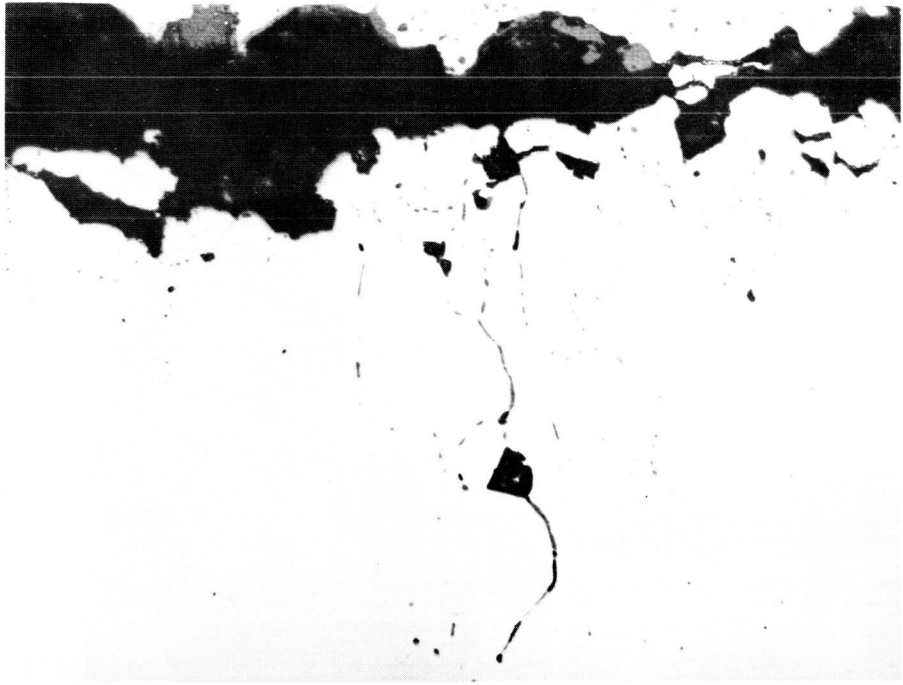
a. UO_2 (grey inclusions) found in clad wall

b. UO_2 (appears grey) found in clad above one weld gap

No gross interaction between the UO₂ and the W-Re was observed in any of the capsules; however, traces of interaction were found in capsule E. Two isolated areas showed nonmetallic inclusions in the container (identified as UO₂ by microprobe analysis). One area near the edge of the container wall had inclusions up to 5 microns (Figure 24a). The other area near one weld gap had somewhat larger inclusions (Figure 24b). It is hypothesized that the UO₂ in the container wall was the product of an excess oxygen reaction. Small pits appeared at four or five locations along the container cap after etching. It was thought that these pits may have been areas where a second metallic phase had formed. Upon repolishing capsule E in preparation for microprobe analysis, these areas disappeared and could not be identified with the microprobe.
