SEMIANNUAL REPORT NO. 3

DEVELOPMENT OF MAIN-SHAFT SEALS
FOR ADVANCED AIR-BREATHING
PROPULSION SYSTEMS

CONTRACT NAS3-7609

Pratt & Whitney Aircraft

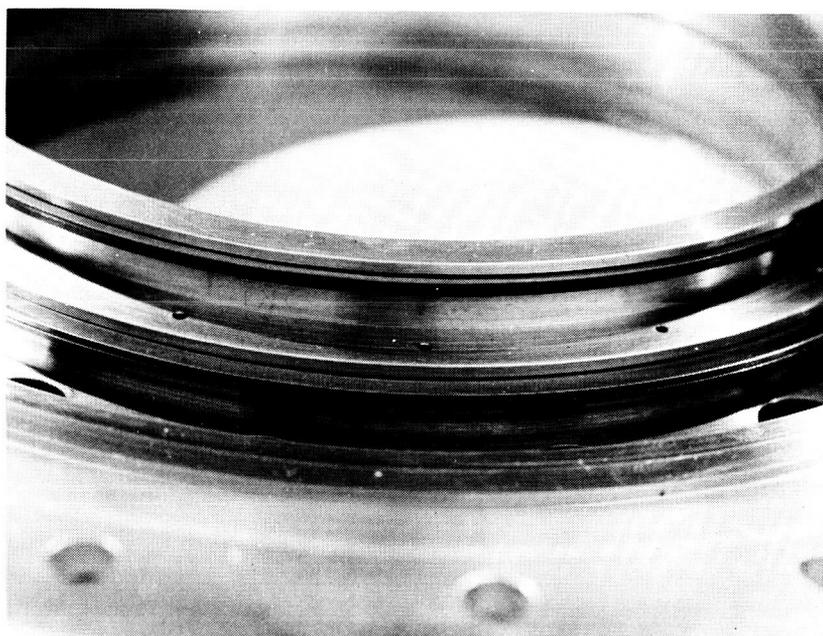
Figure 16 Close-up View of the High-Pressure Compartment of the Externally Pressurized Orifice-Compensated Hydrostatic Face Seal

The first externally pressurized hydrostatic face seal was received on December 27, 1966, and is shown in Figures 14 through 19.

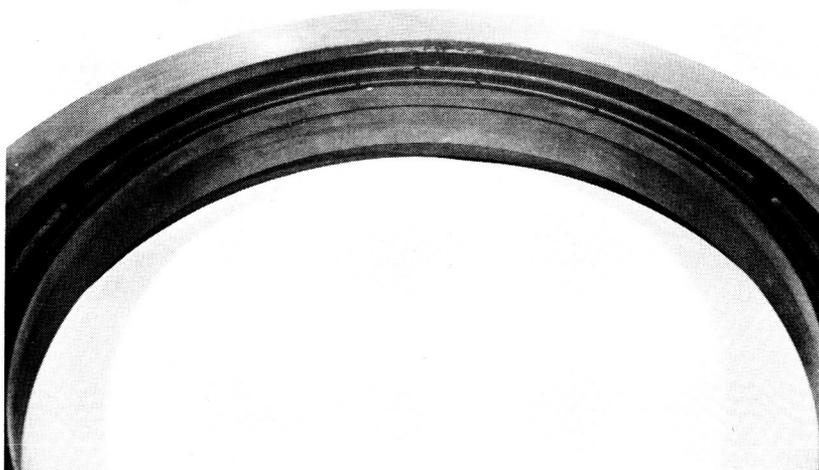
Figure 17 Close-up View of Carbon Seal Ring Assembly of the Externally Pressurized Orifice-Compensated Hydrostatic Face Seal Showing One of the Four Annular Segments With Orifice and Bleed Hole Annulus

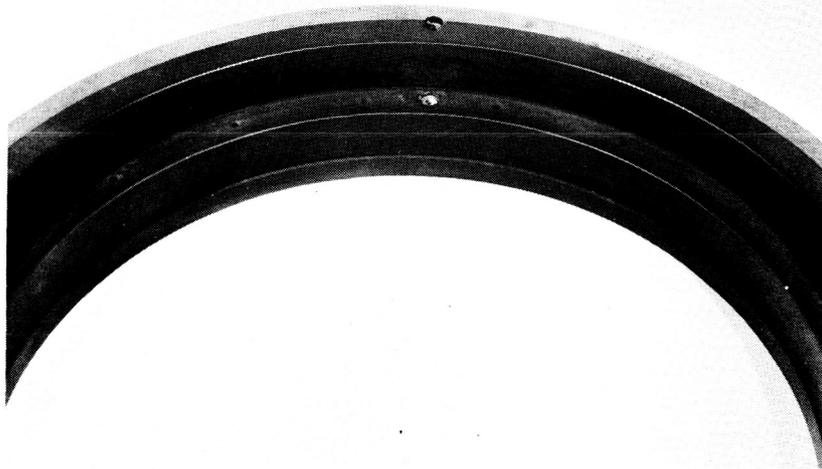
Figure 18 Close-up View of Rear of Carbon Seal Ring Assembly of the Externally Pressurized Orifice-Compensated Hydrostatic Face Seal Showing an Orifice, Bleed Holes Without Orifice, and Anti-Torque Pin Hole
CN-7470

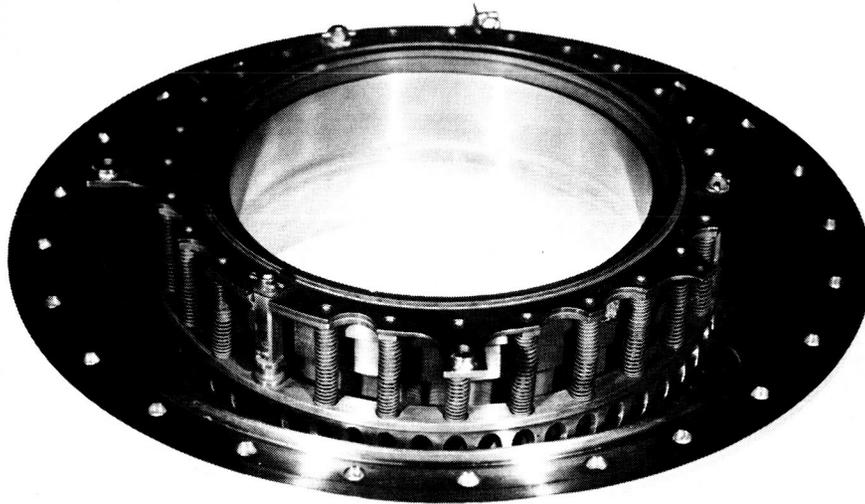
Figure 38 Carbon Face Seal With Piston-Ring Secondary Seal After 9.75 Hours of Simulated Engine Operation (Build 4) XP-68849

Build 4 - Subsequently, the carbon seal lip was machined to the proper dimensions, lapped, and reinstalled in the rig. Testing was resumed on Build 4, and the results obtained are shown in Figure 37. The seal performed well for 9.75 hours when an abnormal increase in air leakage rate caused the breather temperature and pressure to increase excessively. At the time of the increase, the seal was being tested at a rubbing speed of 400 ft/sec, a pressure differential of 160 psi, air at 1000°F, and oil at 325°F. Post-test examination revealed that the carbon lip surface was in an unsatisfactory condition. Carbon wear was 2 mils for 9.75 hours of testing. The seal plate also showed some signs of wear in the carbon lip wear track. The appearance of the seal assembly after Build 4 testing is shown in Figures 38 and 39.

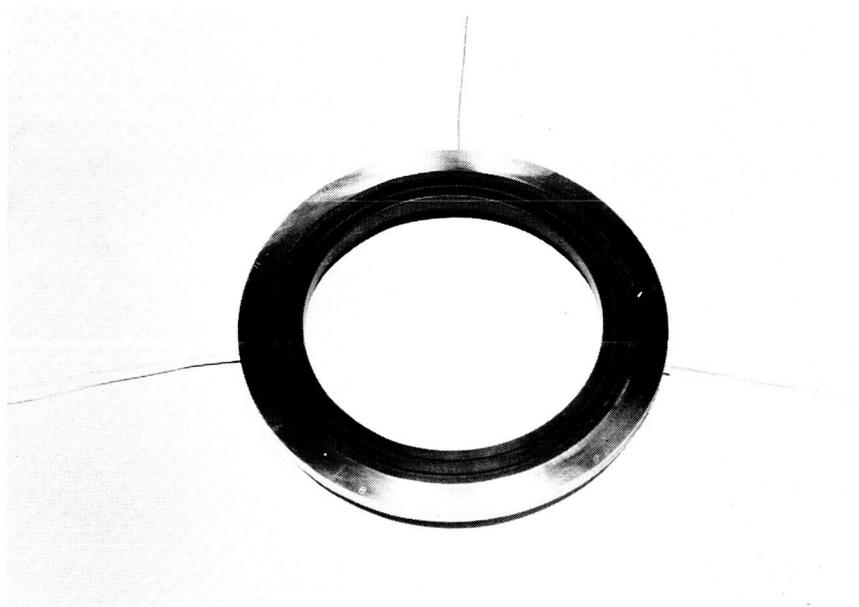
Figure 45 Carbon Seal Ring of Orifice-Compensated Hydrostatic Seal (Build 4) Instrumented for Measuring Annulus Pressures CN-7078

Inspection of the seal revealed a smooth lapped wear path on the outer lip of the carbon, whereas the inner lip was worn and rough. The outer edge of the seal plate face was polished, but the inner edge showed four, distinct, equidistant burn marks.

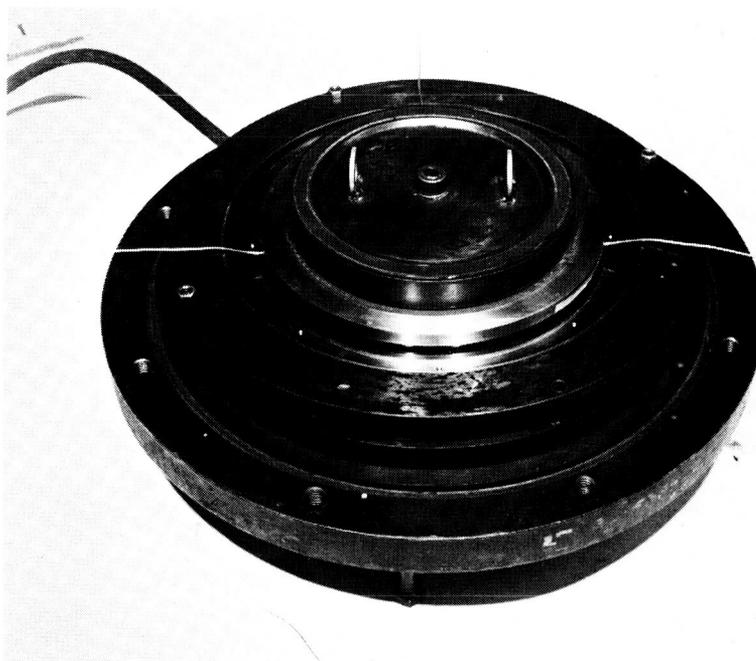
Figure 46 Orifice-Compensated Hydrostatic Seal (Build 4) Instrumented for Measuring Annulus Pressures CN-7077
