# RESEARCH REPORT

## BATTELLE MEMORIAL INSTITUTE

The present report describes the results of a literature and industrial survey of reportedly low-hydrogen-embrittling and nonhydrogen-embrittling cleaning, pickling, and electroplating processes (including cadmium, chromium, and nickel electroplating) and of various hydrogen-embrittlement relief treatments. No attempt has been made to repeat the information on the embrittling effects of conventional processes in the present report. However, it was found desirable to include some reference to work described previously (especially in the area of cleaning processes) to provide necessary background information or to make desirable comparisons.

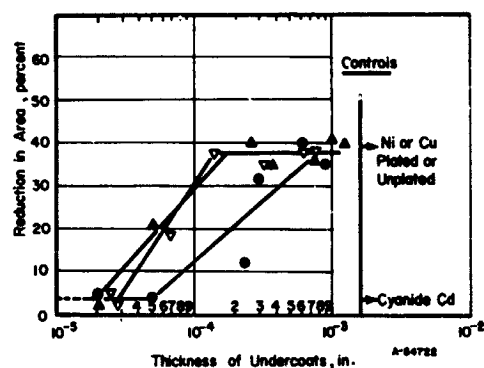
- ▽ Pyrophosphate copper undercoat
- ▲ Bright Watts nickel undercoat
- Sulfamate nickel undercoat

FIGURE 4. THE EFFECT OF COPPER AND NICKEL UNDERCOATS OVERPLATED WITH CYANIDE CADMIUM ON TENSILE DUCTILITY(28)

Reduction in Area on 0.505-in. -diam Tensile Bars  
 Rate of cross-head travel from yield to ultimate =  
 0.1 in. /min.

Strain rate to yield maintained at 0.05 in. /in. /min.

Results of tensile tests of specimens with copper and nickel undercoats overplated with cyanide cadmium are shown in Figure 4. It is shown that there is a minimum thickness of undercoat that must be exceeded before the beneficial effect of the undercoat is obtained. Also, the ductility of the specimens increased rapidly with increased undercoat thickness, until the ductility (reduction in area) of the specimen plated with copper or nickel alone is achieved.
