DEVELOPMENT OF ELECTRICAL SWITCHGEAR FOR SPACE NUCLEAR ELECTRICAL SYSTEMS

QUARTERLY PROGRESS REPORT NO. 6

For Period: March 4, 1966 Thru June 4, 1966

SPACE POWER AND PROPULSION SECTION
MISSILE AND SPACE DIVISION
GENERAL ELECTRIC COMPANY
CINCINNATI, OHIO 45215

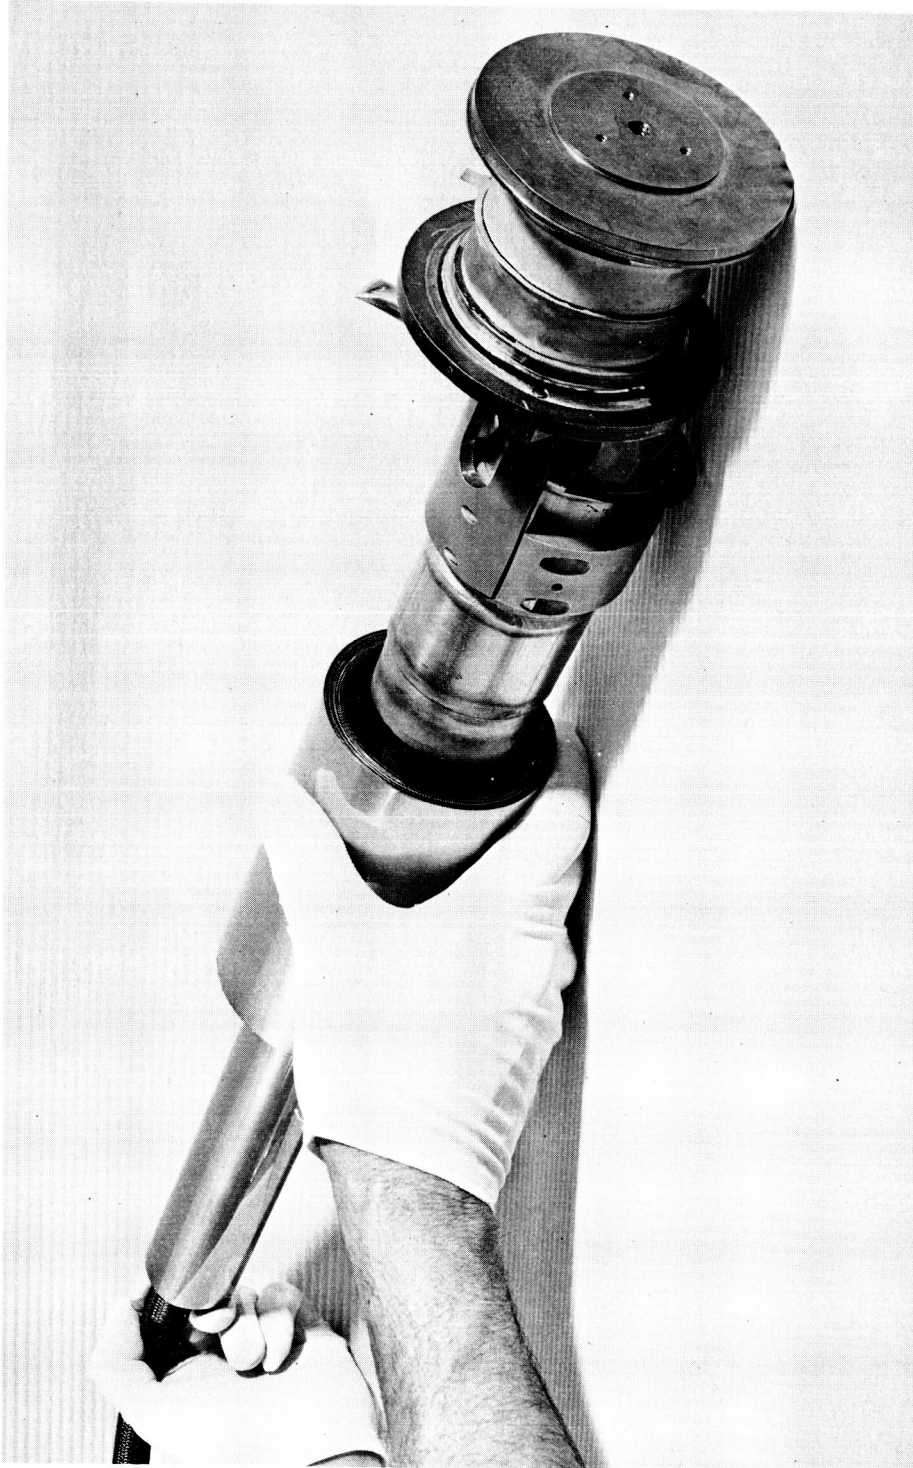
Figure 5. Fifteen Layer Heat Shield Being Slid Over Ion Pump Air Line and Enclosure, Attached to Vacuum Cansole.

To prepare the vacuum capsule and pump for assembly into the interrupter unit, the heat shield was put in place around the pump housing. Figure 5 shows the technician sliding the previously built shield assembly over the pump enclosure. The shield is made of 15 layers of .003" thick stainless steel with .014" diameter nichrome wire as separation between layers. This design followed the requirements given in detail in the Fourth Quarterly Report.

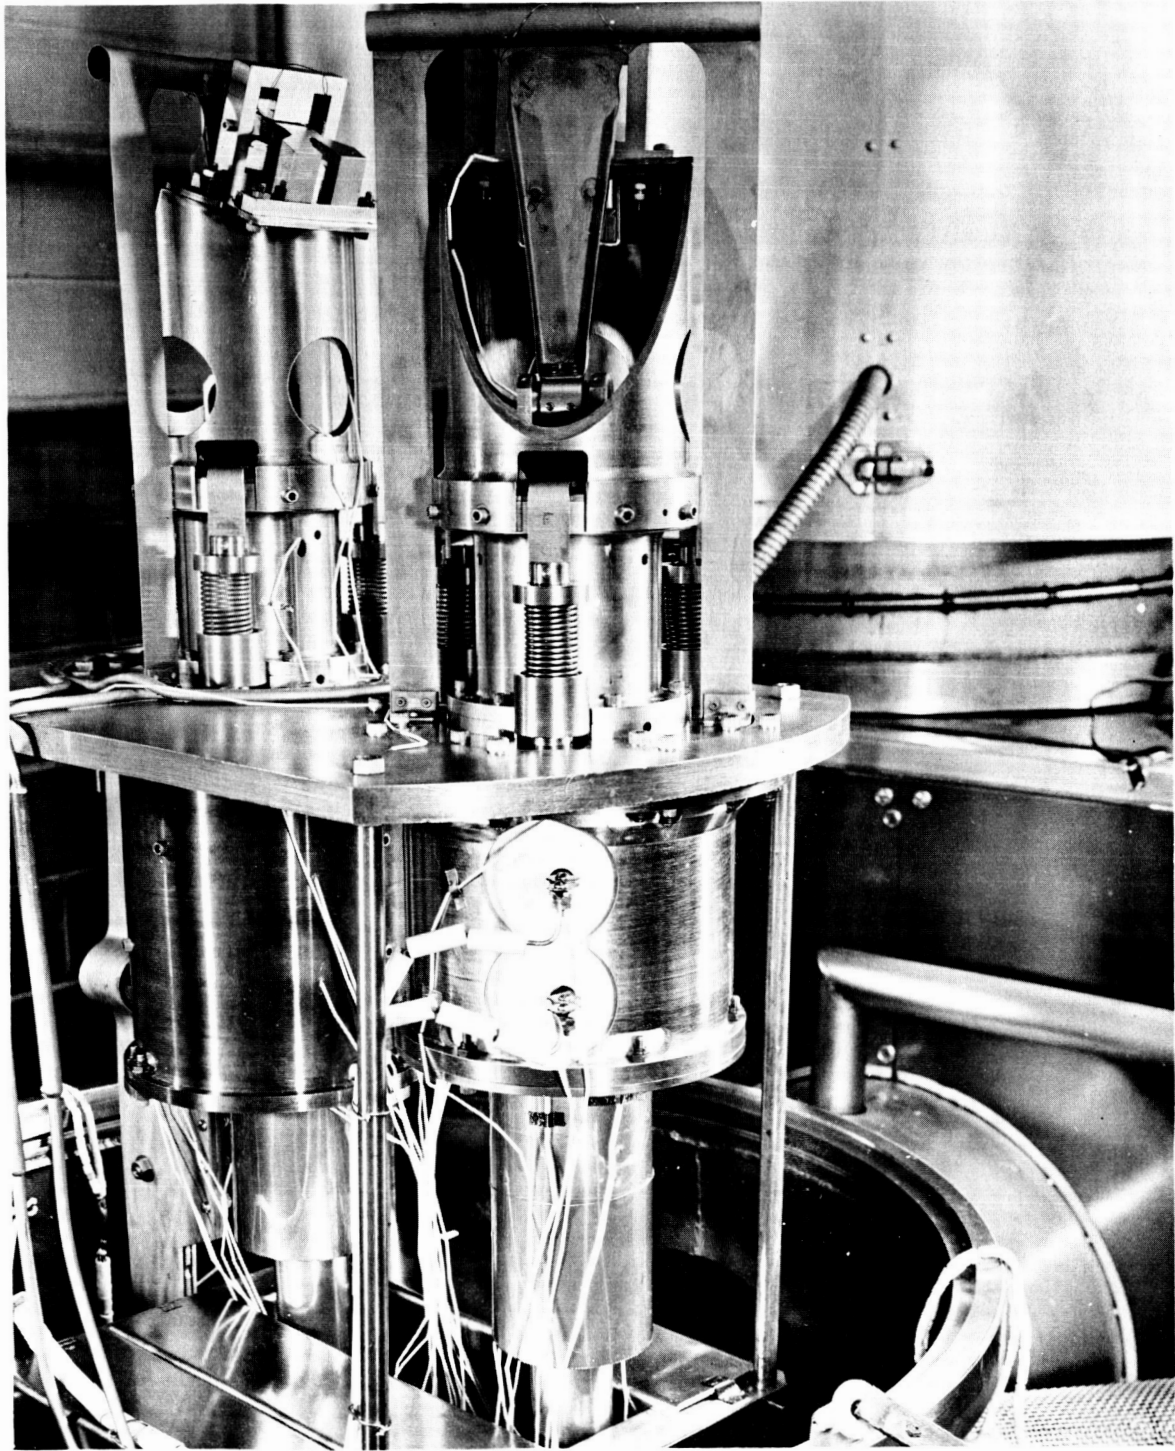
Figure 13. Close-Up of AC Breaker (left) and DC Contactor (right) Set Up in Vacuum Tank, with Heat Sink Supported on Oven Bottom, Just Before Closing Oven for Heat Run Test.
