SUPERSONIC TRANSPORT LUBRICATION SYSTEM INVESTIGATION

W. L. Rhoads and L. B. Sibley

NATIONAL AERONAUTICS AND SPACE ADMINISTRATION

CONTRACT NAS3-6267

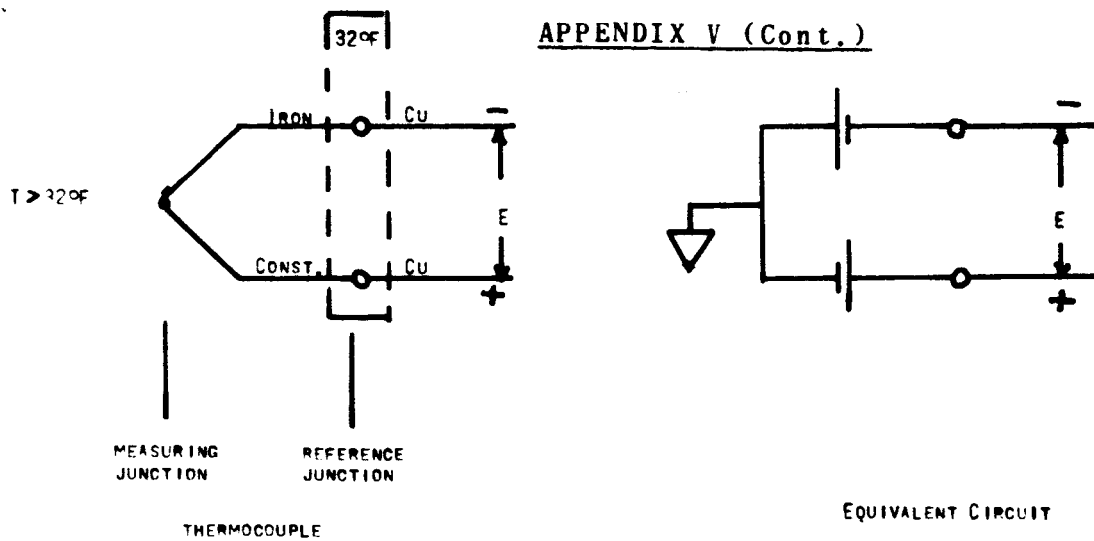
Figure 1 Equivalent Circuit for I-C Couple

Therefore, the emf measured at the reference junction (point 6) will be equal to the emf generated by an I-C couple having junctions at 600°F and 150°F plus the emf of a similar couple with junctions at 100°F and 32°F. The temperature measured through the slip rings will, therefore, be lower than the temperature at the measuring junction (point 1) by an amount equal to the temperature difference between points 2 and 5. Thus the use of stainless steel (or copper) slip rings in the thermocouple assembly will always result in a measurement error equal to the difference between the temperatures of the rotating and stationary connectors. This error can, of course, be corrected if the temperature at each connector is known.

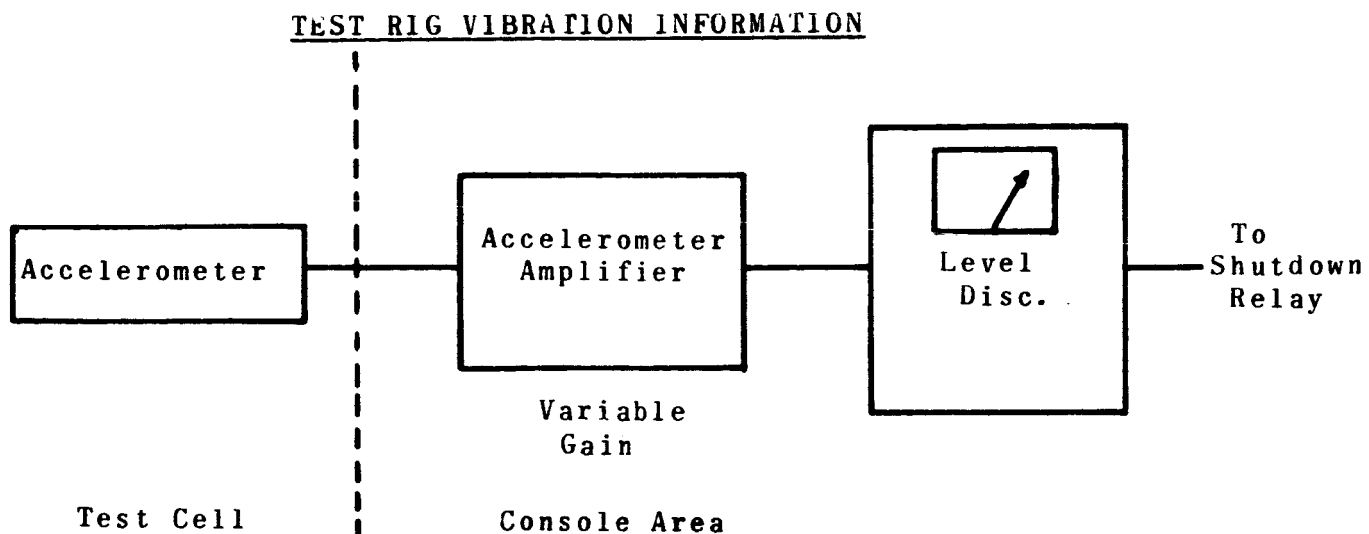
Figure 1

Vibration Measurement Block Diagram

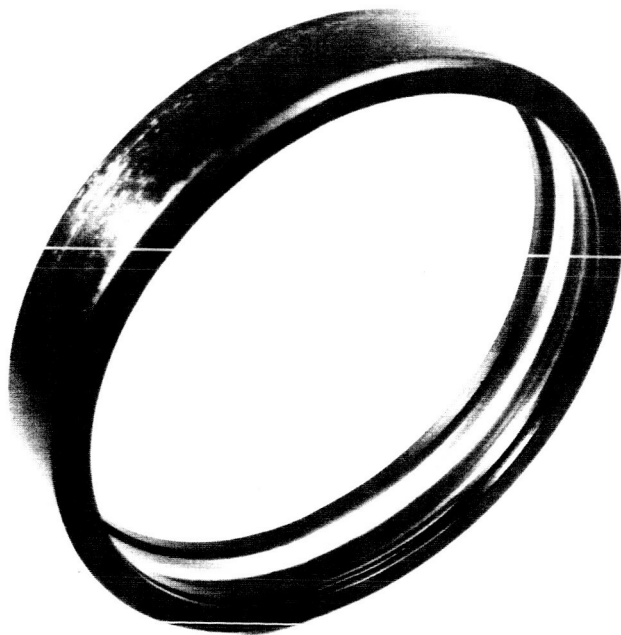
ENCLSOURE 24

TEST INNER AND OUTER RINGS OF FIRST 600°F ESSO  
4040 FAILURE IN RECIRCULATING RIG

Note Beginning of Surface Distress on Inner Ring

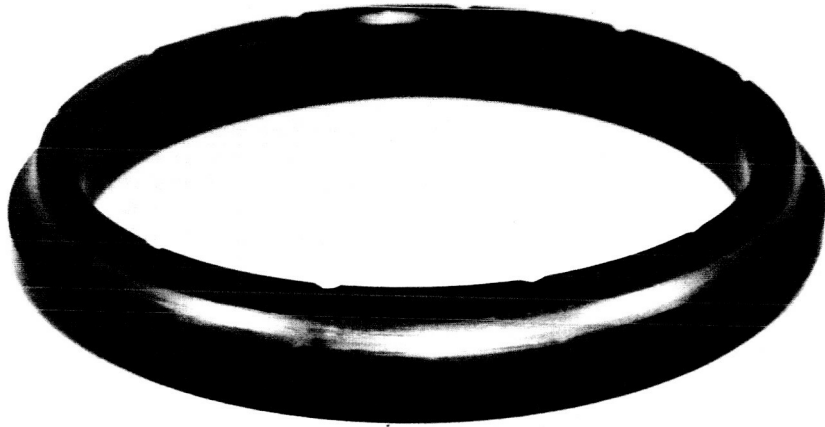
ENCLOSURE 26

TEST INNER AND OUTER RINGS OF SECOND 600°F ESSO  
4040 FAILURE IN RECIRCULATING RIG

Note Distress and Wear Due to Cage Contact on Outer Ring

Wear band  
due to cage  
contact

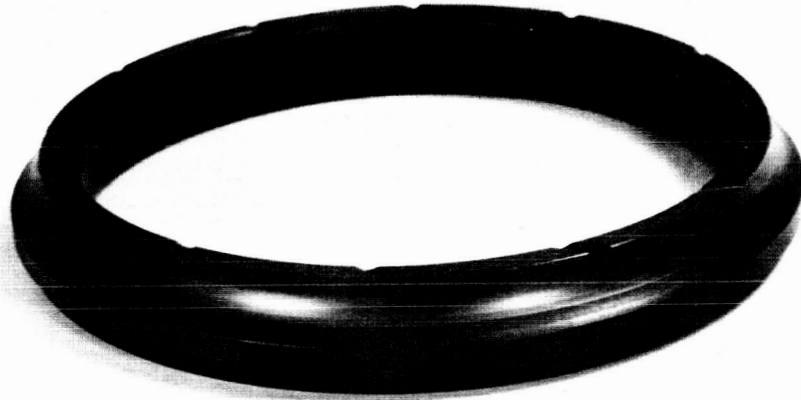
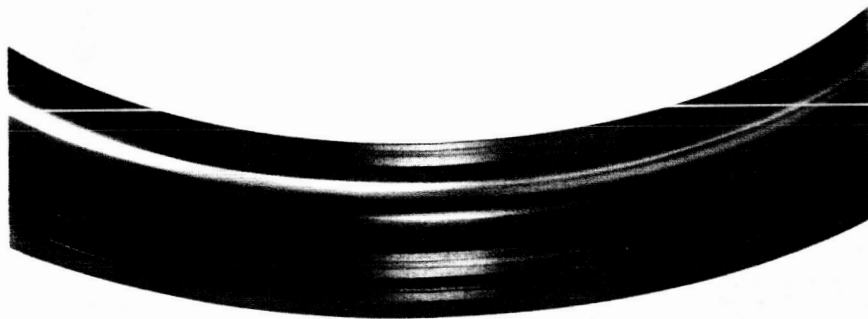
ENCLOSURE 28

TEST INNER AND OUTER RINGS AFTER 600°F MOBIL  
XRM 177F SCREENING TEST IN RECIRCULATING RIG

Note Good Condition With Slight Cage Land Wear On Outer Ring

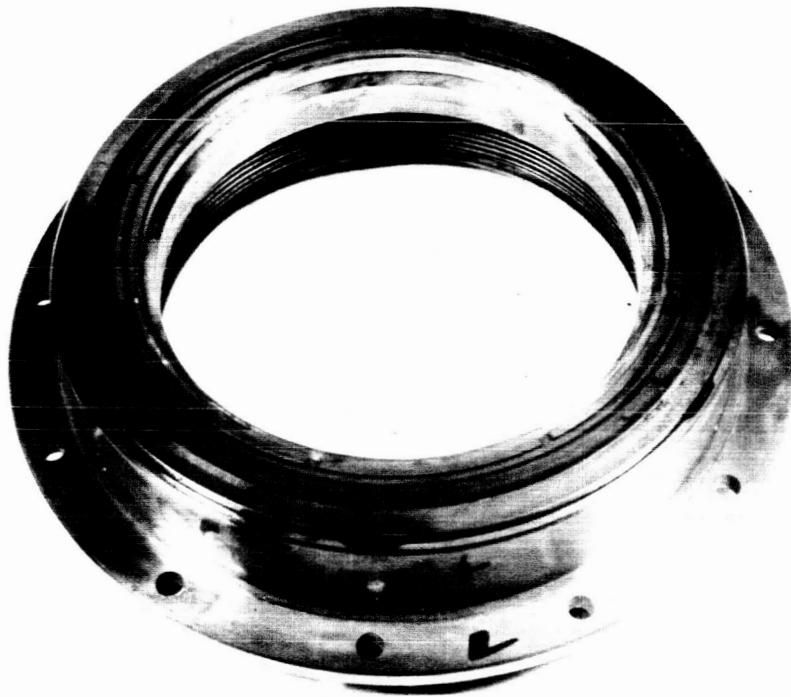
ENCLOSURE 35

AIR SEAL AND RUNNER AFTER 600°F SINCLAIR TURBO S  
SCREENING TEST IN RECIRCULATING RIG

coked oil

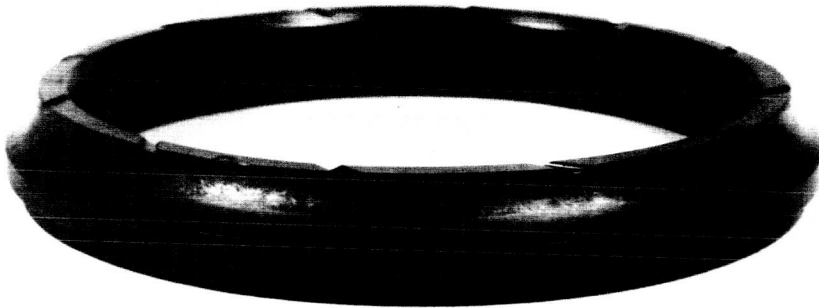
ENCLOSURE 38

TEST INNER AND OUTER RINGS AFTER 600°F FAILURE  
IN RECIRCULATING RIG USING MONSANTO MCS-293 UNDER A NITROGEN BLANKET

Note Severe Damage

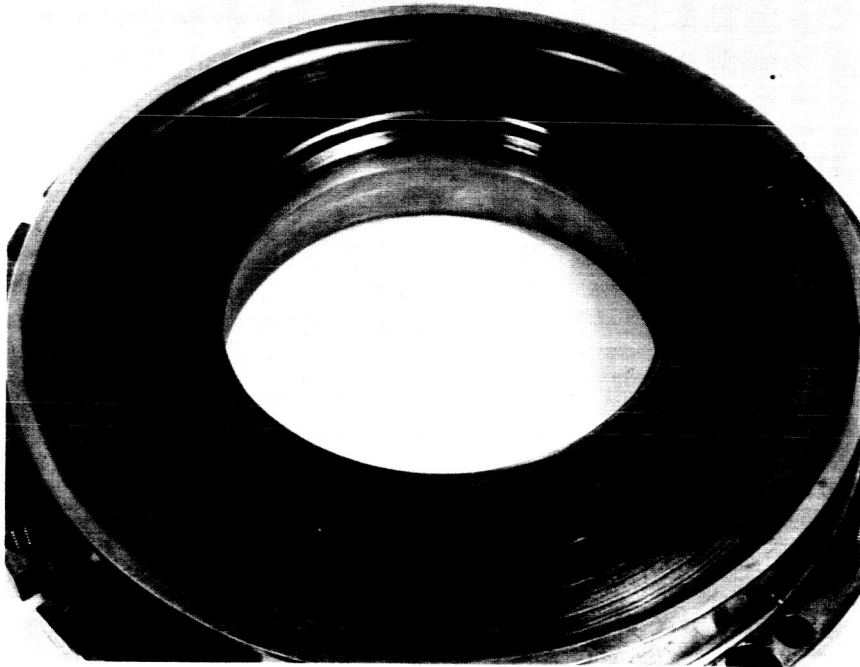
ENCLOSURE 40

OIL SEAL AND RUNNER AFTER 600°F MONSANTO MCS-293  
TEST UNDER NITROGEN BLANKET IN RECIRCULATING RIG

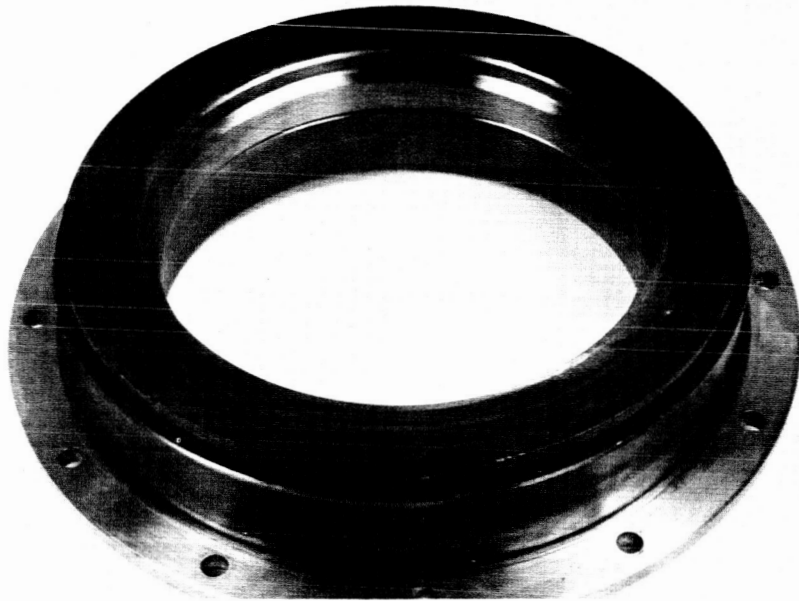
ENCLOSURE 44

OIL SEAL AND RUNNER AFTER 600°F MONSANTO MCS-293  
OPEN ATMOSPHERE SCREENING TEST IN RECIRCULATING RIG

Note Some Distress on Runner

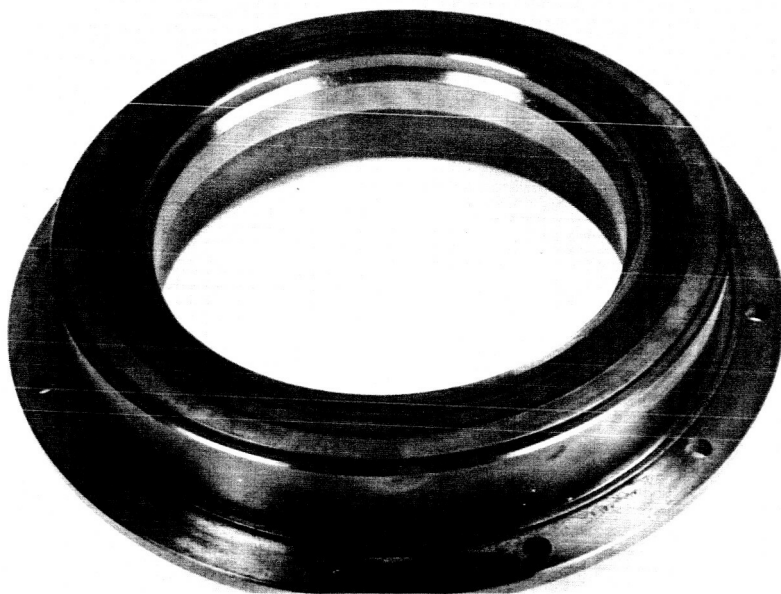
ENCLOSURE 45

AIR SEAL AND RUNNER AFTER 600°F MONSANTO MCS-293  
OPEN ATMOSPHERE SCREENING TEST IN RECIRCULATING RIG

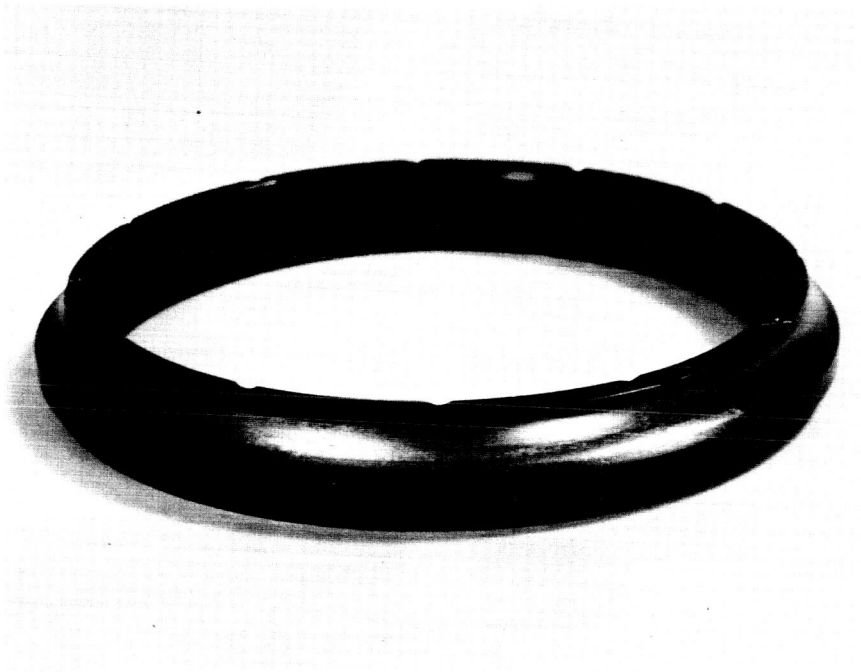
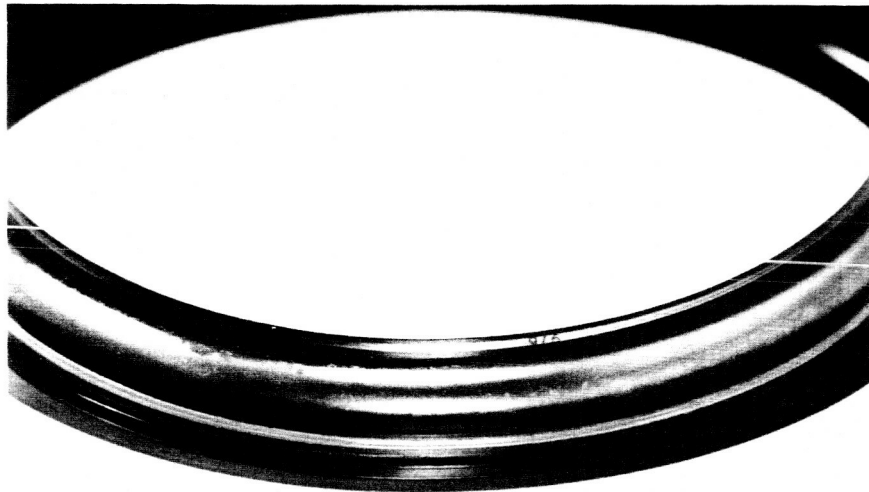
ENCLOSURE 46

TEST INNER AND OUTER RINGS AFTER FAILURE  
IN MIST RIG USING ESSO 4040

Note Severe Land Wear on Outer Ring
