## INDUCTION PROCESSED SEPARABLE TUBULAR BRAZED CONNECTORS

*by V. Hunt*

*Prepared by*  
AEROJET-GENERAL CORPORATION  
Sacramento, Calif.  
*for Lewis Research Center*

NATIONAL AERONAUTICS AND SPACE ADMINISTRATION • WASHINGTON, D. C. • JULY 1966

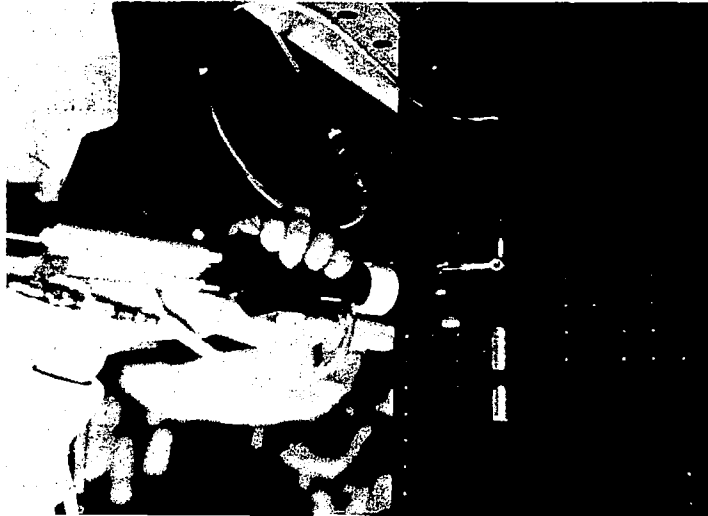
FIGURE 11

A single tube joint fixtured in the vertical position. This set-up was used to develop the brazing cycle to qualify the special braze tool. Also shown are argon gas purge lines to the braze tool and lower end of the joint. The clamp below the tool was used to prevent mislocation of the braze tool.

Single Tube Joint  
Fixtured in Vertical Plane

A single tube joint fixtured in the vertical plane is shown in Figure 11. This set-up was used to establish the process variables required to produce satisfactory brazed joints. The established brazing cycle was used to qualify the special plier-type braze tool with the tubes fixtured in the previously described multiple tube holding fixture.
