P&WA CNLM-5208  
QUARTERLY PROGRESS REPORT NO. 3  
January 2, 1964 to March 31, 1964

INVESTIGATION OF CAVITATION DAMAGE OF MECHANICAL PUMP  
IMPELLERS OPERATING IN LIQUID METAL SPACE POWER LOOPS

R. S. Kulp, Assistant Project Engineer  
J. V. Altieri, Senior Experimental Engineer

CONTRACT NAS3-2541

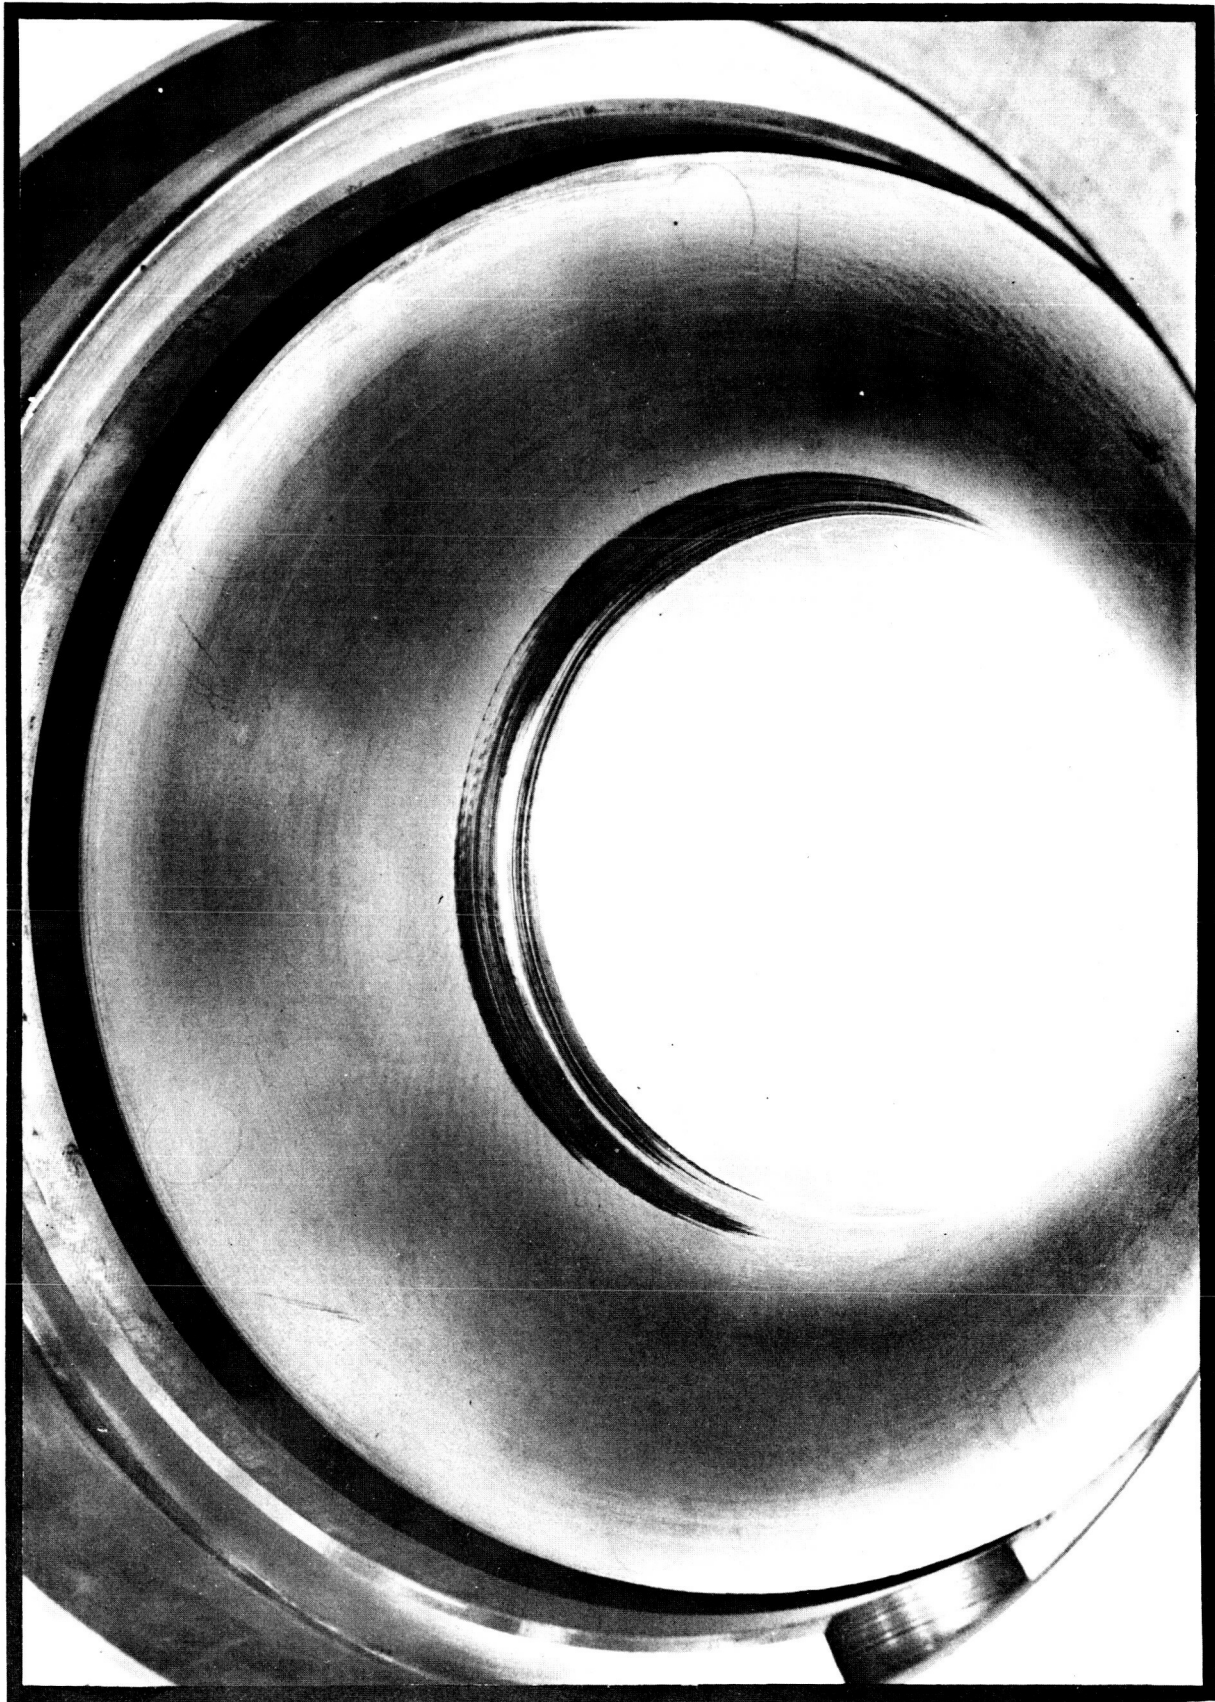
FIG 10  
IMPELLER RUB MARKS IN PUMP SCROLL AFTER  
TEST IN PT-4 STAND

The TP-1 turbopump was removed from PT-4 test stand at the completion of the orifice calibrations. The pump was partially disassembled and inspected for unusual seal wear or any indications of impending trouble. It was noted at this time that the impeller had rubbed lightly against the scroll adapter at some time during the PT-4 tests. Figures 9 and 10 are photographs of the scroll adapter and impeller showing the rub marks.

In neither case do the rub marks go completely around either part. This would indicate that rubbing contact was made during a synchronous transient condition. It is considered likely that the rubbing contact occurred during the period of severe vibration that existed when the originally calculated orifice was being tested. The upper portion of the turbopump was rigidly fixed to the air supply line and exhaust which allowed the pump shaft and housing to deflect under the imposed loads. The wear marks were smoothed off, but not entirely eliminated, by hand-working.
