# STRESS CORROSION CRACKING OF TITANIUM ALLOYS

## PROGRESS REPORT: APRIL 1 - JUNE 30, 1964

P. H. Permar, Research Manager  
Pile Materials Division

National Aeronautics and Space Administration  
Work performed under NASA Purchase Order No. R-124,  
Issued to the United States Atomic Energy Commission

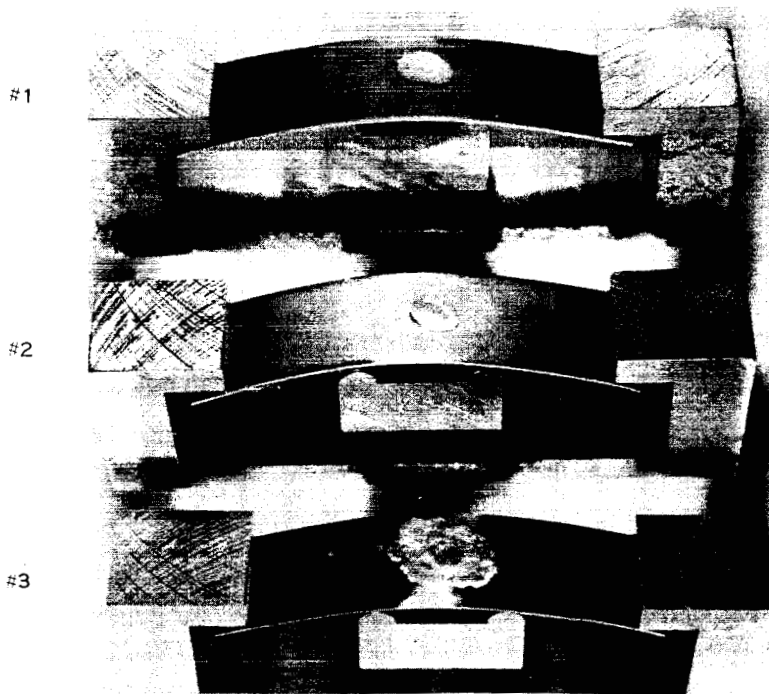
FIGURE 1. SAMPLES OF Ti-8Al-1Mo-1V ALLOY (with deposits of radioactive sea salt) STRESSED TO APPROXIMATELY 144,000 PSI AND HEATED FOR ONE WEEK AT 650°F 1X

Sample surfaces were prepared as follows:

- #1 As-rolled, chemically cleaned with standard procedure\*.
- #2 As-rolled, chemically cleaned with standard procedure except time in HNO<sub>3</sub> was 10 min.
- #3 As-rolled, mechanically polished through 6-micron diamond abrasive.

- (a) Clean with acetone and cloth
- (b) Immerse in NaOH base cleaner (6 oz. NaOH per gallon of water) at 300°F for 10 minutes
- (c) Rinse in hot water
- (d) Dip in 20% nitric acid solution for 30 seconds
- (e) Rinse thoroughly in water and dry

A series of tests was conducted to determine if chloride is concentrated in the surface oxide film and/or the corrosion products at sites of stress corrosion cracking. Deposits of radioactive sea salt were placed on test strips, which were then stressed to approximately 90,000 psi and heated for one week at 650°F. Samples of the alloy with different surface conditions were tested (Figure 1). After hot-salt exposure, the salt was rinsed off and the samples were scanned in a beta radiation counter. Traces of radioactivity were detected on each sample (Figure 2), but no significant concentration of chloride was indicated in the surface oxide. Tiny cracks and pits (visible at magnifications of 10X and higher) were observed around the edge of the salt-coated area on one sample that had been polished through 6-micron diamond abrasive prior to salt exposure (Figure 3). They did not occur where the salt deposit was thickest, which is in agreement with observations by other workers and suggests that atmospheric oxygen may be involved.

Counts per minute over 3-minute counting period on samples shown in Figure 1. Shaded areas indicate salt deposits which were rinsed off prior to counting.

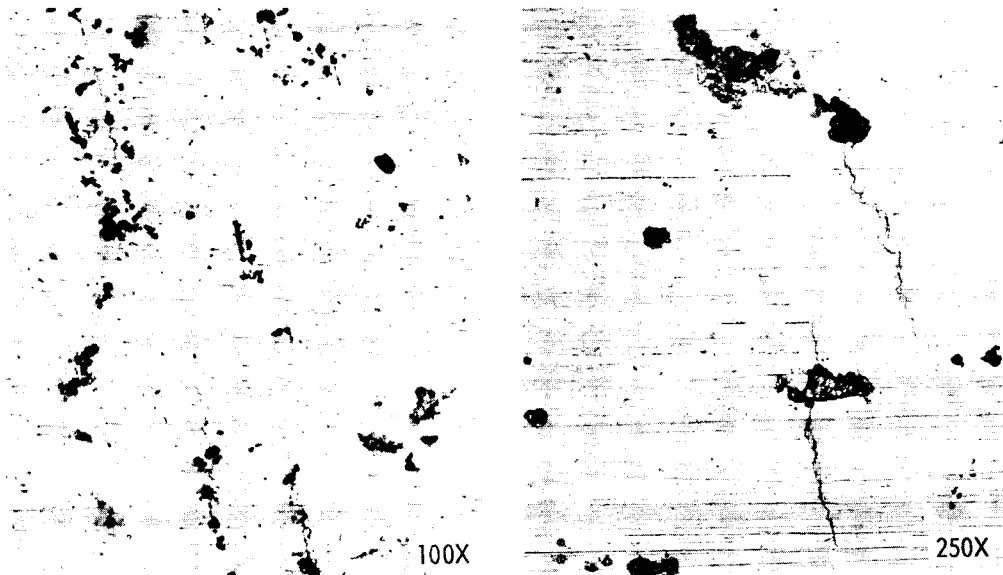
FIGURE 3. PITTING AND CRACKING CAUSED BY SEA SALT ON STRESSED Ti-8Al-1Mo-1V ALLOY (Sample #3, Figure 1)

The time required for initiation of the observed corrosion pitting and cracking has not been determined, but the attack may start very early in the hot-salt exposure. If HCl gas is given off during salt dehydration, some sodium hydroxide must be produced in the salt. Either the HCl or the NaOH may cause the initial attack. Experiments are continuing to determine how the corrosion is initiated.

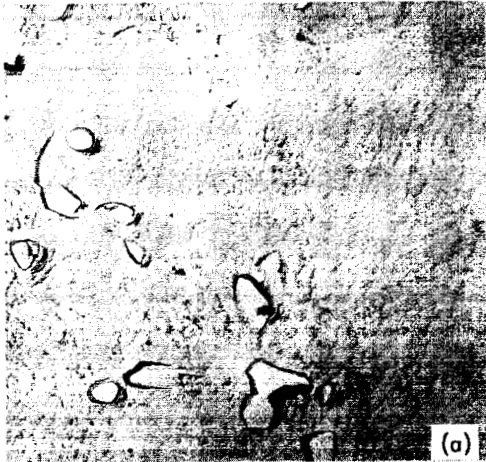
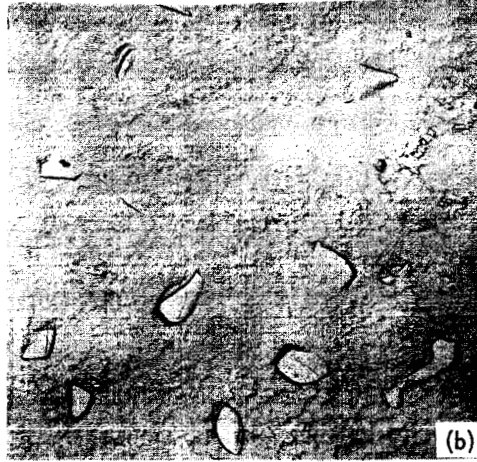
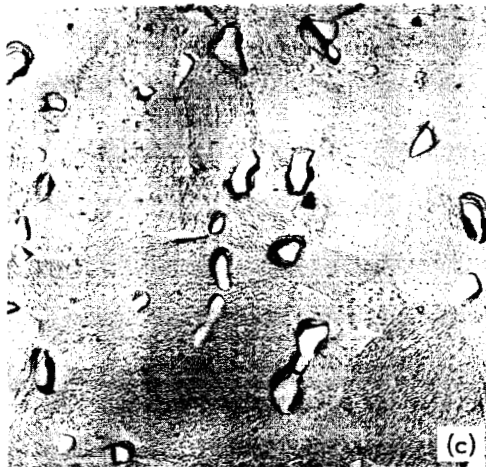
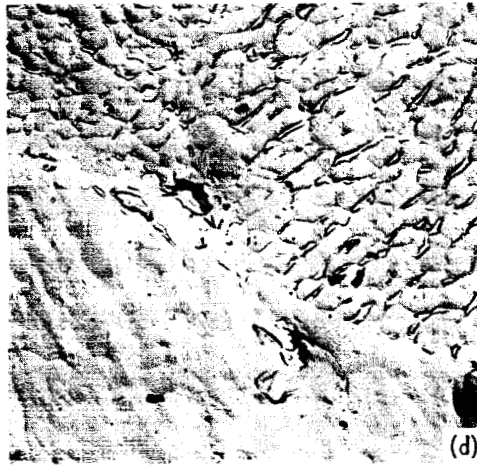
Structure in the mill-annealed condition 3,800X

3,600X 15,800X

Structure in the duplex-annealed condition

FIGURE 5. ELECTRON MICROGRAPHS OF Ti-8Al-1Mo-1V ALLOY

The structures of the mill- and duplex-annealed alloy are shown in Figure 5. In both conditions, small particles of a second phase (presumably the body-centered cubic beta phase) were distributed within the alpha matrix and along grain boundaries. Many fine second phase particles were also seen in some of the alpha grains, but these finer particles were much more distinct in the duplex-annealed material (compare Figure 5b and c). The morphology of this fine precipitate indicates it is either needle-like or plate-like in character and precipitates on a definite habit plane. Evidently the duplex-annealing treatment caused precipitation of this phase within the alpha matrix.

The last observation was made during examination of a U-bend sample of the alloy (in the mill-annealed condition) that had been coated with natural sea salt, stressed to the yield point, heated in air for 17 hours at 1200°F, then cooled to 650°F and held at that temperature for several days. Prior to exposure the structure was similar to that shown in Figure 5a and b. The exposure induced precipitation of the fine particles and produced a structure similar to that of duplex-annealed material (Figure 5c and d).

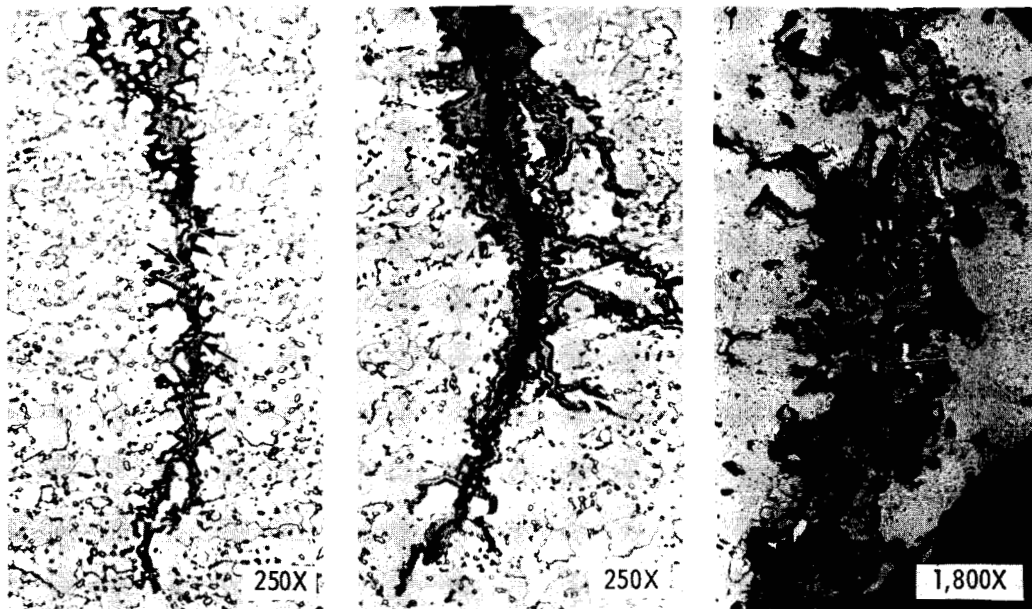
FIGURE 6. TYPICAL STRESS CORROSION CRACKS IN A Ti-8Al-1Mo-1V ALLOY EXPOSED TO DRY SEA SALT AT ELEVATED TEMPERATURES

Second phase is indicated by arrows. Oxide film was on both sides of crack.

The exposure also caused intergranular stress corrosion cracking to occur throughout the bend of the sample. Typical examples of these cracks are shown in Figure 6. Corrosion products (apparently oxides) were observed along the crack walls and the larger second phase was often contained unattached within this oxide.

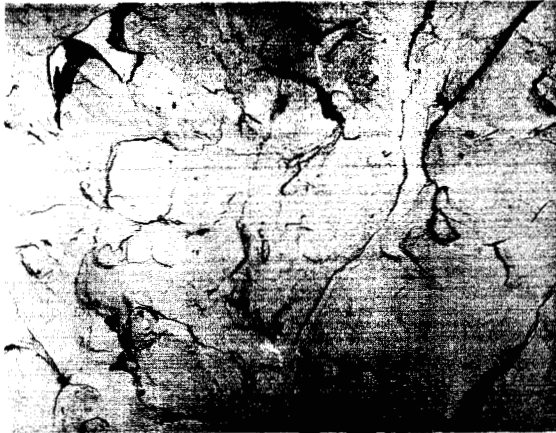
a) Ductile fracture in region remote from cracked area. Note dimpled surface. 3,600X

After metallographic examination of the sample cross section, the specimen was mechanically fractured in regions containing stress corrosion cracks and in regions remote from the cracks. The fracture faces were then examined by fractographic techniques. This examination indicated that the exposure did not embrittle the sample except for the reduction in cross section caused by the cracks. In regions remote from the cracks, fracture occurred by ductile mechanisms, as shown by the dimpled regions seen in Figure 7a; no evidence of brittle fracture was found. In the region containing stress corrosion cracks, fracture also occurred by ductile mechanisms in the area below the crack tips (Figure 7b). In contrast, the faces of the stress corrosion cracks were characterized by a structure with features approximately the same size as the alpha grains of the alloy (Figure 7c). The detail of these faces indicated that stress corrosion cracking occurred by chemical, not mechanical, means. No evidence of ductile rupture was apparent except near the crack tips where a transition from stress corrosion to mechanical fracture occurred (Figure 7d). One interesting feature of the crack faces was the occurrence

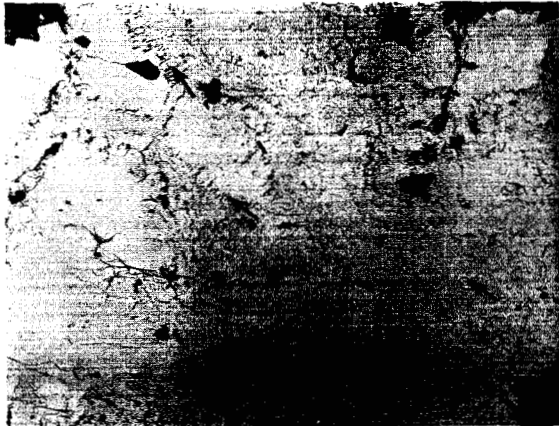
c) Stress corrosion fracture face. Arrows indicate secondary cracks. 3,600X

of small secondary cracks that formed patterns of regular striations in isolated areas (see arrows in Figure 7c). The size and orientations of these cracks corresponded to the size and orientation of the fine second phase in the duplex-annealed alloy, indicating that this phase (or the phase boundary) may be involved in the cracking processes. Although these observations have been made on only one sample and their reproducibility and significance have not been confirmed, they show that fractography and structural observations should be useful tools in determining the nature of the susceptible path for stress corrosion cracking. Additional studies are planned along these lines.

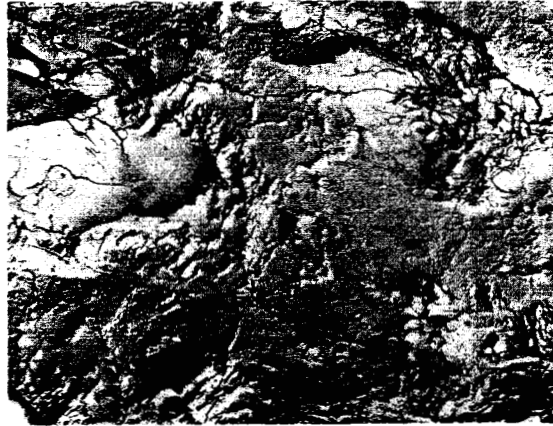
d) Area that failed at crack tip by stress corrosion cracking and mechanical rupture 3,600X

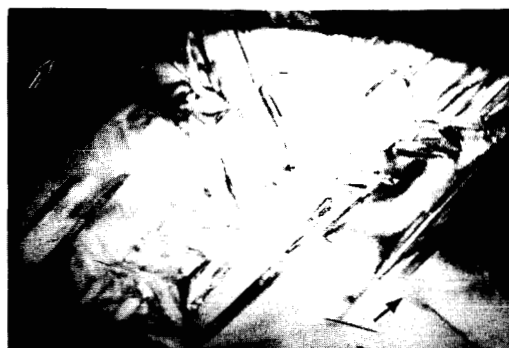
a) Apparent grain boundary runs diagonally between arrows 21,000X

FIGURE 8. TRANSMISSION MICROGRAPHS OF Ti-8 Al-1 Mo-1V ALLOY IN THE MILL-ANNEALED CONDITION

Thin foils of titanium alloy for electron transmission studies of the fine structure were prepared in a  $\text{HNO}_3$ -HF-lactic acid bath while the sample was under an impressed cathodic current. Study of the effect of fine structure on susceptibility to stress corrosion cracking is proceeding. Figure 8 shows several transmission photographs of the alloy in the mill-annealed condition. Electron diffraction patterns were made from the foils, but indexing of the patterns has not been completed. Therefore, positive interpretations of structural details revealed by these transmission electron-micrographs cannot be given at this time. However, the micrographs reveal an apparent grain boundary (Figure 8a), dark spots (Figure 8b and 8c) that are probably beta phase particles, and some structural detail of the alpha matrix (Figure 8d). These structural features may be due to formation of a super lattice, which is known to occur in the alpha phase in Ti-Al alloys<sup>(2)</sup>, to twinning of the hexagonal structure, or to incipient precipitation along stacking faults. These photographs provide further evidence that the beta phase is cathodic to the matrix, because during thinning of the foils, preferential attack occurred around the edges of the dark spots (beta particles) (Figure 8c).

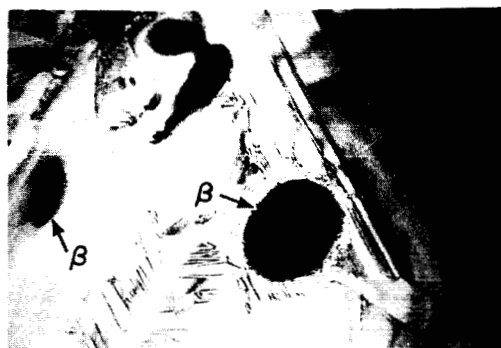
b) Section shows second phase, probably beta, in the matrix 15,800X

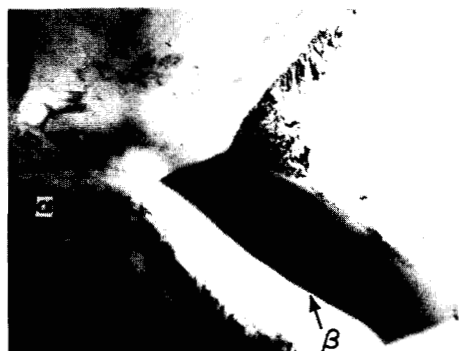
c) Preferential attack at probable alpha-beta interface 21,800X

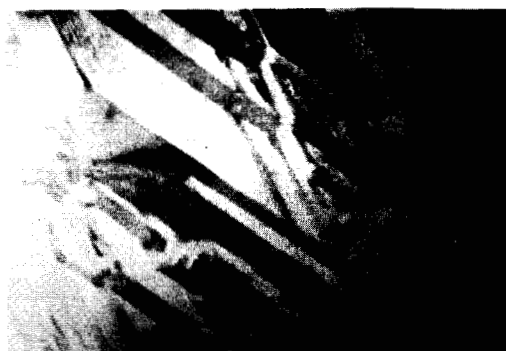
d) Structural detail of alpha matrix 33,000X
