SNAP-8 TOPICAL MATERIALS REPORT FOR 1962

VOL. III - SNAP-8 MERCURY CORROSION AND MATERIALS RESEARCH

National Aeronautics and Space Administration

Report No. 2517

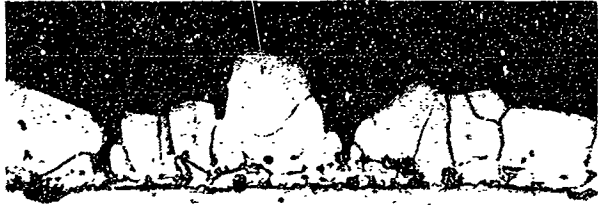
This capsule showed the same corrosion pattern found in the 5000 hour, 1025°F capsule. The depleted layer was approximately 0.0013 in. deep and extended to the middle of the capsule. No evidence of spalling of the depleted layer was found. The mass transfer deposit formed near the top of the capsule built up to 0.0015 in. maximum. Typical sections of the top and bottom portions of the capsule are shown in Figure 16.

500X TOP SECTION OF CAPSULE 1943
 MASS TRANSFER DEPOSIT

500X BOTTOM SECTION OF CAPSULE 1946
 DEPLETED LAYER

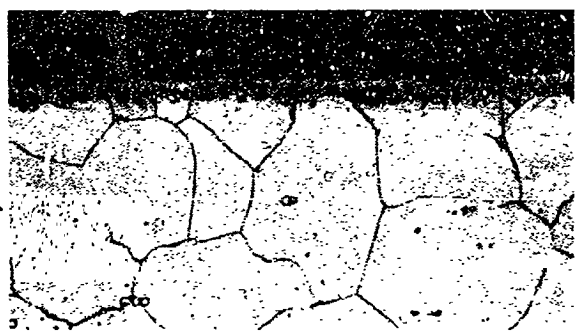
Corrosion effects were found along the entire length of the capsule. A depleted layer was found along the bottom section of the capsule approximately 0.002 in. deep, maximum. The depleted layer tapered off to a very thin layer, but it extended under the mass transfer deposit found at the top of the capsule. No evidence of spalling of the depleted layer is evident. Typical sections are shown in Figure 17.

500X TOP SECTION OF CAPSULE 2457
MASS TRANSFER DEPOSIT
AND DEPLETED LAYER

500X MIDDLE SECTION OF CAPSULE 2458
DEPLETED LAYER

500X BOTTOM SECTION OF CAPSULE 2467
DEPLETED LAYER

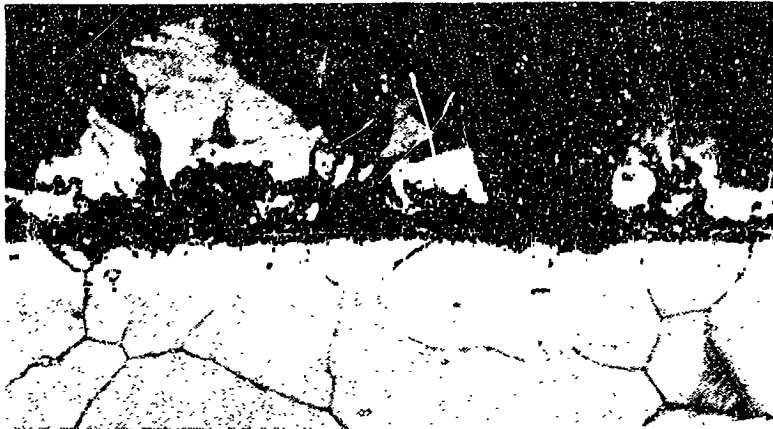
A very thin depleted layer was found along the entire length of the capsule and a mass transfer deposit was evident near the top. Typical sections of the top and bottom of the capsule are shown in Figure 19. This capsule was a vacuum type capsule and it is believed that the mass transfer deposit resulted from refluxing in the space above the liquid.

TOP SECTION OF CAPSULE
MASS TRANSFER DEPOSIT
AND DEPLETED LAYER

BOTTOM SECTION OF
CAPSULE
THIN DEPLETED LAYER

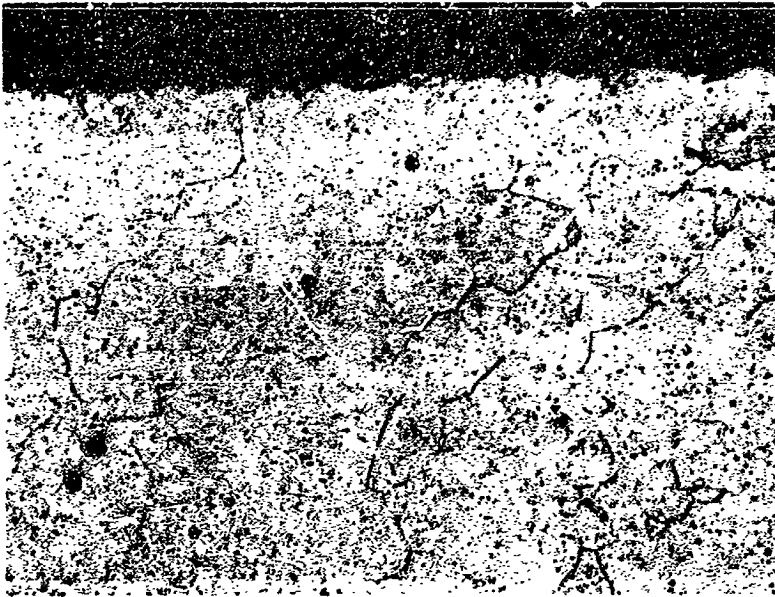
No corrosion layer of any type was found on the Type 405 stainless steel capsule exposed for 5000 hours at 1025°F. A mass transfer deposit was formed at the top of the capsule, indicating that an even solution attack must have taken place. Figure 27 shows a typical microstructure of the inside of the capsule.

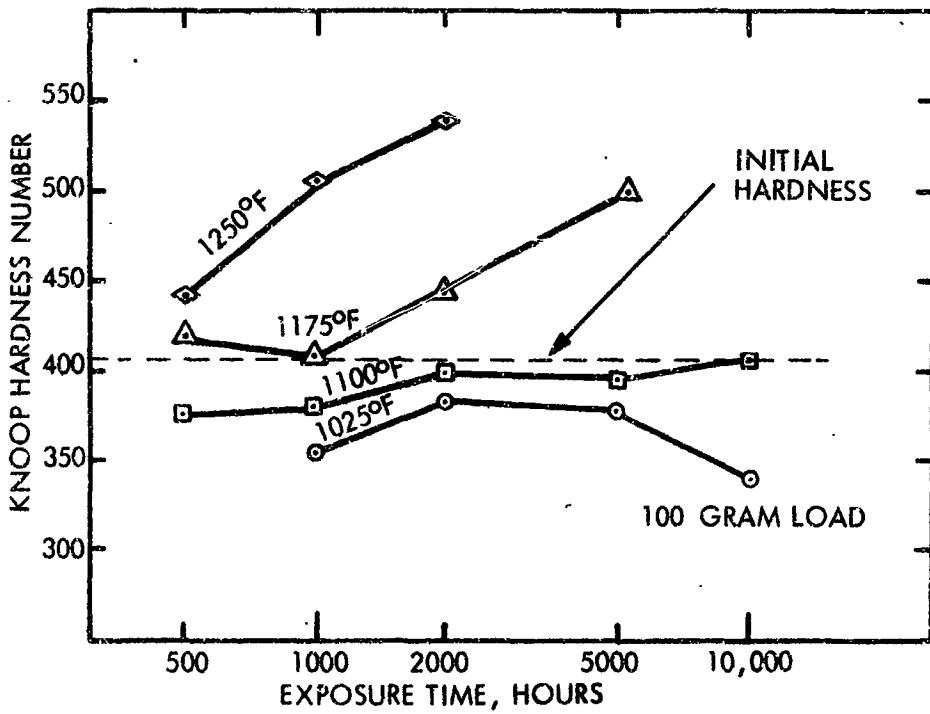
FIGURE 37. KNOOP HARDNESS VERSUS EXPOSURE TIME FOR HAYNES 25

The values obtained from the tensile tests indicate that the mechanical properties of Haynes 25 are affected by age hardening. However, the tensile values are not the same as typical or minimum values obtained for Haynes 25 aged in air at the test temperature. It should be remembered that the tensile specimens machined from compatibility capsules are not standard test specimens and that they have been exposed to Hg; therefore, the values can only be compared with results from tensile tests conducted with the same type of specimens exposed to similar environments.
