NASA WG3 MMOD Protection Summary

34th Interagency Space Debris Coordination Committee (IADC)

Summary of MMOD Protection Activities

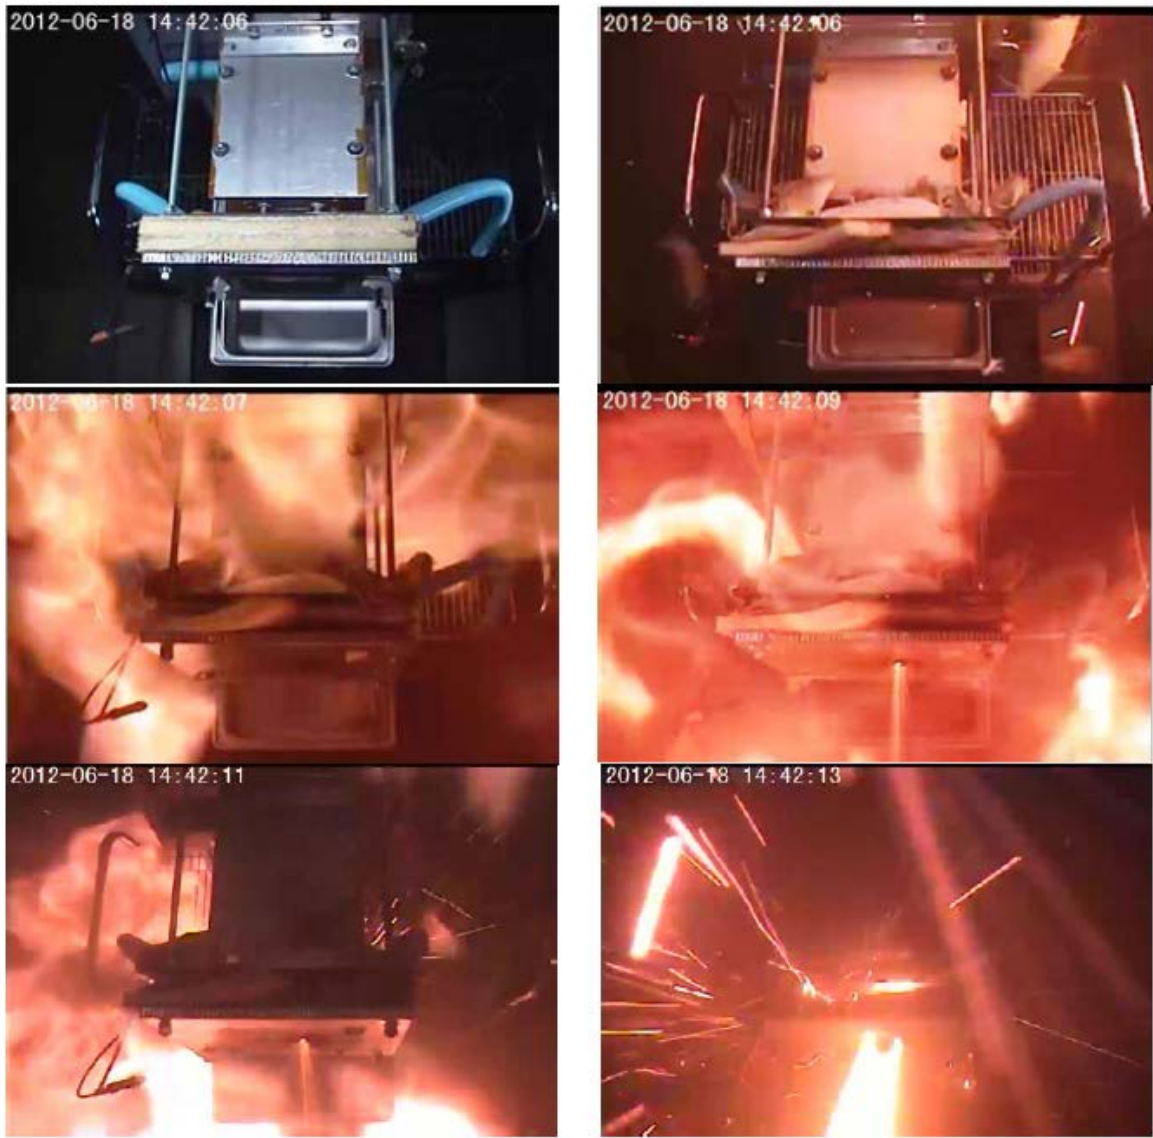
HITF-12143, 1cm diameter Al @ 6.86 km/s

Figure 1.2-1. HITF12143 visible video frames at 1s-2s intervals after impact.

- Several hypervelocity impact tests performed on Li-ion battery cells
- Cells were fully-charged prior to impact and protected by honeycomb panel and additional shielding materials
- Two cells in each test (“primary” was impacted, “secondary” cell was in close proximity to determine if thermal effects propagate

Test #	Projectile Diameter (mm)	Impact Obliquity (°)	Impact Speed (km/s)	Cell Damage Measurements (mm)
HITF12143	10.0	0	6.86	Primary cell-Perforated with peak temperature of 184°C Secondary cell-No ignition or thermal runaway
HITF12144	10.0	0	7.02	Primary cell-Perforated, no ignition, peak temperature 194°C Secondary cell- Thermal runaway peaking at 531°C
HITF12145	10.0	30	7.05	Primary cell-No Perforation Secondary cell-No Perforation
HITF12147	13.5	45	6.88	Primary cell-Perforated with peak temperature of 193°C Secondary cell- Thermal runaway peaking at 315°C
HITF12148	10.0	0	7.19	Primary cell-Perforated, no ignition Secondary cell-No ignition or thermal runaway

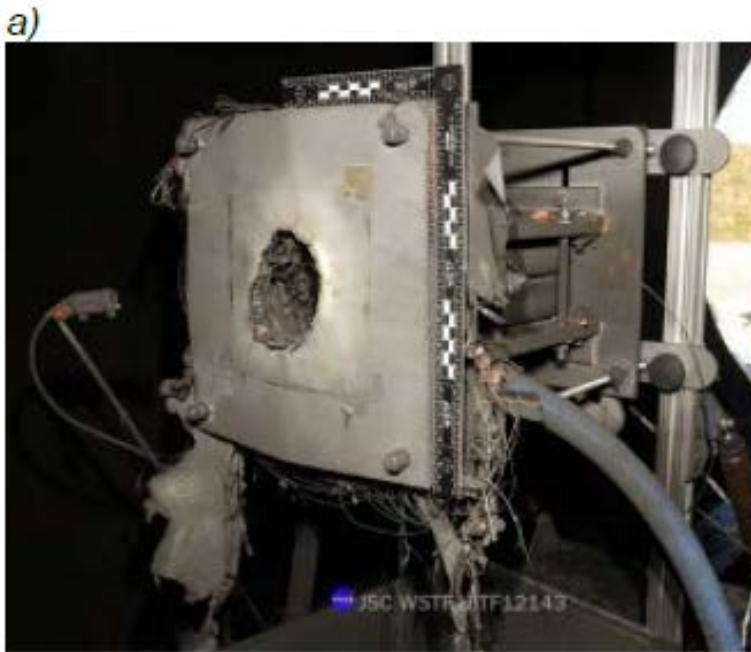
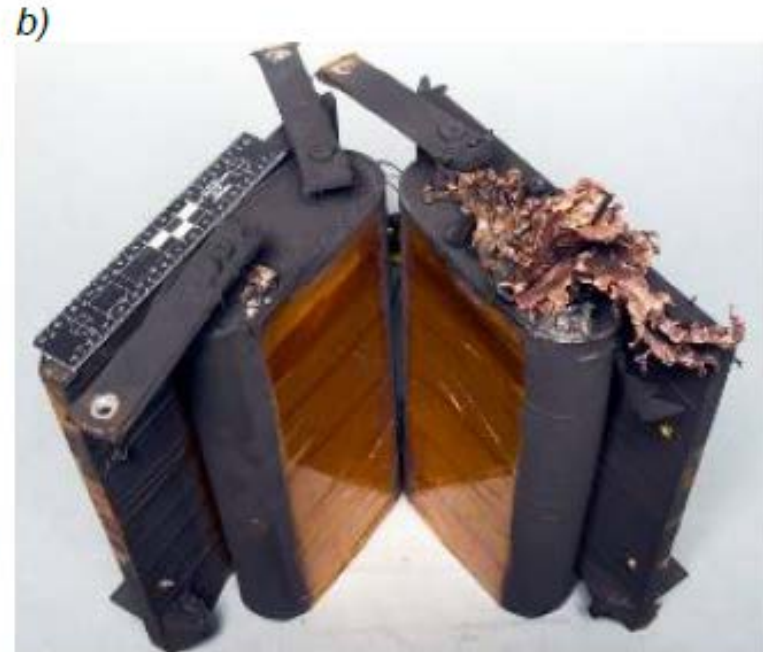
HITF-12143, 1cm diameter Al @ 6.86 km/s

- Energetic response to hypervelocity impact

Figure 1.2-2. After test imagery of HITF12143 a) shield with 9.5cm diameter through-hole, and b) cell close-up with impacted cell on right showing molten material from cell interior that was ejected and deposited on exterior of cell.

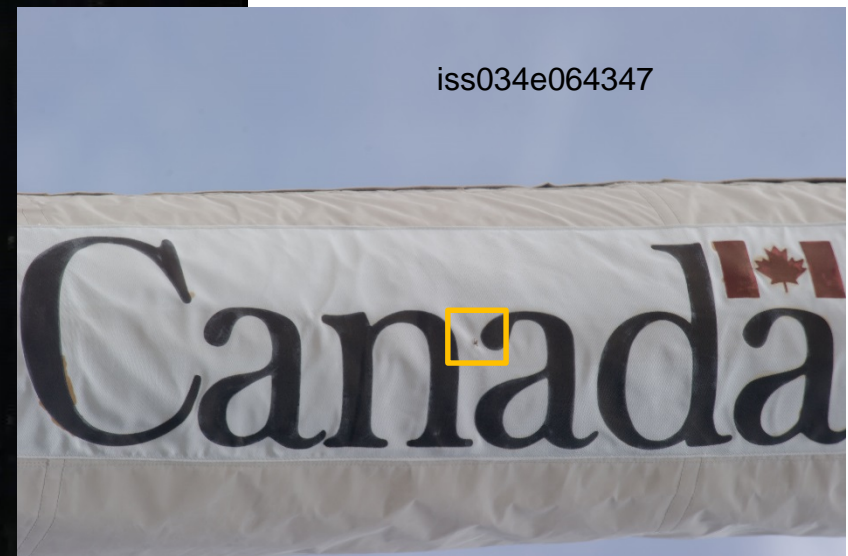
Possible MMOD strike on SSRMS, close-up image obtained 9 Oct 2015
