# Wear Trends of the HERMeS Thruster as a Function of Throttle Point

IEPC-2017-207

*Presented at the 35th International Electric Propulsion Conference  
Georgia Institute of Technology • Atlanta, Georgia • USA  
October 8 – 12, 2017*

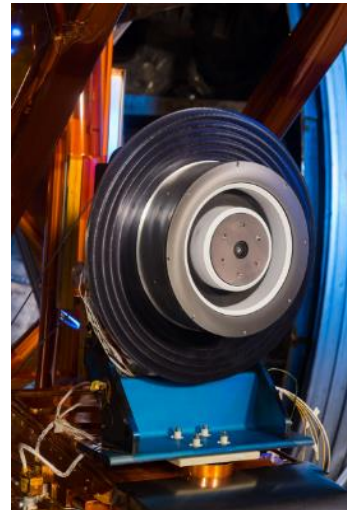
**Figure 3. TDU-1 in VF-6 configured for short-duration wear testing.**

TDU-1 was operated in Vacuum Facility 6 (VF-6) at GRC. A base pressure of  $9 \cdot 10^{-8}$  Torr (air) was achieved throughout the campaign. However, the pumping speed of VF-6 is roughly half that of VF-5 and TDU-1 operated at higher pressures than did TDU-3 in VF-5 for the same thruster operating condition. VF-6 was modified to accommodate AEPS testing as described in Peterson.<sup>18</sup> This included the fabrication of a thrust stand and assembly of a plasma probe rake identical to the one used in VF-5. An improved data acquisition and recording software suite was developed for VF-6 testing and then incorporated at VF-5. Figure 3 shows TDU-1 in VF-6 during the test campaign.

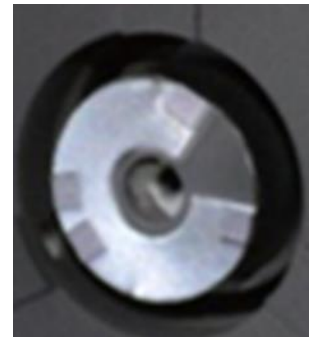
Figure 4 shows a Mo mask that was used to characterize the erosion of the keeper electrode. The mask incorporated a notch that exposed the underlying graphite surface and an orifice that was significantly larger than the keeper orifice to minimize the impact of the mask on the keeper's operating characteristics. The mask was replaced after each test and the notch was clocked to expose a different segment of the keeper electrode. The mask was held in place by a tantalum sleeve that was spot-welded to the Mo mask and friction fit around the outer diameter of the keeper tube. The tabs of the Ta sleeve that folded over the Mo mask and provided the point of attachment also provided unexposed surfaces on the Mo mask for measurement reference.

**Figure 4. Mo mask on keeper electrode.**
