Characterizing GEO Titan IIIC Transtage Fragmentations using Ground-based and Telescopic Measurements

Abstract

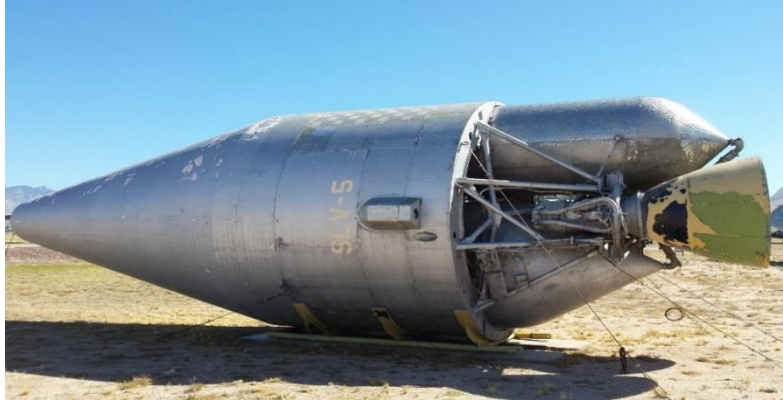
Fig. 2. Titan IIIC Transtage test article stored at the “Boneyard”

The authors found the Transtage test article resident at the U.S. Air Force's 309th Aerospace Maintenance and Regeneration Group (AMARG), better known as the "Boneyard," at Davis-Monthan Air Force Base in Tucson, Arizona. A June 2015 inspection by ODPO scientists Dr. Phillip Anz-Meador and Dr. Heather Cowardin determined that the Transtage object was probably an engine test article, one of the so-called "battleship" mockups used for design, integration, test, and validation, and not a flight ready vehicle. Digital images of the inspection are shown in Fig. 2 and Fig. 3.

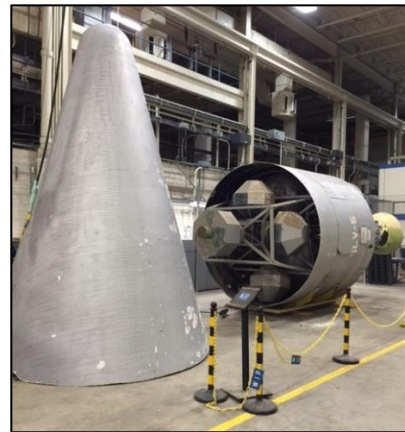
Fig. 7. Nosecone removal and staging after the test article’s arrival at NASA JSC. Note sample payload attachments that show how a Titan IIIC Transtage was used to put satellites in a GEO orbit.

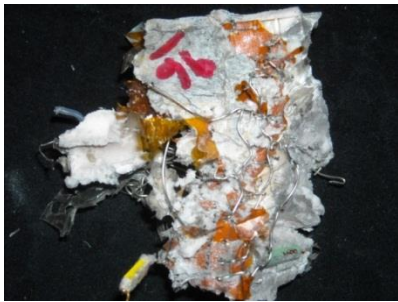
Fig.22. Composite fragment from an impact experiment based on a 1960s era Transit satellite. The color-color plot matched the closest with the observed SSN 3432 Titan Transtage fragment.
